**Re: Lovington Paddock Unit No. 59 Well Site
Case No. 1RP-915
2018 Site Assessment Report and Work Plan
Lea County, New Mexico**

Site Assessment Report

Lovington Paddock Unit 59

Produced Water Release

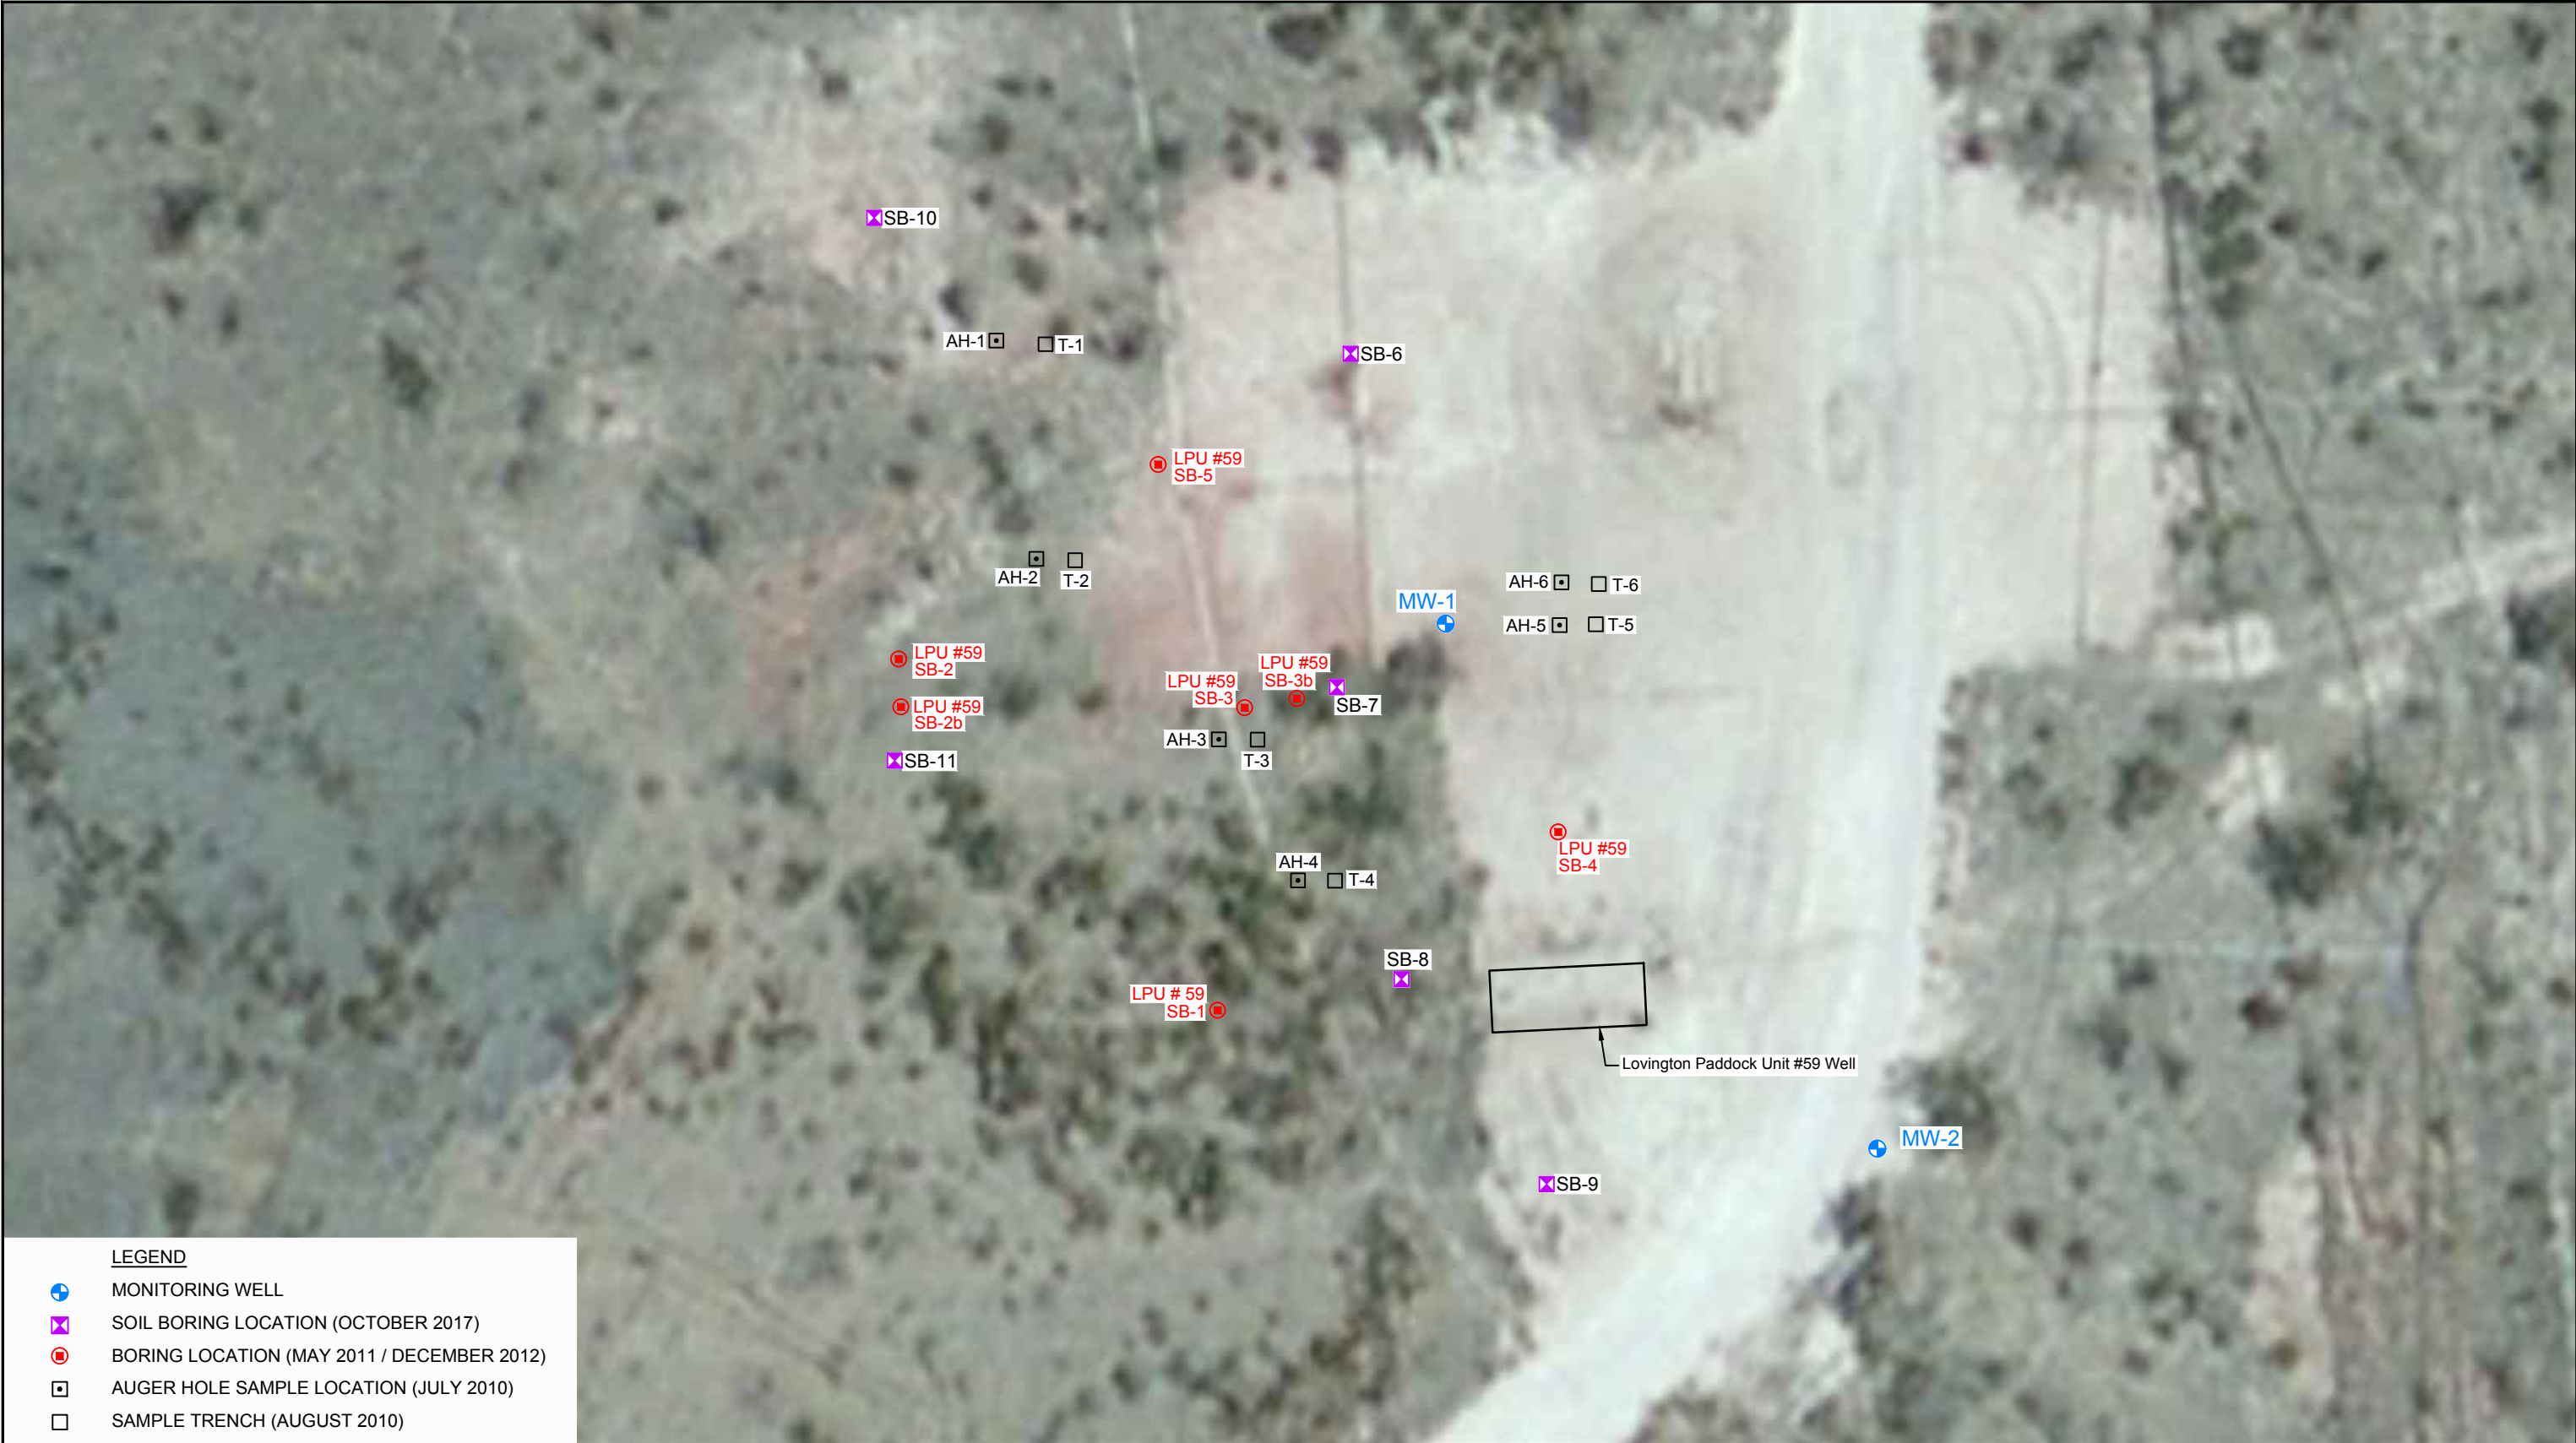
FIGURE 4

A soil analytical summary of results from 2010 through 2018 is presented in Table 1. A Chloride Analytical Results Map for Soils (2010 – 2018) is presented as Figure 4.

- Chloride concentrations above the revised Rule 19.15.29 screening limit of 20,000 mg/kg were not reported in any of the soil samples collected from MW-2.

CHLORIDE ANALYTICAL RESULTS MAP - SOILS
