Report Type: Closure Report 1RP-5103

Site:	Vaca Draw 20-17 Fed 1H					
Company:	Cimarex Energy					
Section, Township and Range	Unit M	Sec. 20	T 25S	R 33E		
Lease Number:	API No. 30-025-44135					
County:	Lea County					
GPS:	32.109787°			-103.600849°		
Surface Owner:	Federal					
Mineral Owner:	Federal					
Directions:	From the intersection of J-1 and Pipeline Rd head east on Pipeline Rd for 5.05 miles,, turn hard left (northwest) onto unnamed lease road and go 0.7 miles, turn right (northeast) and and go 0.4 miles, turn left (northwest) and go 0.12 miles, turn right (northeast and go 1.08 miles, keep left at the fork in the road and go 1 mile, turn left (west) and go 0.64 miles, arrive at location. Work area is 400 feet to the north in the pasture.

Re: Closure Report for the Cimarex Energy, Vaca Draw 20-17 Fed 1H, Unit M, Section 20, Township 25 South, Range 33 East, Lea County, New Mexico. 1RP-5103.

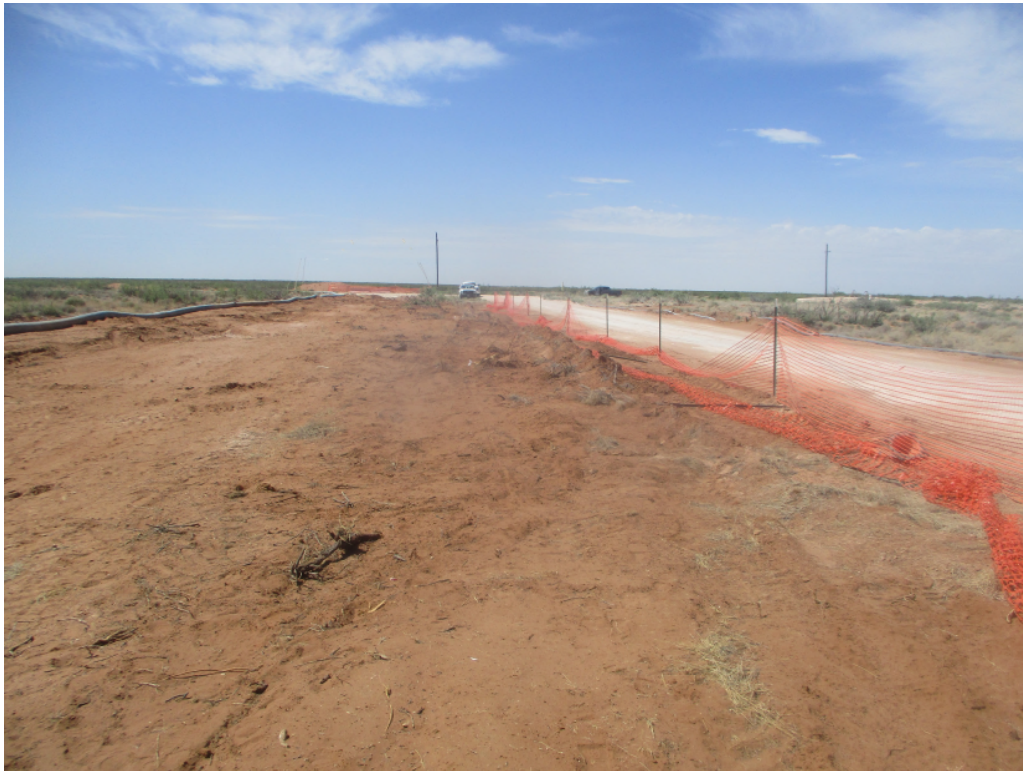
View South – Areas of AH-1 and AH-2

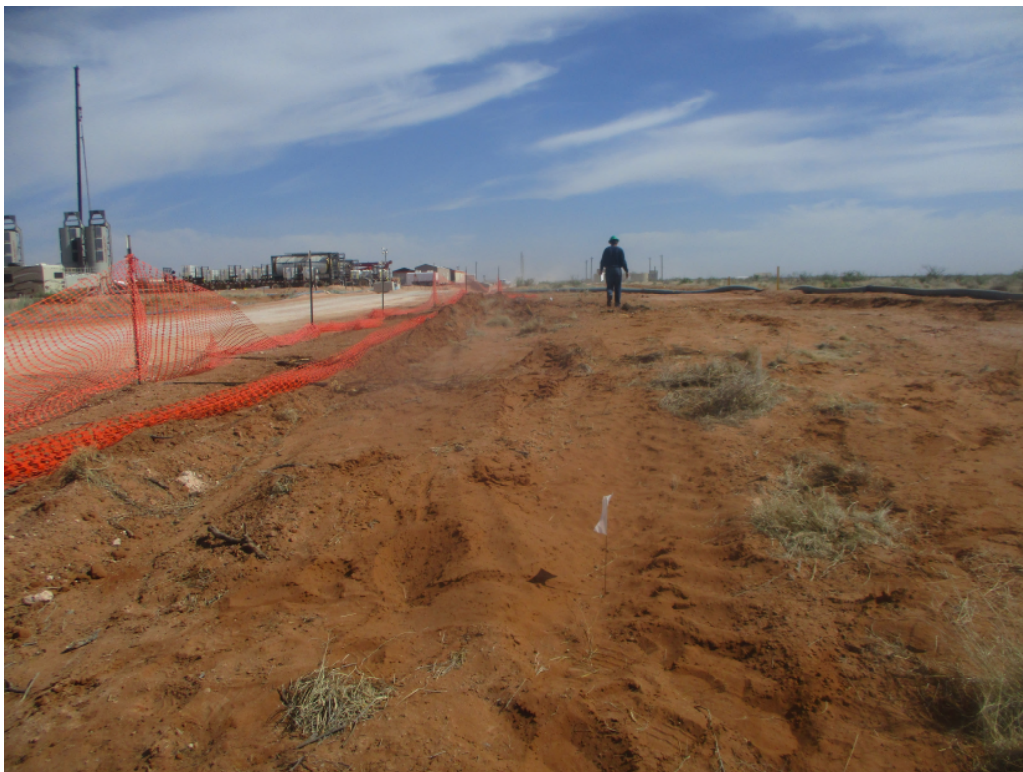
View North – Area of AH-3

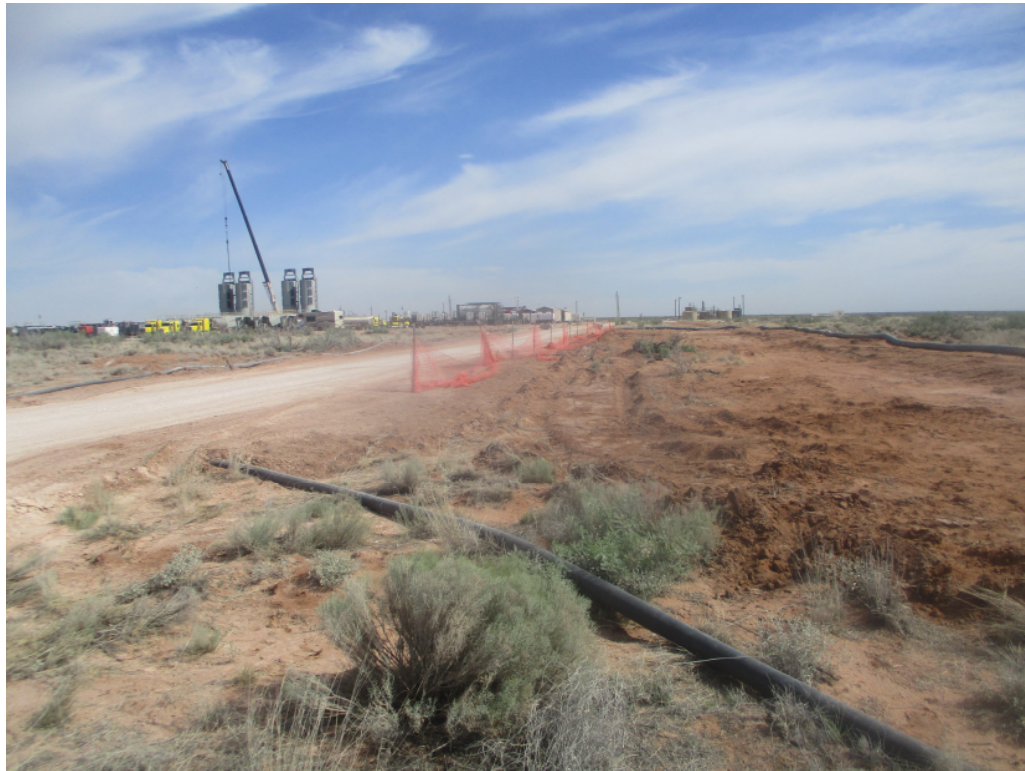
View North – Area of AH-4

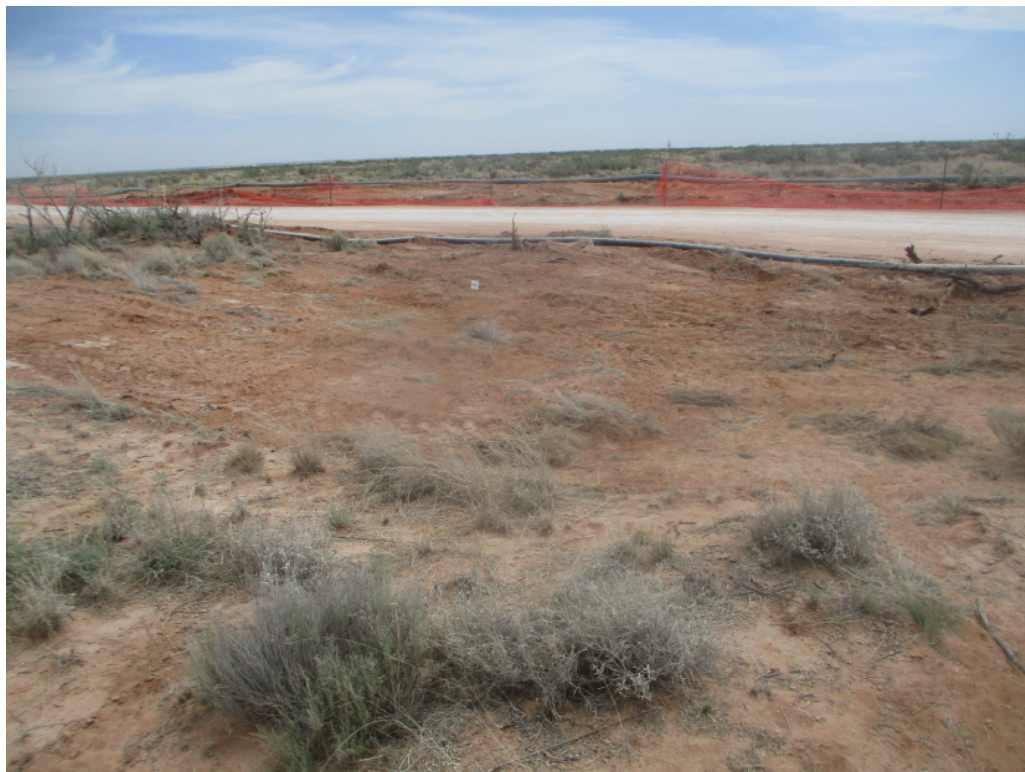
View East – Area of AH-5

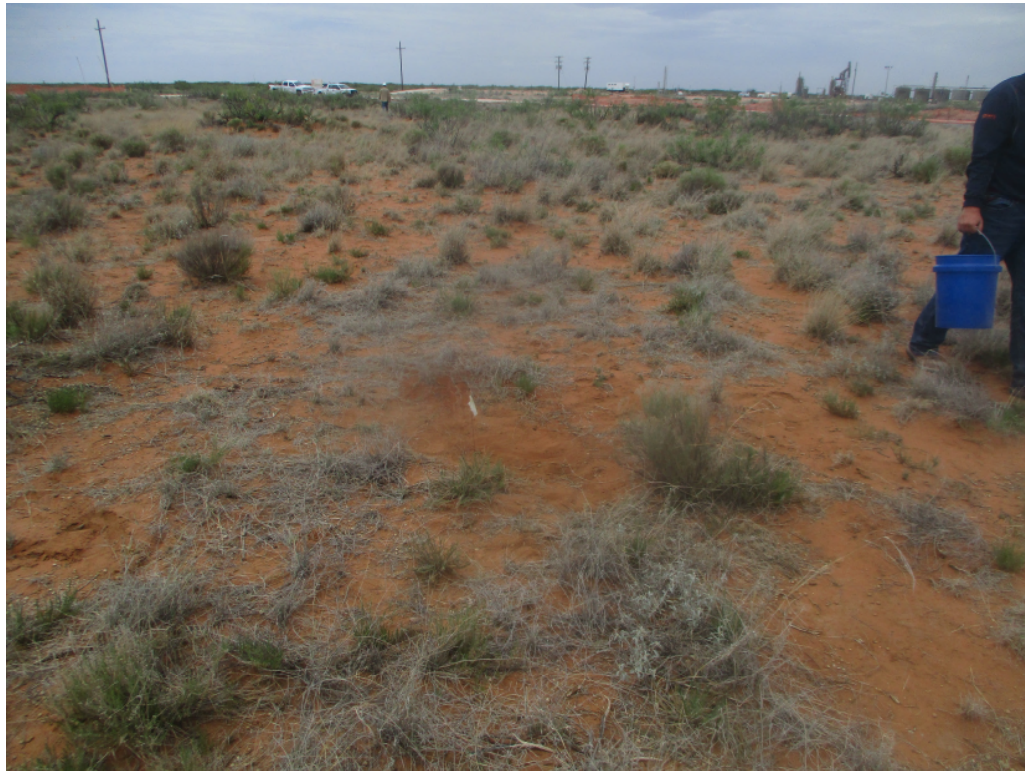
View West – Area of Background

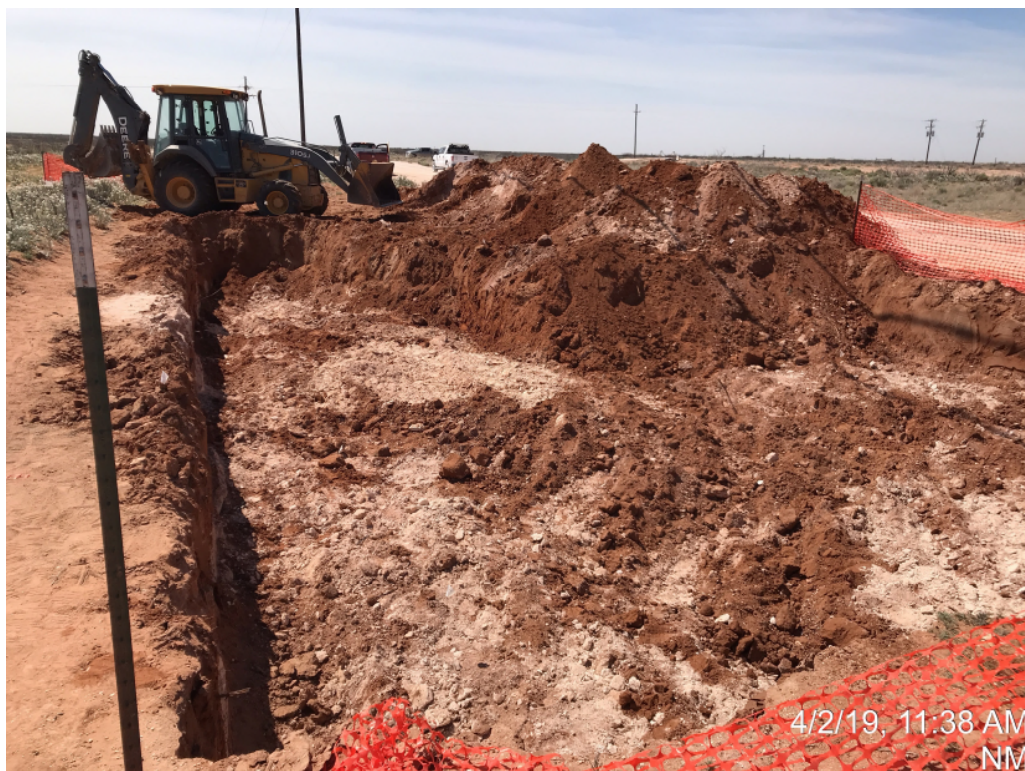
View South – Area of Excavation

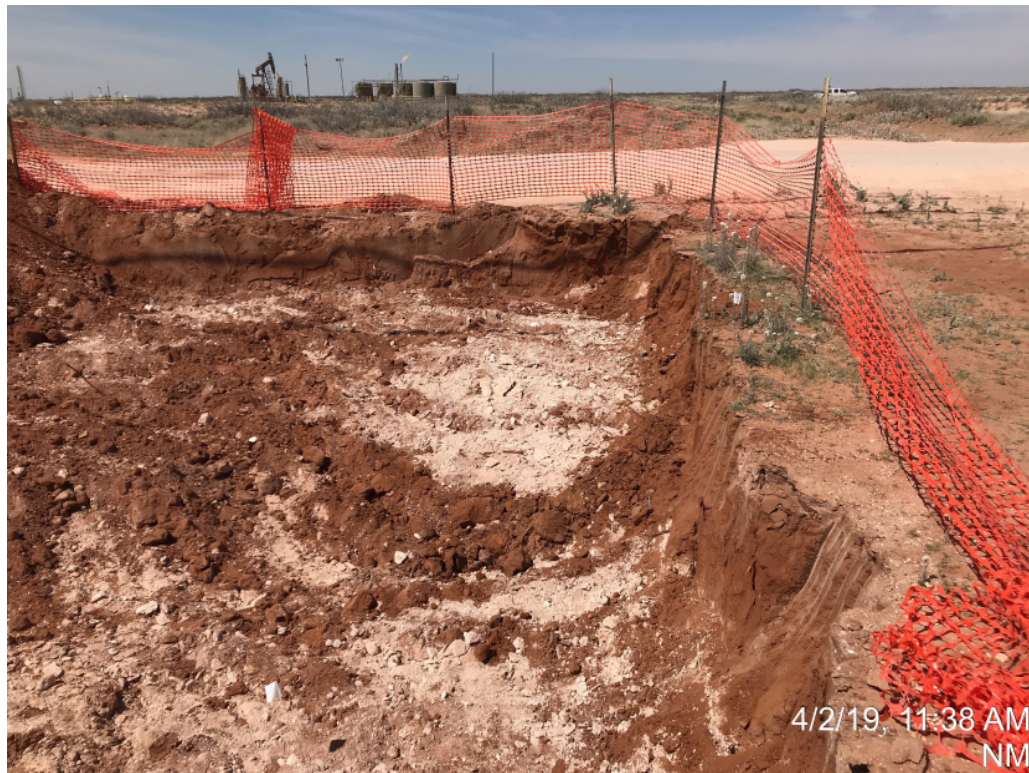
View West – Area of Excavation

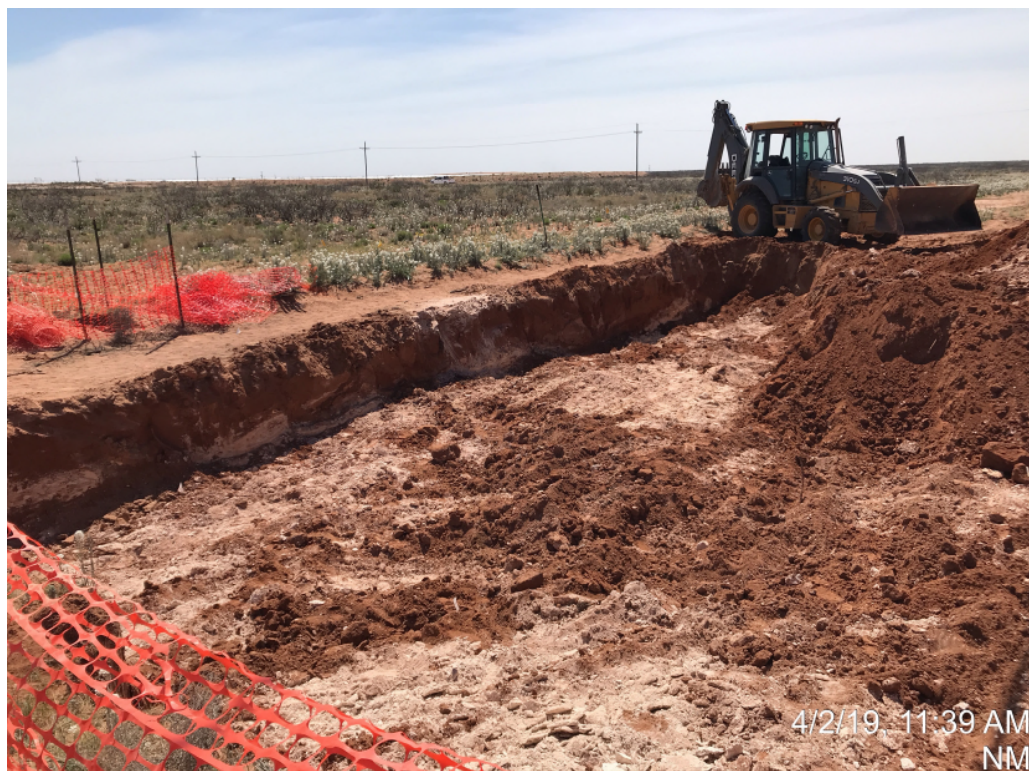
View Southeast – Area of Excavation
