## Release Notification

| Site Name: <b>Rojo 38 41 Tank Battery</b> | Site Type: <b>Tank Battery</b> |

## Daily Progress Report

| <b>Task</b> | Site assessment and grab samples |

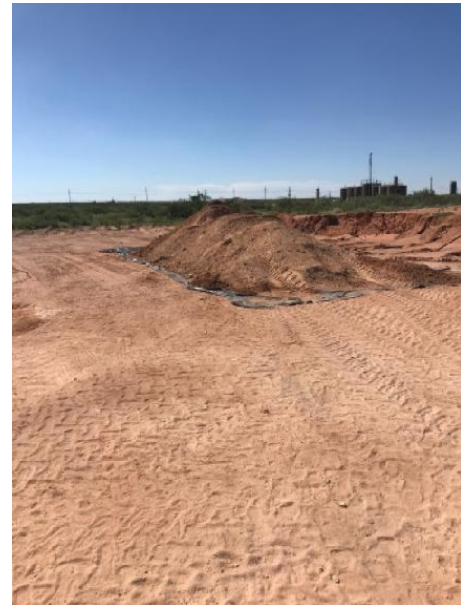
| <b>Picture 1</b> | |

Rojo 38-41 scrape has been completed. Looks very good compared to the pic the day the of spill. Notice a few salt scars and oil wetness in the scrape zones but very minimal. Scrape zone on south of pad is about 80x70

feet. North side near oil tank is about 110x40 feet. The stock pile measures 35x20 at 6feet high. I grabbed a composite sample of stock pile and will be taking to lab.
