ORE IDA 14 Federal 1

Closure

Unit Letter D, Section 14, T24S, R29E
Eddy County, New Mexico

March 23, 2016

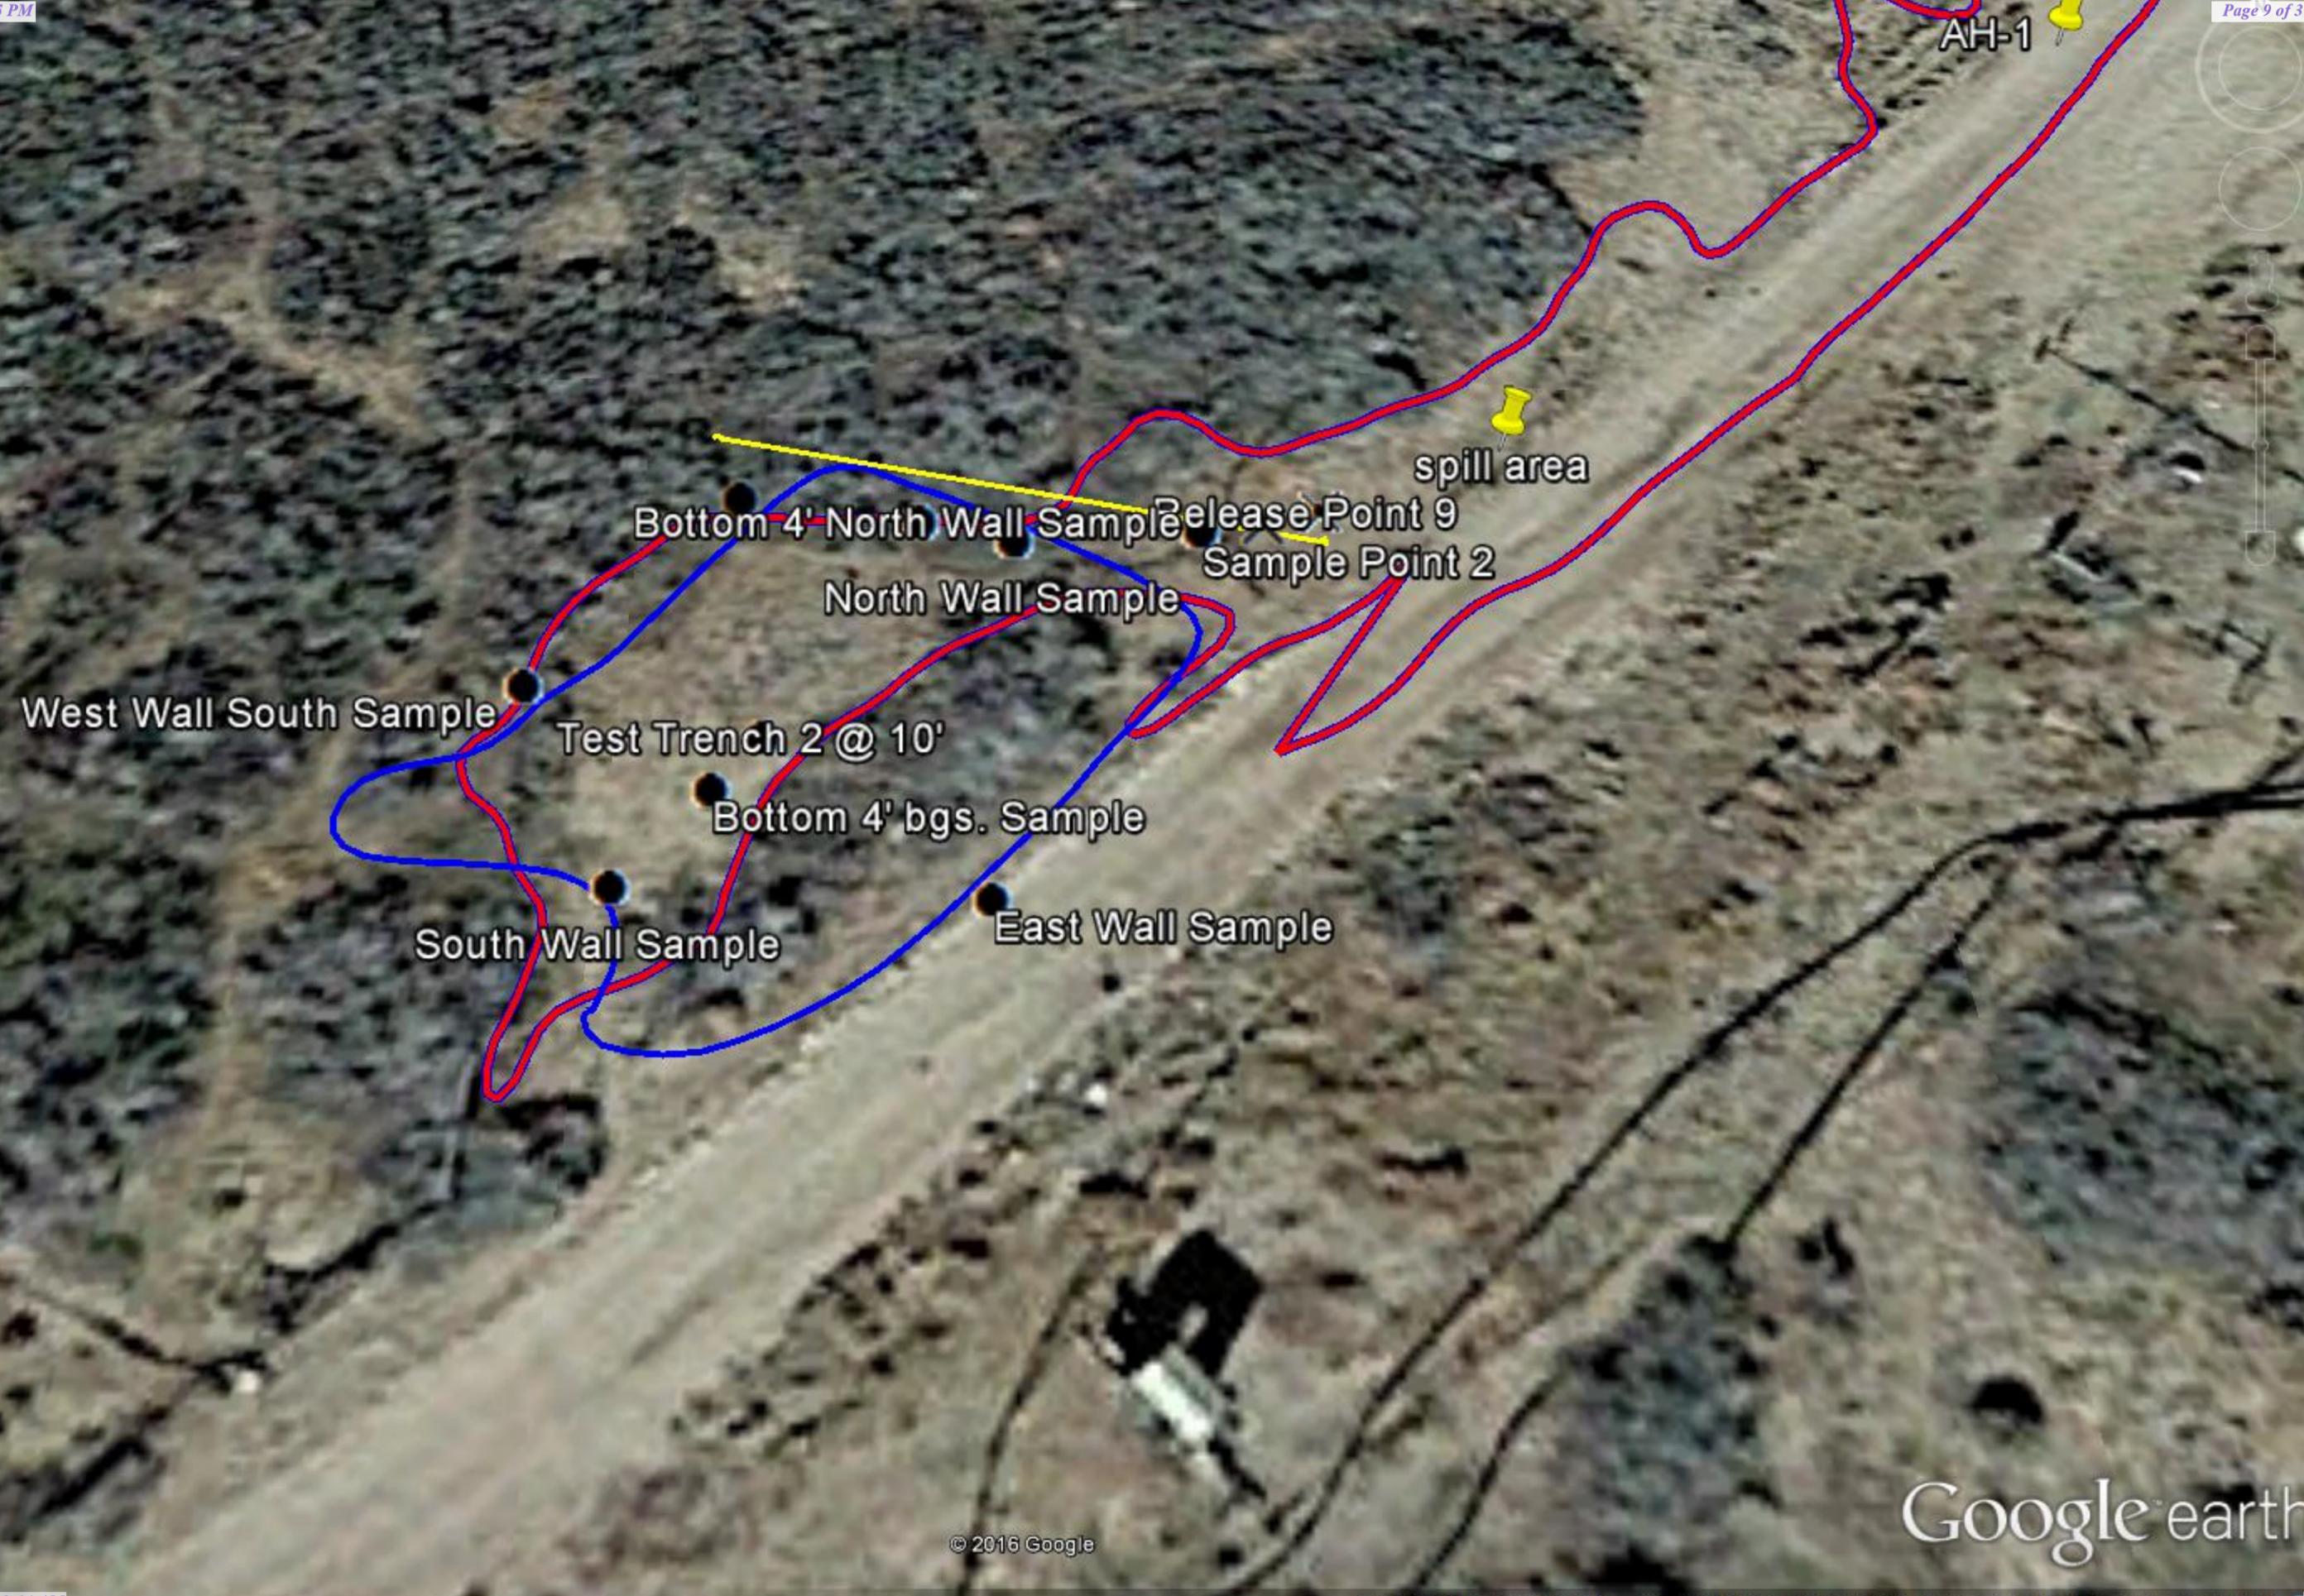
Figure 2 Site Plan

On January 29, 2016 SESI was onsite to photograph, assess and map the spill area. Auger holes were advanced in order to determine vertical extent. The first auger hole was advanced on the north end of the leak area that is located on the lease road. Auger hole two was advanced to 5' bgs., where auger refusal was encountered. Auger hole three was installed at the area where the fluid appeared to have settled, thereby causing the greatest impact, and again auger refusal was encountered at 5' bgs (Figure 2).

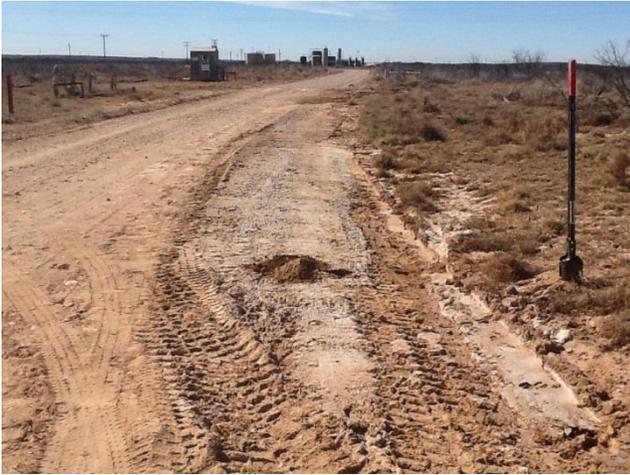
Lease Rd

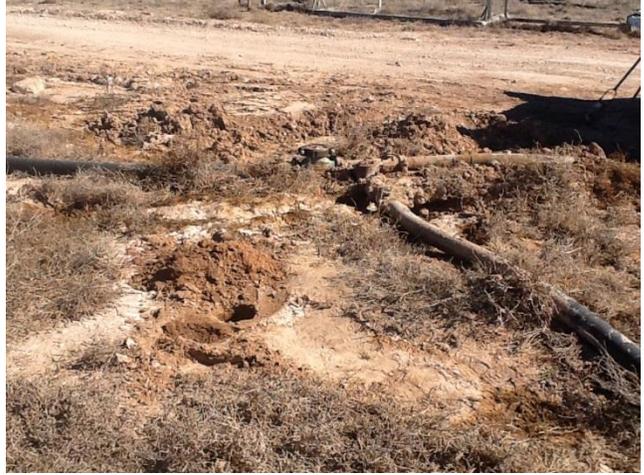
Leak Source Sample Point

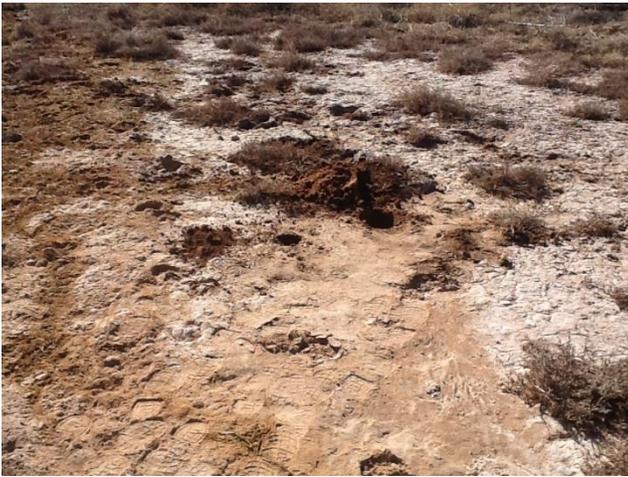
Pasture Sample Point

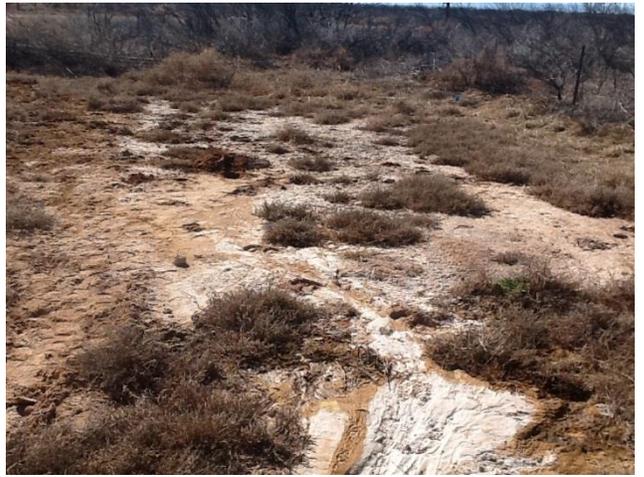
Surface Chlorides

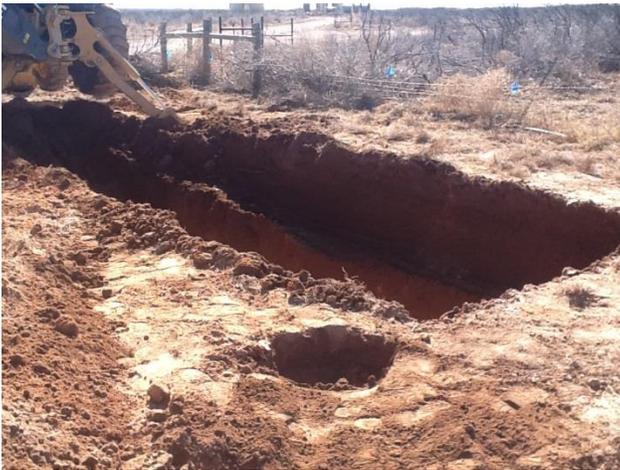
Test Trench

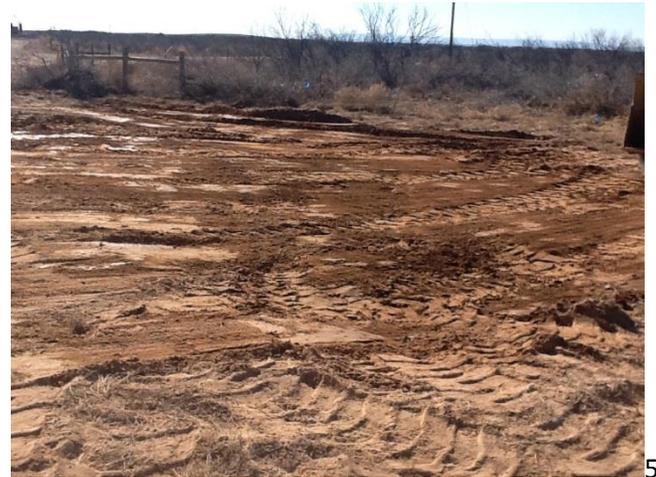
Test Trench restored to grade

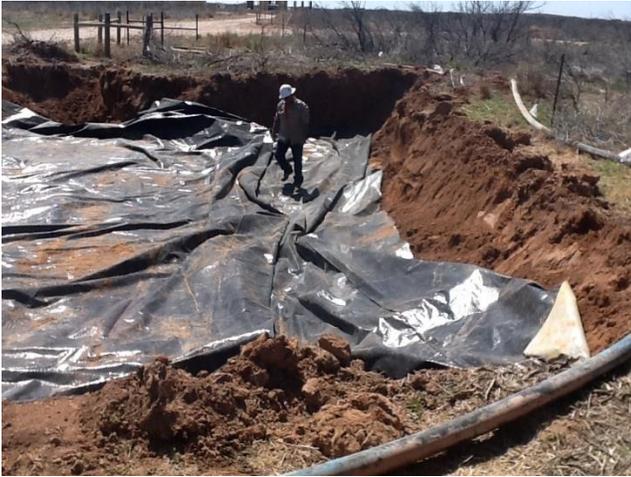
3-16-16 Liner Installation

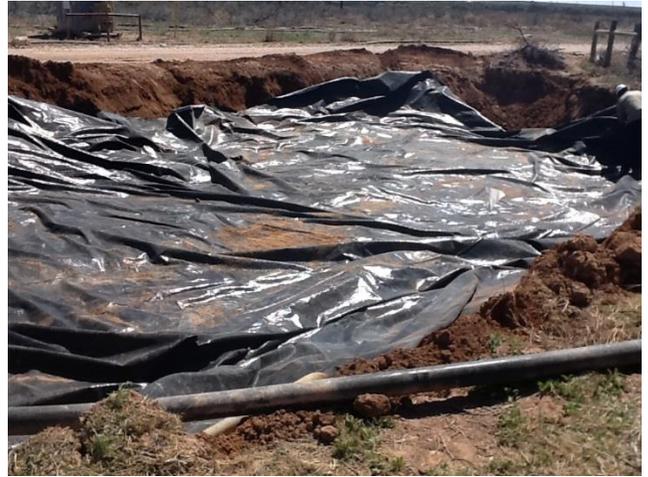
3-16-16 Lined Area

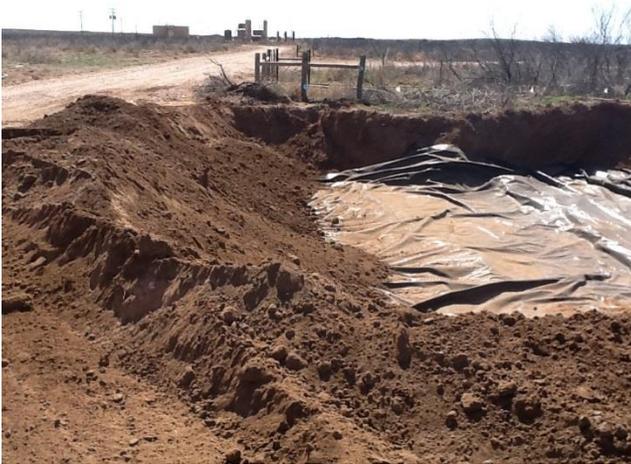
3-17-16 Backfill of south end

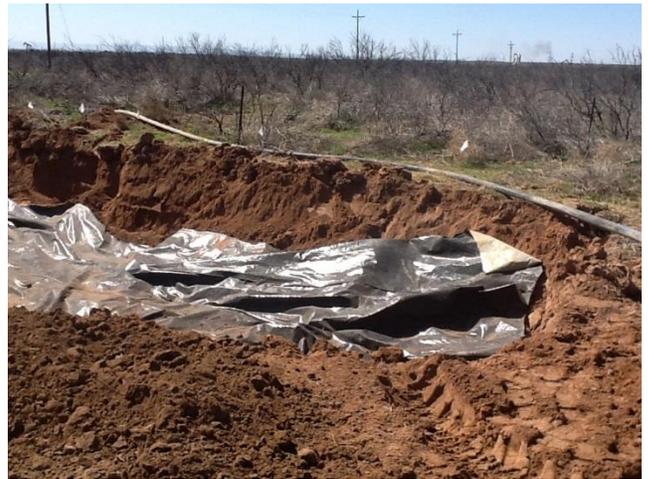
3-17-16 Backfill-unobstructed flowline

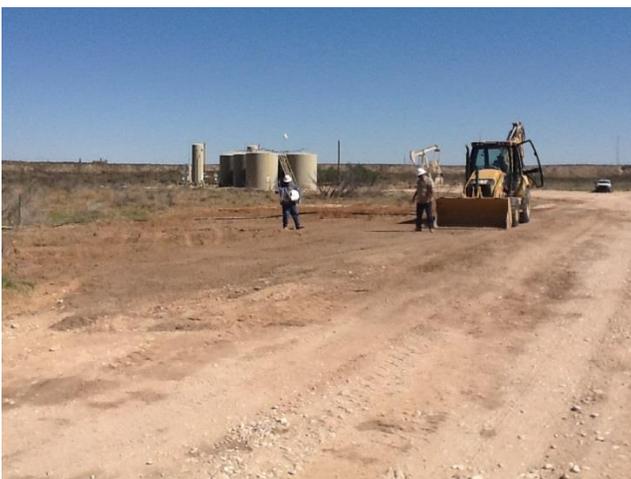
3-17-16 Seeding

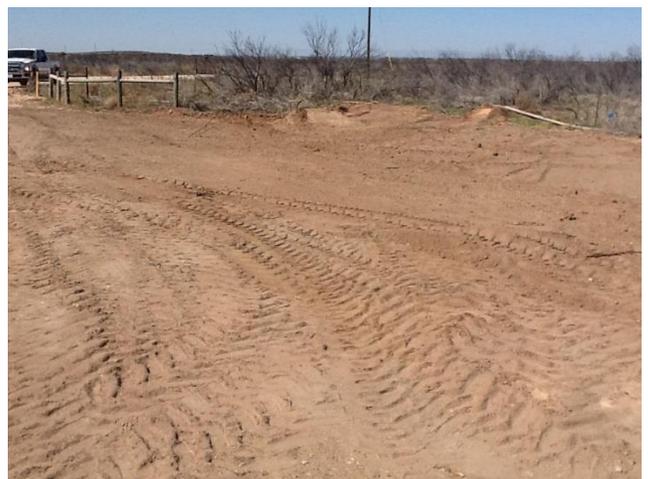
3-17-16 Completion

Based on the confirmation of desired soil constituency levels: all impacted soils were transported to Lea Land, an NMOCD approved facility. On March 17, 2016 the area was returned to natural grade and seeded with the BLM approved seed mixture of LPC #3 that is native to the area, see photo documentation (Appendix D).
