## CLOSURE REPORT

**Carlsbad West 12" Launcher**

**Eddy County, New Mexico  
32.281529 N, 104.287475 W  
NMOCD Incident # NAPP2117254270  
NM OGRID # 329971**

July 8, 2021  
Ensolum Project No. 03B1206021

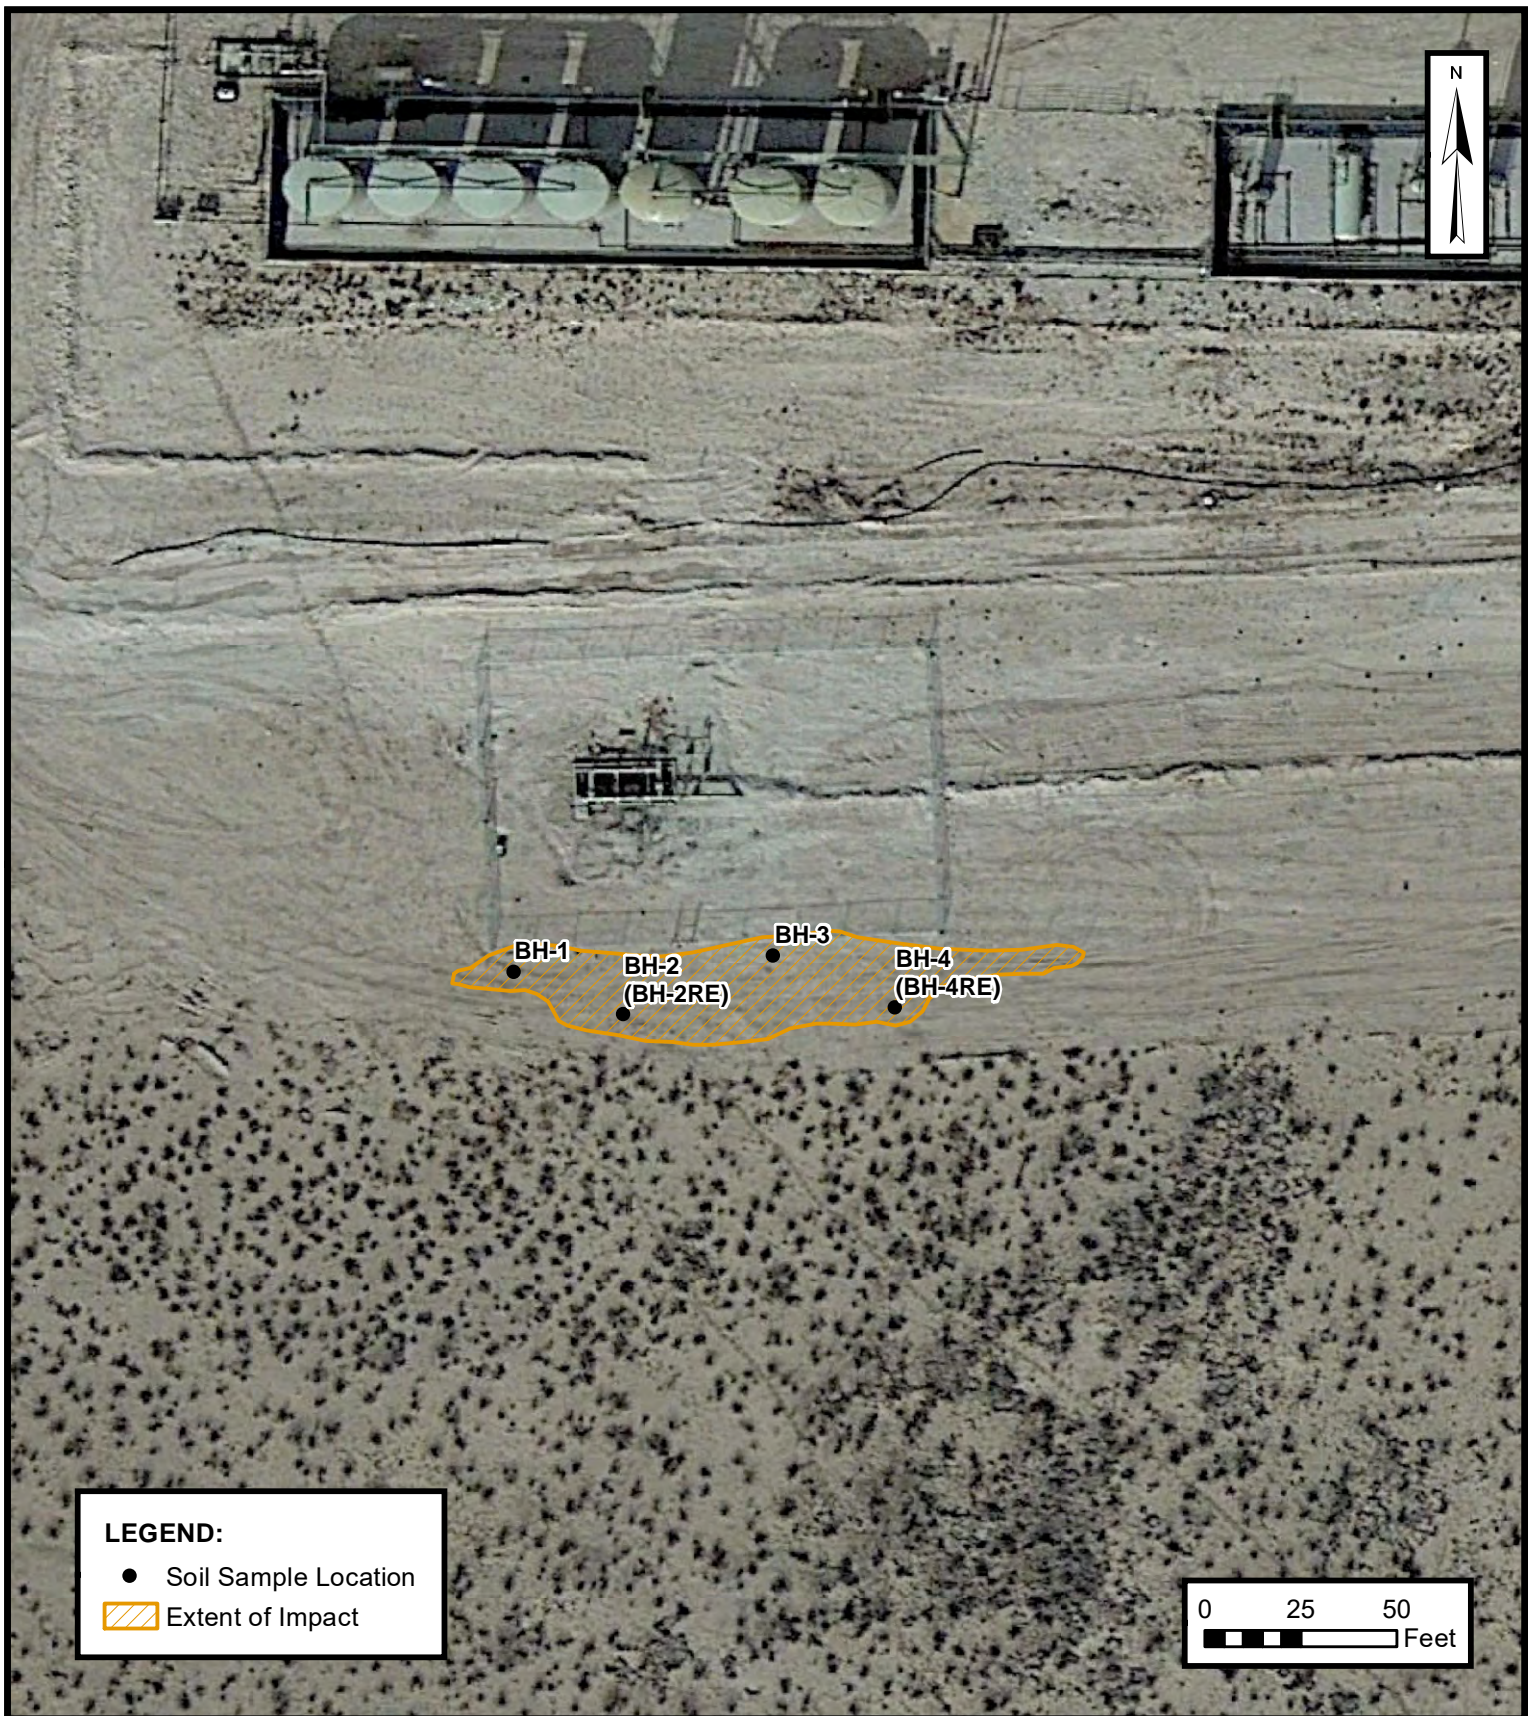
**FIGURE****3**

**Figure 3** identifies approximate composite soil sample locations and approximate dimensions of the excavation with respect to the Site (**Appendix A**). Photographic documentation of the field activities is included in **Appendix C**.

**SITE MAP****ORYX DELAWARE OIL TRANSPORT LLC  
CARLSBAD WEST 12" LAUNCHER**Eddy County, New Mexico  
32.281529° N, 104.287475° W

On June 1, 2021, Lighthouse collected four (4) soil samples (BH-1 through BH-4) at a depth of six (6) to 12 inches bgs in the release area which were analyzed for benzene, toluene, ethylbenzene, and xylene (BTEX), total petroleum hydrocarbons (TPH) and chloride in accordance with NMOCD Closure Criteria for Soils Impacted by a Release (NMOCD Closure Criteria). Based on laboratory analytical results, additional soils needed to be removed in the areas of soil sample locations BH-2 and BH-4.

Subsequent to additional excavation activities by Lighthouse, two additional soil samples were collected (BH-2 RE and BH-4 RE) at a depth of 12 to 15 inches bgs on June 14, 2021, and analyzed for BTEX, TPH and chloride in accordance with NMOCD Closure Criteria.

The final impacted area measured approximately 135 feet long and 25 feet wide at the maximum extents. The maximum depth of the excavation measured approximately 15 inches bgs.

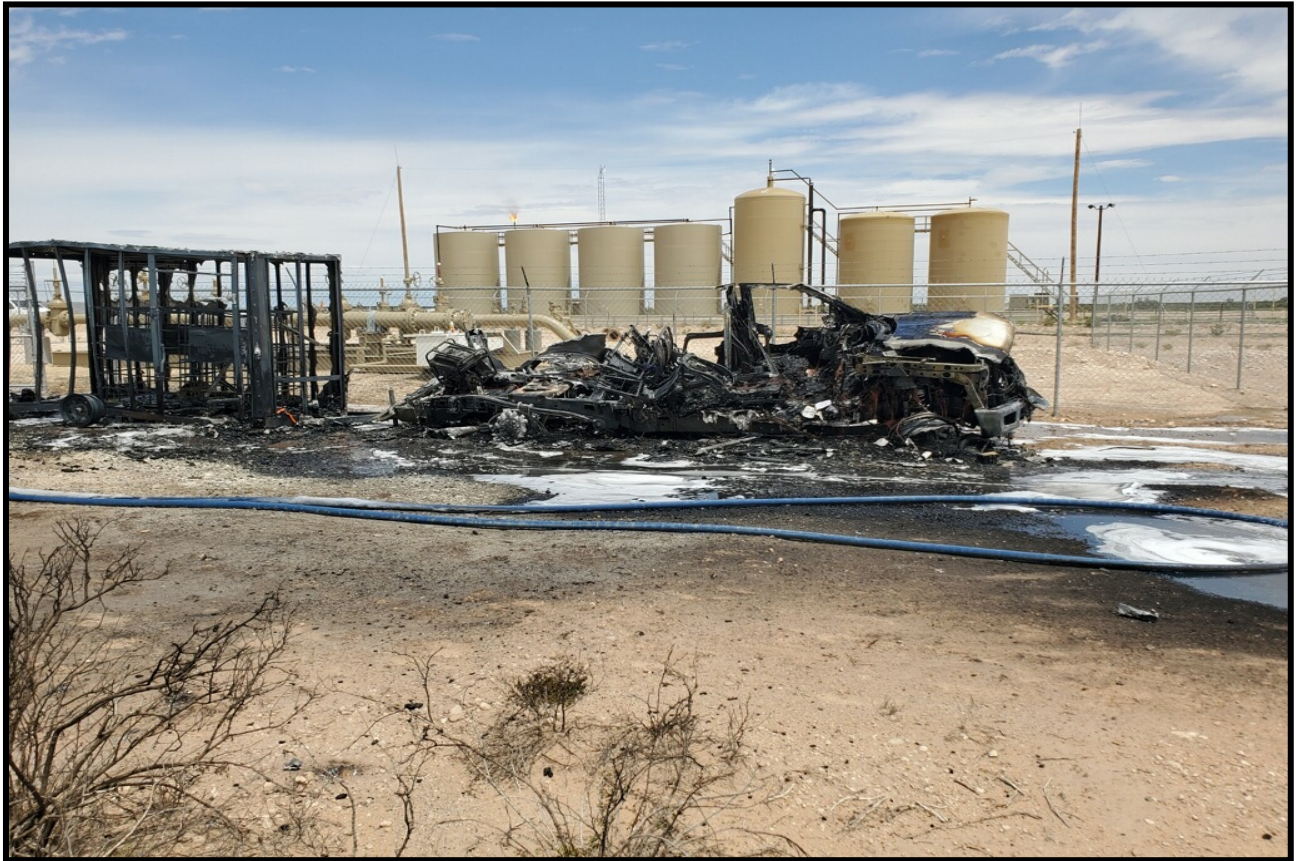
View of spill area prior to remediation activities, facing north.

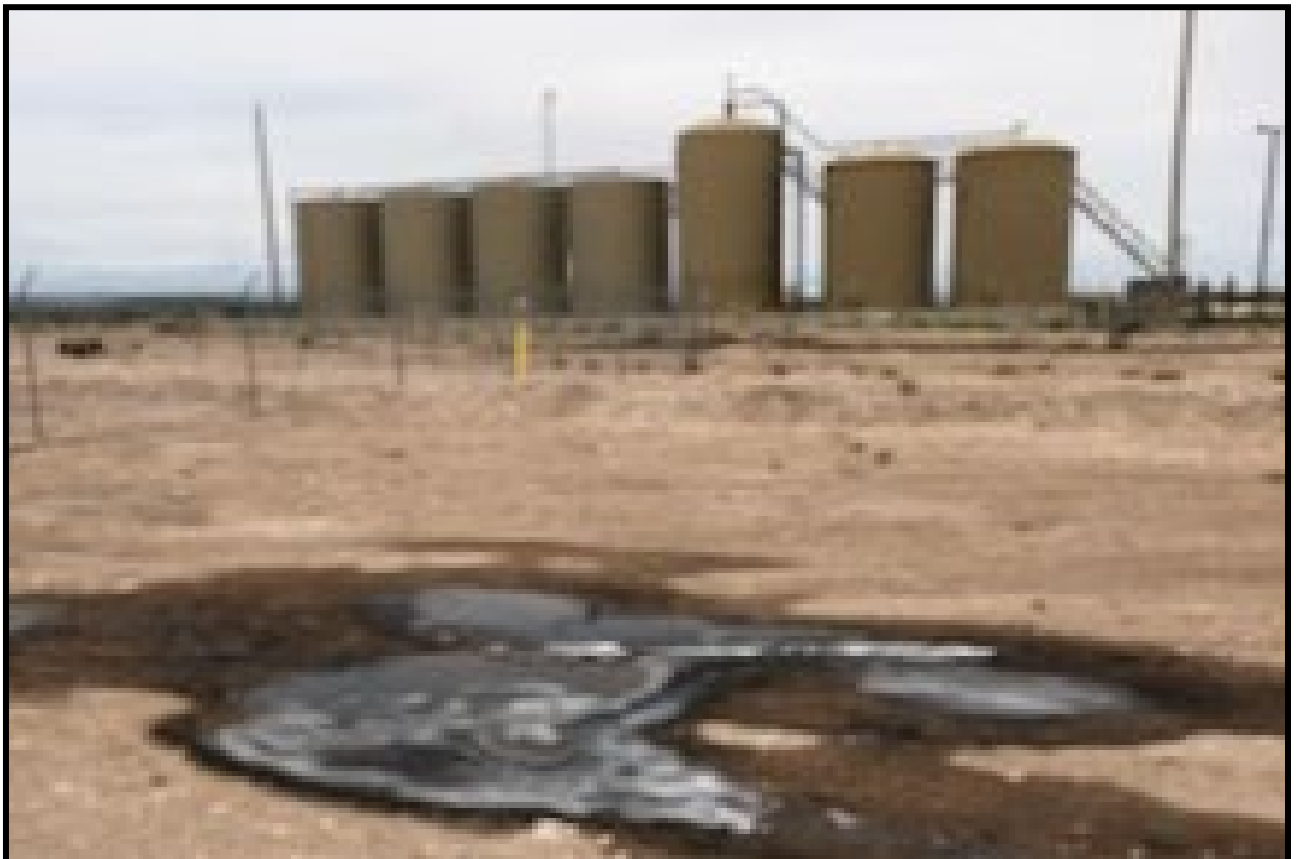
View of spill area prior to remediation activities, facing north.

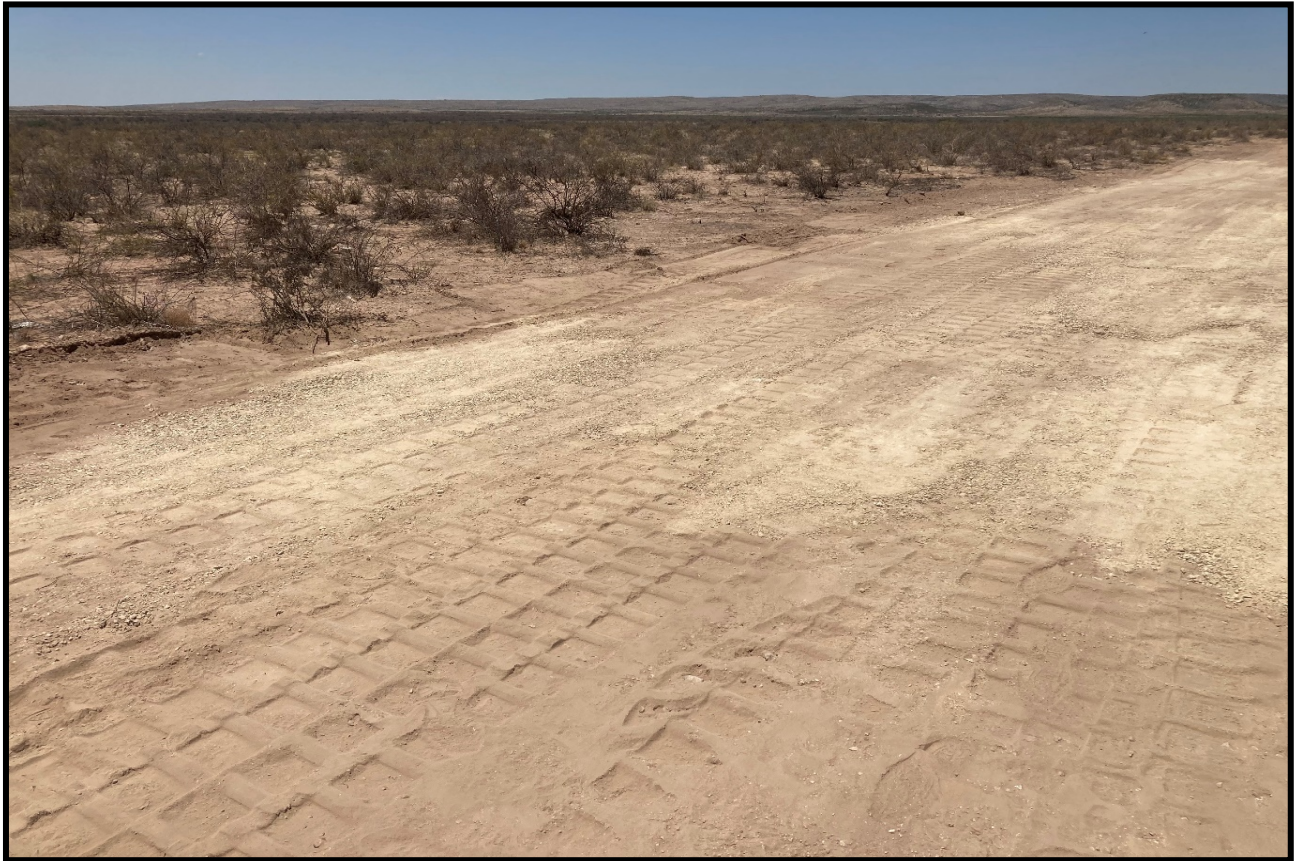
View of spill area subsequent to remediation activities, facing west.

During the completion of response action activities, approximately 20 cubic yards (cy) of impacted soil was excavated and stockpiled on-Site. The soil stockpile was taken off-Site for proper disposal in accordance with local, state and federal regulations. Based on correspondence with Lighthouse, the excavated area was backfilled with clean fill material and then contoured to the original surrounding grade. The release area is located on the caliche pad of an active station; therefore, Lighthouse has compacted and backfilled excavation area in order to minimize dust and erosion.

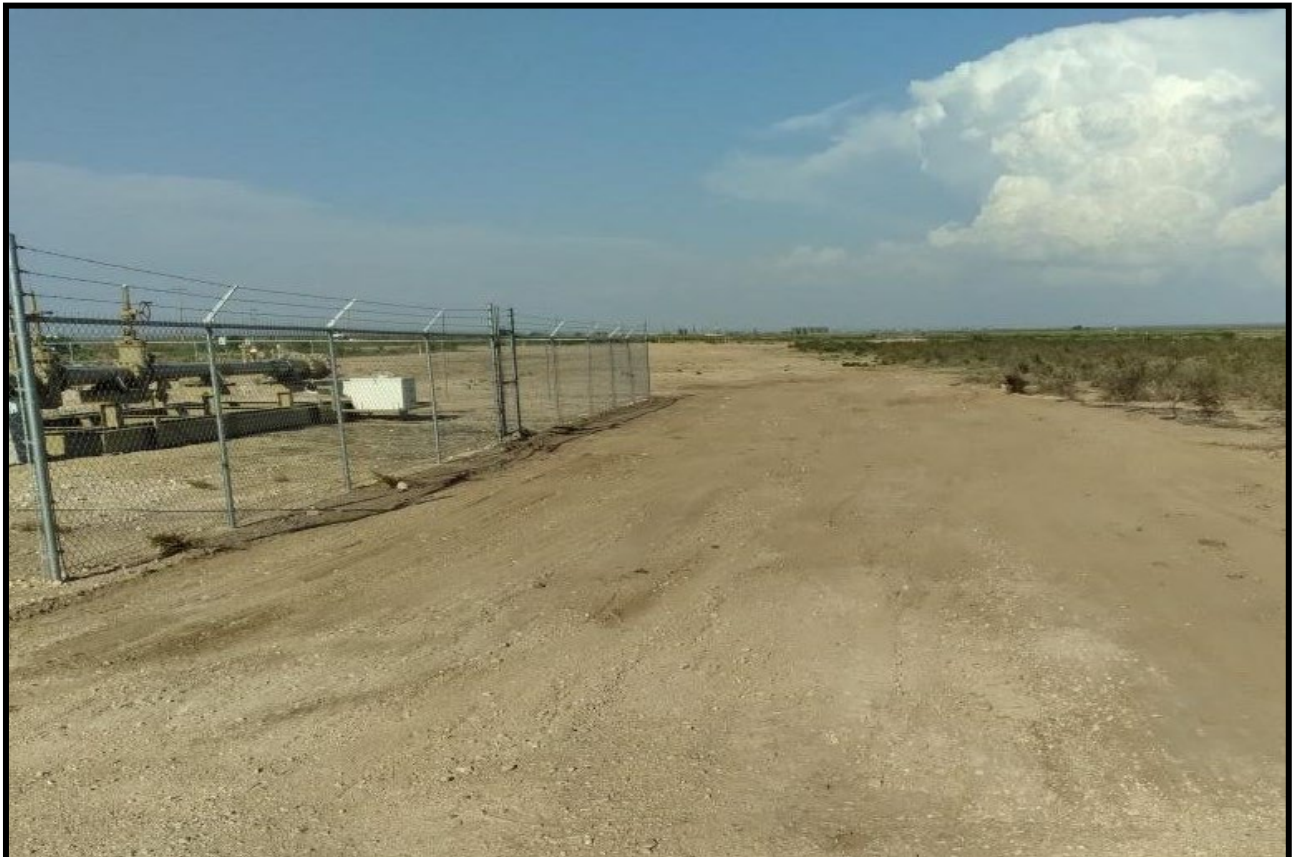
View of spill area during remediation activities, facing east.
