Incident ID	nAPP2113758637
District RP	
Facility ID	
Application ID

Site Name Bamboozled BBX Federal Com #2	Site Type Battery
Date Release Discovered 05/06/2021	API# (if applicable) 30-015-32885

Re: **Site Characterization and Closure Report
Bamboozled BBX Fed Com #2 Release Site
EOG Resources Inc.
Incident ID: nAPP2113758637
P-03-21S-24E, Eddy County, New Mexico**

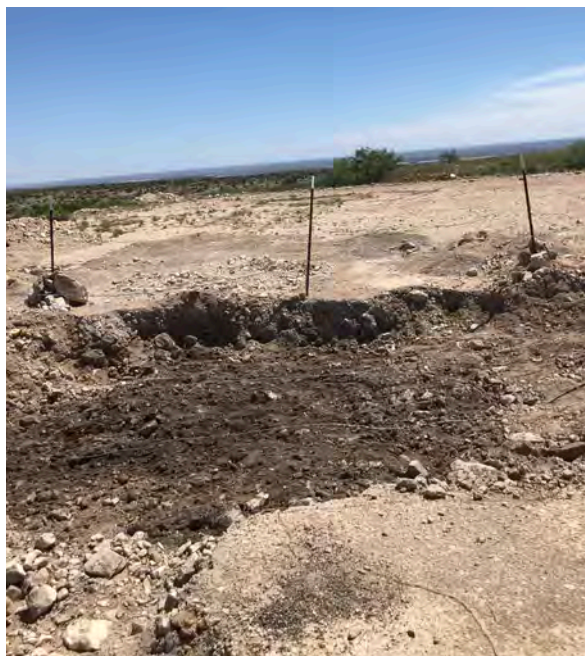
The image to the right depicts the complete excavated area facing West.

Due to the preliminary soil sampling activities exhibiting a chloride exceedance above the closure criteria in the above Table 3.1 values, GHD and BDS returned to the site on June 2, 2021, to excavate the affected soils. Surface dimensions of the excavation were approximately 20' x 20' and 2.5' in depth. As shown in Figure 3, two sidewall and three bottom hole composite confirmation samples were collected at a depth of 2.5 bgs. The five (5) confirmation samples were taken to HEAL in Albuquerque, New Mexico. All samples were analyzed for BTEX by EPA Method 8021B, TPH by Method 8015B NM, and chloride by EPA Method 300. All confirmation samples collected represented areas no greater than 200 square feet. Laboratory Analytical Reports and Chain-of-Custody Documentation are provided in Attachment B. Analytical results are summarized in attached Table 1. An approximate total of 61.25 tons of impacted soils were removed from the remedial excavation.

The excavation was backfilled with non-impacted material on July 12, 2021.

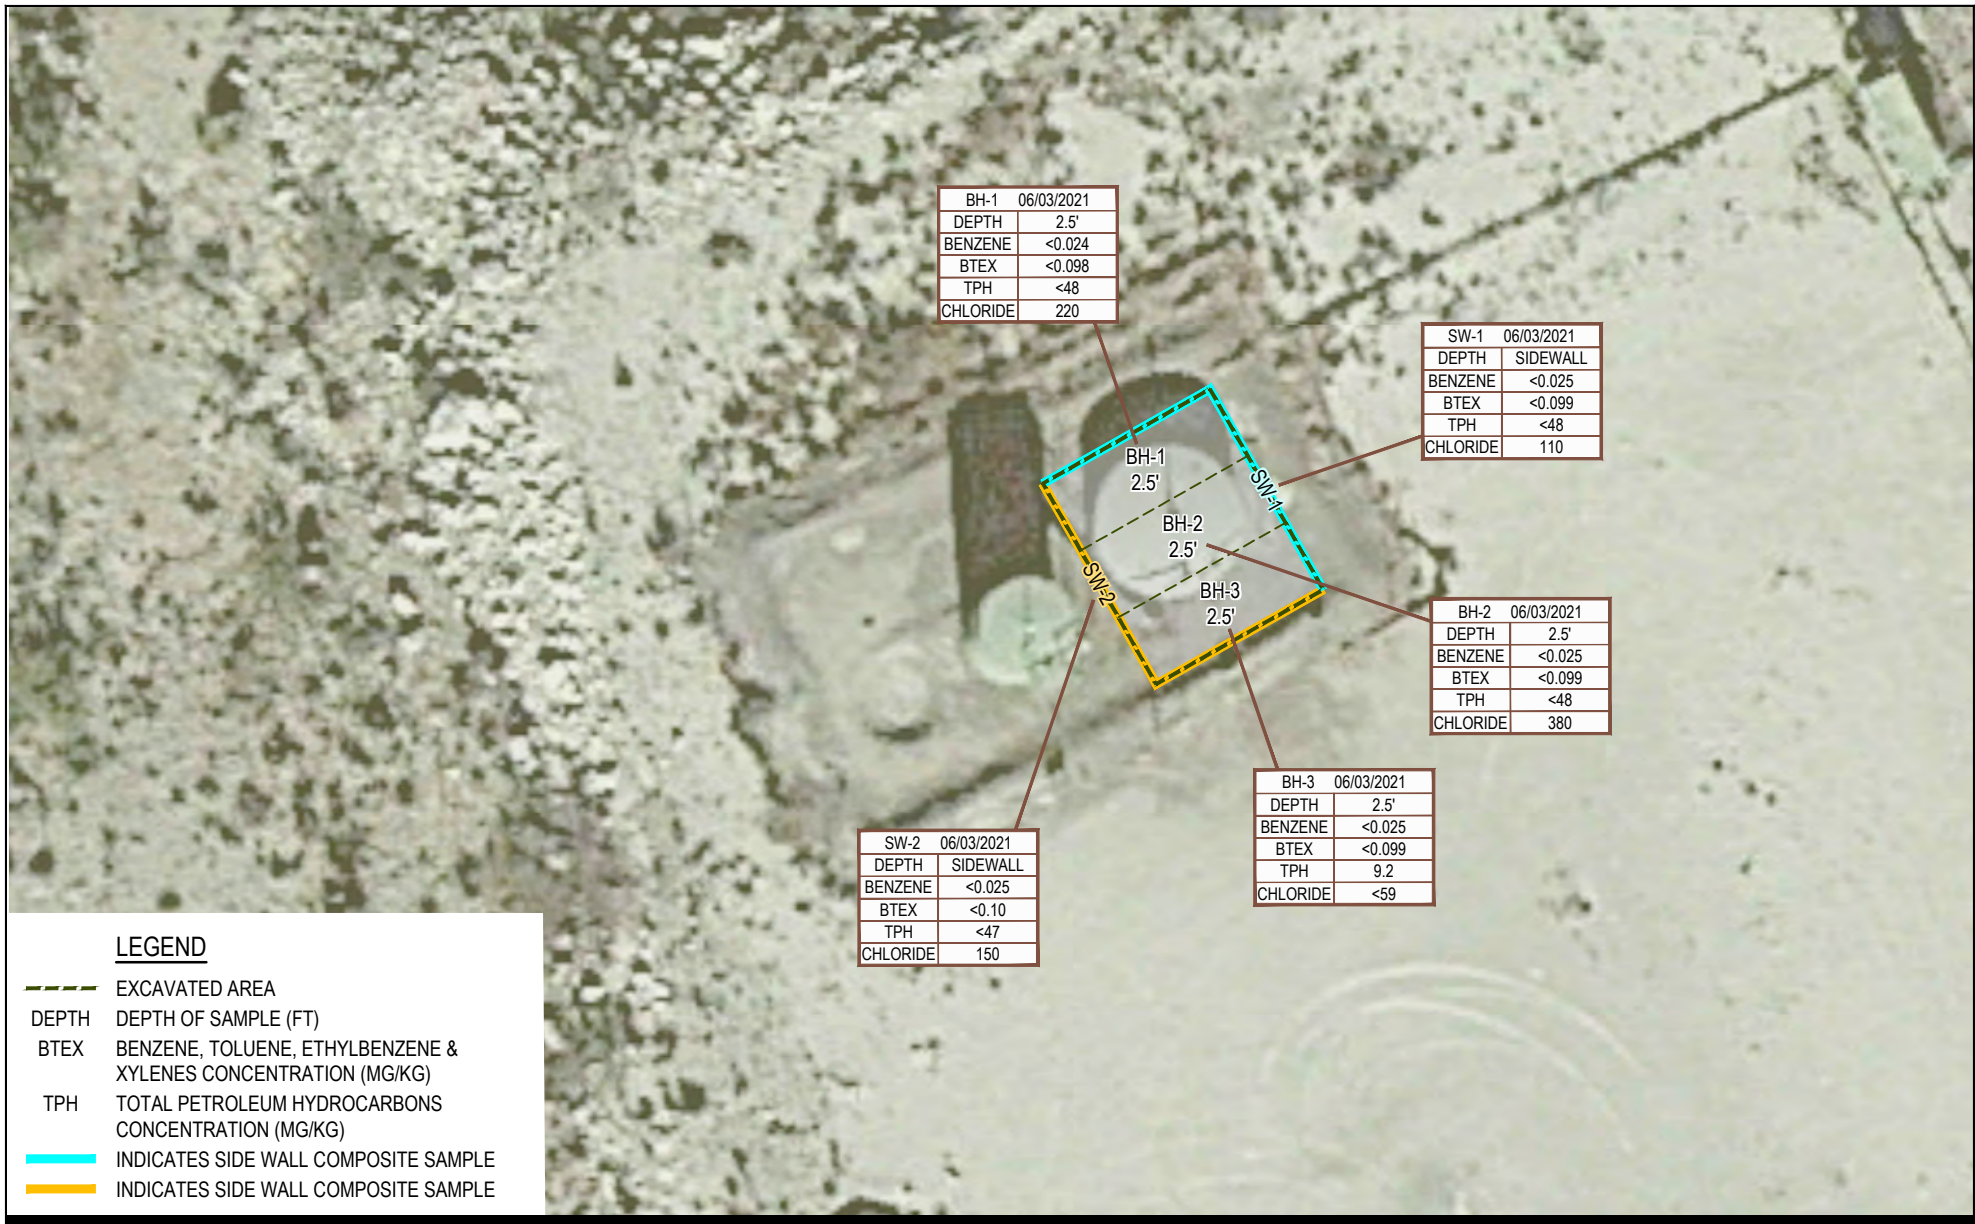
FIGURE 3

- RESULTS IN MILLIGRAMS PER KILOGRAM (MG/KG).
- SEE TABLE 1 FOR FULL ANALYTICAL RESULTS/DETAILS.
- APPROXIMATELY 50 TONS OF IMPACTED SOIL DISPOSED AT LEA LAND, INC.
- BOTTOM HOLE AND SIDEWALL SAMPLES COLLECTED AS 5-PART COMPOSITE.

POST-REMEDIATION
FINAL CONFIRMATION
ANALYTICAL RESULTS MAP

Analytical results indicated all five confirmation samples exhibited TPH, benzene, BTEX, and chloride concentrations below Table 1 Closure Criteria for depth to groundwater less than or equal to fifty (50) feet.
