**Re: Closure Request  
PLU 23 Delaware B  
Incident Number NAPP2113833620  
Eddy County, New Mexico**

WSP USA Inc. (WSP) on behalf of XTO Energy, Inc. (XTO), presents the following Closure Request detailing site assessment and soil sampling activities at the PLU 23 Delaware B (Site) located in Unit C, Section 23, Township 24 South, Range 30 East, in Eddy County, New Mexico (Figure 1). The purpose of the site assessment and soil sampling activities was to assess for the presence or absence of impacts to soil following the release of produced water within lined containment at the Site. Based on field observations, field screening activities, and soil sample laboratory analytical results, XTO is submitting this Closure Request and requesting no further action (NFA) for Incident Number NAPP2113833620.

PHOTOGRAPHIC LOG		
XTO Energy, Inc.	PLU 23 Delaware B Eddy County, New Mexico	31403236.016.0129

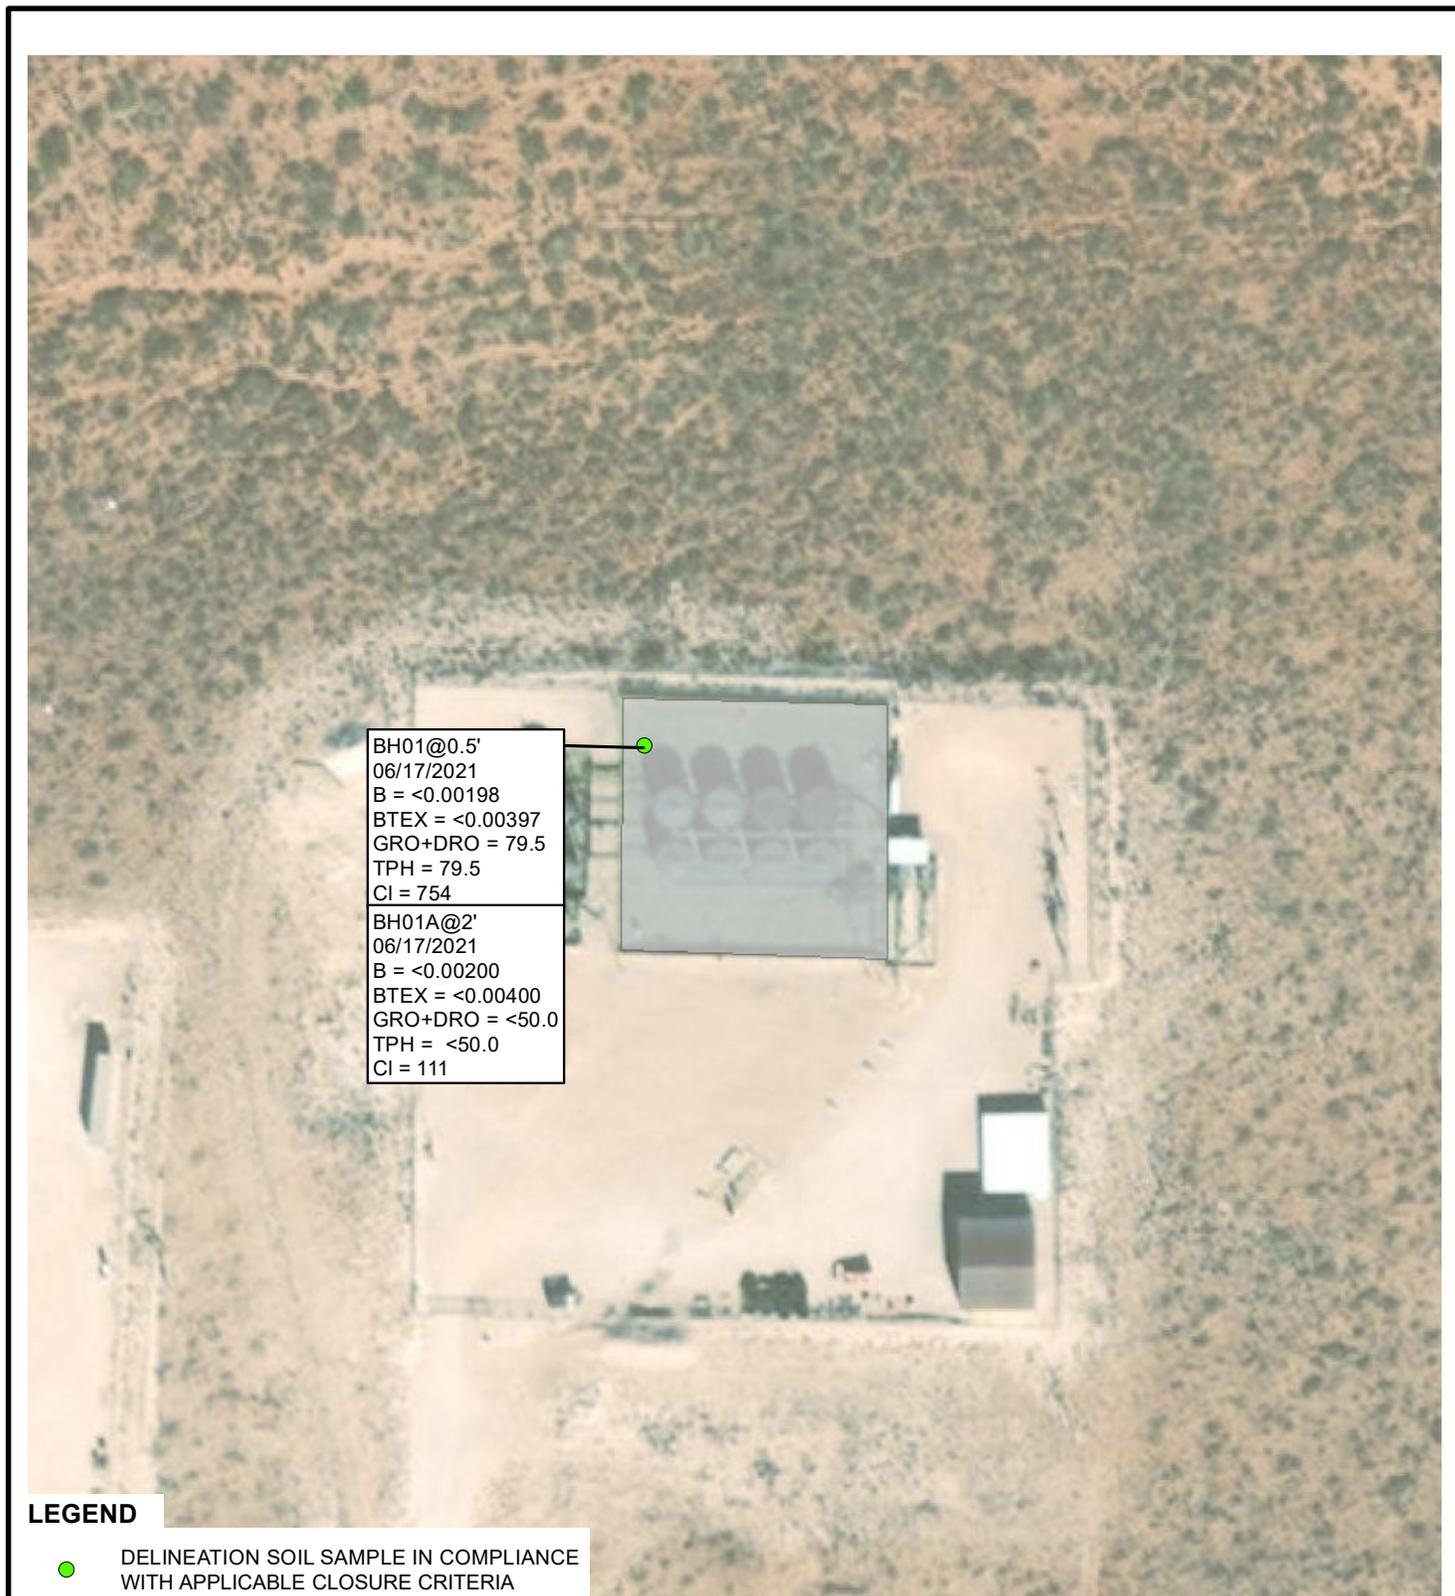
**FIGURE 2**  
**DELINEATION SOIL SAMPLE LOCATIONS**  
**PLU 23 DELAWARE B**  
**UNIT C SEC 23 T24S R30E**  
**EDDY COUNTY, NEW MEXICO**  
**XTO ENERGY, INC.**

Laboratory analytical results for delineation soil samples BH01 and BH01A, collected at depths of approximately 0.5 feet and 2 feet bgs, indicated that benzene, BTEX, TPH-GRO/TPH-DRO, TPH, and chloride concentrations were compliant with the Closure Criteria. Additionally, sample BH01A collected at 2 feet bgs provides vertical delineation to the strictest Table 1 Closure Criteria. Laboratory analytical results are summarized in Table 1 and the complete laboratory analytical report is included as Attachment 4.

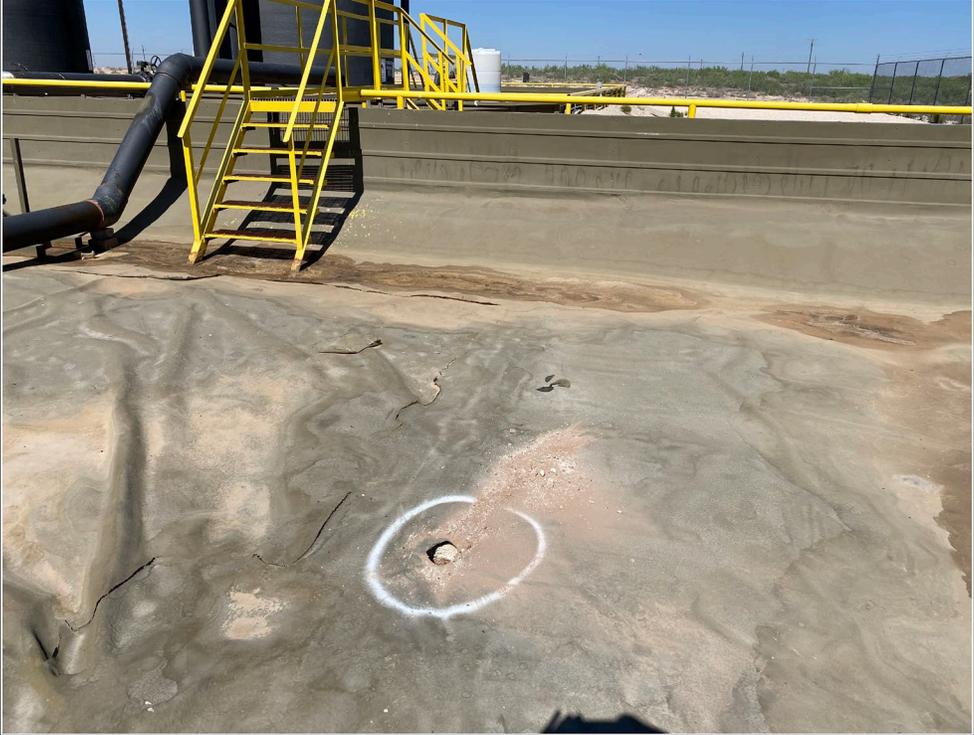
Photo No.	Date	
1	June 17, 2021

West facing view of delineation soil sampling location.

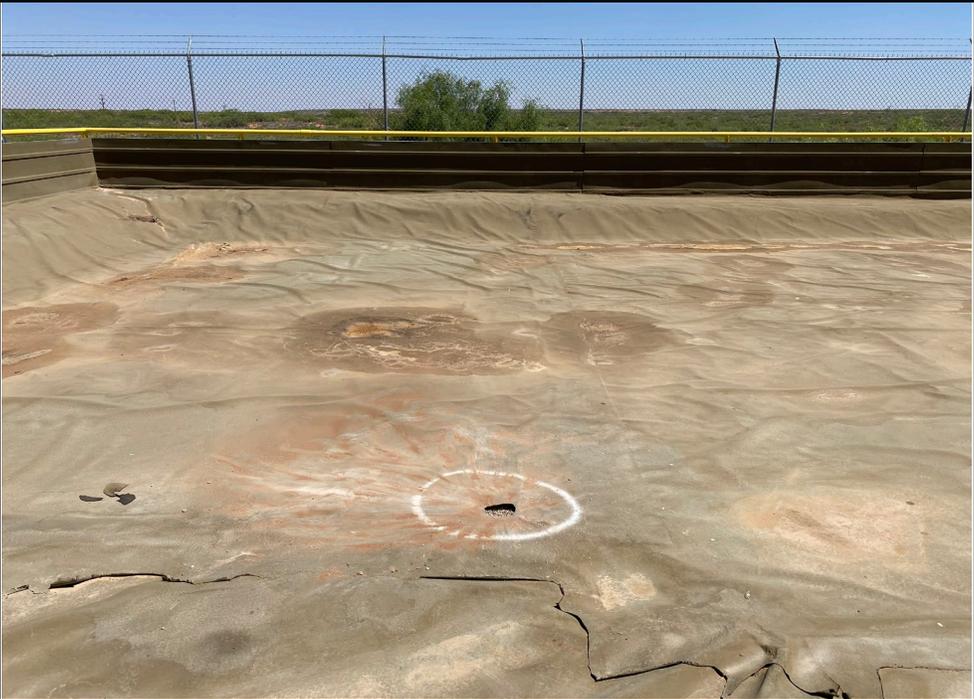
Photo No.	Date	
2	June 17, 2021

North facing view of delineation soil sampling location following backfilling procedures.

Following the failed liner integrity inspection at the Site, WSP personnel advanced one borehole (BH01) at the location of the tear in the liner to assess for the presence or absence of soil impacts resulting from the May 9, 2021 produced water release within lined containment. Two delineation soil samples were collected from borehole BH01 at depths of approximately 0.5 feet and 2 feet bgs. Laboratory analytical results indicated that benzene, BTEX, TPH-GRO/TPH-DRO, TPH, and chloride concentrations were compliant with the Closure Criteria. Additionally, field screening of soil from the borehole indicated no elevated volatile aromatic hydrocarbons or chloride concentrations beneath the tear in the liner. The release was contained laterally by the lined containment and all released fluids were recovered during initial response activities. The tear in the liner was subsequently repaired.
