**Frontier Field Services,
AKA Durango Midstream
Caviness 8" PPL**

Closure Report

**UL O, Section 13, T18S, R32E
Lea County, New Mexico**

NAPP2101836808

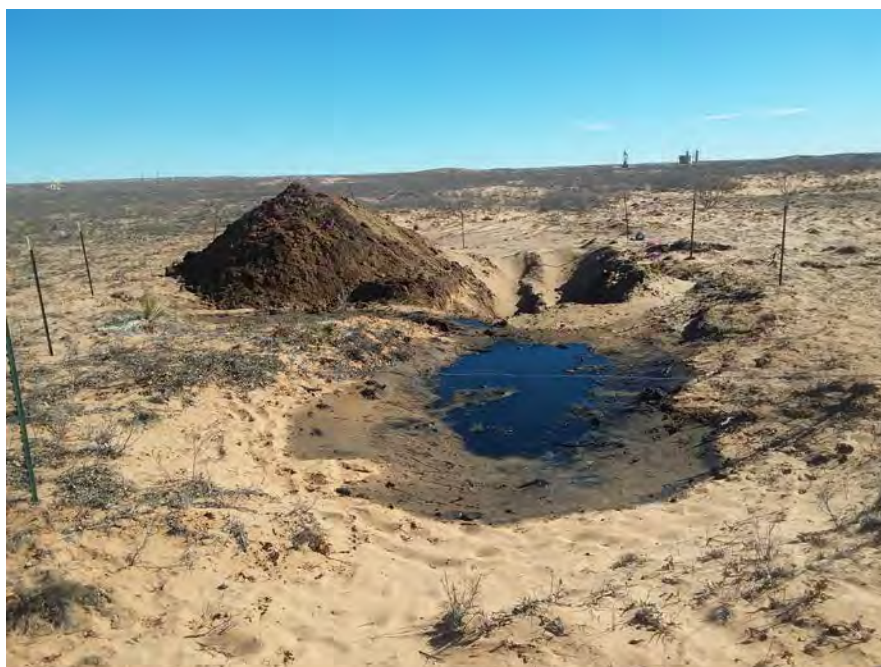
Figure 1. Release and Pipeline Excavation, View East.

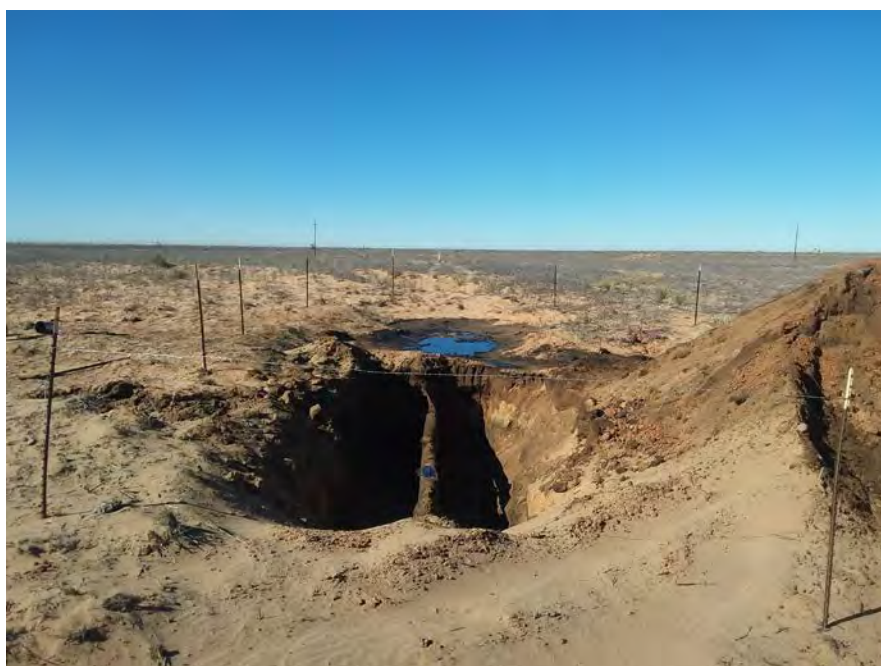
Figure 2. Release and Pipeline Excavation, View West.
