## Release Notification

Site Name: Dos Equis 12 Federal Com	Site Type: Battery
Date Release Discovered: 8/1/2021	API# (if applicable)

#### Cause of Release: Equipment Failure

**From:** [Laci Luig](#)  
**To:** [Mike Bratcher, EMNRD](#); [Chad Hensley, EMNRD](#); [Robert Hamlet, EMNRD](#); [BLM NM CFO Spill](#)  
**Subject:** Liner Inspection - Dos Equis 12 Fed Com Battery  
**Date:** Monday, August 2, 2021 10:20:42 AM

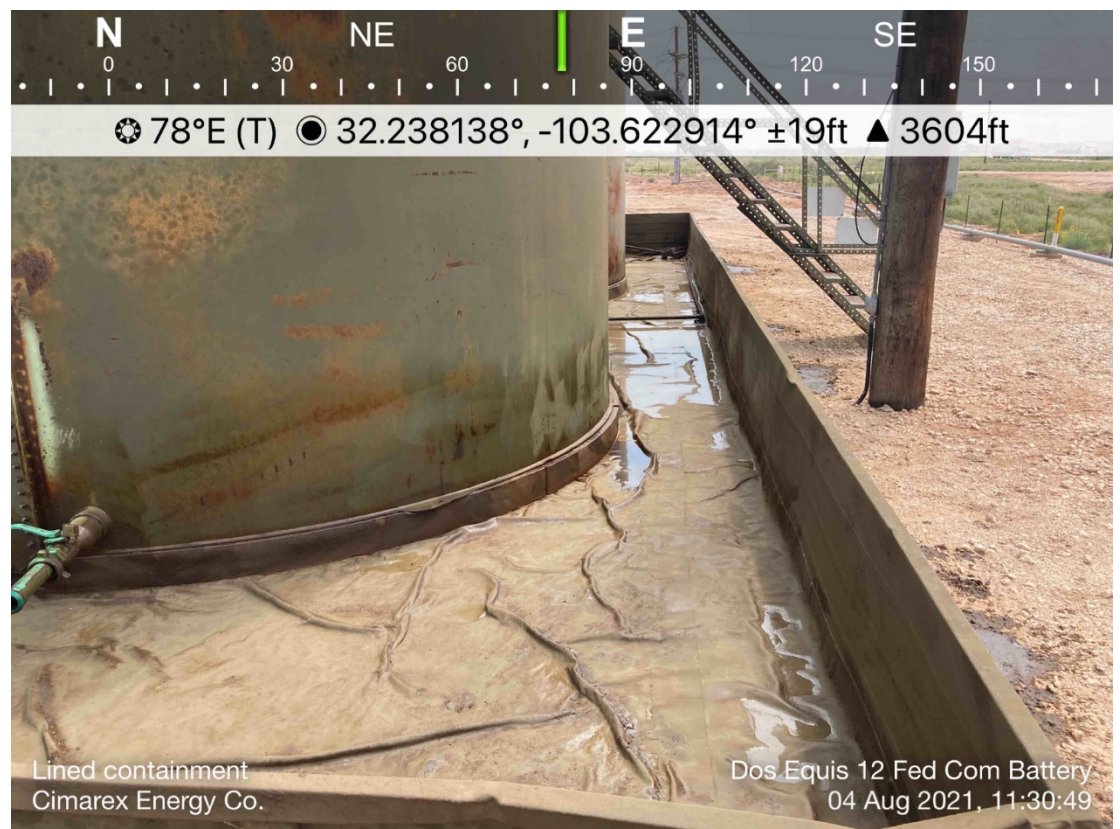
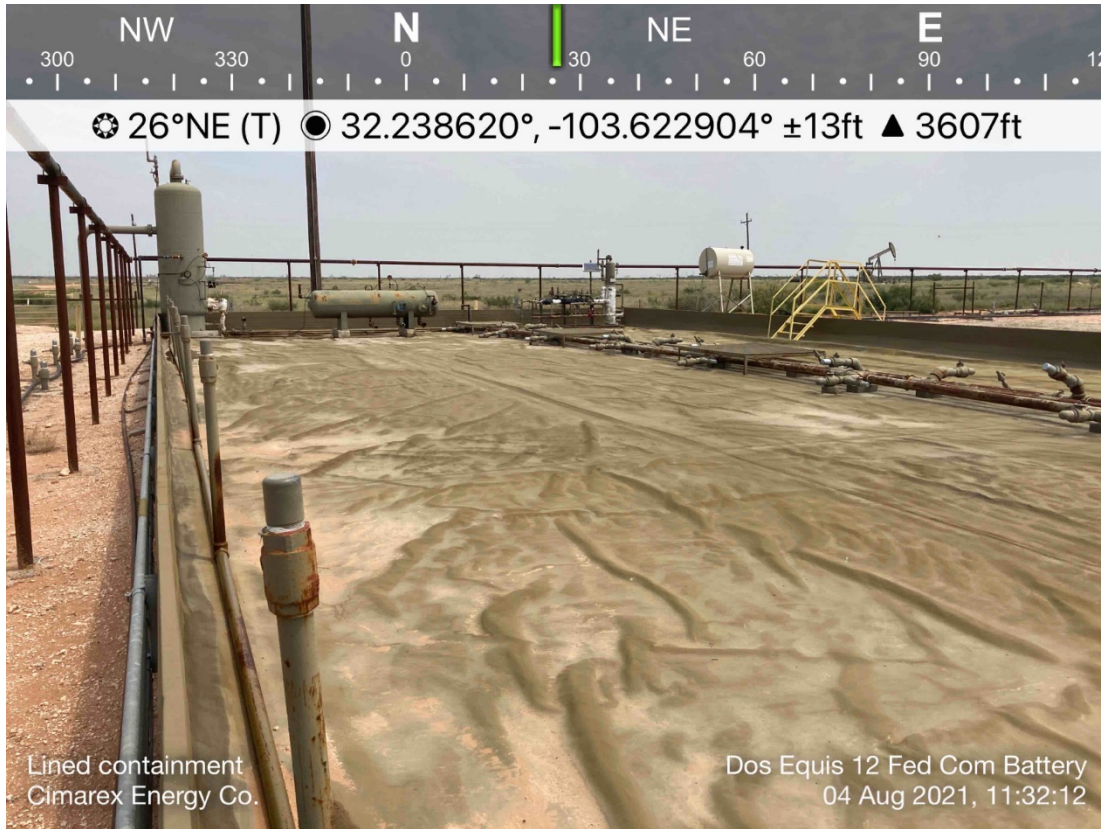
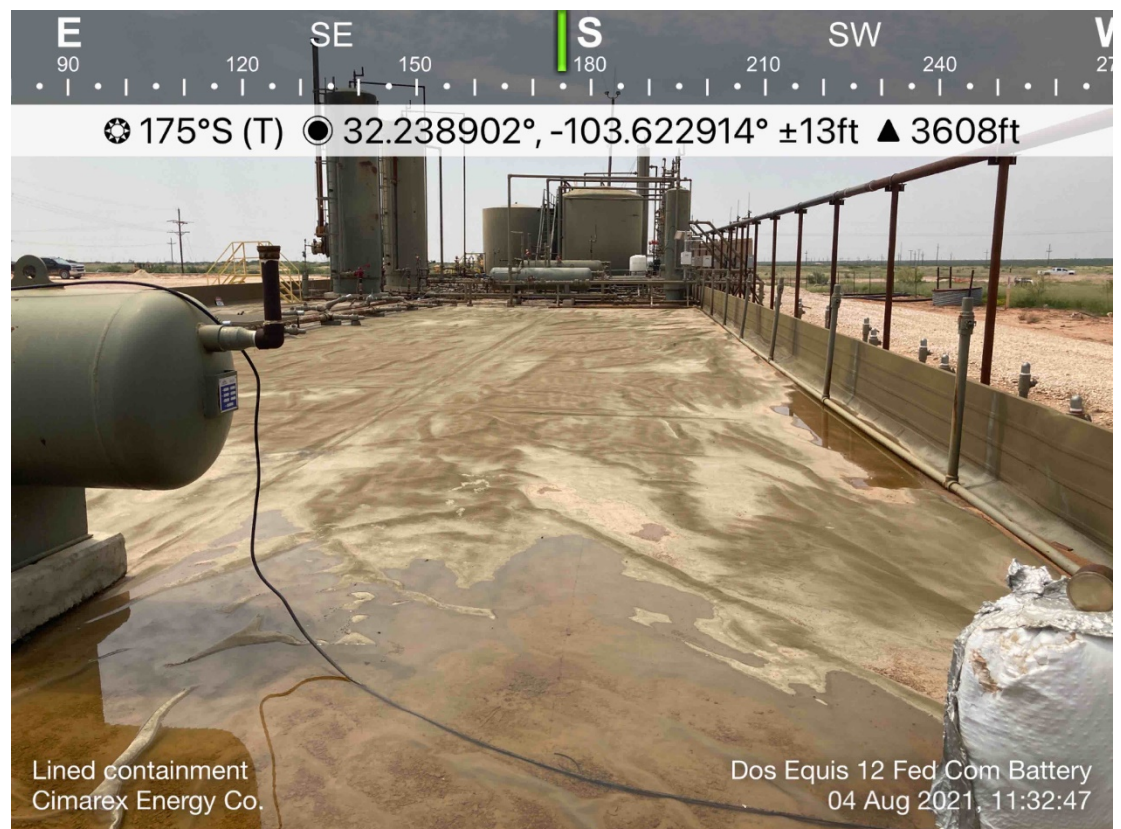
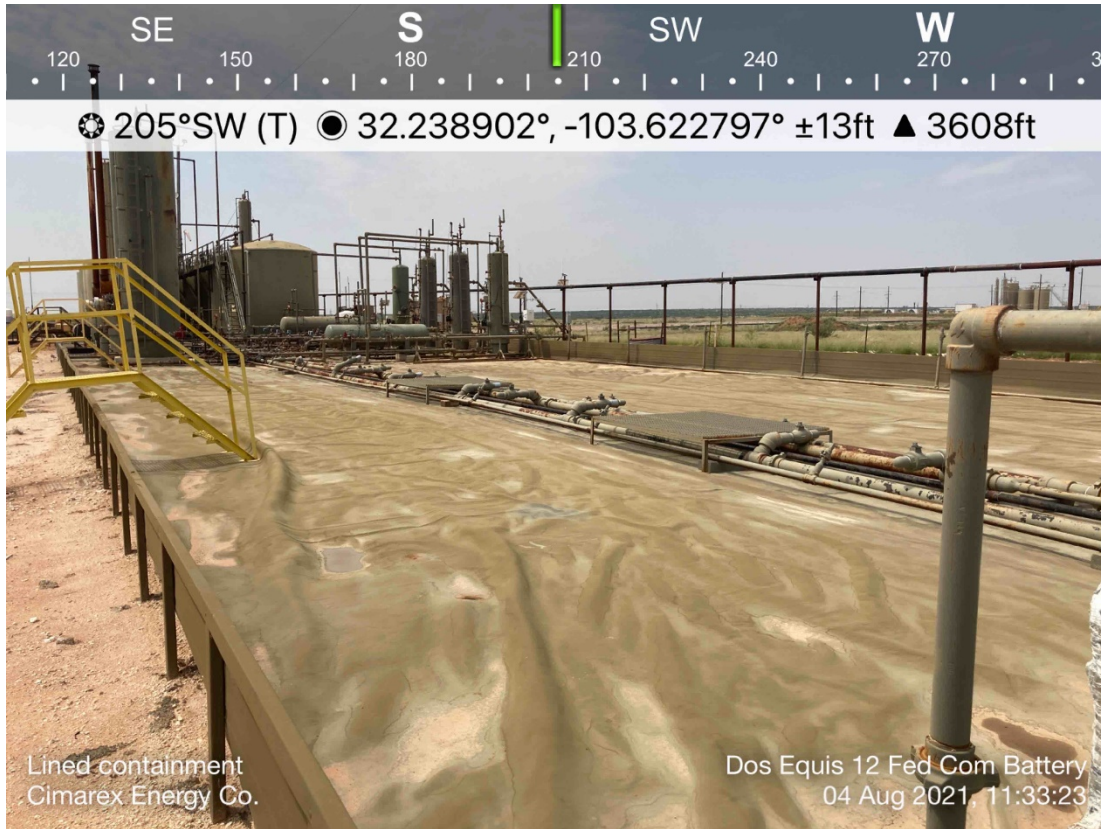
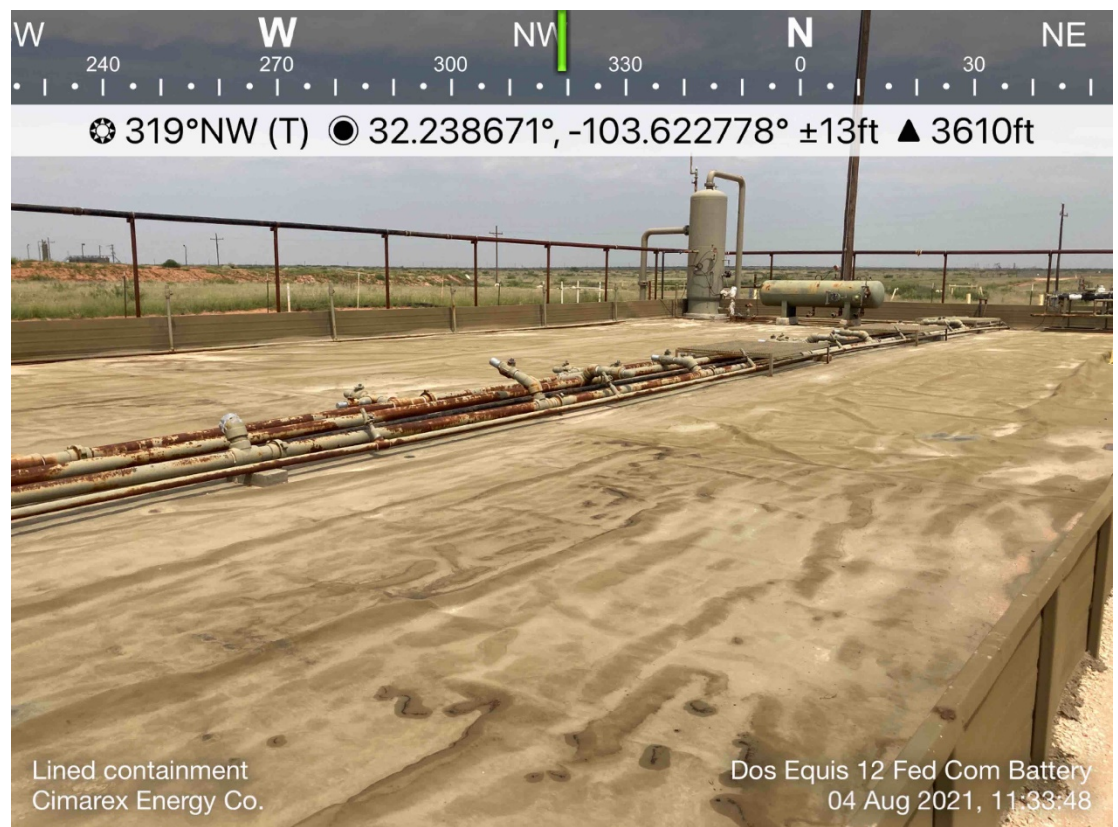
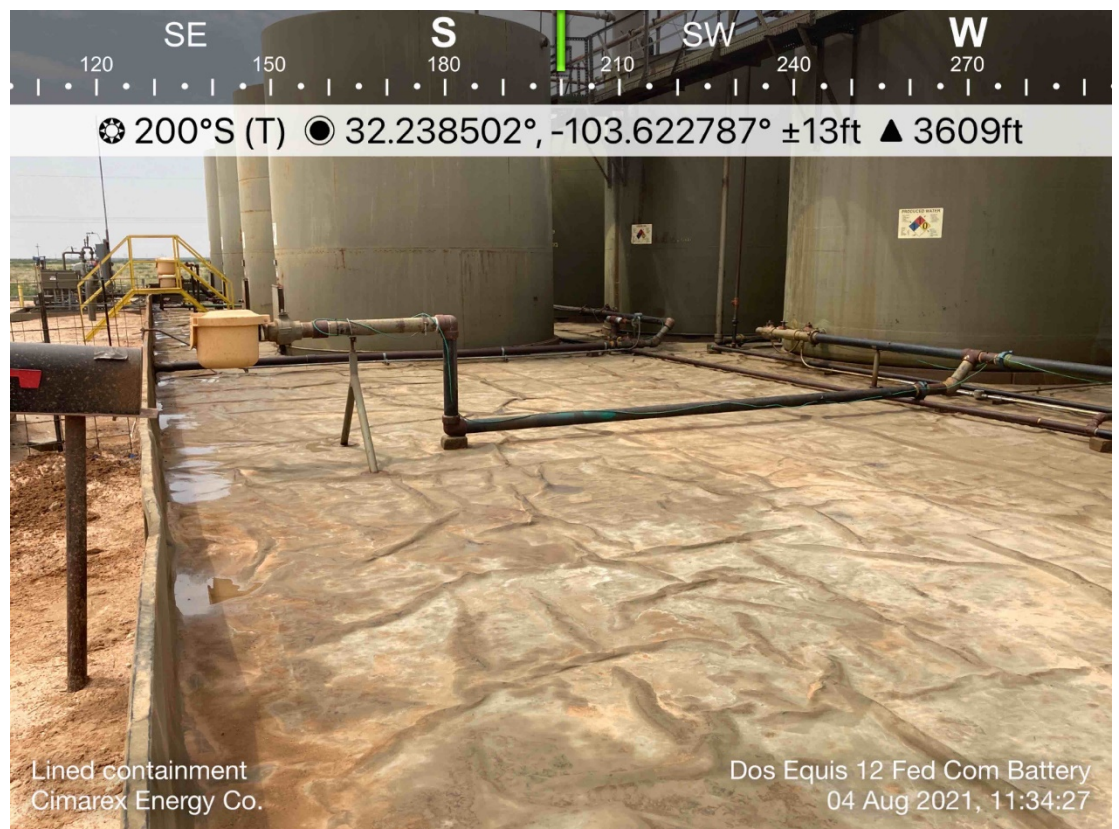
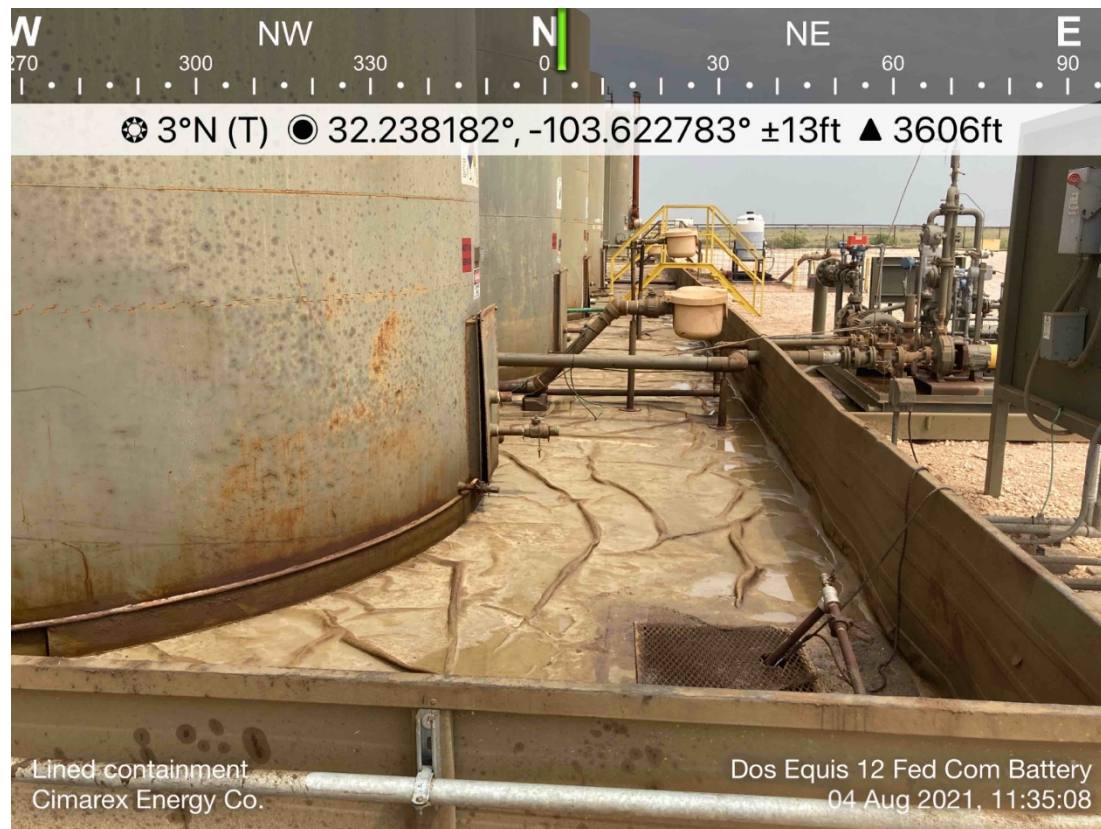
CIMAREX ENERGY  
DOS EQUIS 12 FEDERAL COM  
BATTERY  
LEA, NM

The tanks at this facility high leveled, and the Protek safety system failed to shut down a water pump at the Dos Equis 11-1. The Dos Equis 11-1 was found in an alarm state, but communication failed. The water from the Dos Equis 11-1 is sent to the Dos Equis 12. Total released 110 barrels of produced water onto lined containment, all fluids were recovered. Protek and Klein Automation were called out to address the failure. The containment will be washed and a liner inspection scheduled.

A liner inspection at the Dos Equis 12 Federal Com Battery has been scheduled for Wednesday, August 4<sup>th</sup> at 10:00am (MST)
