Report Type: Work Plan NAPP2103564128

Site:	EVGSAU 0546-001 Flowline Release					
Company:	ConocoPhillips					
Section, Township and Range	Unit Letter O	Sec. 32	T 17S	R 35E		
Lease Number:	N/A					
County:	Lea					
GPS:	32.786404			-103.478239		
Surface Owner:	State					
Mineral Owner:	N/A					
Directions:	Depart from Buckeye (NM238/Buckeye Rd.). Head east on Buckeye Rd. for 1.17 miles. Turn right onto dirt road. Head south for 0.43 miles. Turn left onto dirt road. Head southeast for 0.59 miles. Arrive at location.

**Re: Release Characterization and Remediation Work Plan
ConocoPhillips
EVGSAU 0546-001 Flowline Release
Unit Letter O, Section 32, Township 17 South, Range 35 East
Lea County, New Mexico
Incident ID# NAPP2103564128**

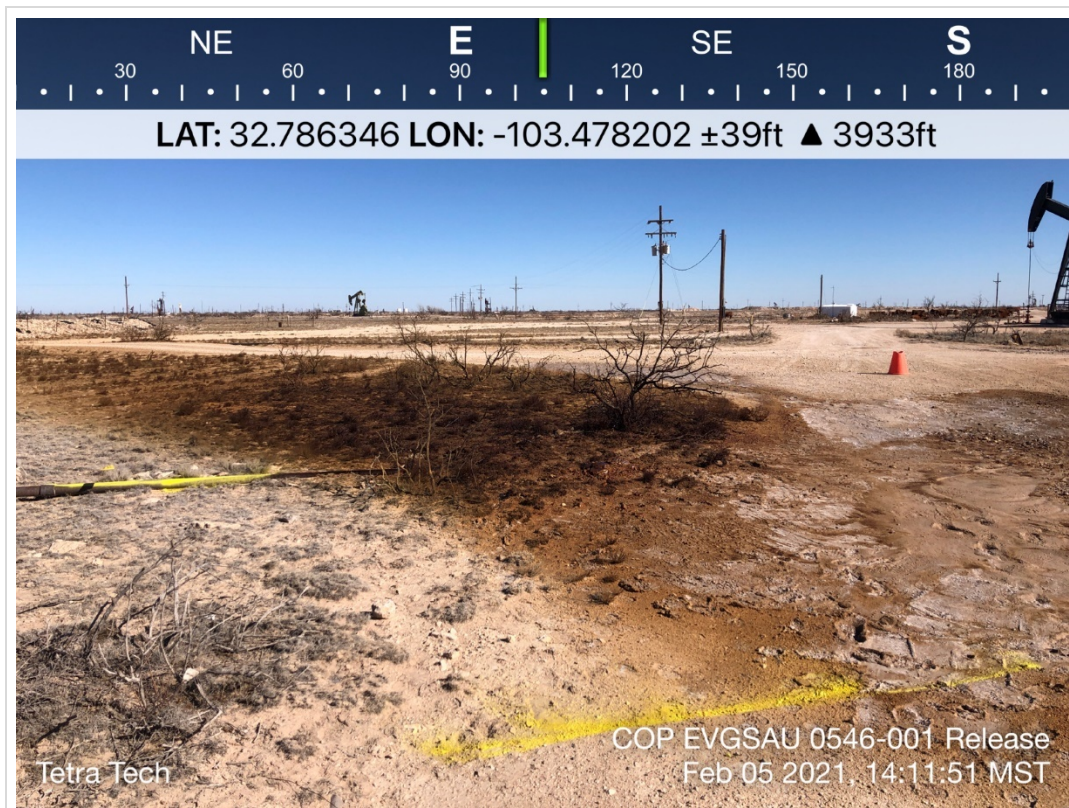
TETRA TECH, INC. PROJECT NO. 212C-MD-02538	DESCRIPTION	View east southeast of the release area and lease road.	1
	SITE NAME	ConocoPhillips EVGSAU 0546-001 Flowline Release	2/5/2021

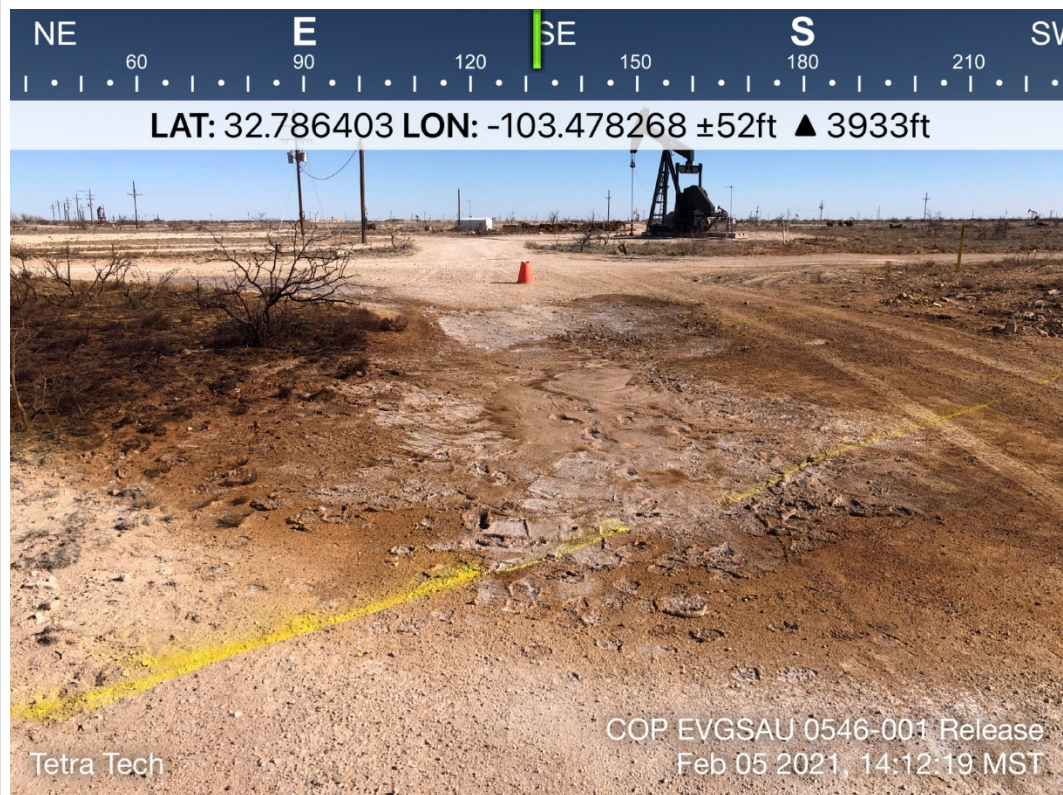
TETRA TECH, INC. PROJECT NO. 212C-MD-02538	DESCRIPTION	View southeast of the release area, lease road, and the EVGSAU #015 well.	2
	SITE NAME	ConocoPhillips EVGSAU 0546-001 Flowline Release	2/5/2021

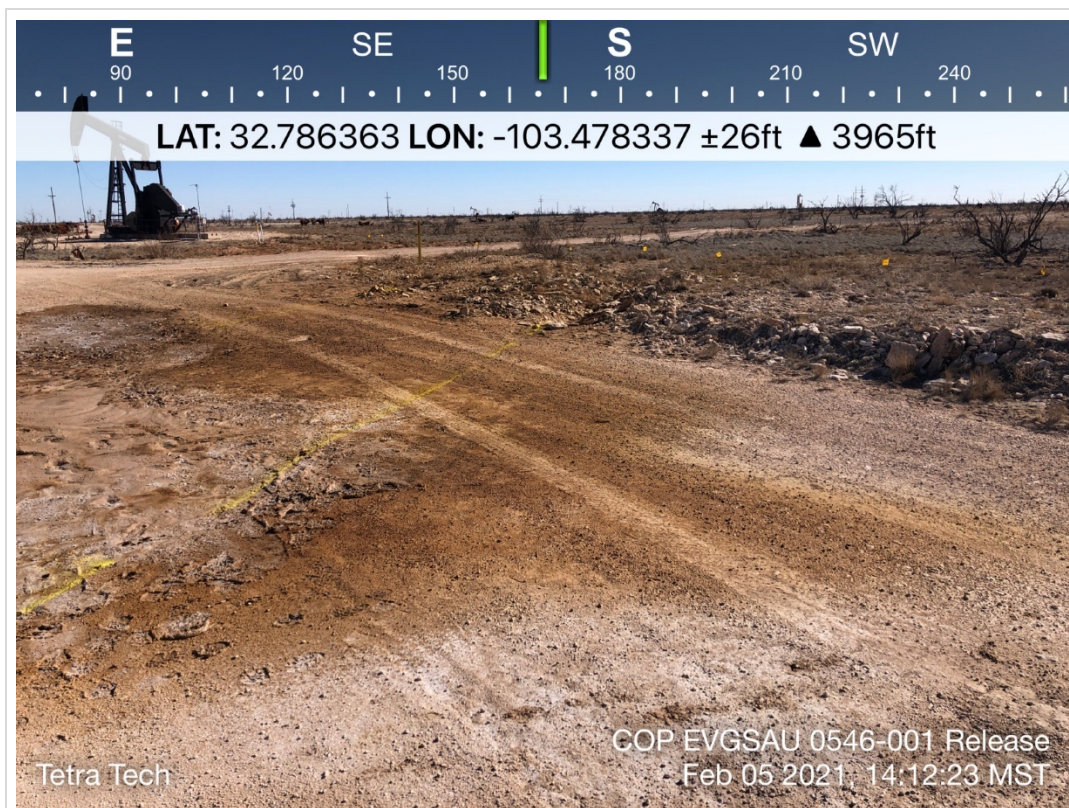
TETRA TECH, INC. PROJECT NO. 212C-MD-02538	DESCRIPTION	View south southeast of the release area and lease road	3
	SITE NAME	ConocoPhillips EVGSAU 0546-001 Flowline Release	2/5/2021

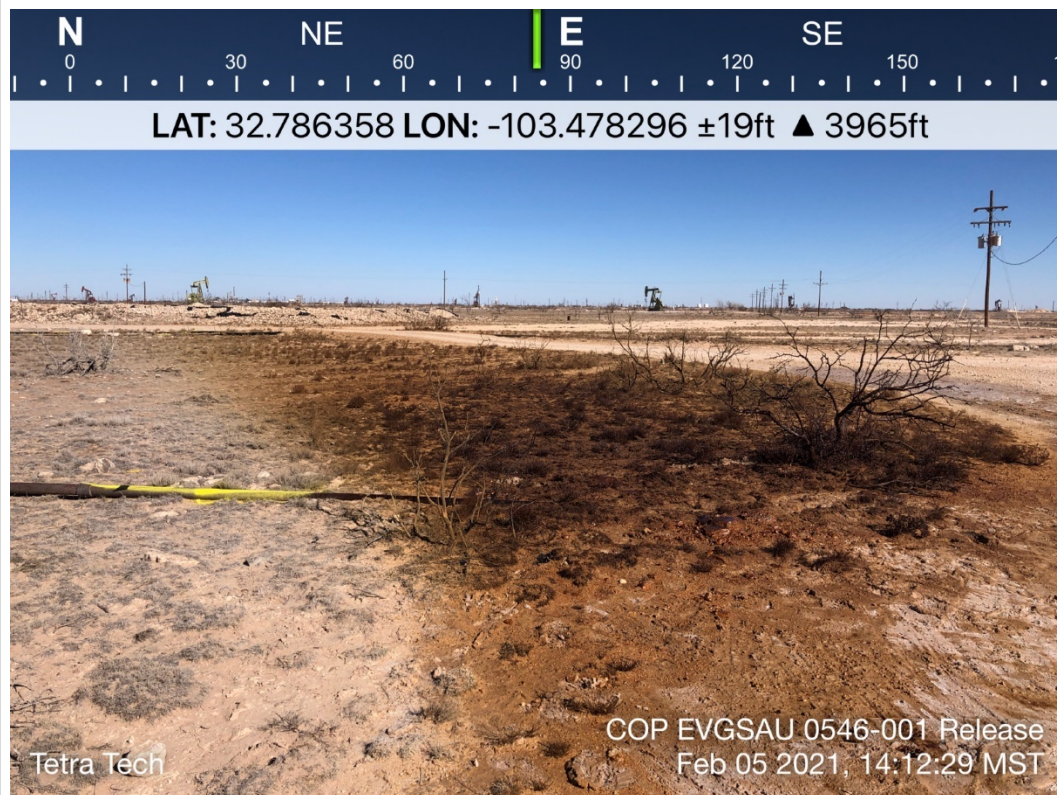
TETRA TECH, INC. PROJECT NO. 212C-MD-02538	DESCRIPTION	View east of the release area and lease road.	4
	SITE NAME	ConocoPhillips EVGSAU 0546-001 Flowline Release	2/5/2021

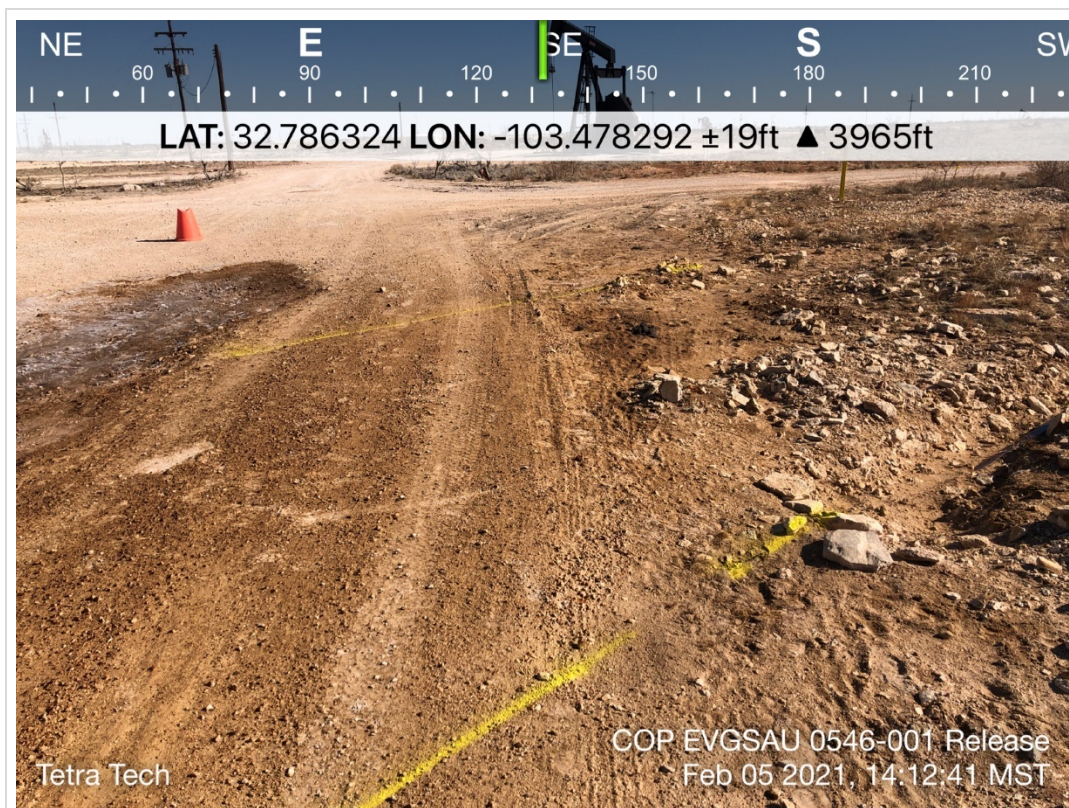
TETRA TECH, INC. PROJECT NO. 212C-MD-02538	DESCRIPTION	View southeast of the release area and lease road.	5
	SITE NAME	ConocoPhillips EVGSAU 0546-001 Flowline Release	2/5/2021

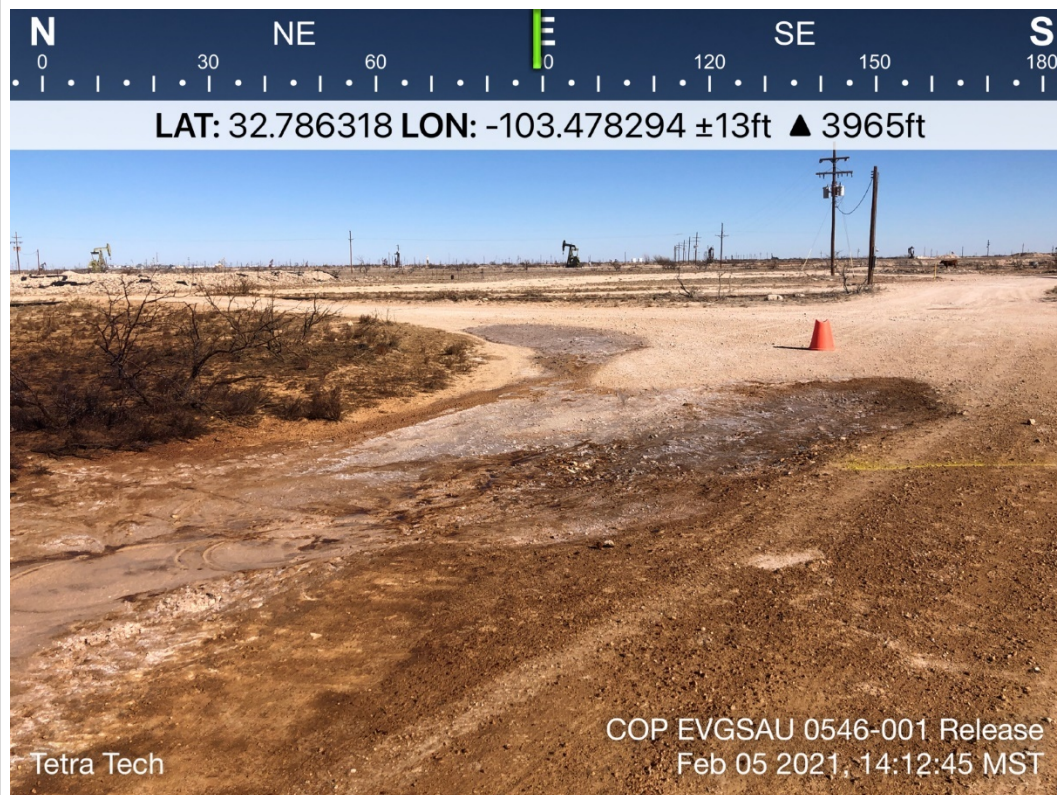
TETRA TECH, INC. PROJECT NO. 212C-MD-02538	DESCRIPTION	View east of the release area and lease road.	6
	SITE NAME	ConocoPhillips EVGSAU 0546-001 Flowline Release	2/5/2021

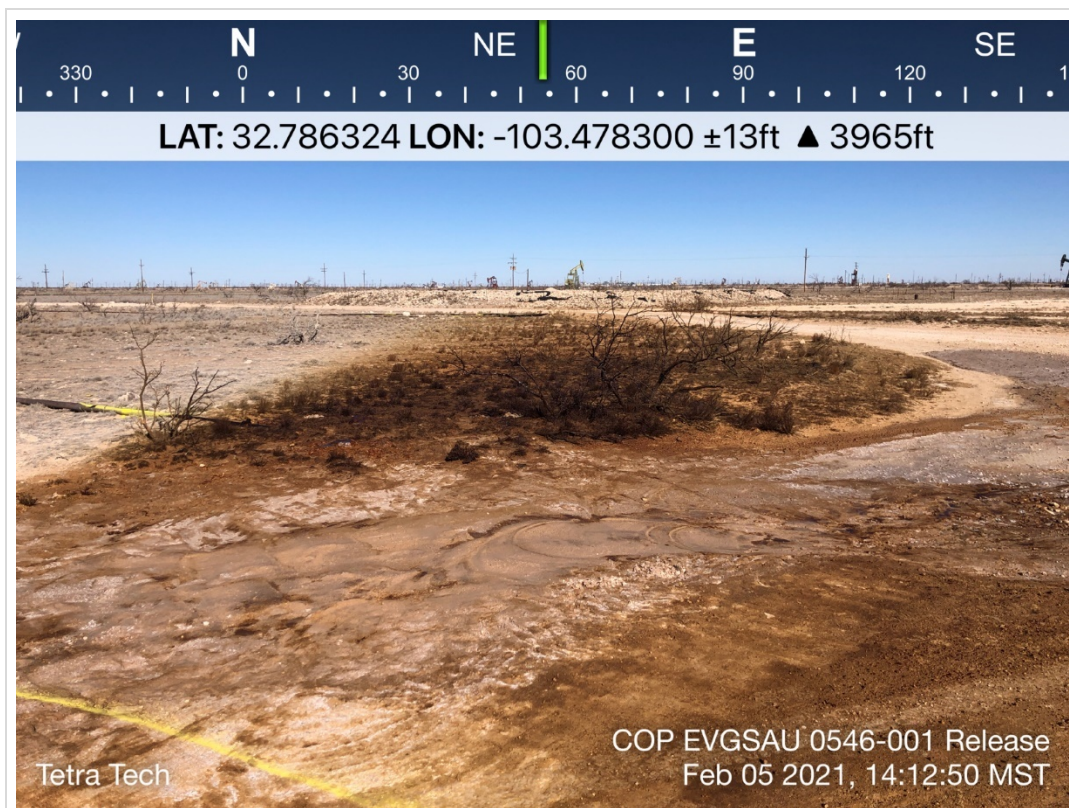
TETRA TECH, INC. PROJECT NO. 212C-MD-02538	DESCRIPTION	View northeast of the release area, lease road, and surface lines.	7
	SITE NAME	ConocoPhillips EVGSAU 0546-001 Flowline Release	2/5/2021

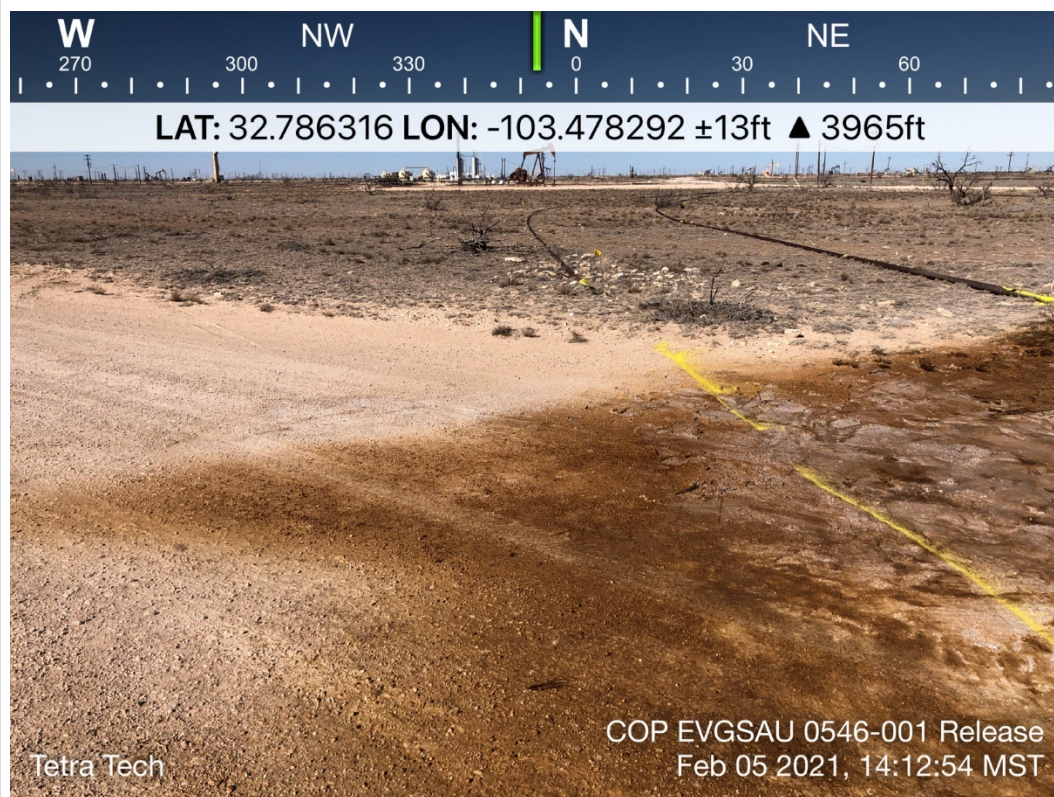
TETRA TECH, INC. PROJECT NO. 212C-MD-02538	DESCRIPTION	View north of the release area, lease road, and surface lines.	8
	SITE NAME	ConocoPhillips EVGSAU 0546-001 Flowline Release	2/5/2021

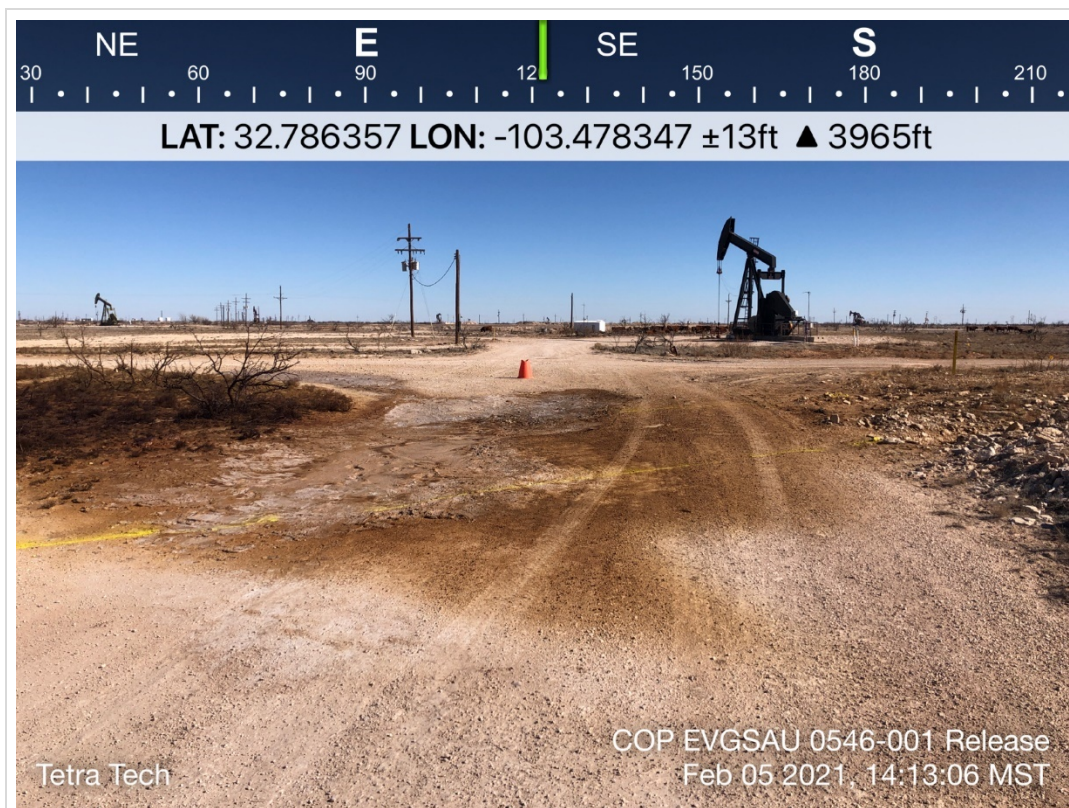
TETRA TECH, INC. PROJECT NO. 212C-MD-02538	DESCRIPTION	View southeast of the lease road.	9
	SITE NAME	ConocoPhillips EVGSAU 0546-001 Flowline Release	2/5/2021

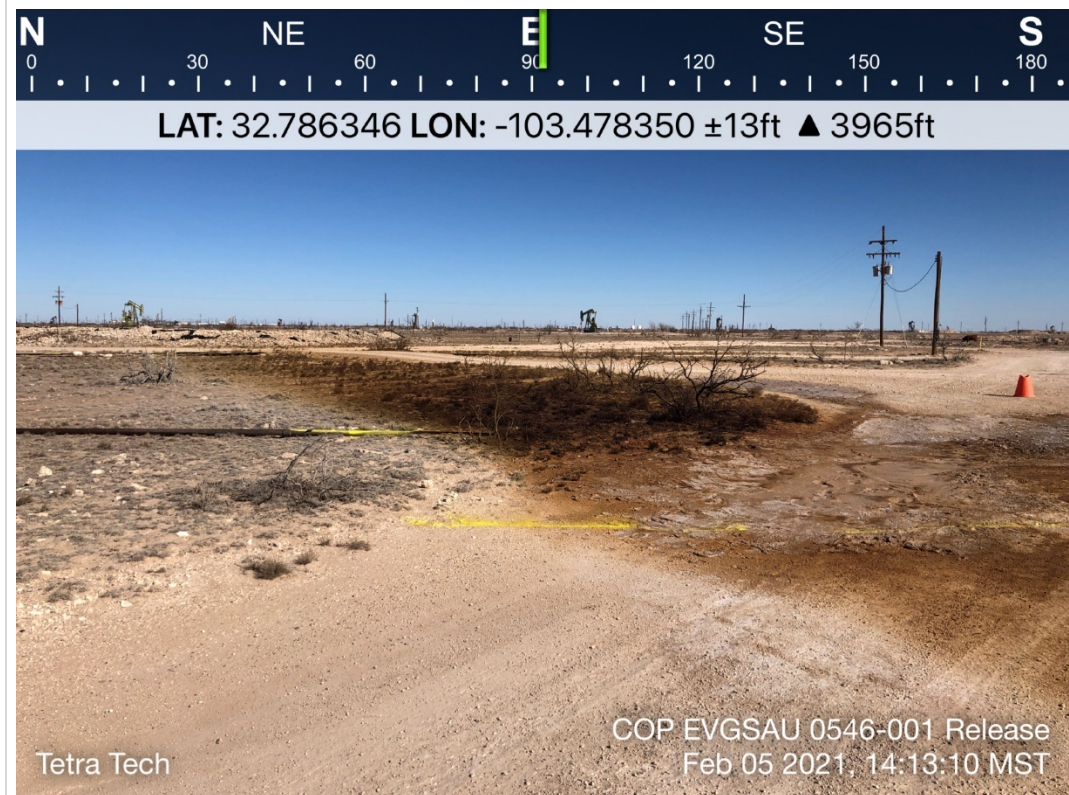
TETRA TECH, INC. PROJECT NO. 212C-MD-02538	DESCRIPTION	View east of the release area, lease road, and surface lines.	10
	SITE NAME	ConocoPhillips EVGSAU 0546-001 Flowline Release	2/5/2021
