Incident ID	nAPP2126455144
District RP	
Facility ID	
Application ID

## DELINEATION AND SITE CHARACTERIZATION REPORT

Mesa B 005 Spill Path 5,532 SQ FT

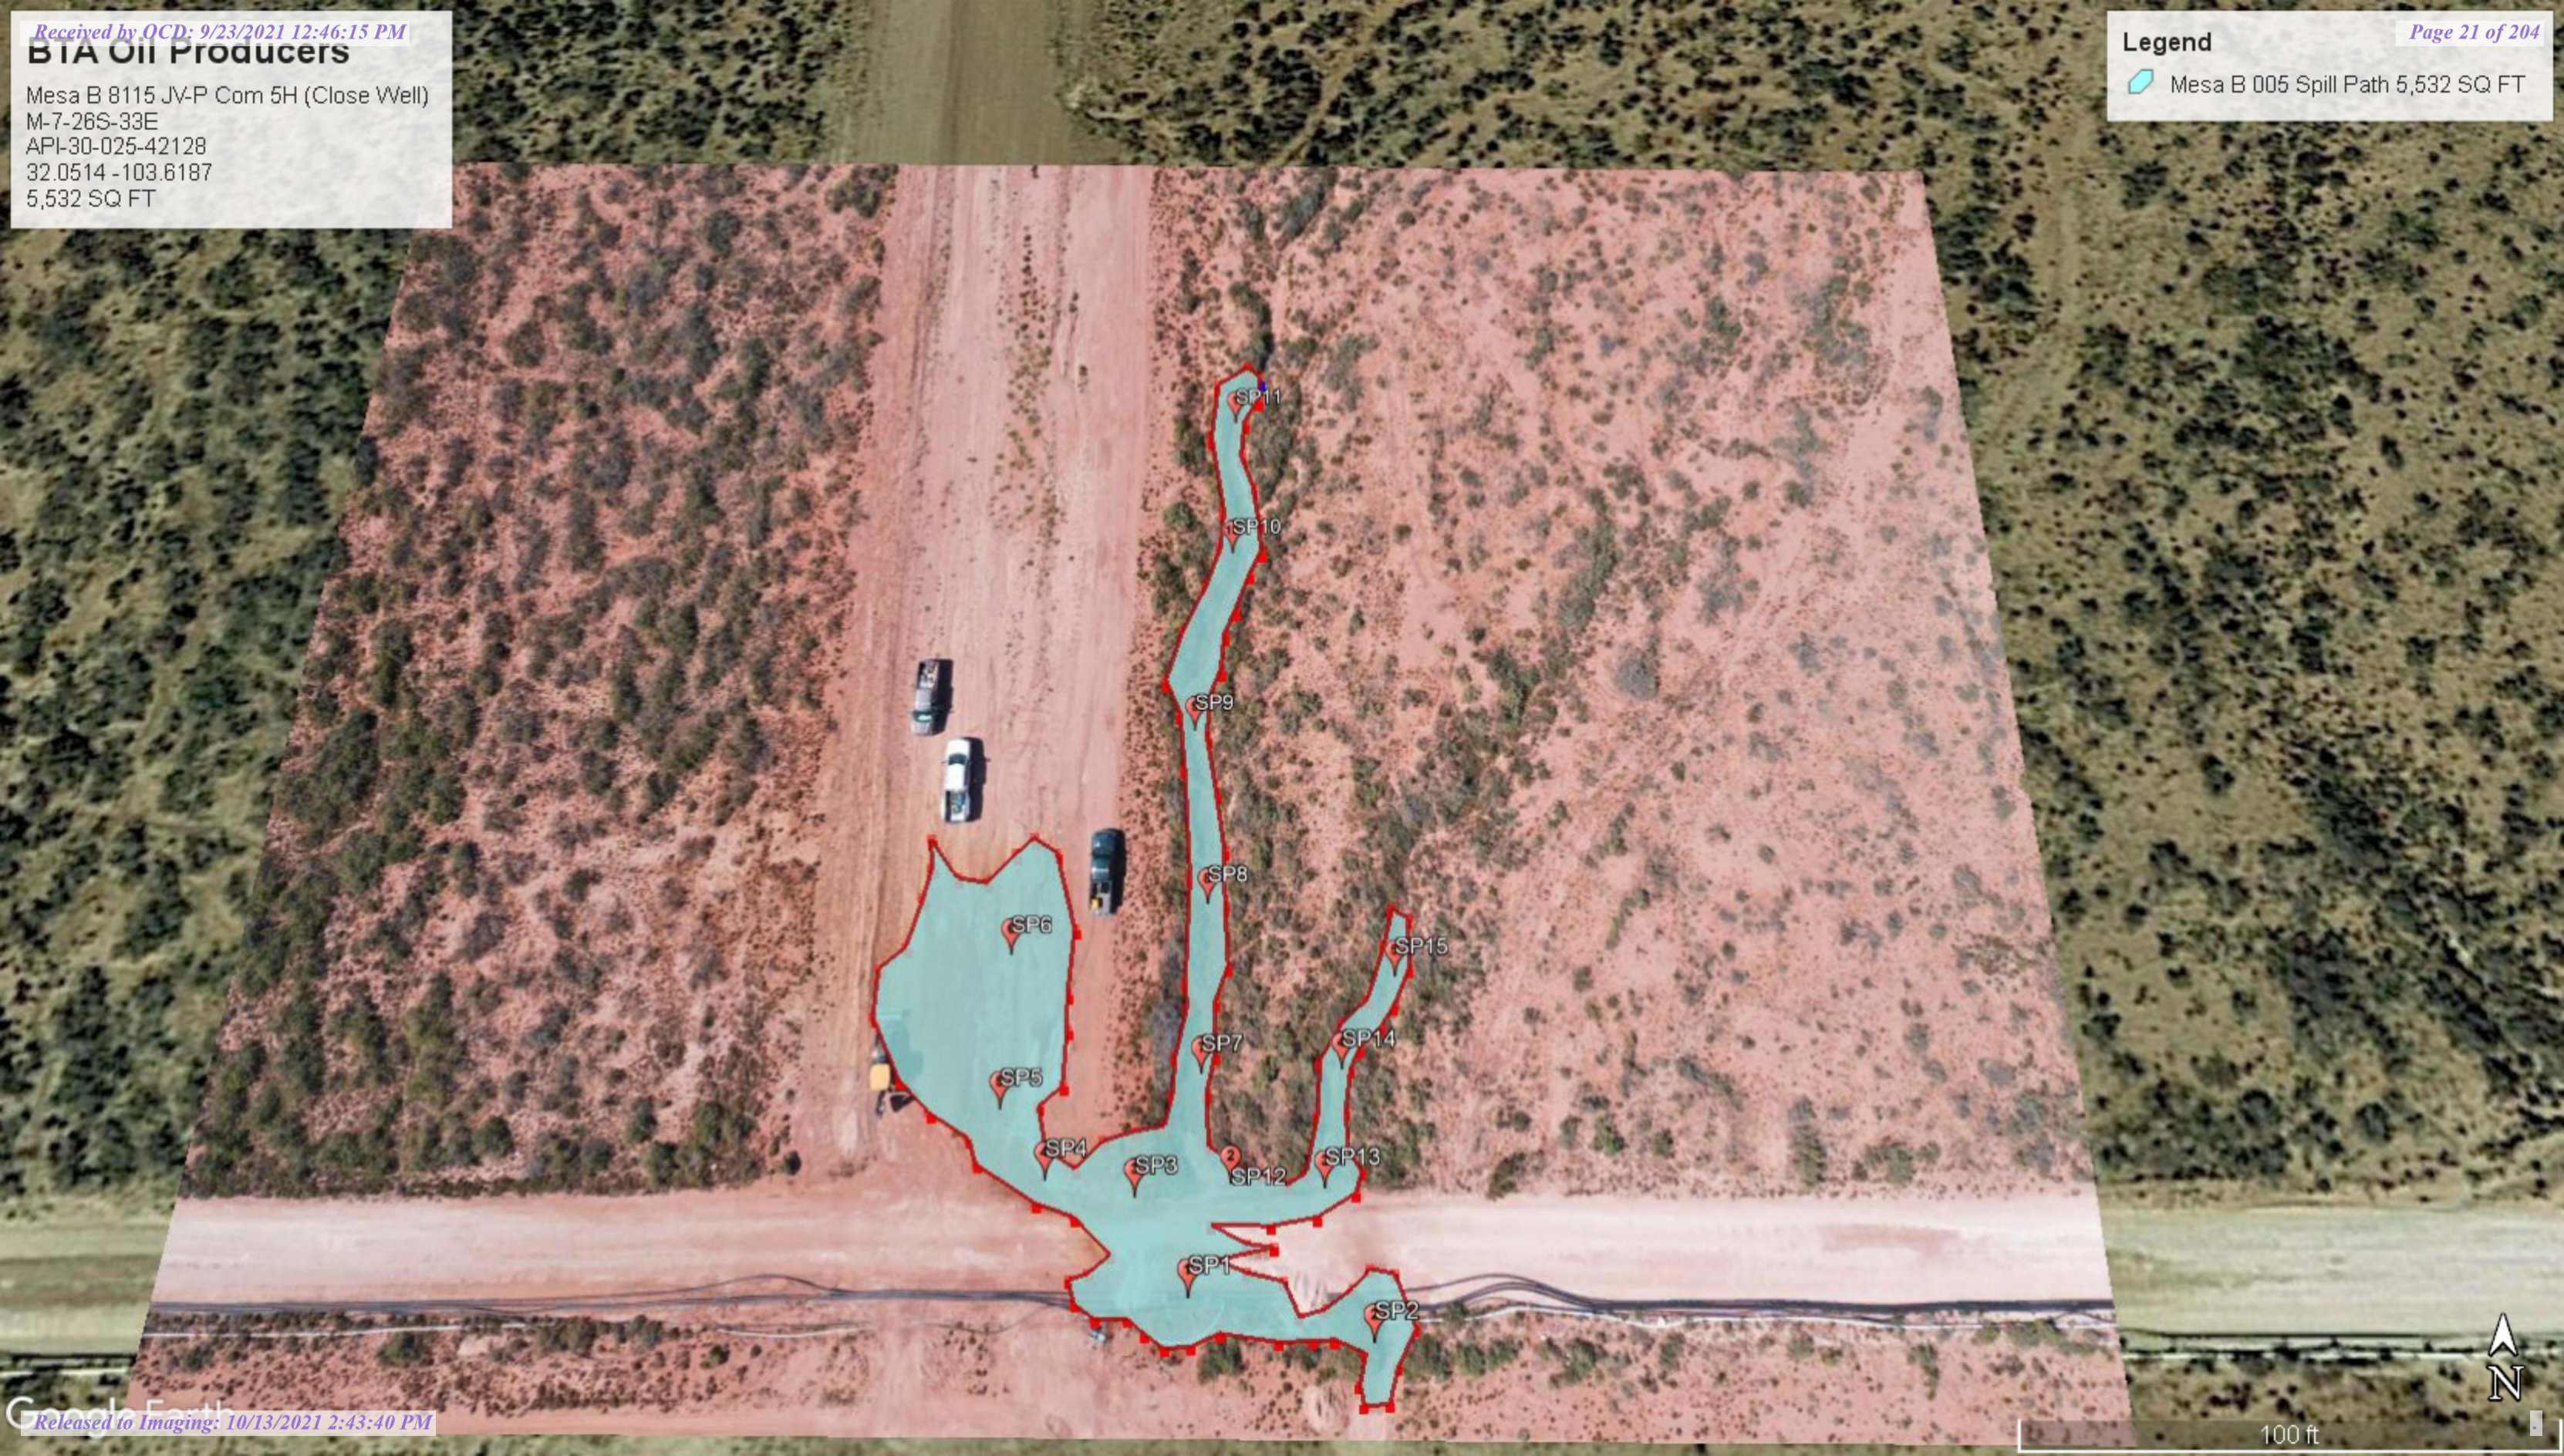
Mesa B 8115 JV-P Com 5H (Closest Well)  
M-7 28S,33E  
API-30-025-42120  
32.0514 -103.6187  
24,756 SQ FT

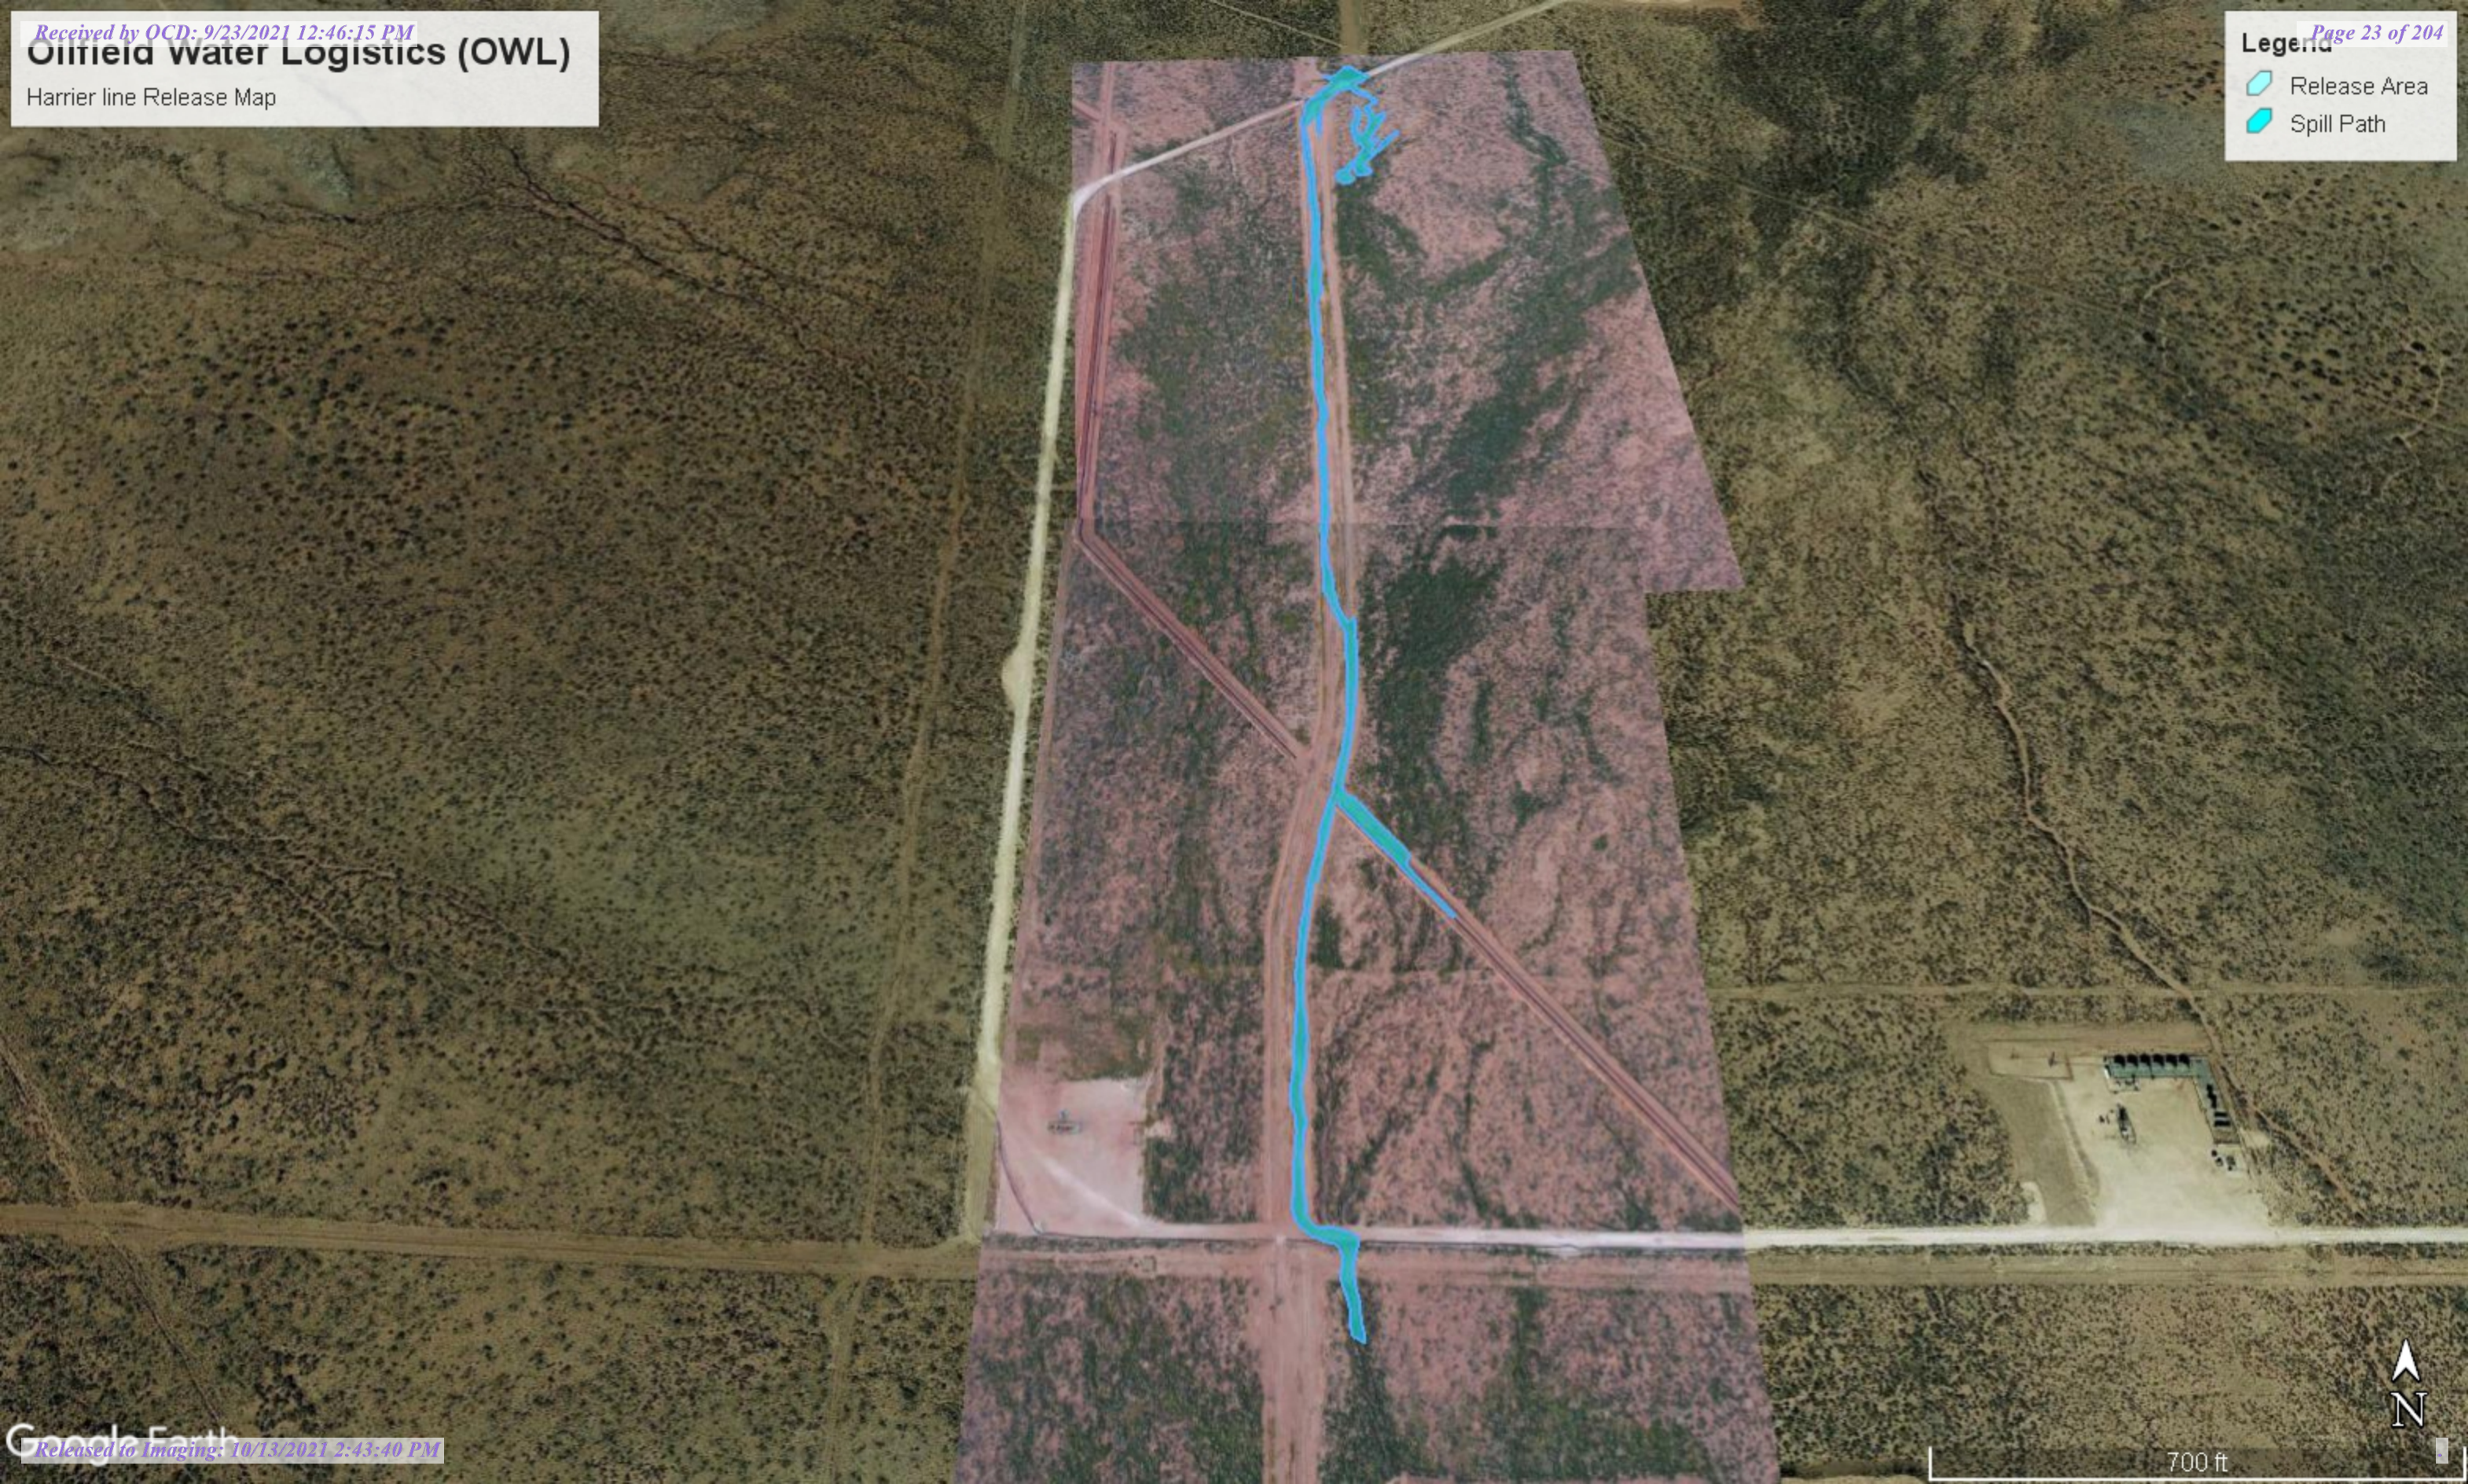
Harrier line Release Map

-   Release Area
-   Spill Path

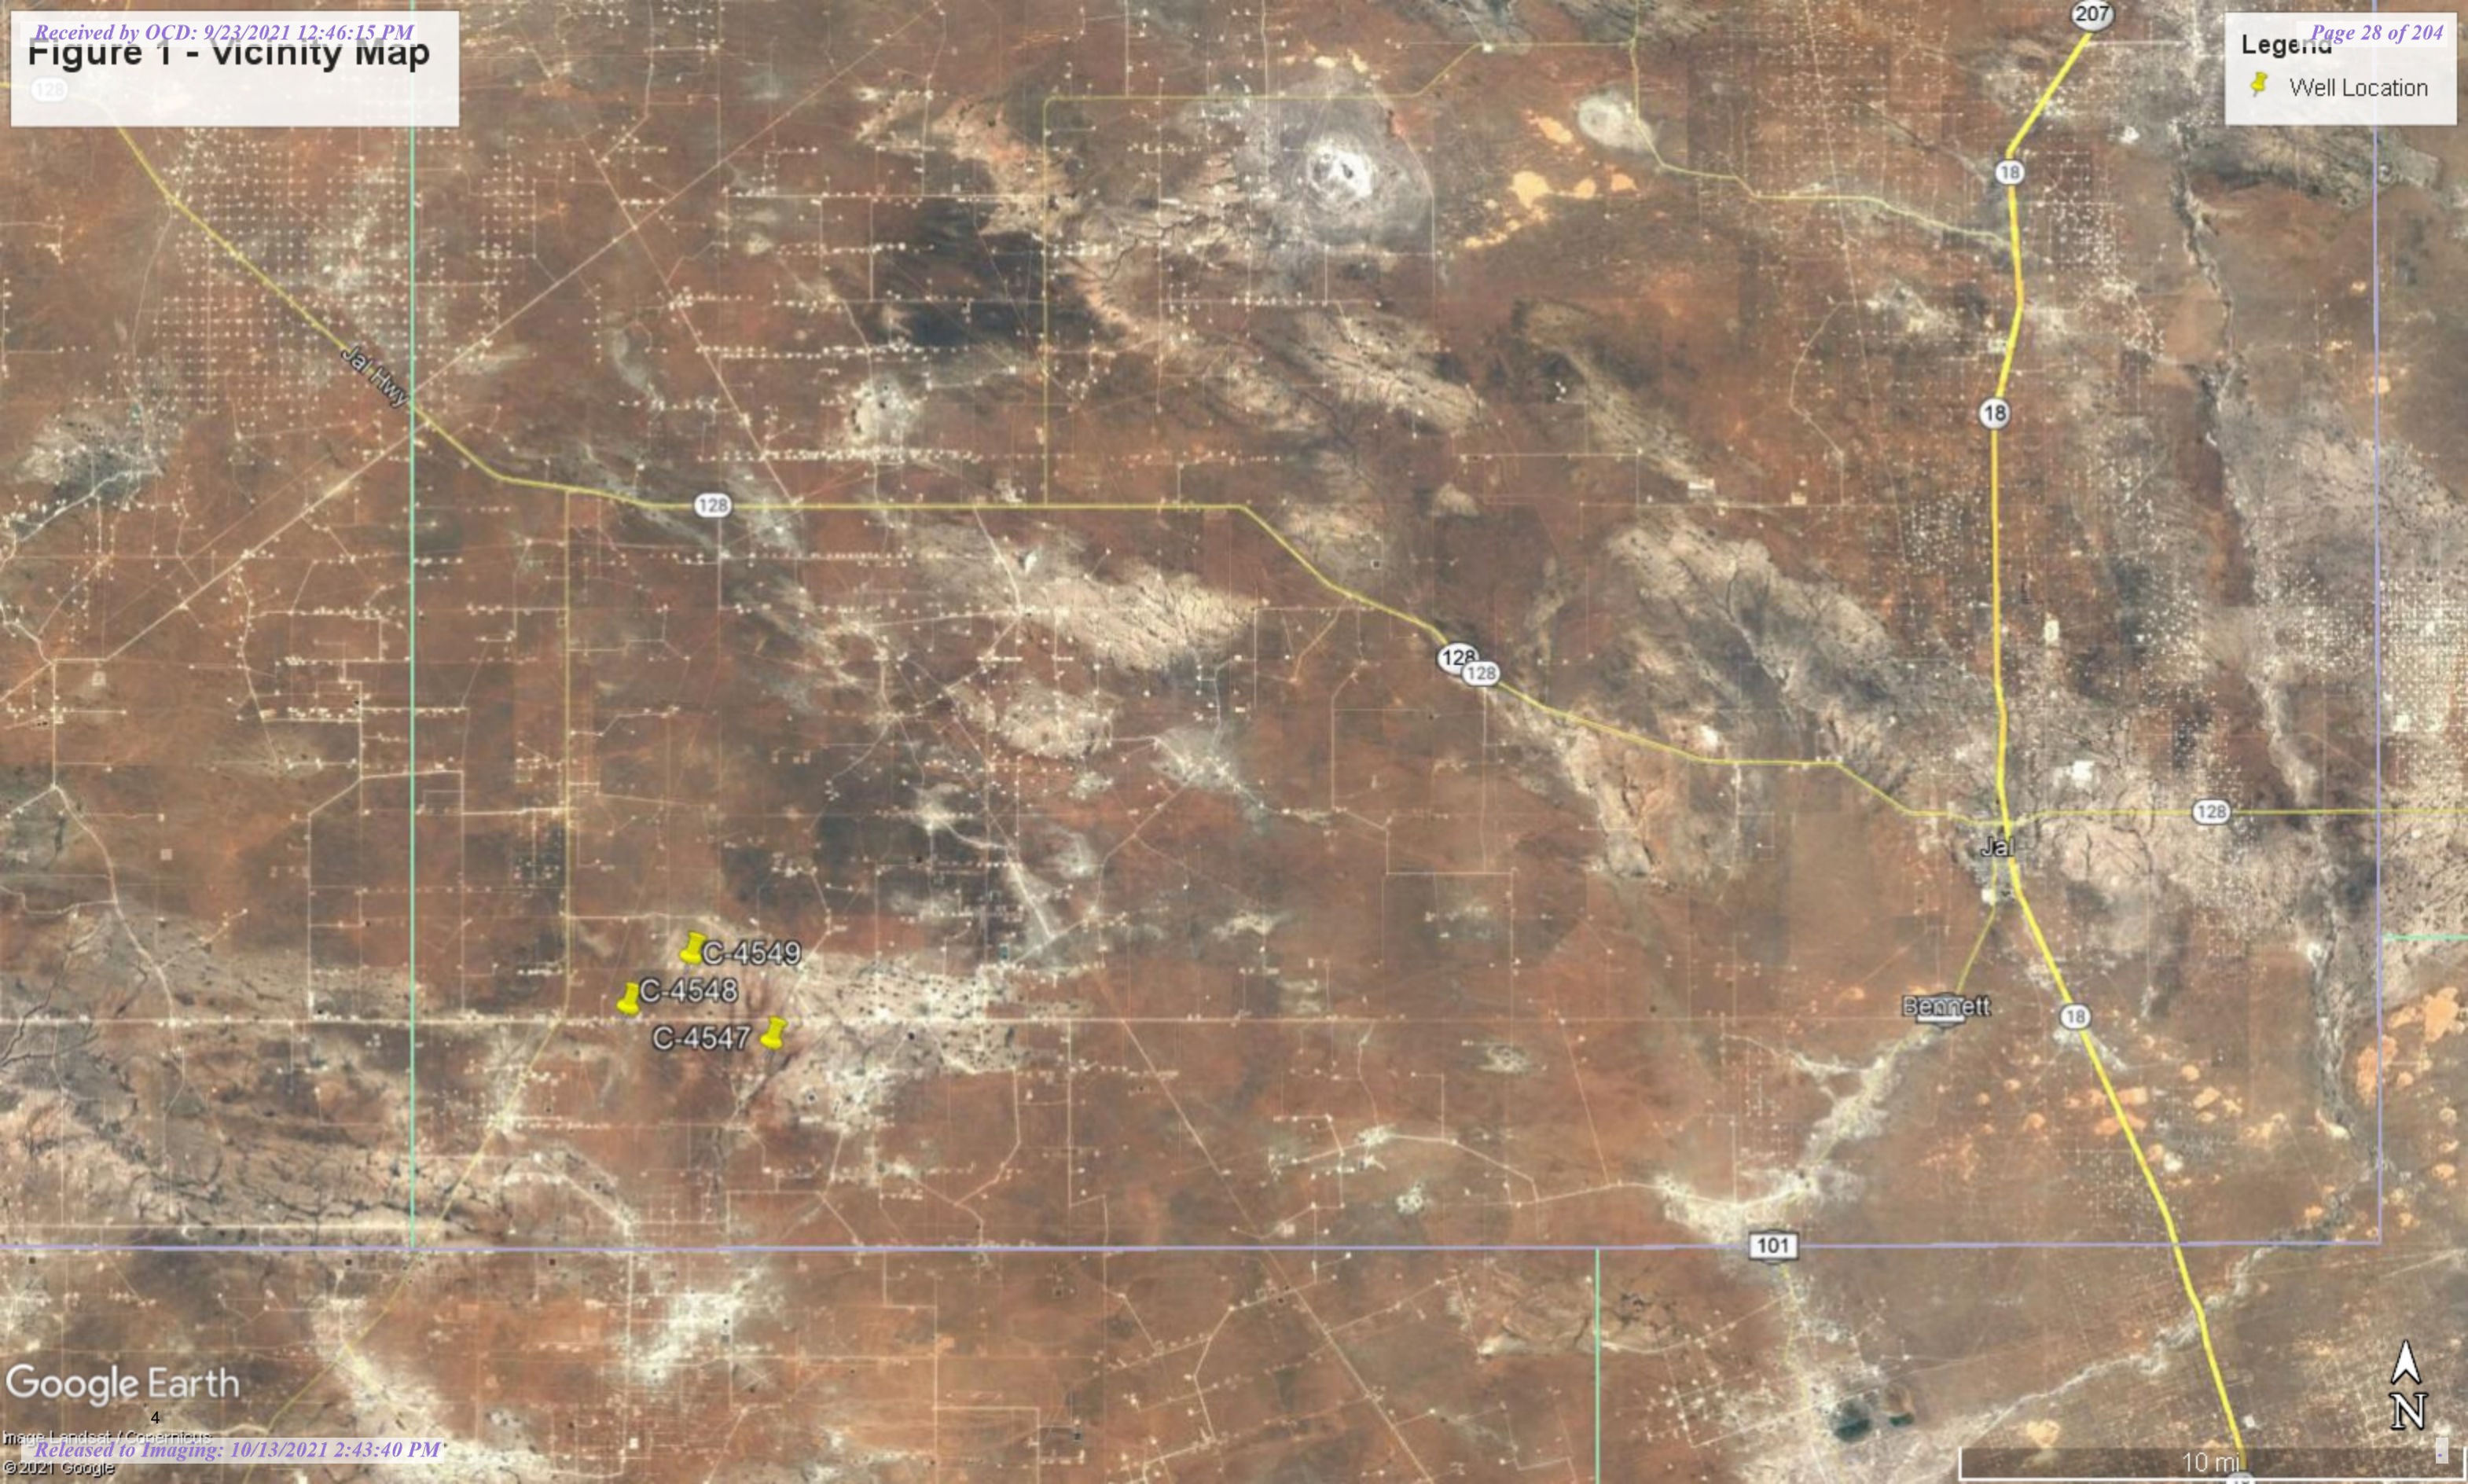
Figure 2 - well map

Well Location

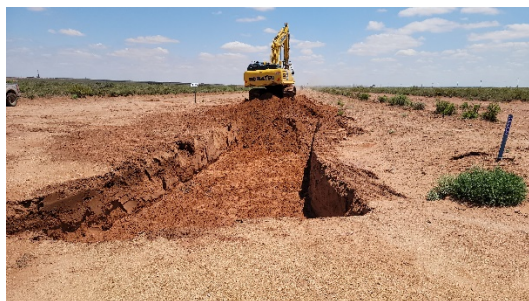
Excavation started on location

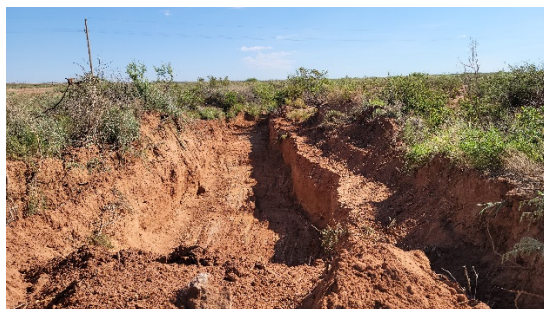
Continuing excavation on location

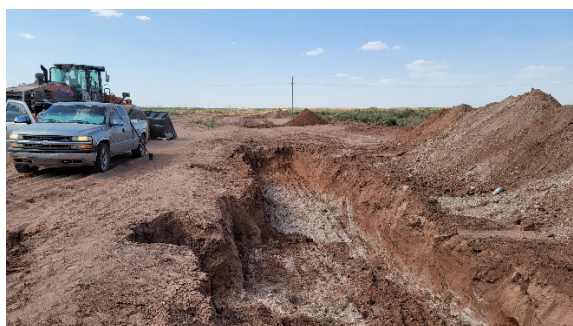
Excavation in progress on location

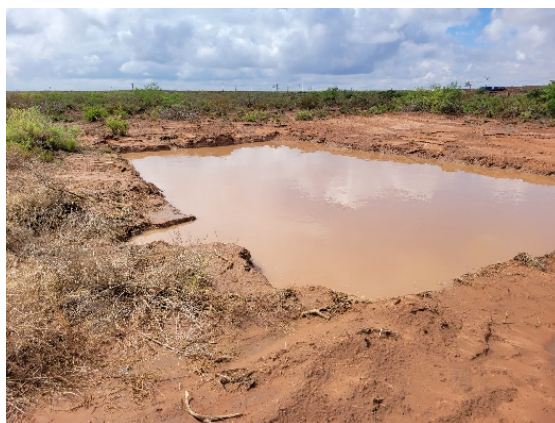
- The area of SB 11,12,13 was excavated to 6' where contamination could be completely removed.
- 7/15/2021-8/15/21: Heavy rain took place on a few different occasions. The rain caused massive flooding and erosion. The excavation doubled in size due to erosion and flooding. The clean imported soil that was stockpiled was washed down ROW or went into the trench and washed away. The lease road was washed out in two different spots

Flooded excavation due to heavy rain

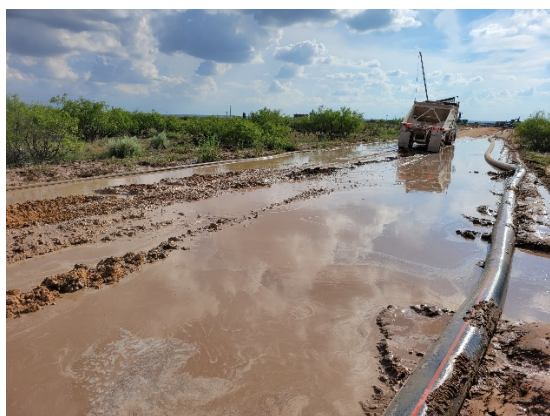
which caused an issue with being able to get oil trucks or any vehicles in or out. The roads were fixed within a few days of flooding.

Photo of the washed out road due to Heavy rain

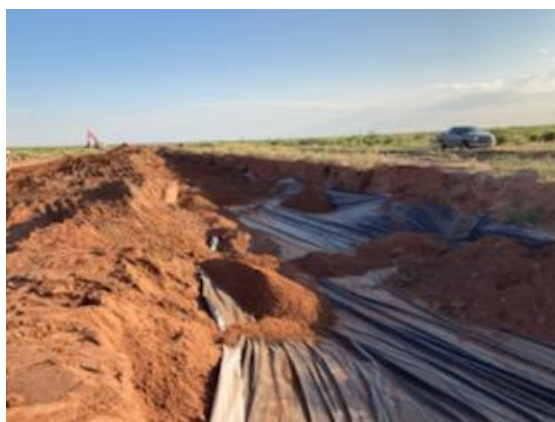
20 ML liner installed in excavation

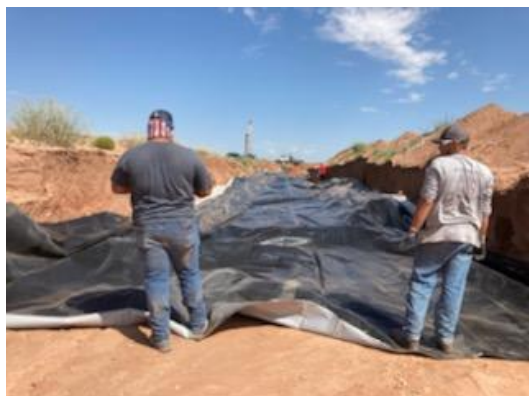
Seating liner in excavation area

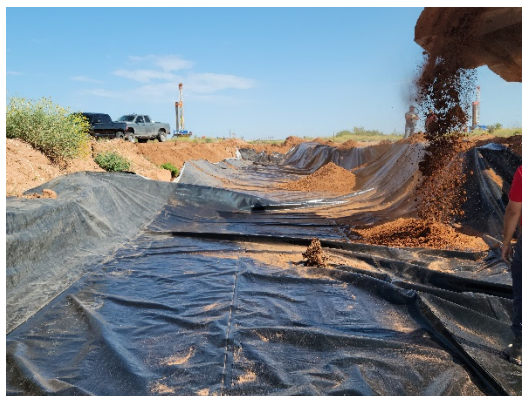
Backfilling excavation after liner installation

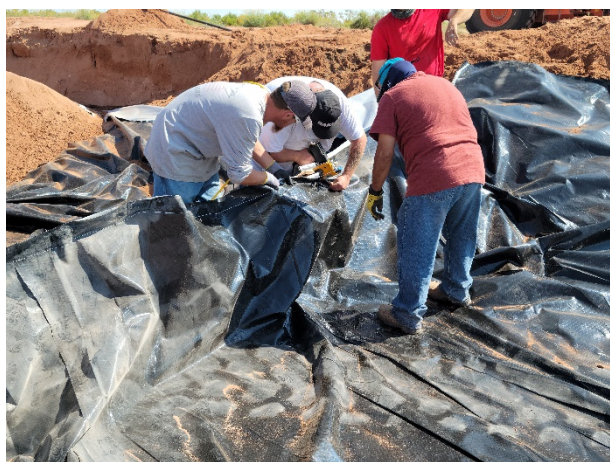
Sewing liner together in excavation

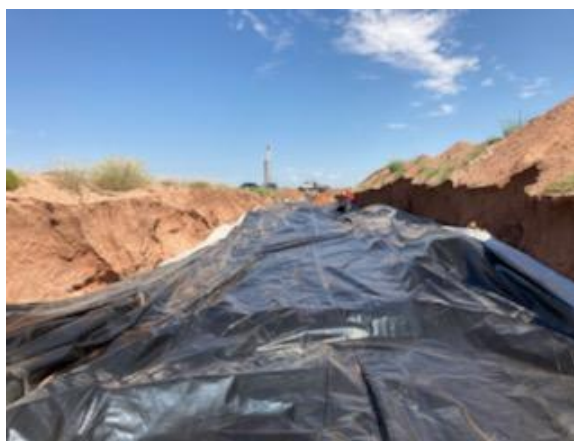
Liner properly seated in excavation
