State of New Mexico
Energy Minerals and Natural
Resources Department
Oil Conservation Division
1220 South St. Francis Dr.
Santa Fe, NM 87505

#E29921-BG6

SUBJECT: Remediation Closure Report for the Line 1003 Release (NAPP2113331984), Eddy County, New Mexico

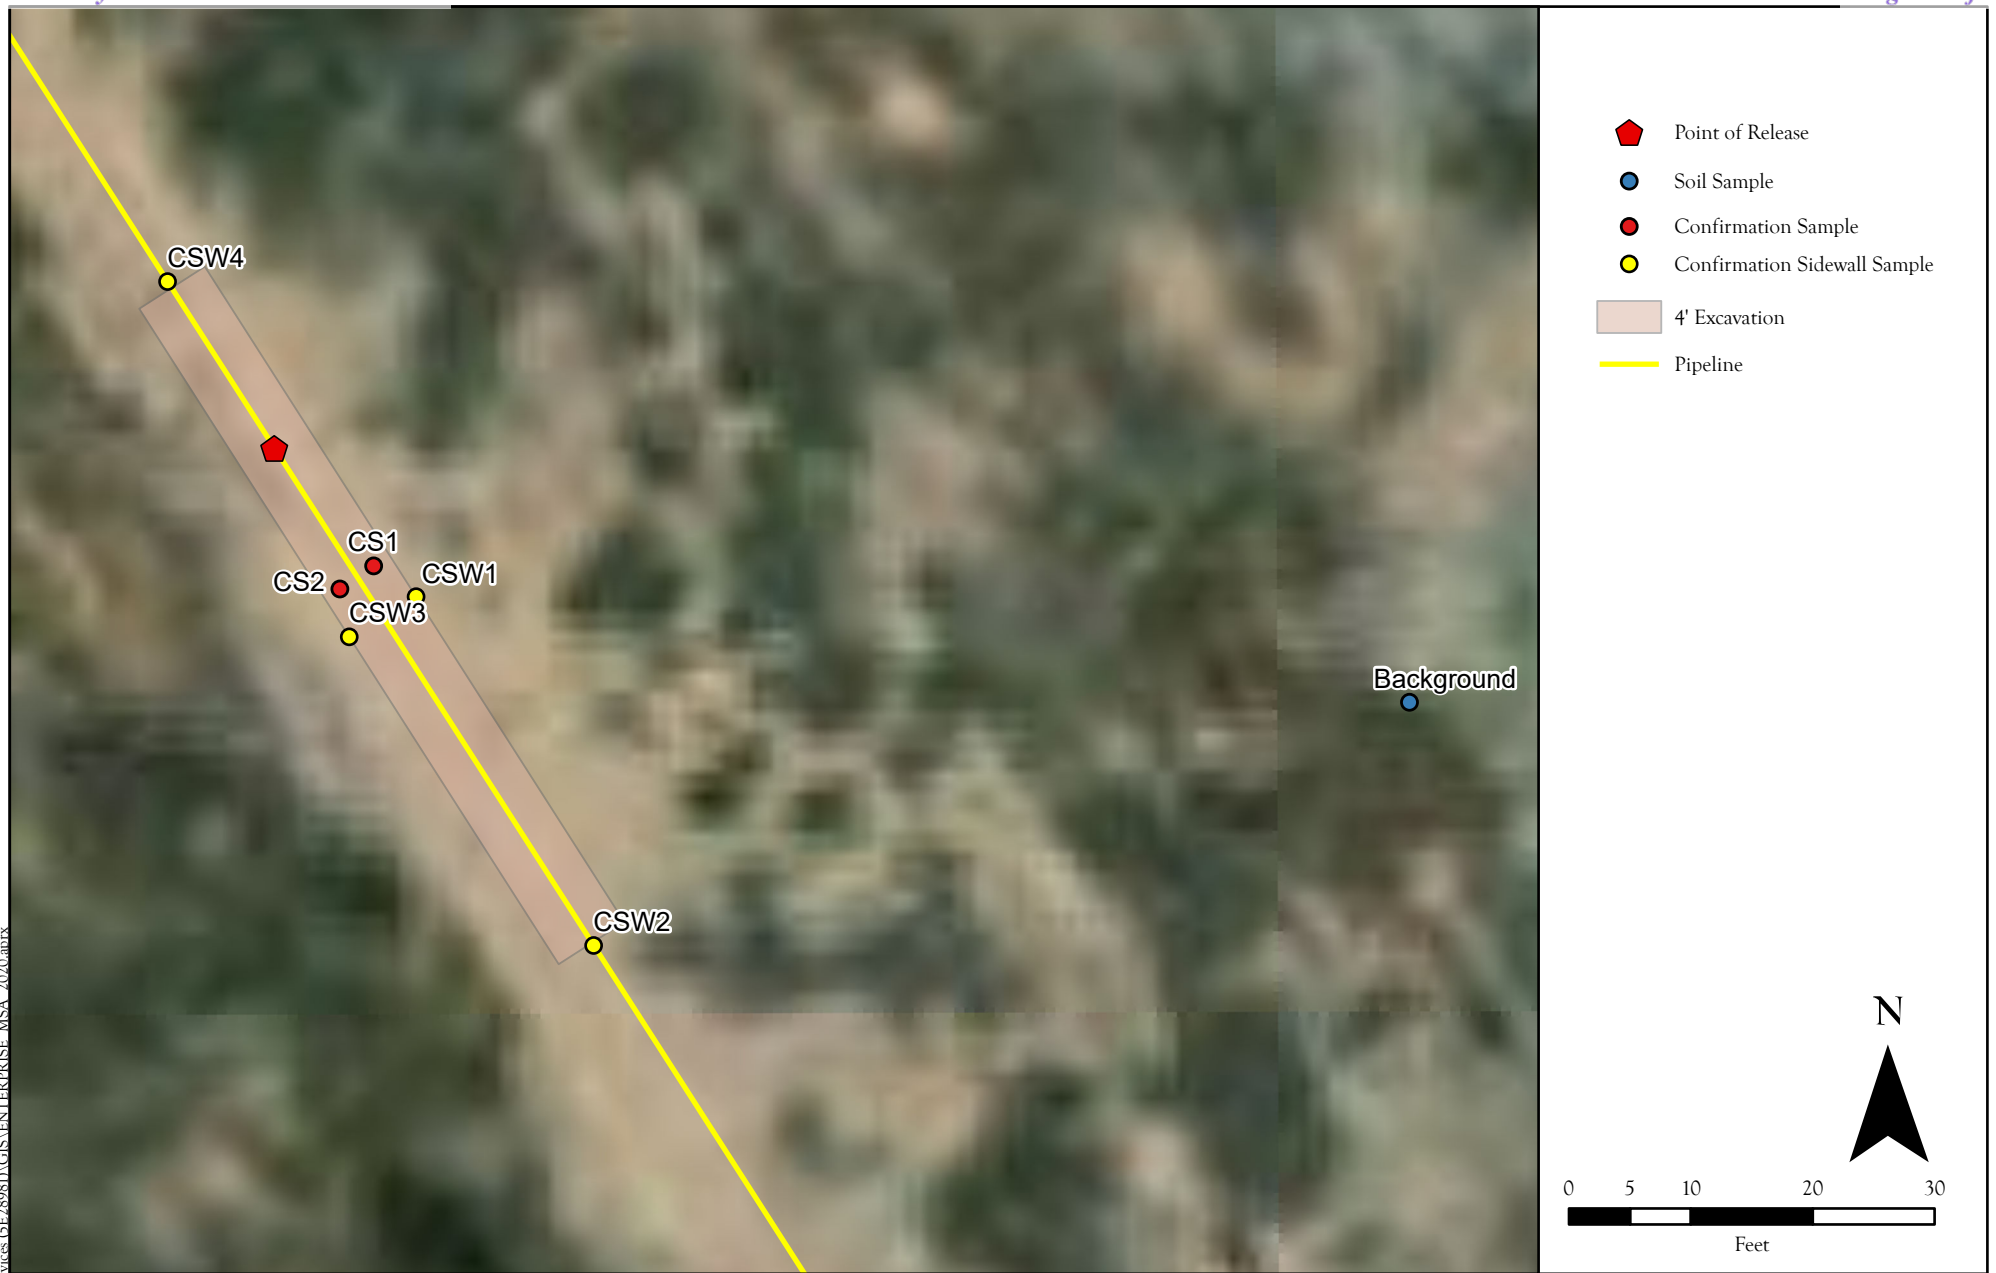
On May 14, 2021, following excavation activities to expose the line to conduct repairs, SMA collected confirmation samples from the walls and base of the excavation, which measured approximately 6 feet by 65 feet with a depth of 4 feet.

Confirmation samples were comprised of five-point composites of the base (CS1-CS2) and walls (CSW1-CSW4). A background and a spoils sample were also collected.

Figure 3 shows the extent of the final excavation and closure sample locations. Laboratory results are summarized in Table 3. Laboratory reports are included in Appendix D.

Site and Confirmation Sample Location Map
 1003 Line Release - Enterprise Field Services LLC
 32.309272, -104.035949, Eddy County, New Mexico

Contaminated soils were removed and replaced with clean backfill material to return the surface to previous contours. The contaminated soil was transported and disposed of at Lea Land LLC, Hobbs, New Mexico, an NMOCD-permitted disposal facility.

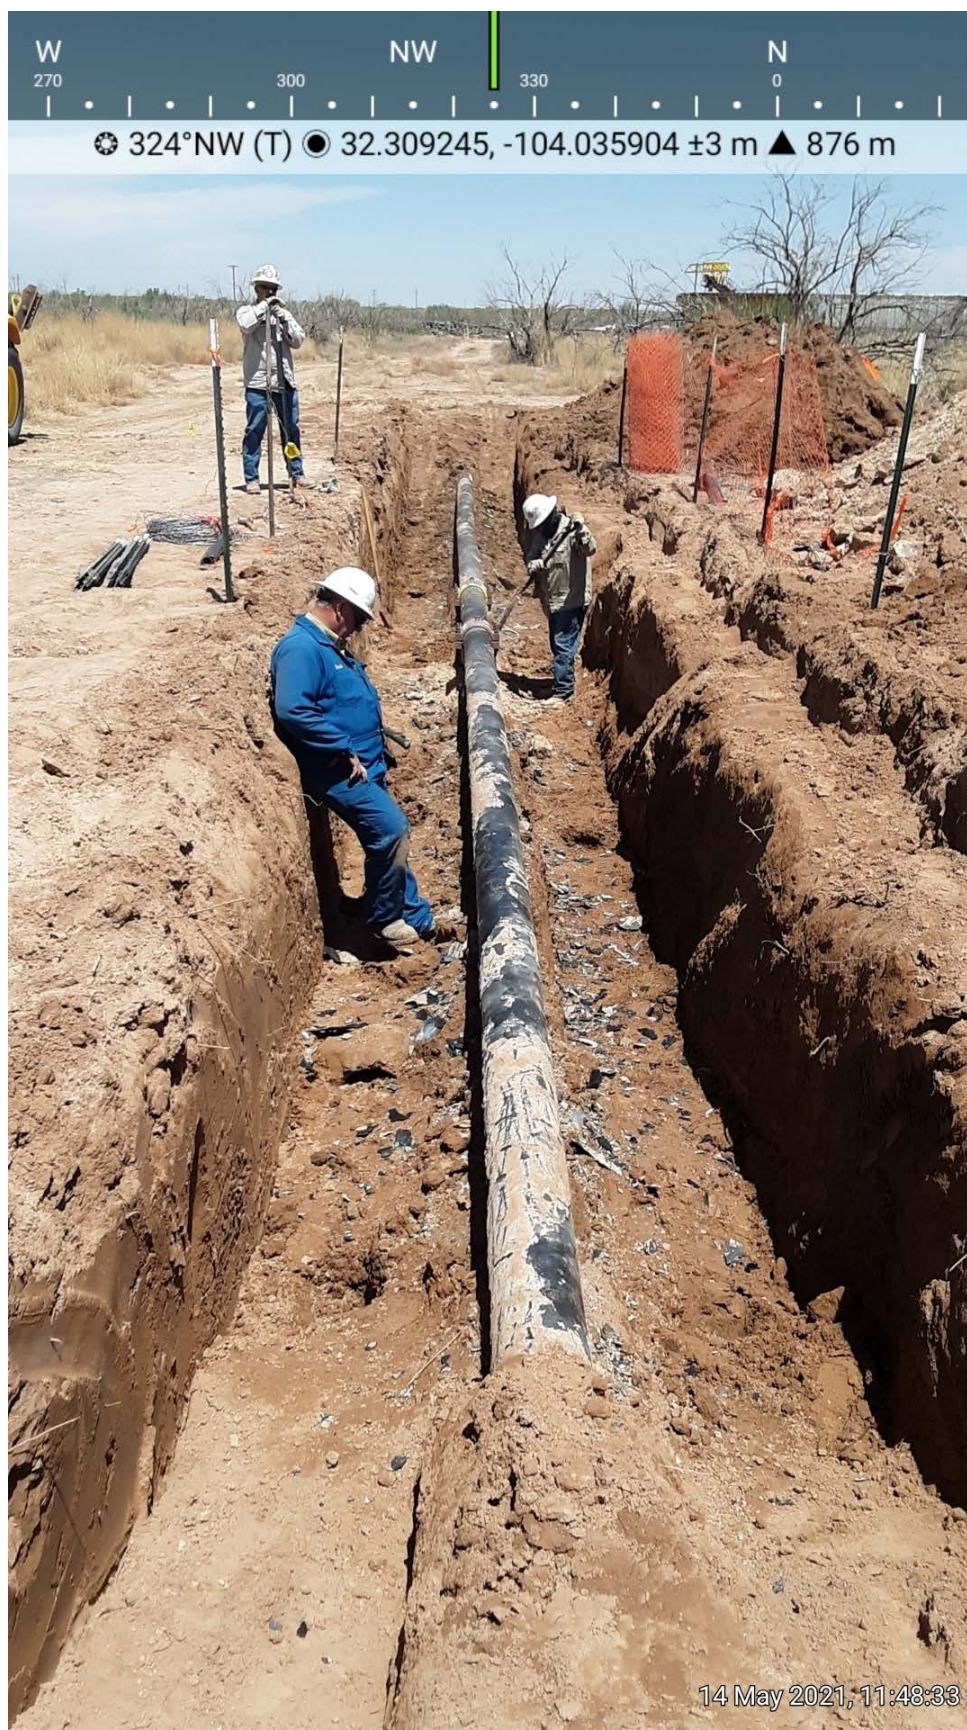
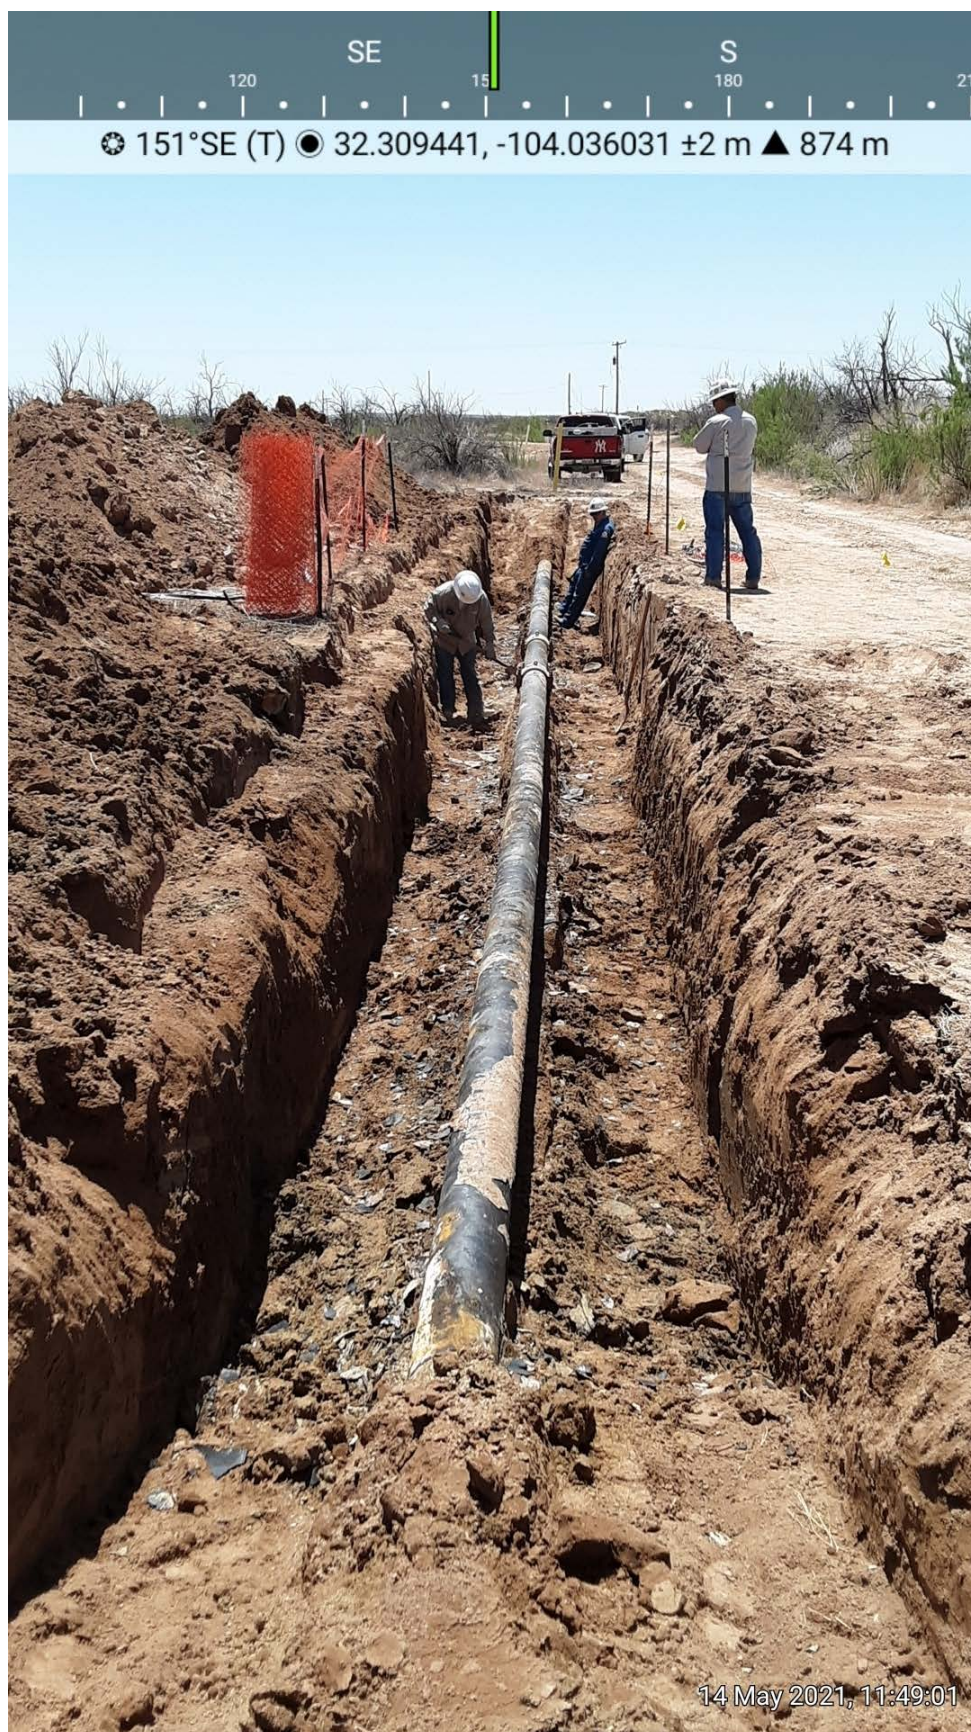
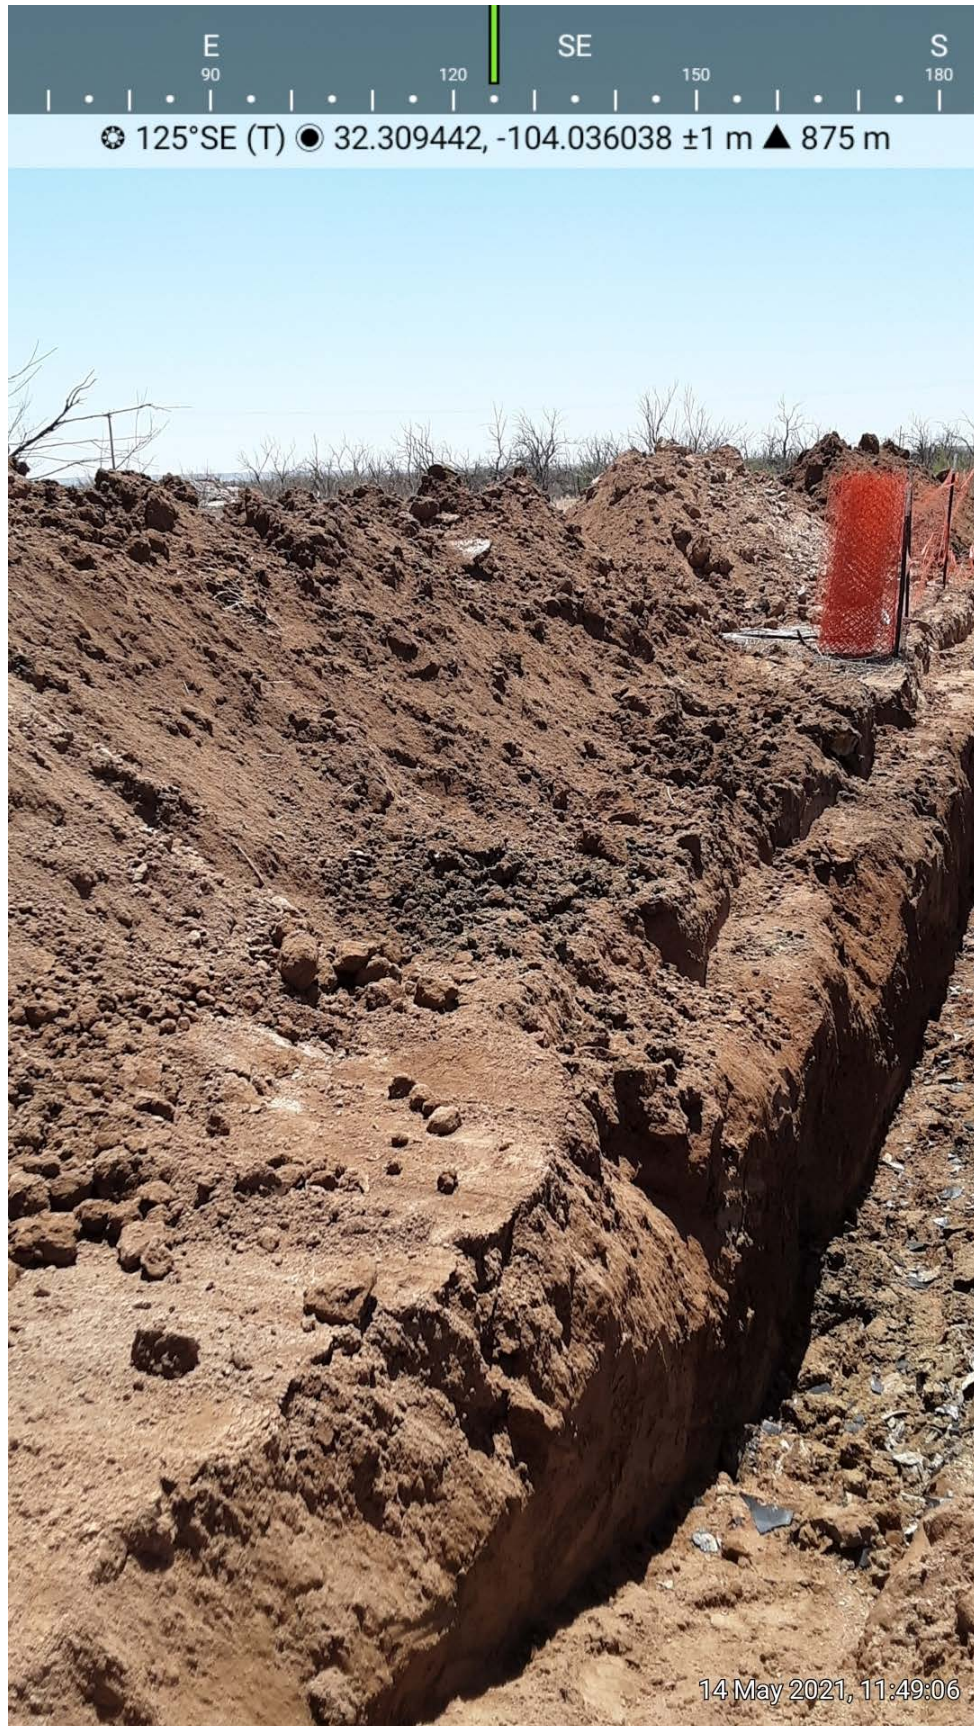
- One Composite Sample was taken on north side of pipeline and a Separate Composite on the South side of ~~center~~ Pipeline.

- Four Stillwell Composite Samples of Pit were collected.

- Back gravel Sample taken away from excavation showed surrounding area was high in chlorides.

• Pipeline shown in middle of excavated area

Excavation depth = 4 Feet.
