Release Notification

| Site Name PLU 28 Big Sinks | Site Type Central Tank Battery |

**RE: Closure Request
PLU 28 Big Sinks Central Tank Battery
Incident Number NAPP2105535211
Eddy County, New Mexico**

WSP USA Inc. (WSP) on behalf of XTO Energy, Inc. (XTO), presents the following Closure Request detailing site assessment and soil sampling activities at the Poker Lake Unit (PLU) 28 Big Sinks Central Tank Battery (Site) in Unit F, Section 28, Township 25 South, Range 31 East, in Eddy County, New Mexico (Figure 1). The purpose of the site assessment and soil sampling activities was to assess for the presence or absence of impacts to soil following a release of produced water at the Site. Based on field observations, field screening activities, and soil sample analytical results, XTO is submitting this Closure Request and requesting no further action (NFA) for Incident Number NAPP2105535211.

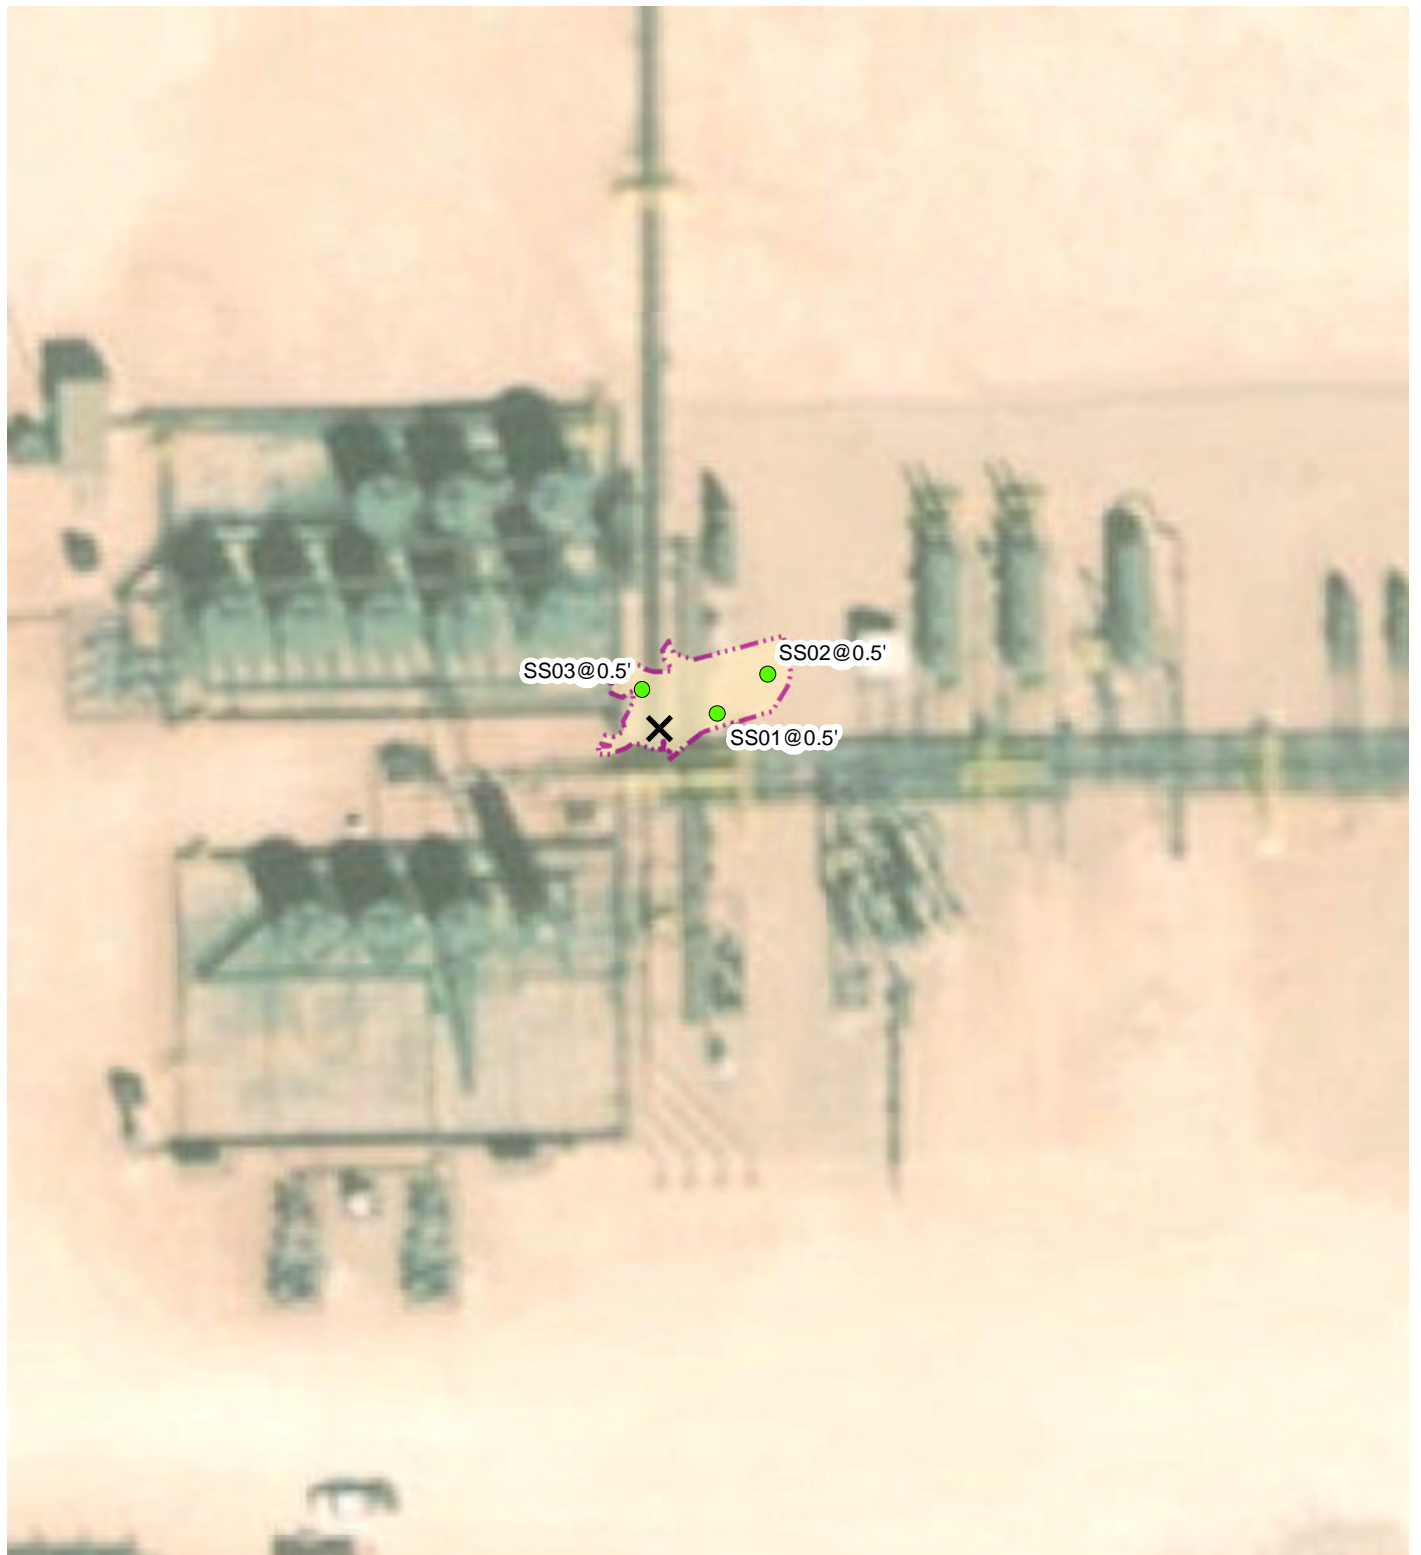
FIGURE 2
PRELIMINARY SOIL SAMPLE LOCATIONS
PLU 28 BIG SINKS CENTRAL TANK BATTERY
UNIT F SEC 28 T25S R31E
EDDY COUNTY, NEW MEXICO
XTO ENERGY, INC.

On May 11, 2021, WSP personnel visited the Site to evaluate the release extent based on information provided on the Form C-141 and visual observations. WSP personnel collected three preliminary assessment soil samples (SS01 through SS03) within the release area from a depth of 0.5 feet bgs to assess for the presence or absence of soil impacts. The preliminary soil samples were field screened for volatile aromatic hydrocarbons and chloride utilizing a calibrated photoionization detector (PID) and Hach® chloride QuanTab® test strips, respectively. The release extent and preliminary soil sample locations were mapped utilizing a handheld Global Positioning System (GPS) unit and are depicted on Figure 2.

Laboratory analytical results for preliminary soil samples SS01 through SS03 indicated that benzene, BTEX, TPH-GRO/TPH-DRO, TPH, and chloride concentrations were compliant with the Closure Criteria. To further evaluate for the presence or absence of impacted soil, additional vertical assessment activities were scheduled.

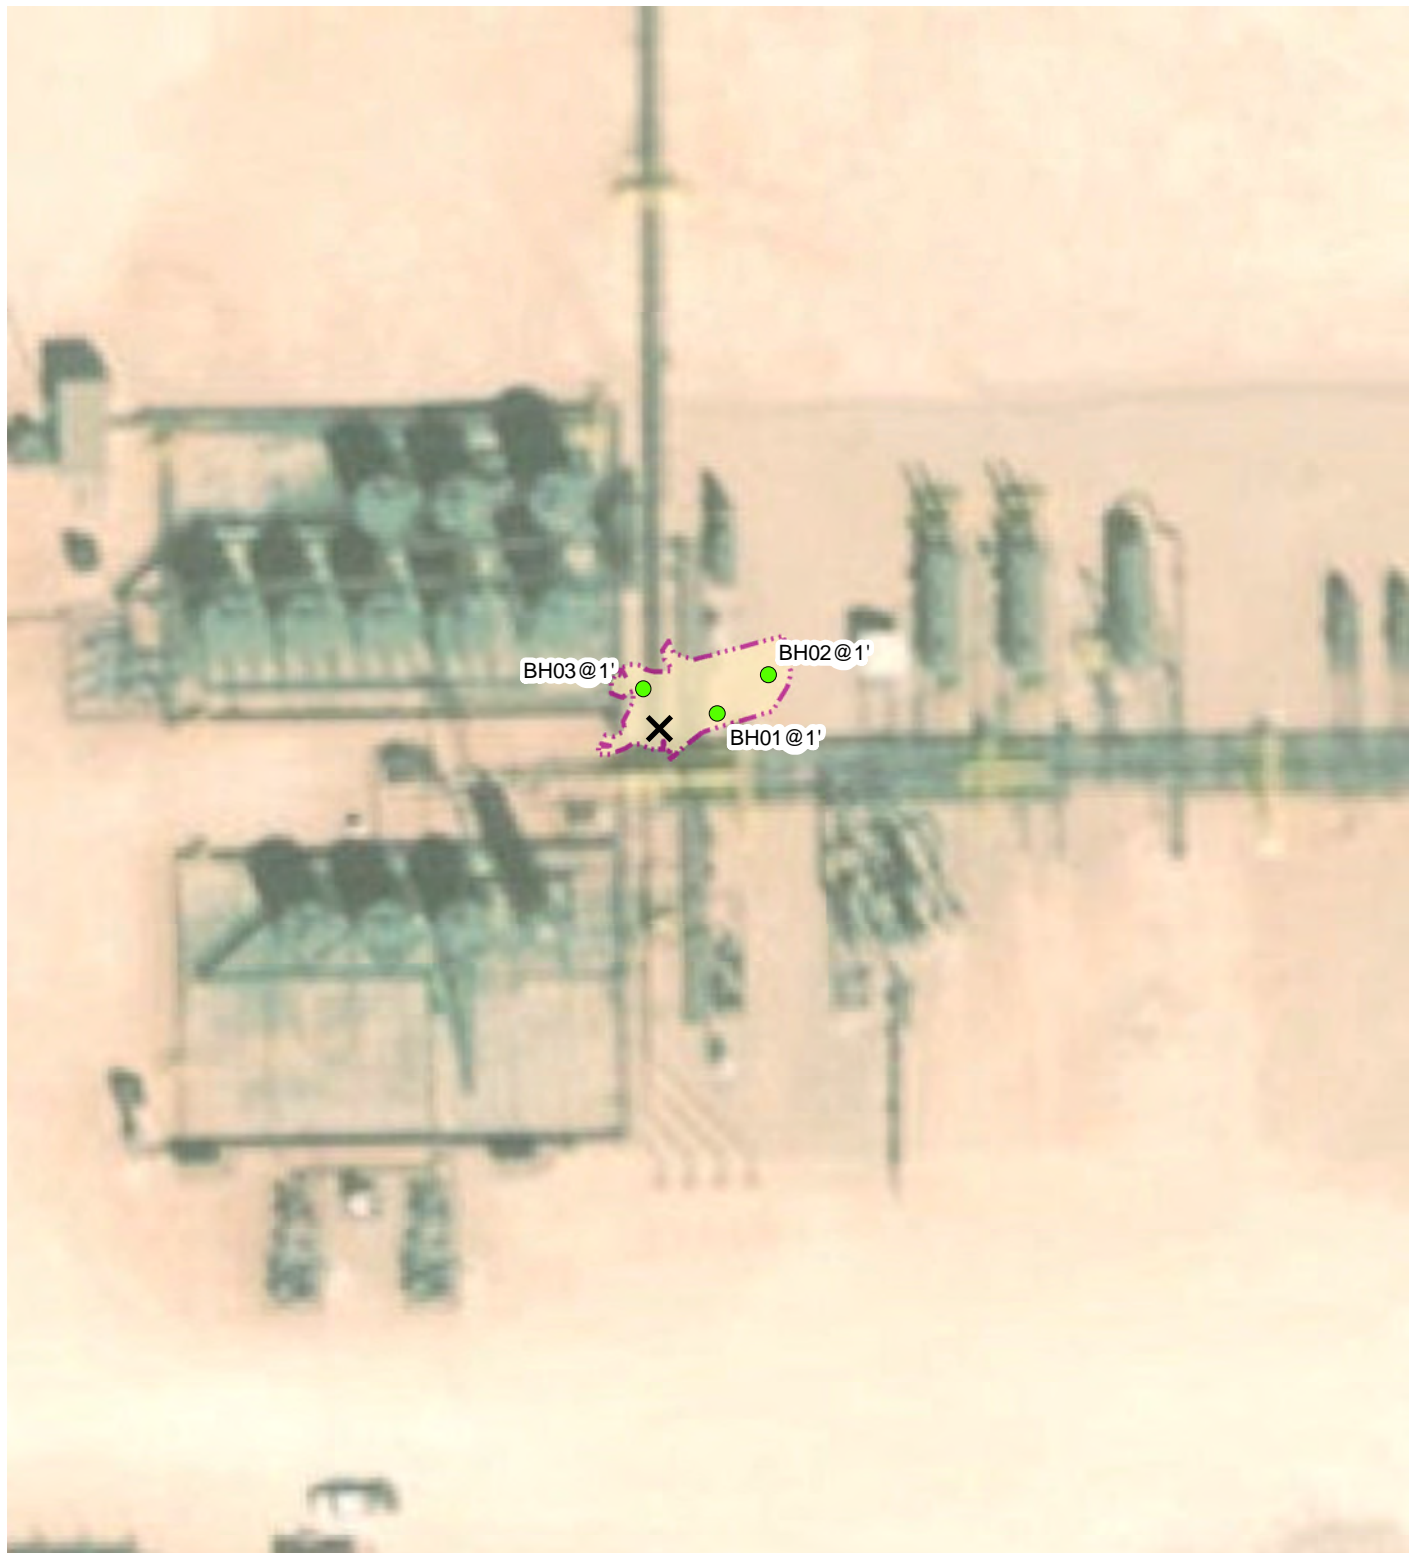
FIGURE 3
DELINEATION SOIL SAMPLE LOCATIONS
 PLU 28 BIG SINKS CENTRAL TANK BATTERY
 UNIT F SEC 28 T25S R31E
 EDDY COUNTY, NEW MEXICO
XTO ENERGY, INC.

On May 25, 2021, WSP personnel returned to the Site to oversee additional soil assessment activities. Three boreholes (BH01 through BH03) were advanced using a hand auger to a depth of 1 foot bgs, at SS01 through SS03 preliminary soil sample locations. Delineation soil samples were collected from the boreholes at a depths of 1-foot bgs. Soil from the boreholes was field screened for volatile aromatic hydrocarbons and chloride utilizing a PID and Hach® chloride QuanTab® test strips, respectively. Field screening results and observations for the boreholes were logged on lithologic/soil sampling logs, which are included in Attachment 2. The borehole delineation soil sample locations are presented on Figure 3. The delineation soil samples were collected, handled, and analyzed as described above at Eurofins in Carlsbad, New Mexico. Photographic documentation was conducted during the Site visits. A Photographic log is included in Attachment 3.

Laboratory analytical results for the delineation soil samples collected from boreholes BH01 through BH03 indicated that benzene, BTEX, TPH-GRO/TPH-DRO, TPH, and chloride concentrations were compliant with the Closure Criteria. Laboratory analytical results are summarized in Table 1 and the complete laboratory analytical reports are included as Attachment 4.

Preliminary soil samples SS01 through SS03 and delineation soil samples BH01 through BH03 were collected from within the release extent from depths ranging from 0.5 feet to 1 foot bgs to assess for the presence or absence of soil impacts as a result of the February 13, 2021 produced water release. Laboratory analytical results for the preliminary and delineation soil samples indicated that benzene, BTEX, TPH-GRO/TPH-DRO, TPH, and chloride concentrations were compliant with the Site Closure Criteria. Additionally, the release was vertically delineated to below the most stringent Table 1 Closure Criteria.

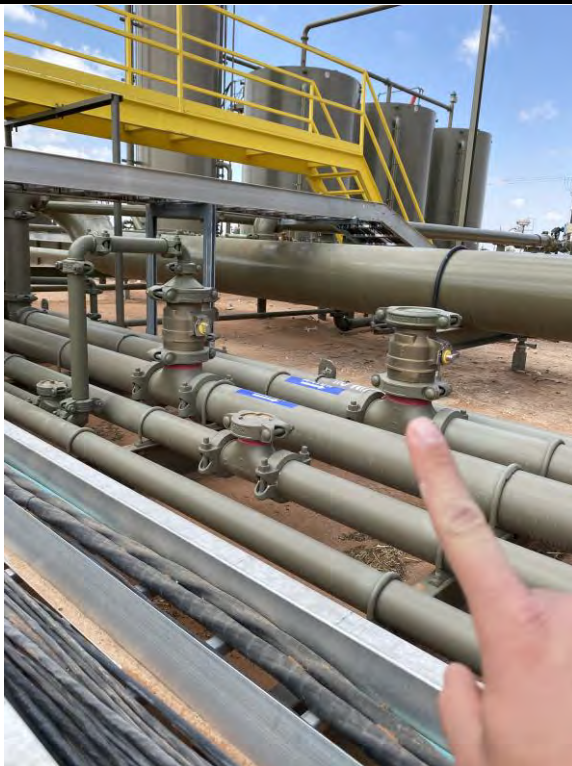
| Photo No. | Date | |
|---|---|--|
| 1 | May 11, 2021 | |

| Photo No. | Date | |
|---|---|--|
| View of release point to the southeast. | | A close-up photograph of industrial equipment. Several large, horizontal, grey metal pipes are visible, equipped with various valves and flanges. A person's hand is pointing towards one of the valves. In the background, there are yellow metal walkways and large industrial storage tanks under a clear blue sky. |
