Incident ID	nAPP2121030753
District RP	
Facility ID	
Application ID

Based on laboratory analytical results and field activities conducted to date, Etech recommends ETC Texas Pipeline, Ltd., provide copies of this *Remediation Summary & Soil Closure Request* to the appropriate agencies and request closure be granted to the Site.

Figure 2
 Aerial Proximity Map
 ETC Texas Pipeline, Ltd.
 Rajin Cajin Pipeline
 GPS: 32.05845, -103.43224
 Lea County

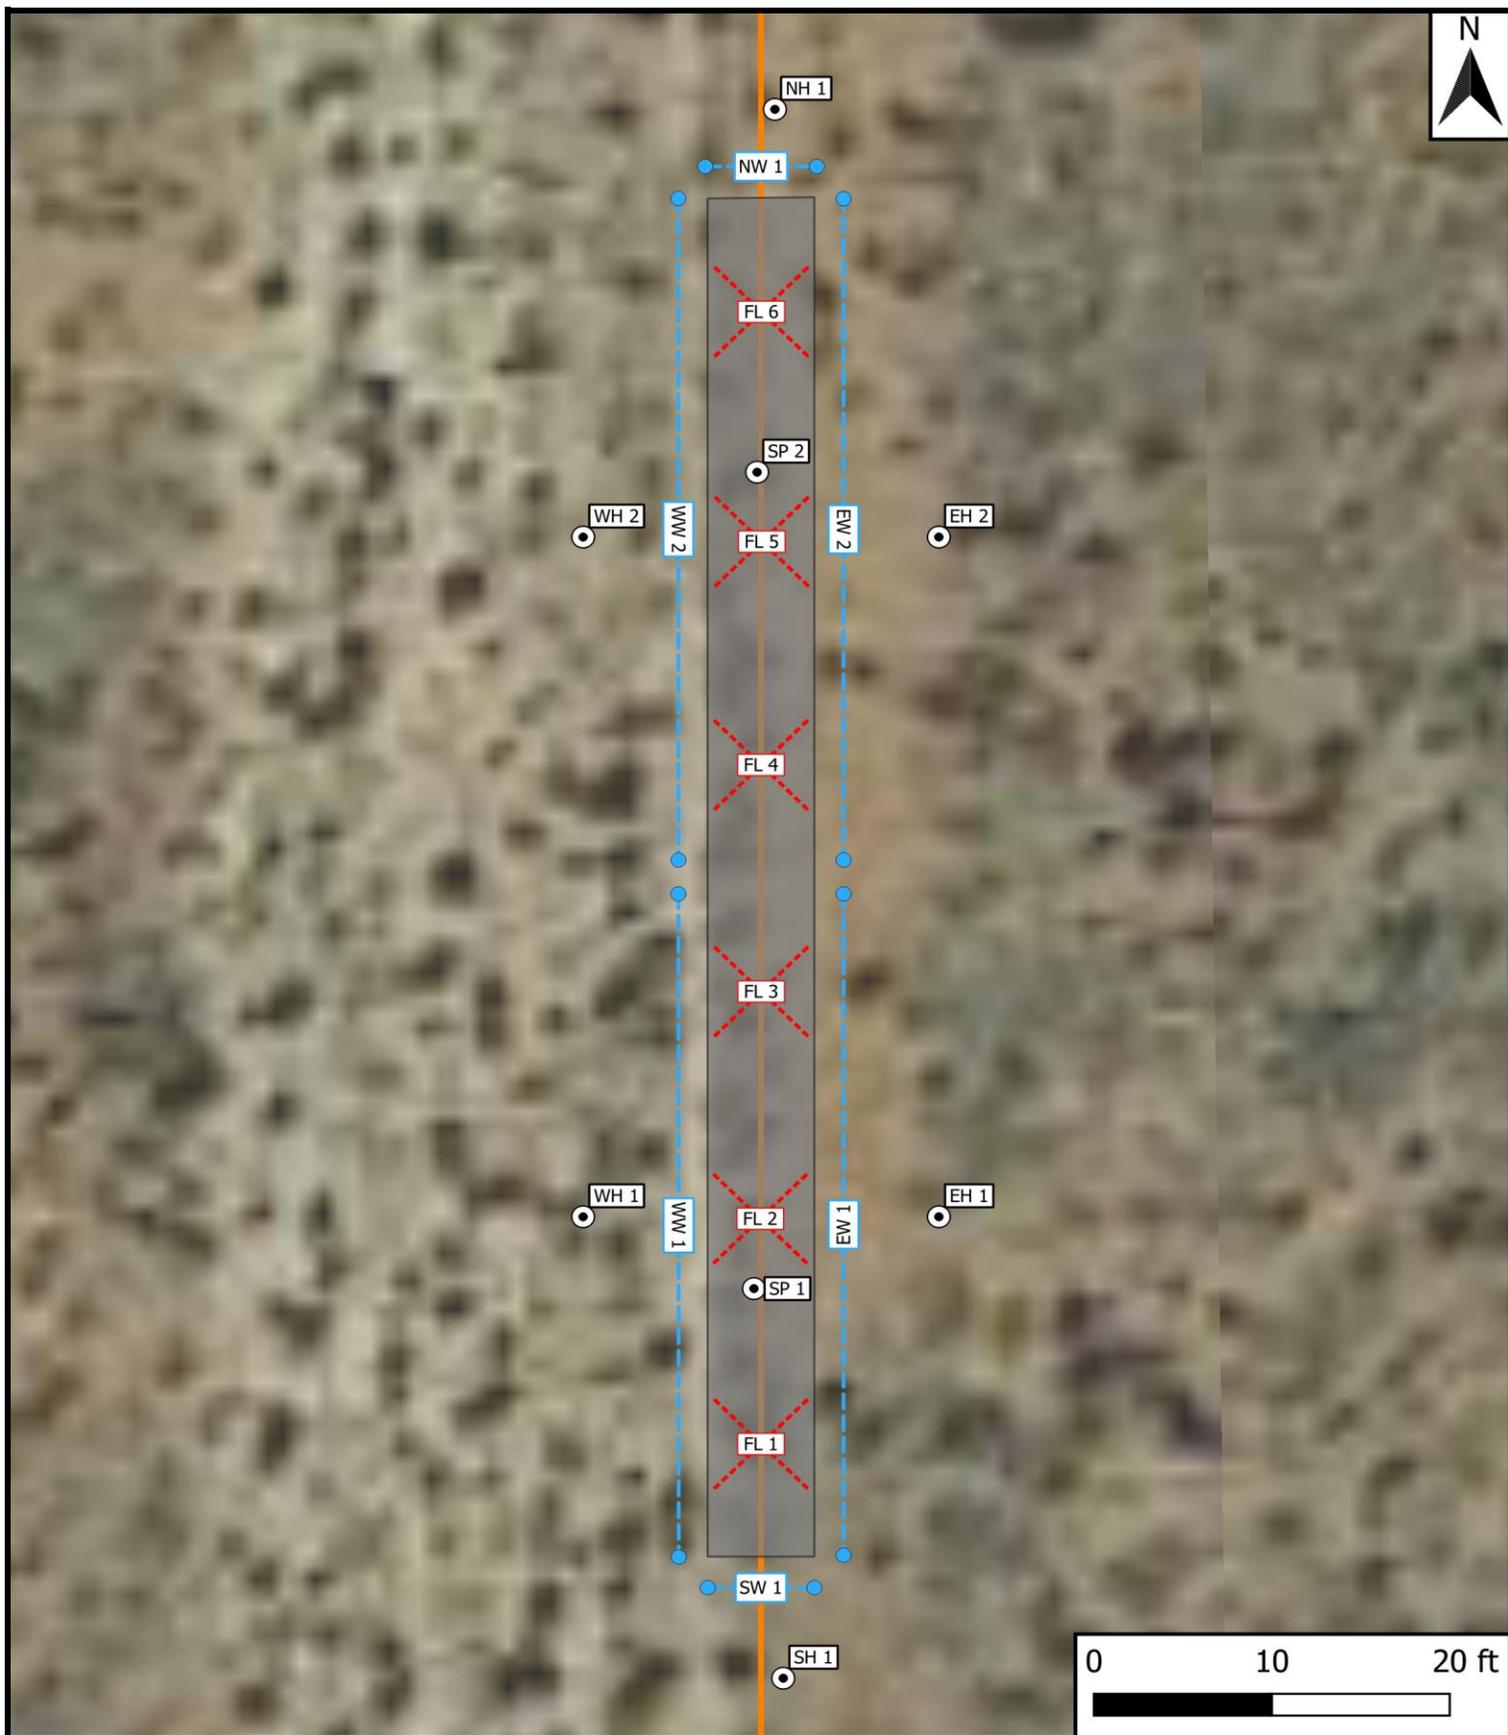
Figure 3

Site & Sample Location Map

- Excavation Extent
- Pipeline
- Auger Hole
- X Composite Floor Sample
- Composite Wall Sample

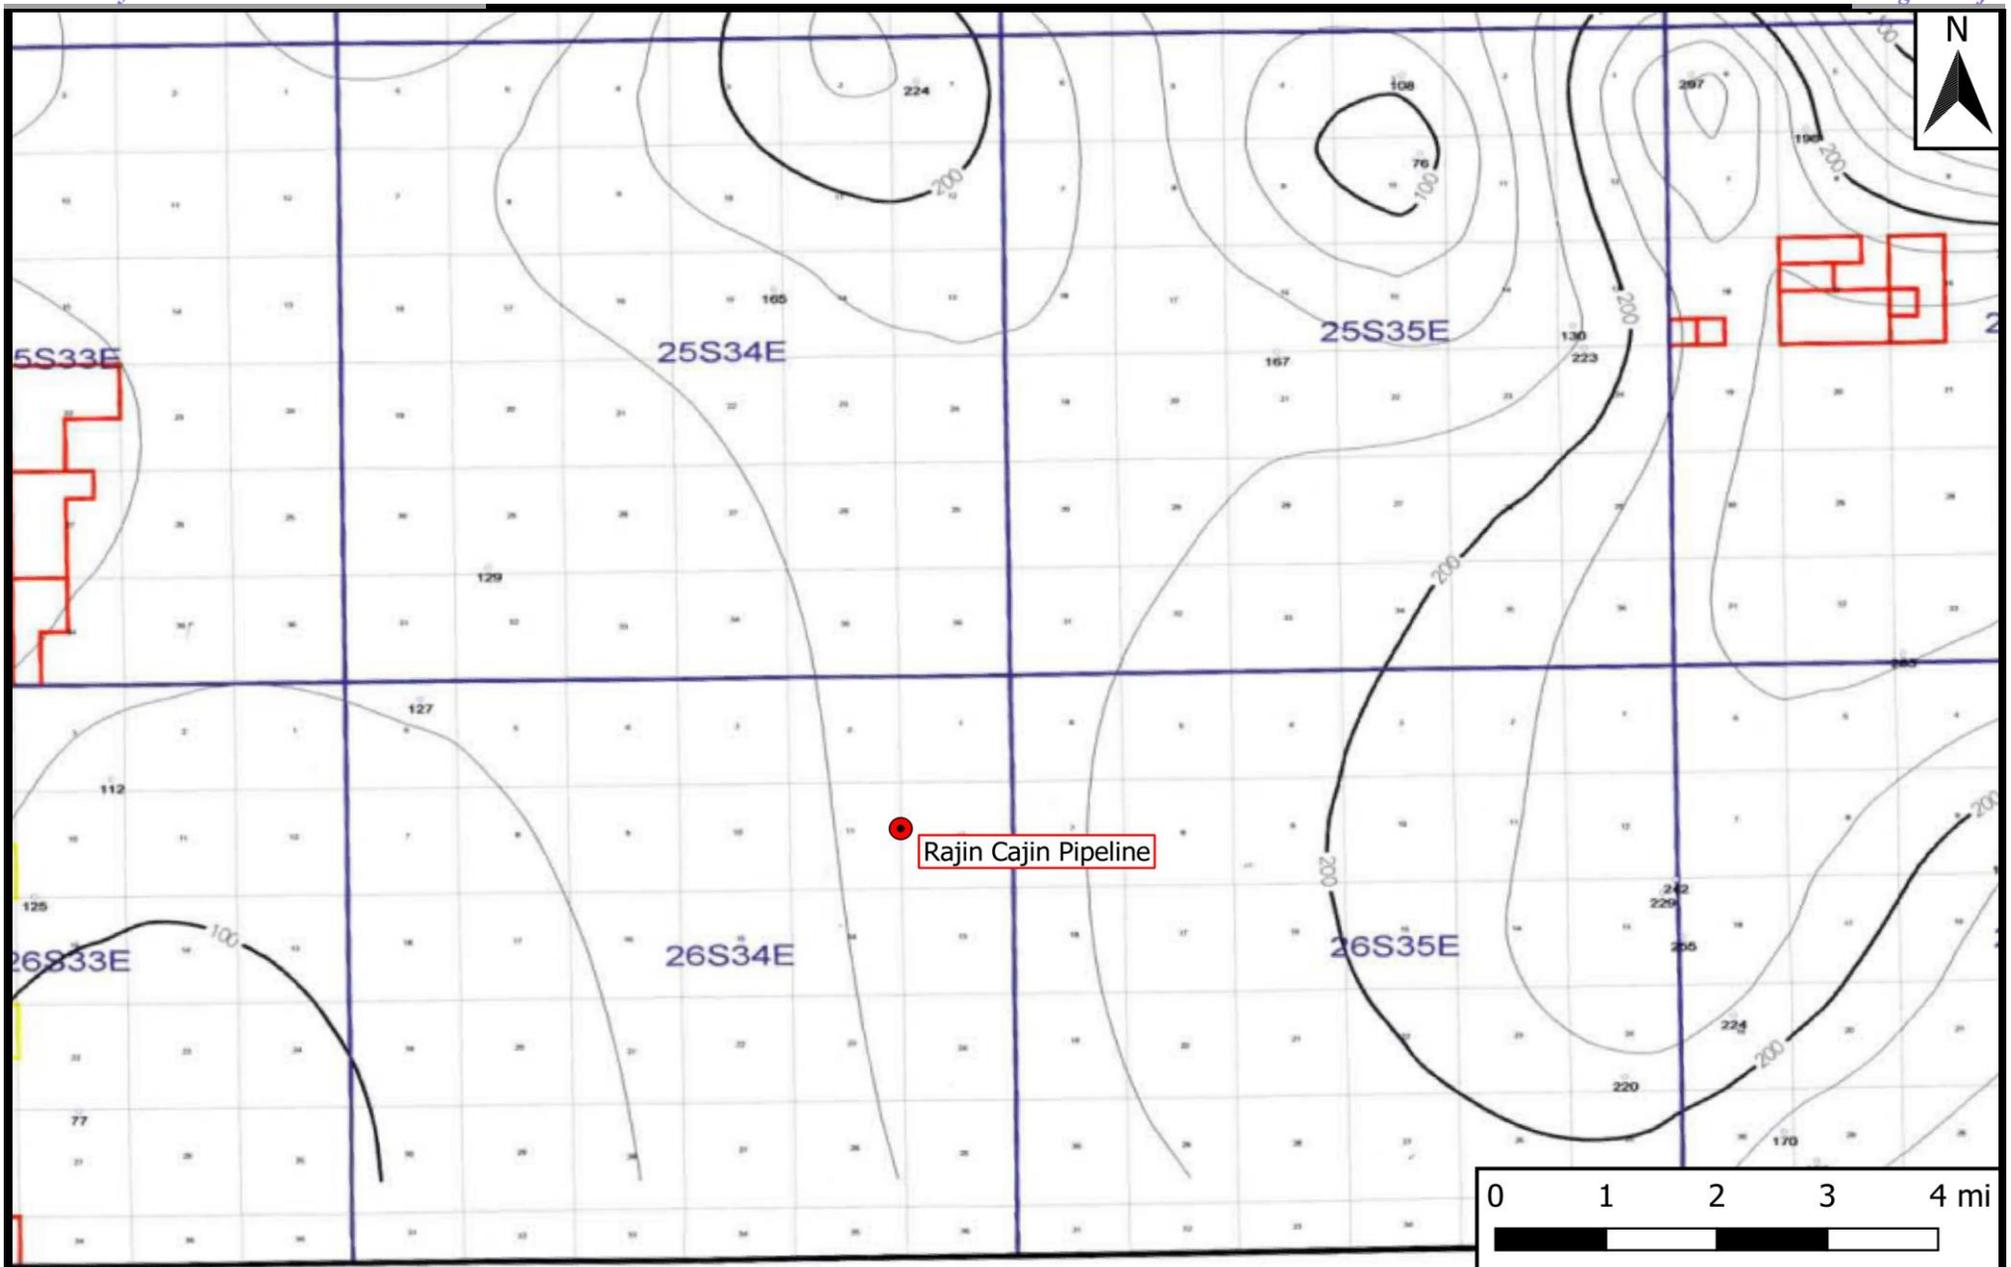
Figure 4
 Inferred Depth to Groundwater Trend Map
 ETC Texas Pipeline, Ltd.
 Rajin Cajin Pipeline
 GPS: 32.05845, -103.43224
 Lea County

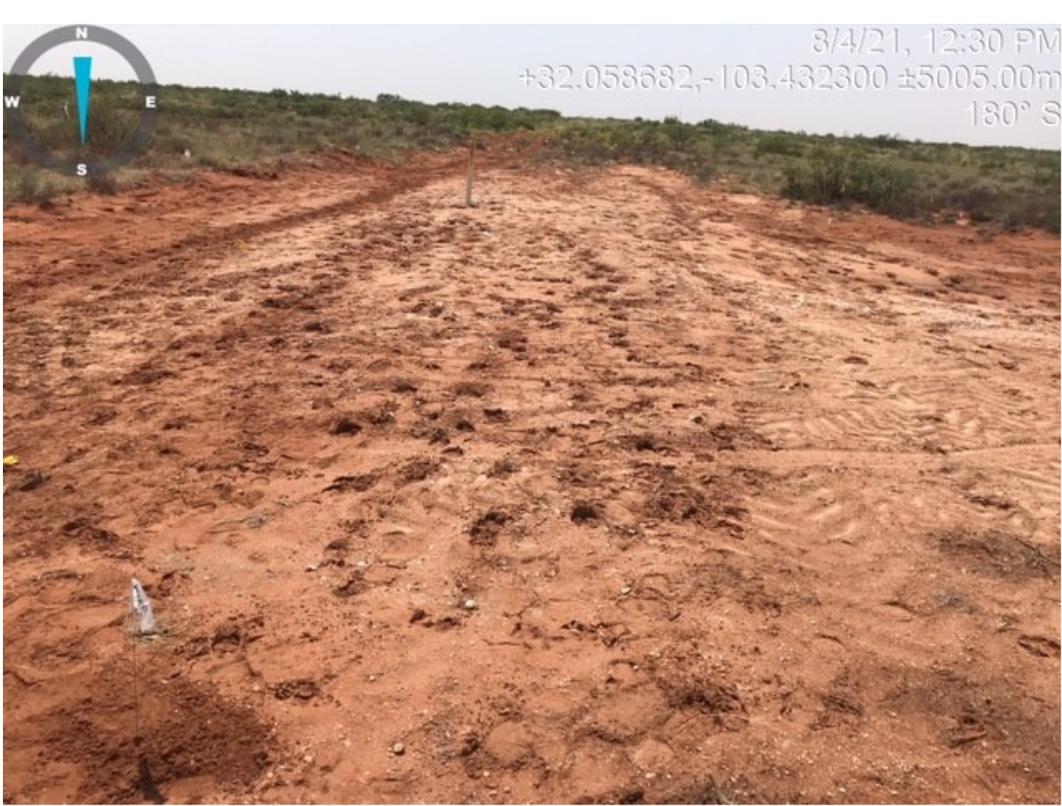
Photo Number: 1

Photo Direction: South	
Photo Description: View of the affected area.

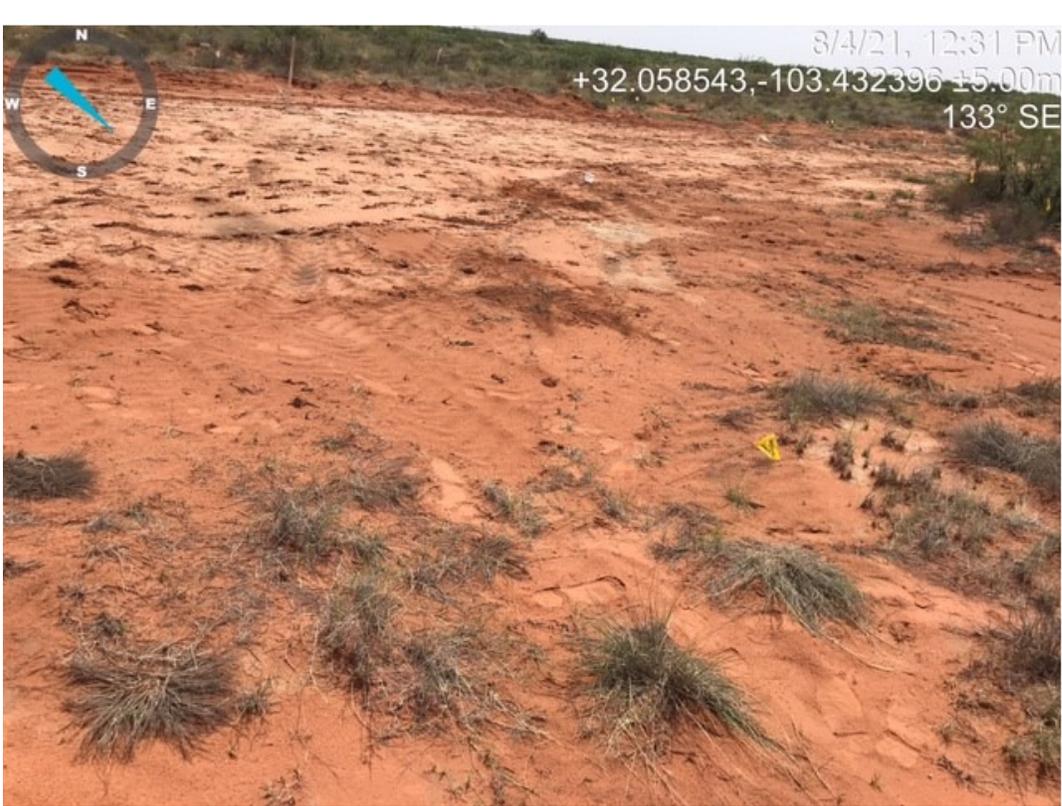
Photo Number: 2

Photo Direction: Southeast	
Photo Description: View of the affected area.

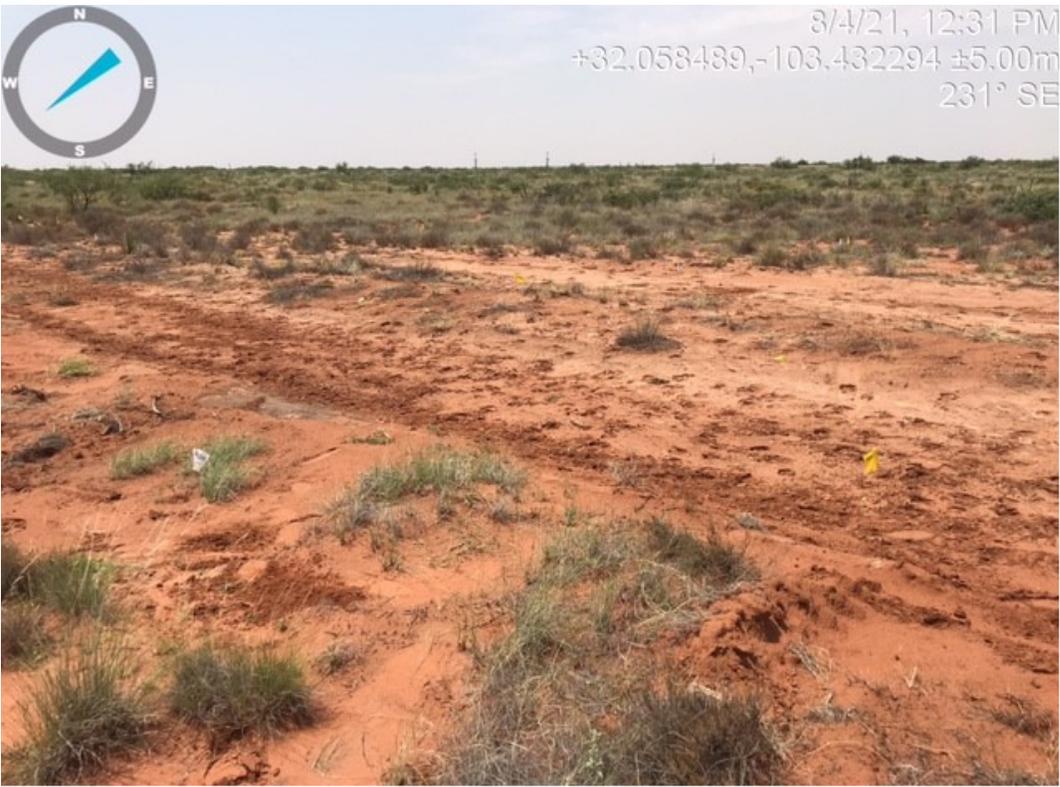
Photo Number: 3

Photo Direction: Southwest	
Photo Description: View of the affected area.

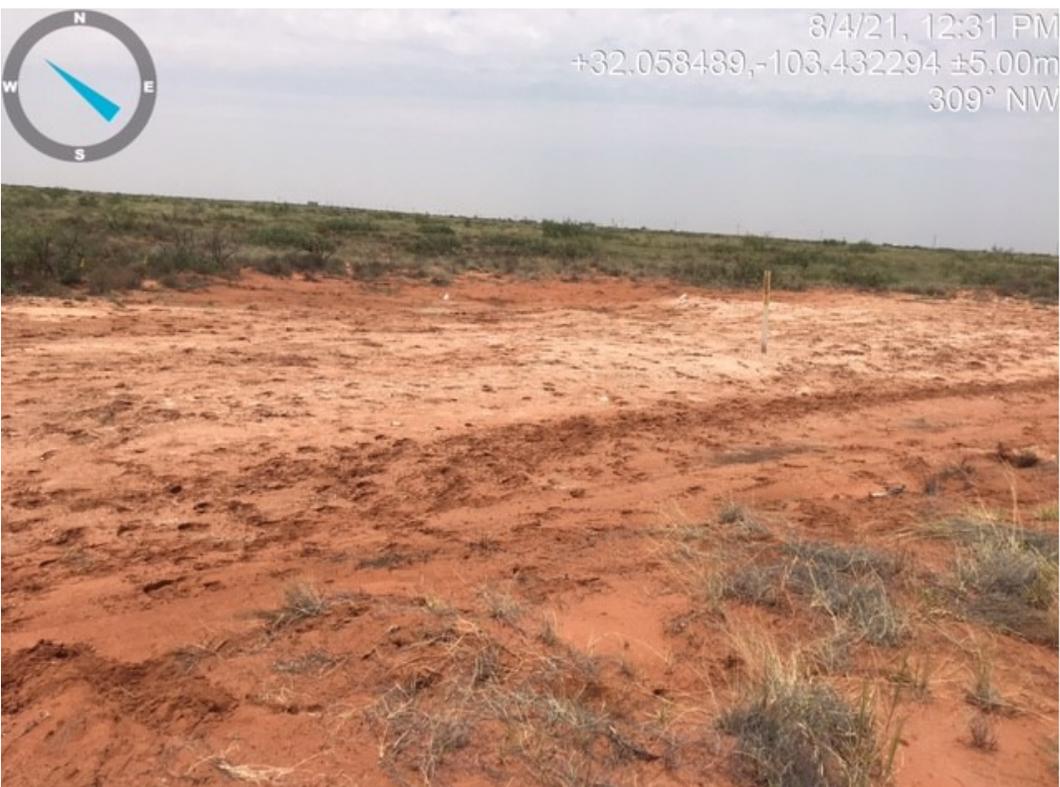
Photo Number: 4

Photo Direction: Northwest	
Photo Description: View of the affected area.

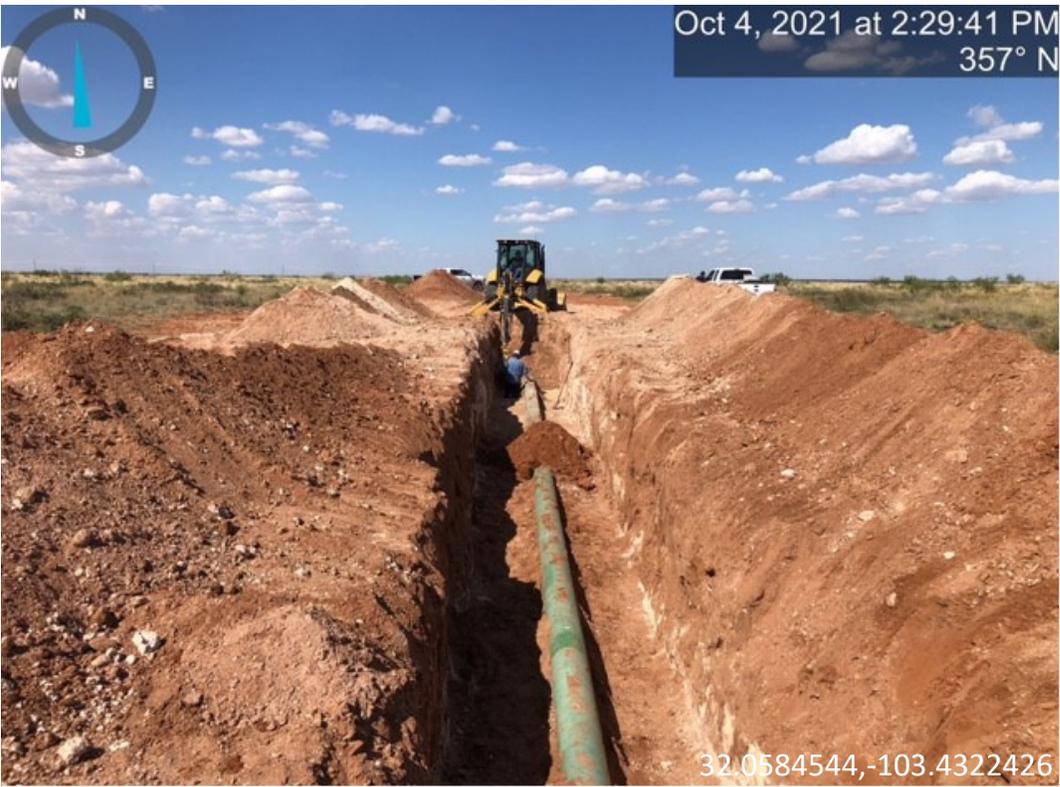
Photo Number: 5

Photo Direction: North	
Photo Description: View of the excavated area.

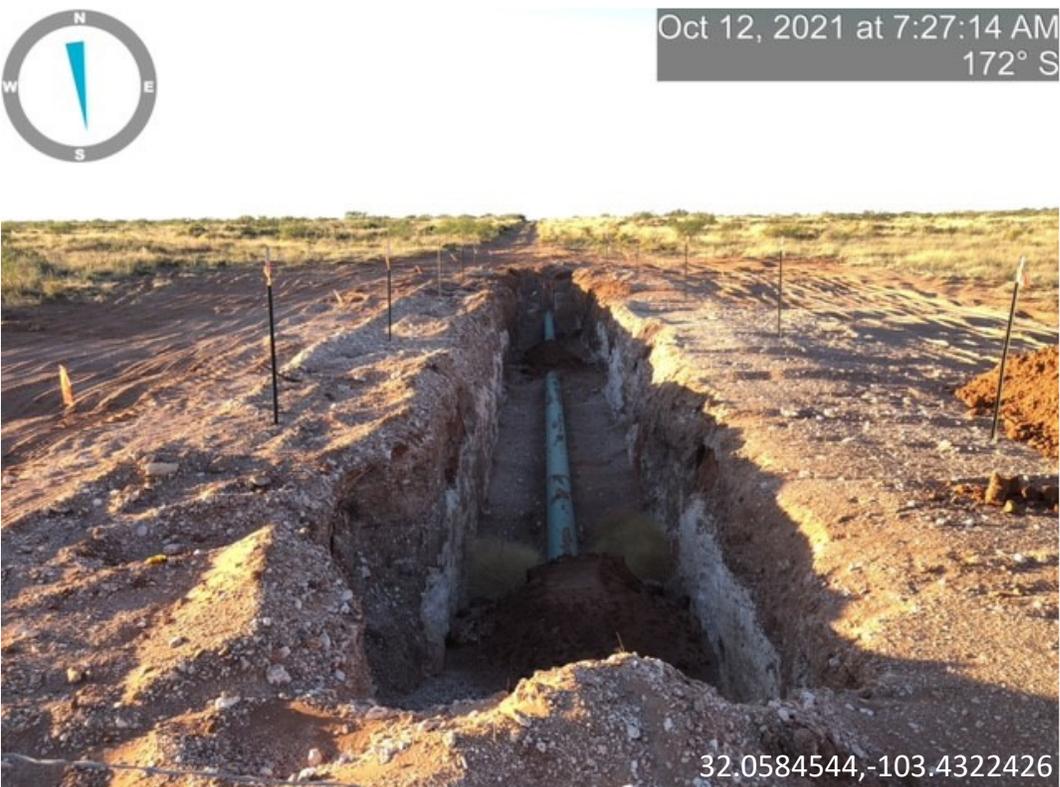
Photo Number: 6

Photo Direction: South	
Photo Description: View of the excavated area.

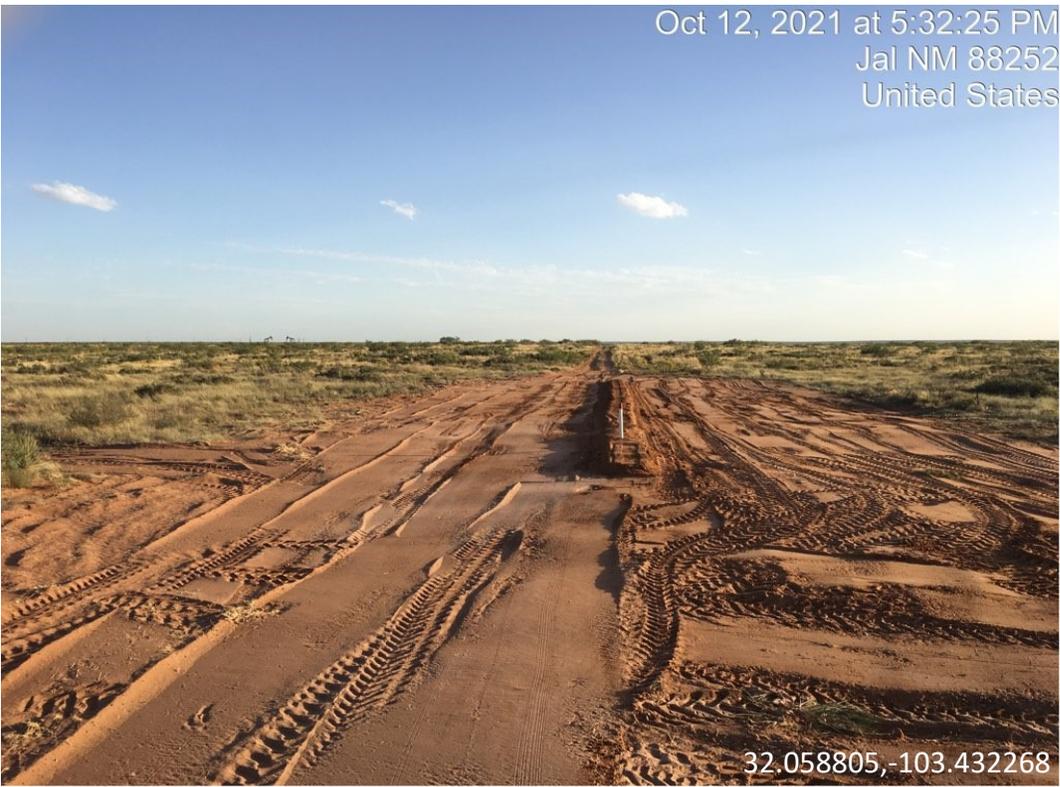
Photo Number: 7

<p>Oct 12, 2021 at 5:32:25 PM Jal NM 88252 United States</p> <p>32.058805,-103.432268</p>
Photo Direction: South-Southeast	
Photo Description: View of the remediated area after backfilling and regrading.

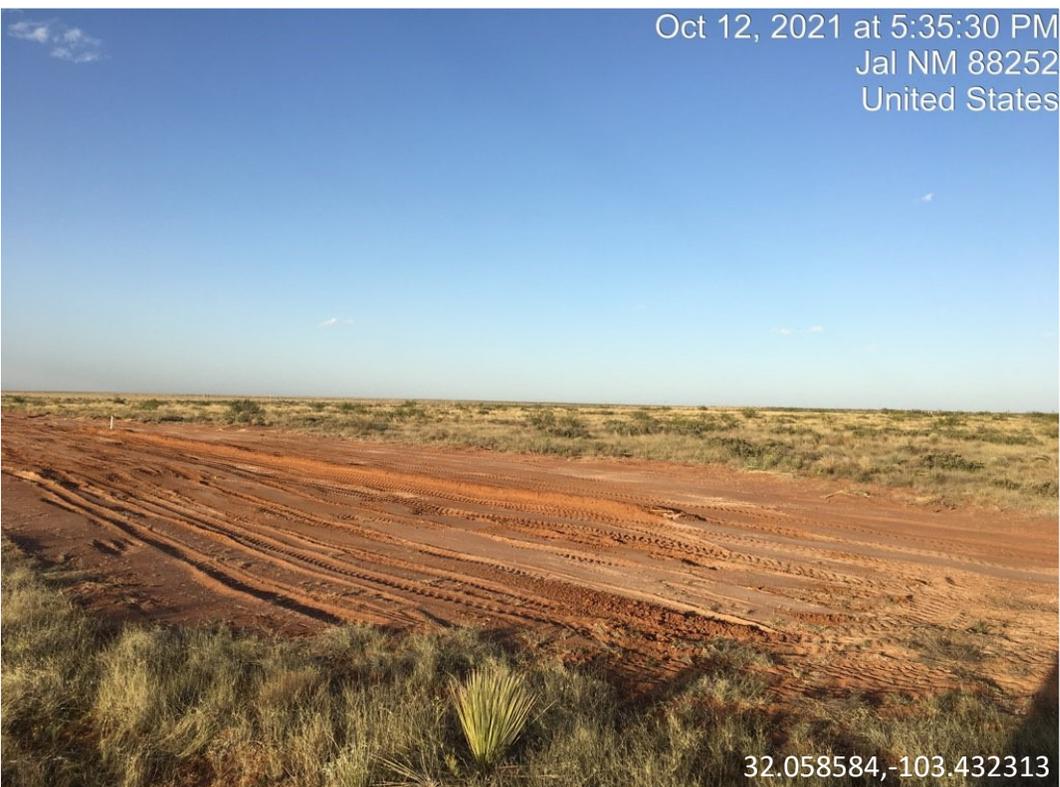
Photo Number: 8

<p>Oct 12, 2021 at 5:35:30 PM Jal NM 88252 United States</p> <p>32.058584,-103.432313</p>
Photo Direction: Northeast	
Photo Description: View of the remediated area after backfilling and regrading.
