October 22, 2021

**Re: Release Characterization and Remediation Work Plan
ConocoPhillips (Heritage Concho)
Sopapilla State 2D CTB Flex Line Release
Unit Letter M, Section 15, Township 23 South, Range 33 East
Lea County, New Mexico
Incident ID: NAPP2115525504**

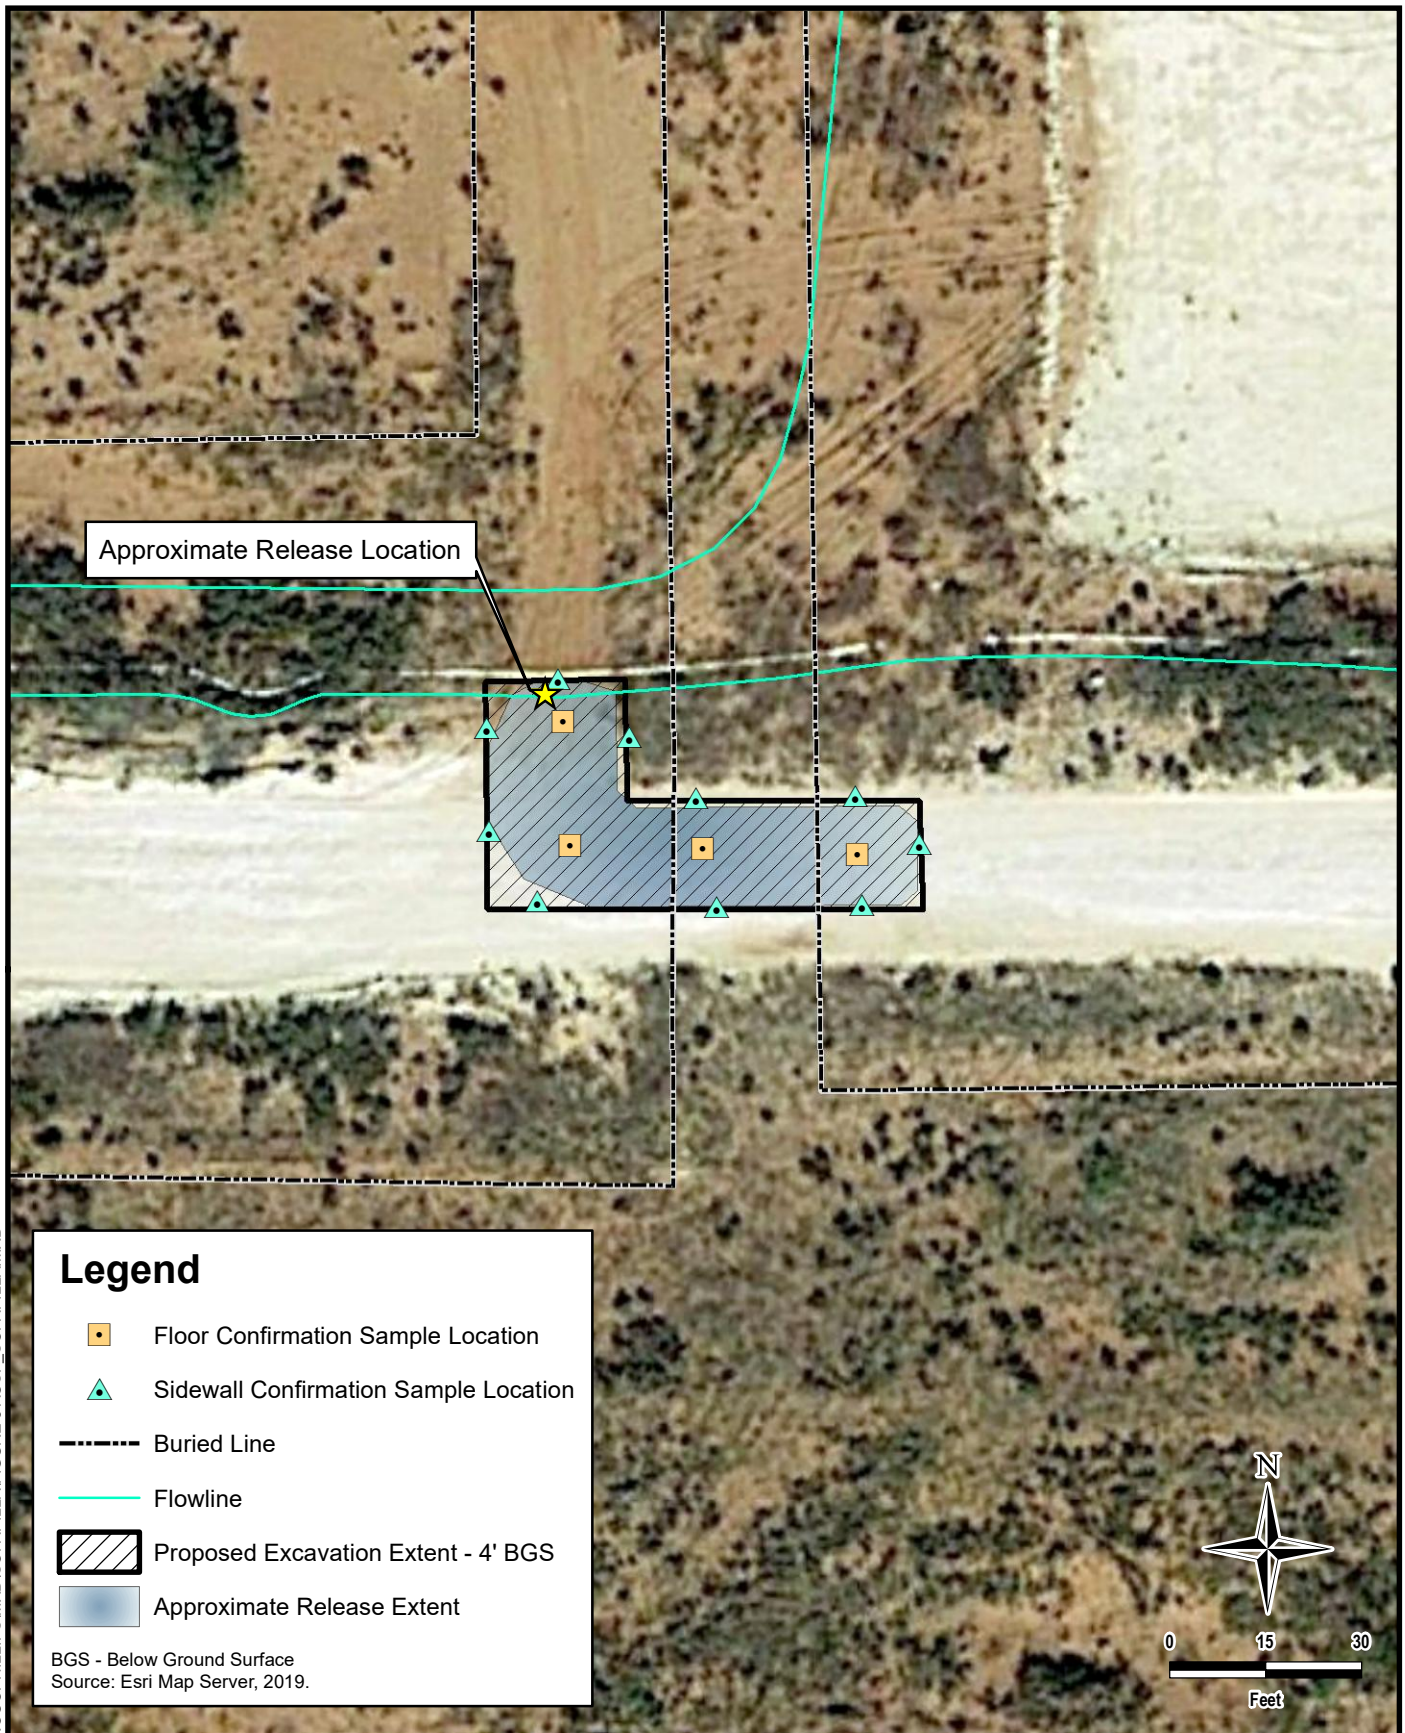
DOCUMENT PATH: D:\CONOCOPHILLIPS\MXD\SOPAPILLA\FIGURE 5 ACSP SOPAPILLA.MXD

In accordance with 19.15.29.12(D)(1)(b) NMAC, COP proposes the following alternative confirmation sampling plan to adhere with NMOCD requirements. The proposed confirmation sample locations are depicted in Figure 5. Four (4) confirmation floor samples and ten (10) confirmation sidewall samples are proposed for verification of remedial activities. The proposed excavation encompasses a surface area of approximately 1,560 square feet.

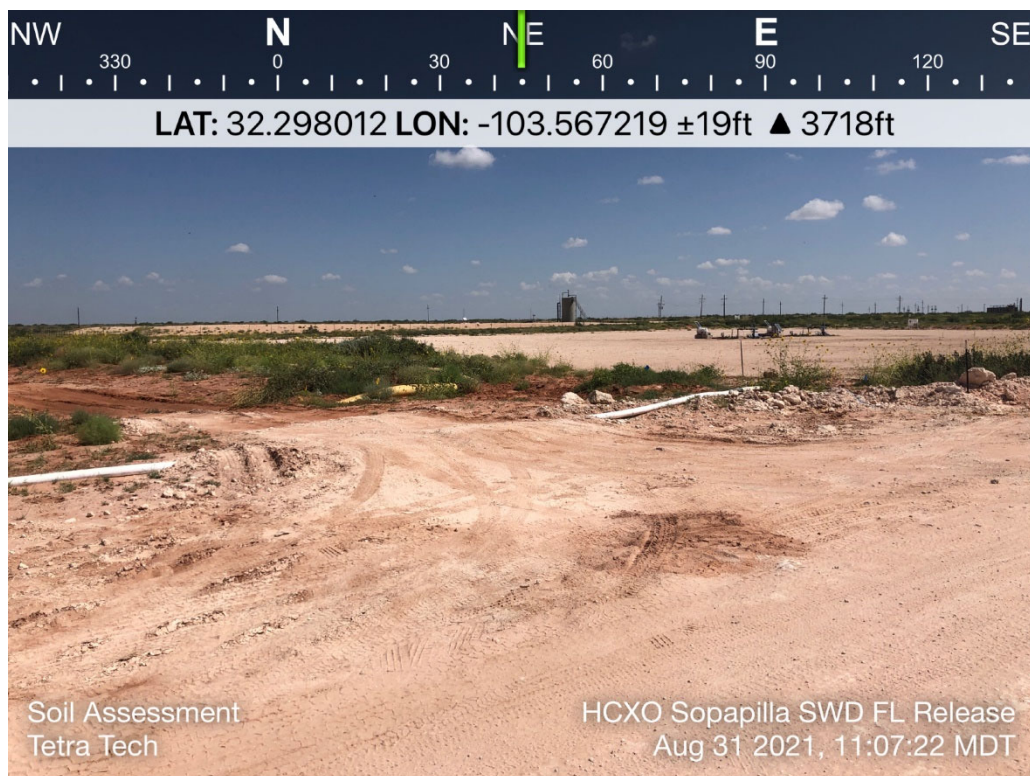
TETRA TECH, INC. PROJECT NO. 212C-MD-02532A	DESCRIPTION	View of the release area near the flowline running to the Sopapilla SWD	1
	SITE NAME	ConocoPhillips Sopapilla SWD Release	8/31/2021

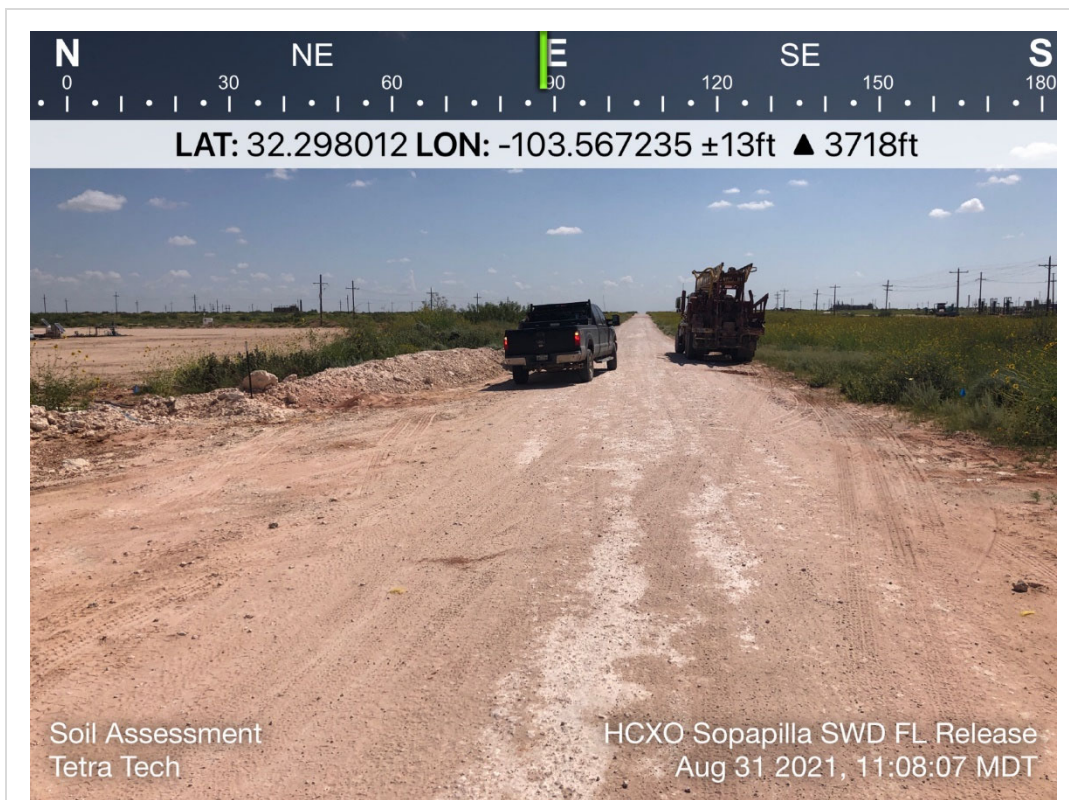
TETRA TECH, INC. PROJECT NO. 212C-MD-02532A	DESCRIPTION	View of the release area near the flowline running to the Sopapilla SWD	3
	SITE NAME	ConocoPhillips Sopapilla SWD Release	8/31/2021

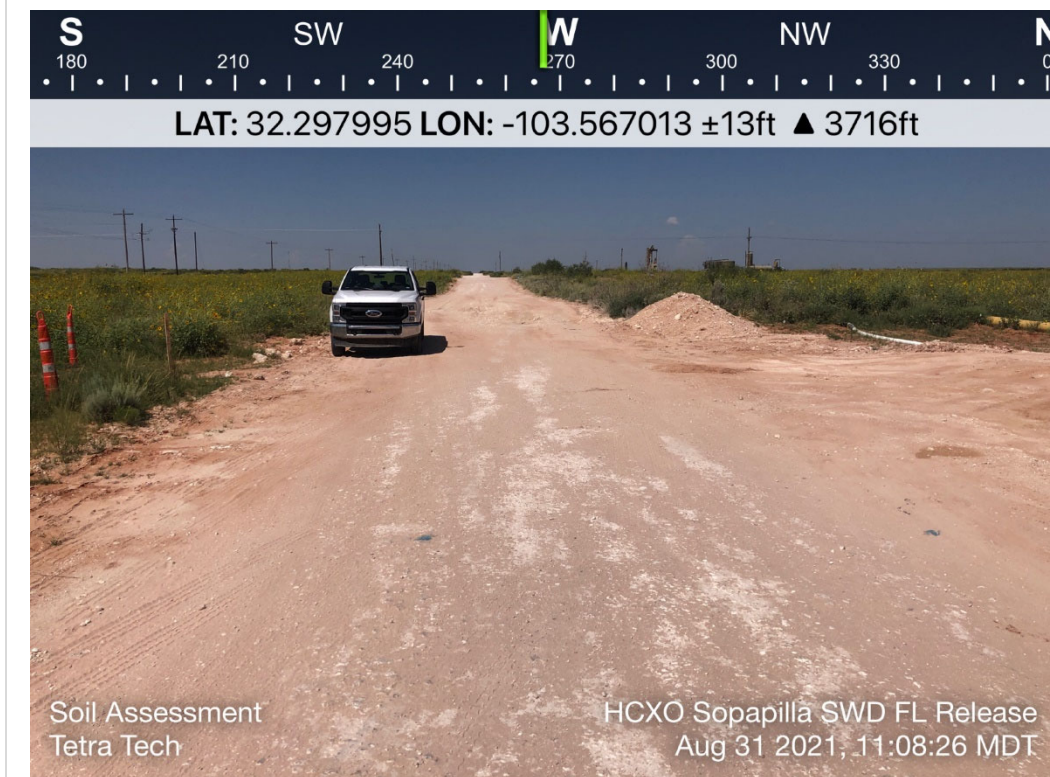
TETRA TECH, INC. PROJECT NO. 212C-MD-02532A	DESCRIPTION	View of the release area near the flowline running to the Sopapilla SWD	4
	SITE NAME	ConocoPhillips Sopapilla SWD Release	8/31/2021

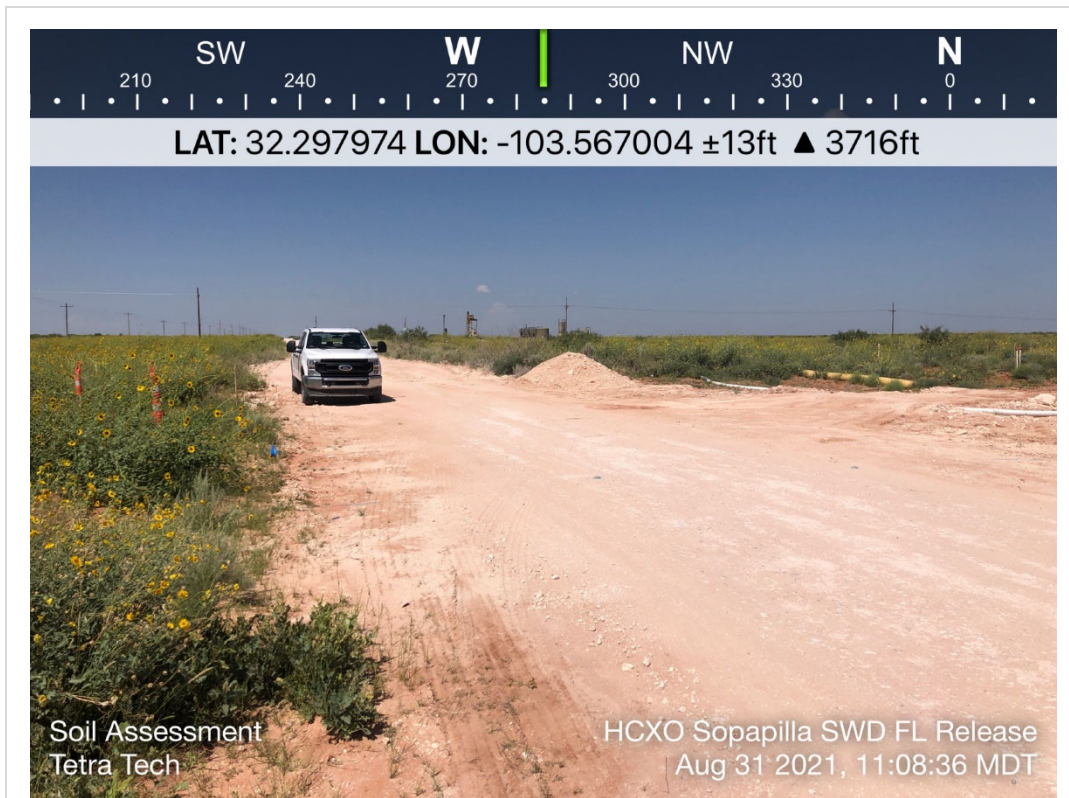
TETRA TECH, INC. PROJECT NO. 212C-MD-02532A	DESCRIPTION	View of the release area near the flowline running to the Sopapilla SWD	5
	SITE NAME	ConocoPhillips Sopapilla SWD Release	8/31/2021

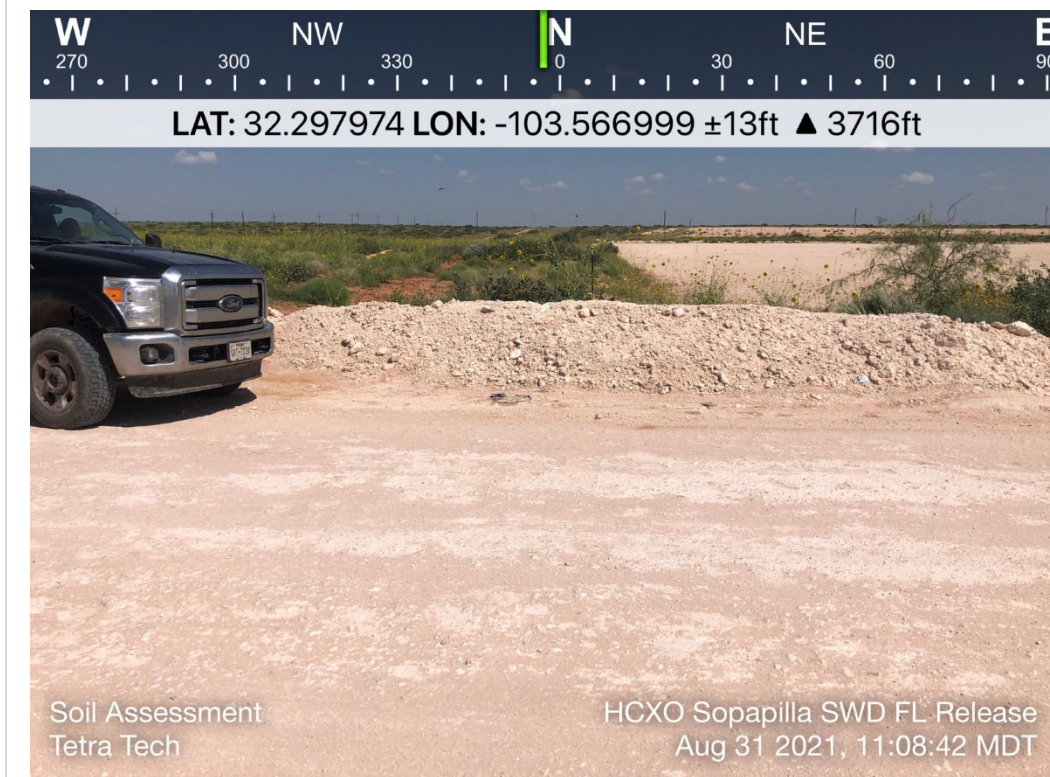
TETRA TECH, INC. PROJECT NO. 212C-MD-02532A	DESCRIPTION	View of the release area near the flowline running to the Sopapilla SWD	6
	SITE NAME	ConocoPhillips Sopapilla SWD Release	8/31/2021

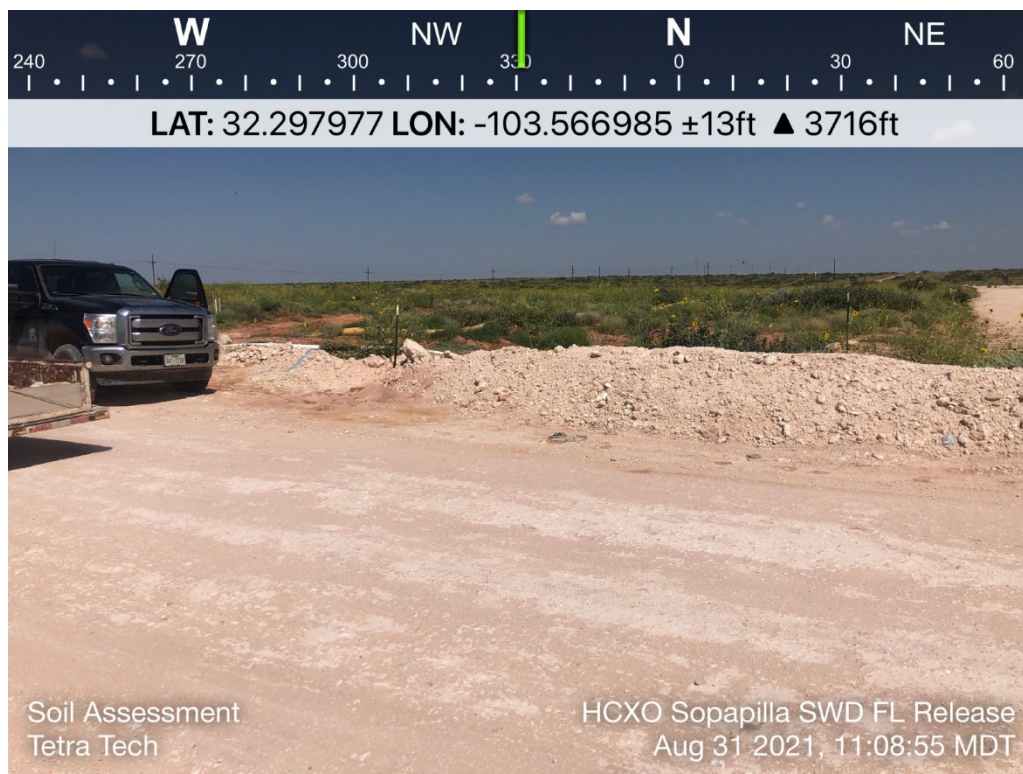
TETRA TECH, INC. PROJECT NO. 212C-MD-02532A	DESCRIPTION	View of the release area near the flowline running to the Sopapilla SWD	7
	SITE NAME	ConocoPhillips Sopapilla SWD Release	8/31/2021

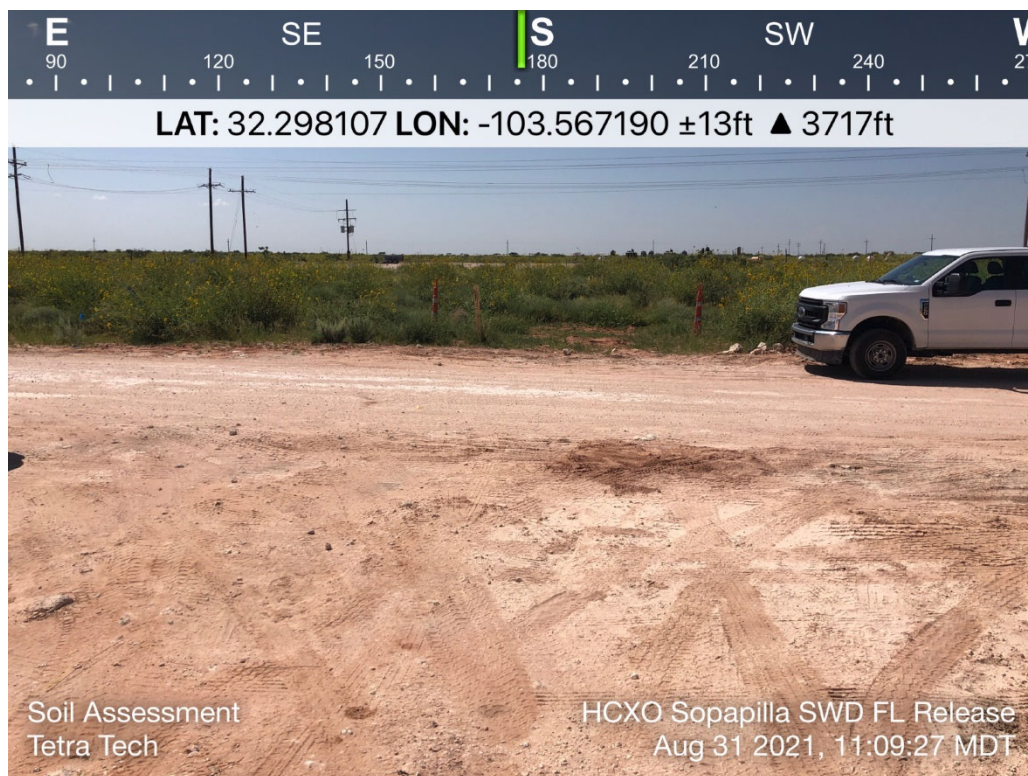
TETRA TECH, INC. PROJECT NO. 212C-MD-02532A	DESCRIPTION	View of the release area near the flowline running to the Sopapilla SWD	9
	SITE NAME	ConocoPhillips Sopapilla SWD Release	8/31/2021
