RE: Revised Remediation Plan  
Incident ID: NRM2000354631  
AEP #: 10302019-1600-prodops  
Location: Dagger Lake Tank Battery 10.30.19

Incident ID: NRM2000354631  
AEP #: 10302019-1600-prodops

June 2020 Sampling Grid and  
Composite Sample Locations  
Dagger Lake Battery 10302019  
Incident # nRM2000354631

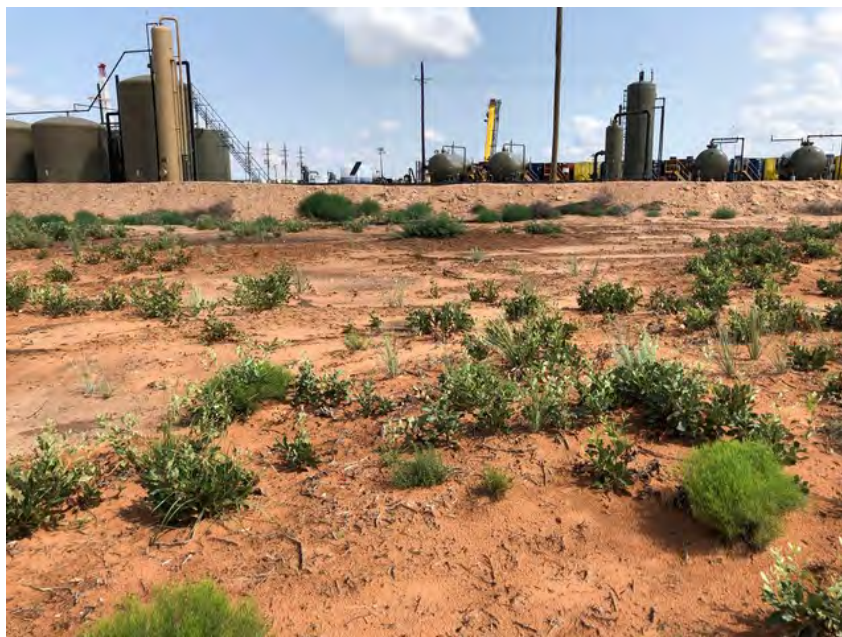
- Soil samples will be collected from
  - 0 – 1 ft
  - 1 – 2 ft
  - 3 – 4 ft
  - 4.5 ft. Sample will only be analyzed if the 3-4 ft sample exhibits TPH concentrations above closure criteria limits.
- Soil samples will be analyzed for chloride, BTEX, benzene, and TPH.
- Grids 2 through 5 are beginning to show signs of natural revegetation as shown in Figure 2, below. Grid 1 is located on top of the caliche berm on the active production pad, photo background.

**Figure 2: Photo of natural revegetation within release area. Photo is viewing north from the southern edge of Grid 4/5. Date/Time: 2021-07-20 10:17:56 GPS: 32.4183417 N, 103.6017139 W.**

of bioremediation and natural attenuation of hydrocarbons, the constituent of concern. Plate 2-2 shows the location of proposed soil locations that represent areas between 665 and 1,198 square feet, with an average square footage of 1,007; within the release extent. Additional soil samples are located to define the east and west extents. If soil sample results exhibit concentrations exceeding closure criteria, we will resume MicroBlaze application and continue to monitor for a reduction in hydrocarbon concentrations.

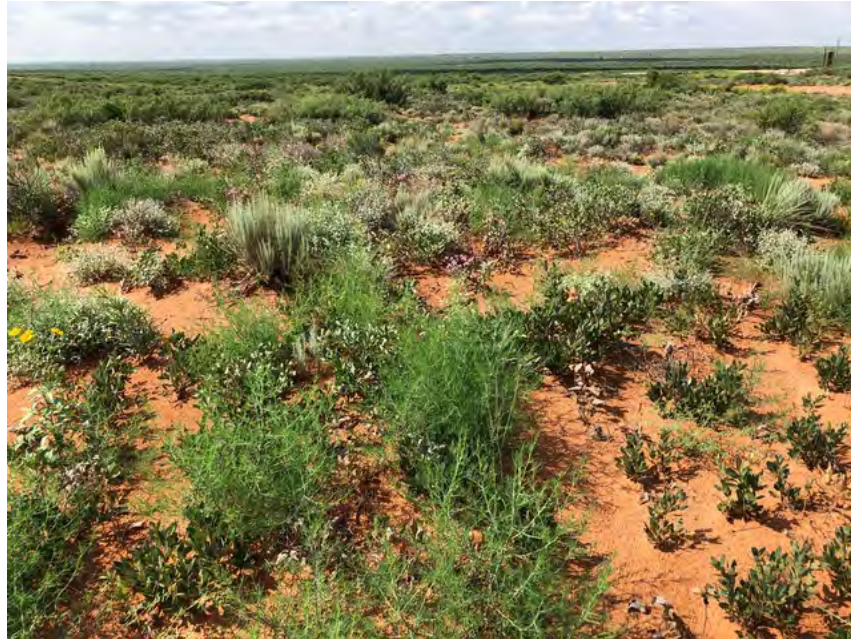
- Grid-06 through Grid-11. Sample results meet the most stringent closure criteria for areas not in-use. Therefore, no additional remediation is required; and volume of excavated material is zero.
  - Grid-06 through Grid-11 shows signs of natural revegetation as shown in Figure 3, below.

**Figure 3: Photo of natural revegetation within release area. Photo is viewing south-southwest from the northern edge of Grid 7. Date/Time: 2021-07-20 10:15:45. GPS: 32.4179750 N, 103.6017917 W.**
