**RE: Closure Request
Vast East State CTB
Incident Number NAPP2124347654
Lea County, New Mexico**

WSP USA Inc. (WSP) on behalf of COG Operating, LLC (COG), presents the following Closure Request detailing site assessment and soil sampling activities at the Vast East State CTB (Site) in Unit P, Section 17, Township 26 South, Range 33 East, in Lea County, New Mexico (Figure 1). The purpose of the site assessment and soil sampling activities was to assess for the presence or absence of impacts to soil following a release of produced water and crude oil within lined containment at the Site. Based on field observations, field screening activities, and soil sample laboratory analytical results, COG is submitting this Closure Request and requesting no further action (NFA) for Incident Number NAPP2124347654.

PHOTOGRAPHIC LOG		
COG Operating, LLC	VAST EAST STATE CTB Lea County, New Mexico	NAPP2124347654

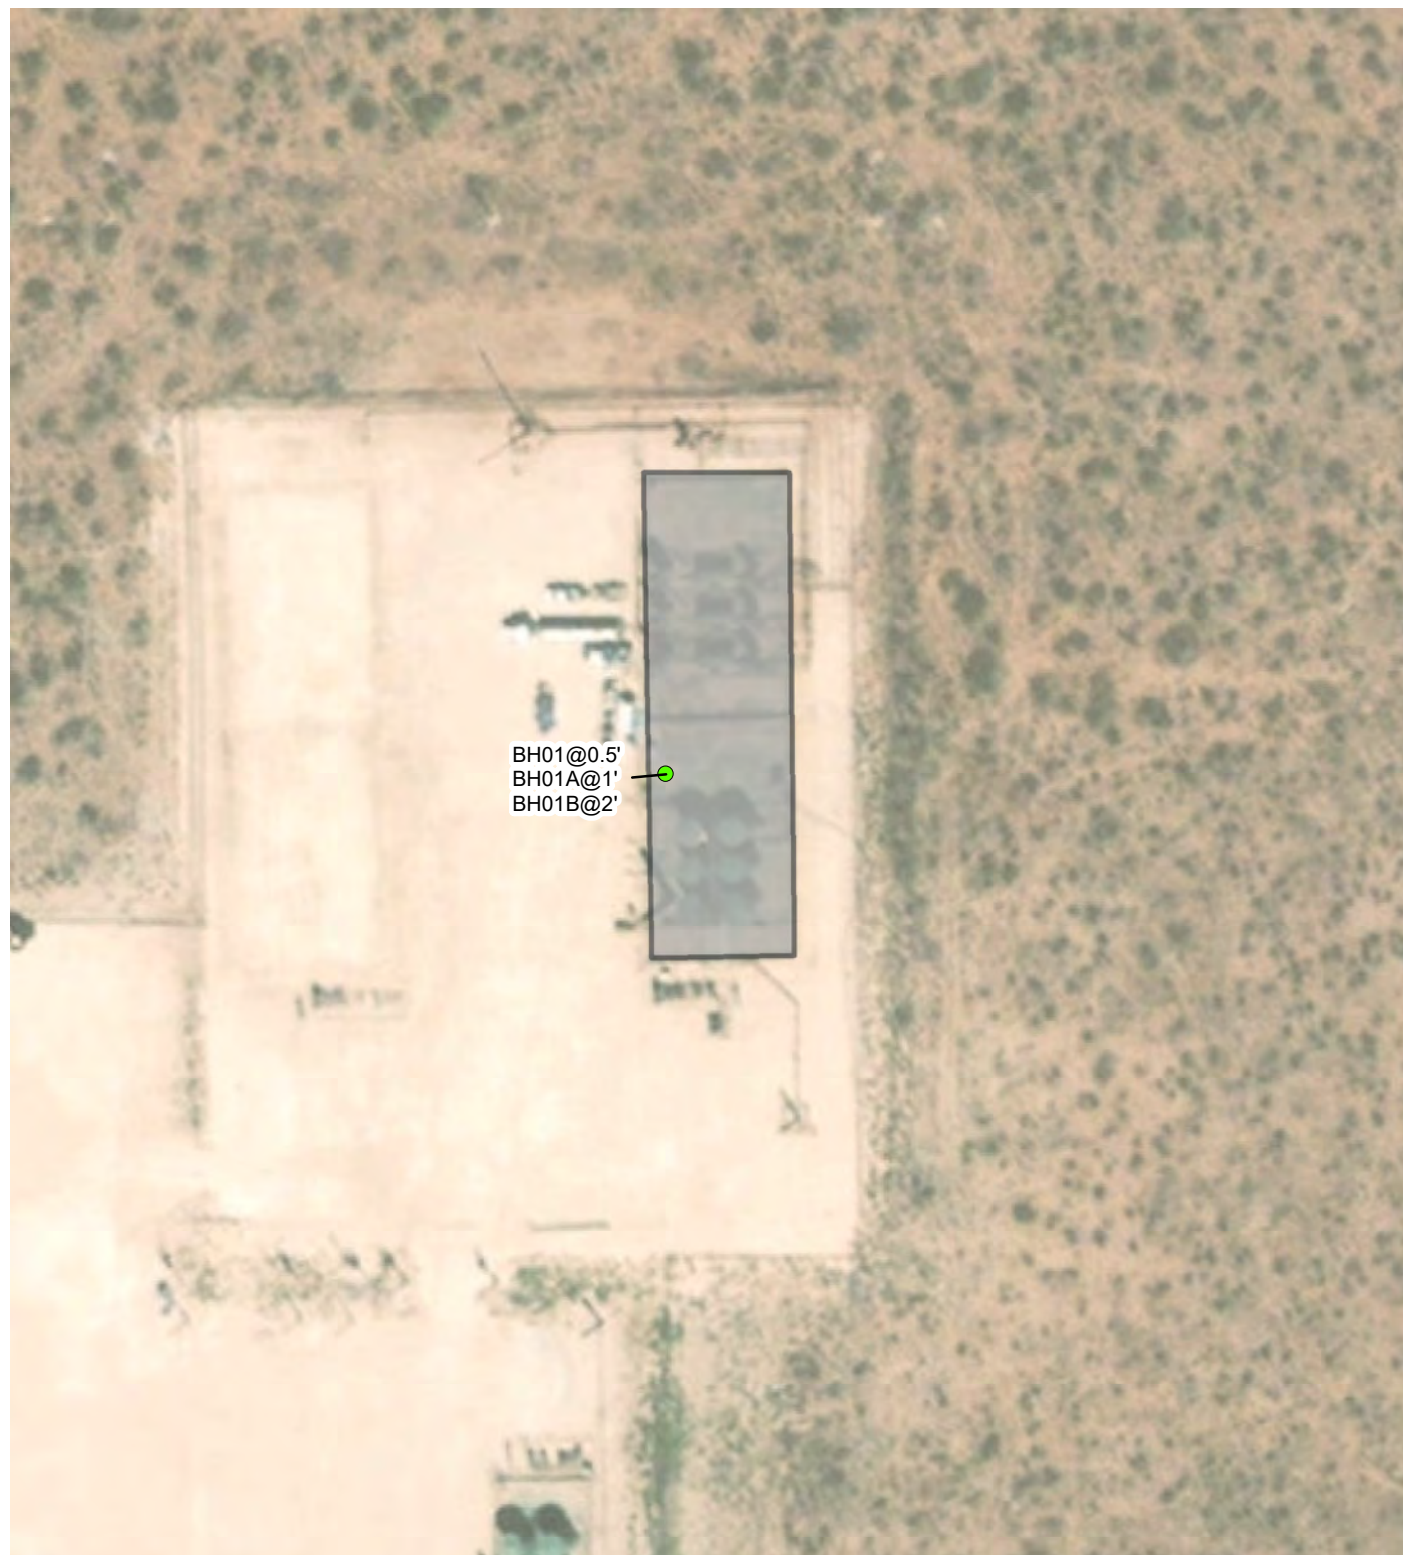
FIGURE 2
DELINEATION SOIL SAMPLE LOCATIONS
VAST EAST STATE CTB
UNIT P SEC 17 T26S R33E
LEA COUNTY, NEW MEXICO
COG OPERATING, LLC

Laboratory analytical results for delineation soil samples BH01, BH01A, and BH01B indicated that benzene, BTEX, TPH-DRO/TPH-GRO, TPH, and chloride concentrations were compliant with the Closure Criteria. In addition, all delineation soil samples were compliant with the most stringent Table 1 Closure Criteria. Laboratory analytical results are summarized in Table 1 and the complete laboratory analytical report is included as Attachment 4.

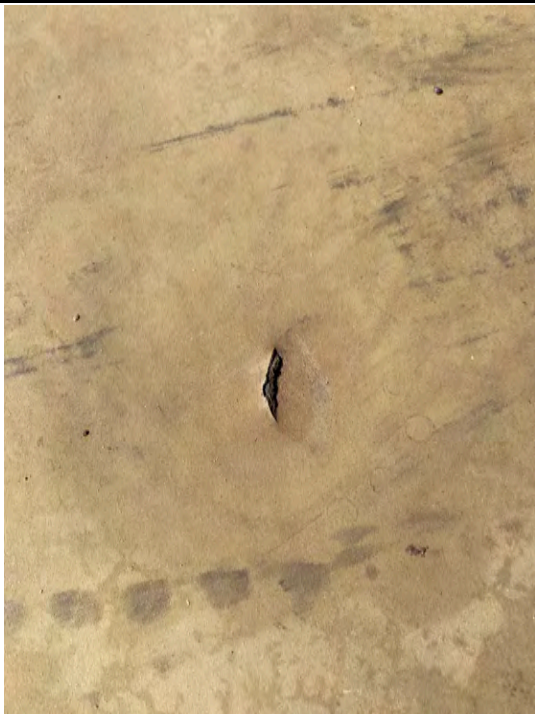
Photo No.	Date	
1	September 10, 2021	
View of hole identified in tank battery liner during inspection.

Following the failed liner integrity inspection at the Site, WSP personnel advanced one borehole, (BH01), within the lined containment to assess for the presence or absence of soil impacts resulting from the August 21, 2021 produced water and crude oil release within lined containment. Three delineation soil samples were collected from borehole BH01, at depths of approximately 0.5 feet, 1 foot, and 2 feet bgs. Laboratory analytical results for the delineation soil samples indicated that benzene, BTEX, TPH-DRO/TPH-GRO, TPH and chloride concentrations were compliant with the Closure Criteria. In addition, all delineation soil samples were compliant with the most stringent Table 1 Closure Criteria. The release was contained laterally by the lined containment and all released fluids were recovered during initial response activities. The tear in the liner was subsequently repaired.

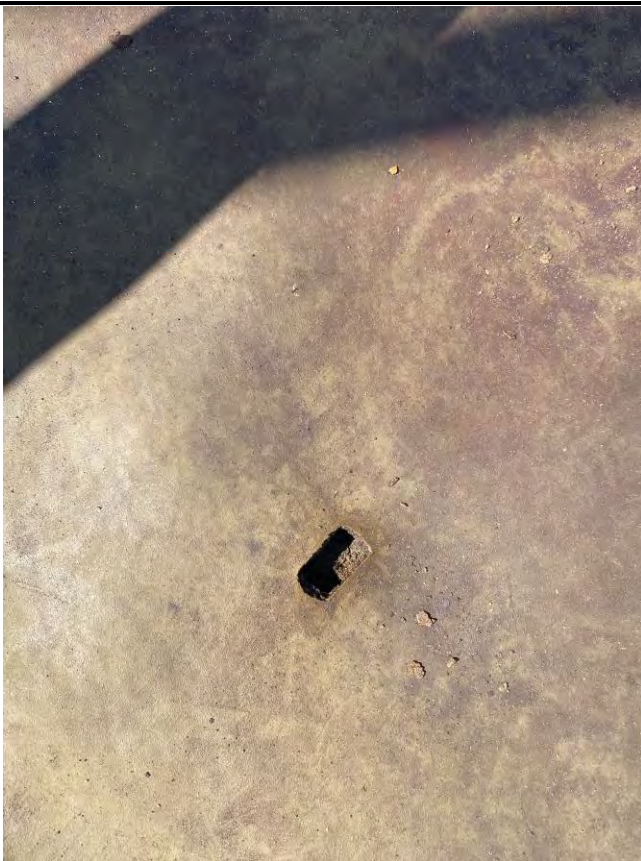
Photo No.	Date	
2	September 10, 2021	
View of hole in tank battery liner.

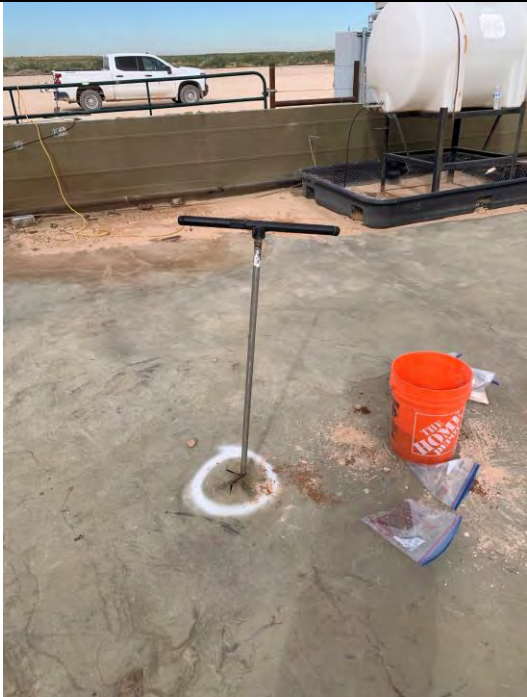
Photo No.	Date	
3	October 12, 2021	
View of borehole BH01 location inside tank battery containment.

A photograph showing a concrete floor with a circular white chalk mark indicating the location of borehole BH01. A metal rod with a T-handle is stuck into the mark. To the right is an orange bucket and some debris. In the background, a white pickup truck is parked near a large white tank.
