Incident ID	NAPP2121819612
District RP	
Facility ID	
Application ID

**RE: Closure Request  
Goldeneye 18 Federal Battery  
Incident Number NAPP2121819612  
Lea County, New Mexico**

PHOTOGRAPHIC LOG		
ConocoPhillips Company	GOLDENEYE 18 FEDERAL BATTERY Lea County, New Mexico	NAPP2121819612

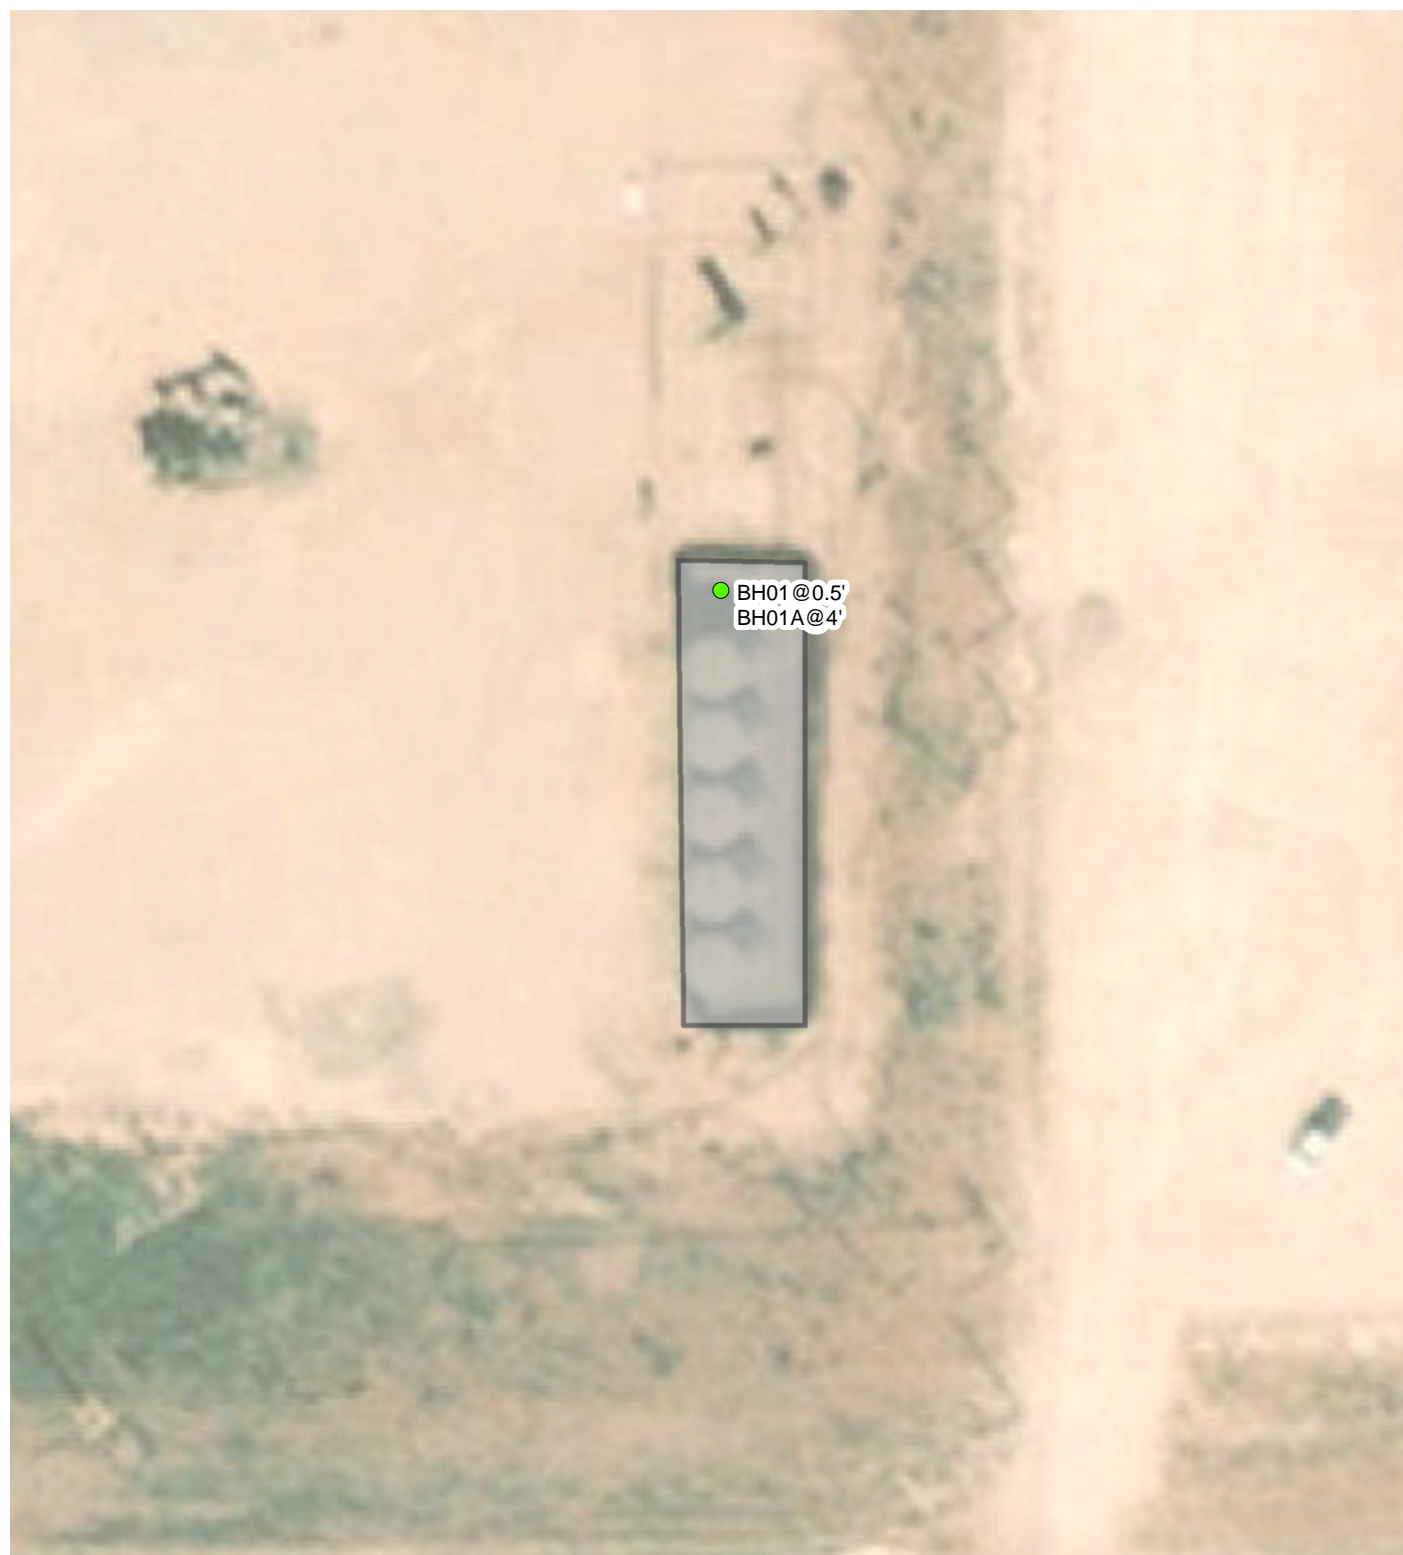
**FIGURE 2**  
 DELINEATION SOIL SAMPLE LOCATIONS  
 GOLDENEYE 18 FEDERAL BATTERY  
 UNIT M SEC 18 T24S R34E  
 LEA COUNTY, NEW MEXICO  
**CONOCOPHILLIPS COMPANY**

- DELINEATION SOIL SAMPLE IN COMPLIANCE WITH APPLICABLE CLOSURE CRITERIA
- LINED CONTAINMENT

NOTE: INCIDENT NUMBER NAPP2121819612  
 SAMPLE ID@DEPTH BELOW GROUND SURFACE (FEET)

borehole location is depicted on Figure 2. Photographic documentation was conducted during the Site visit. A photographic log is included in Attachment 3.

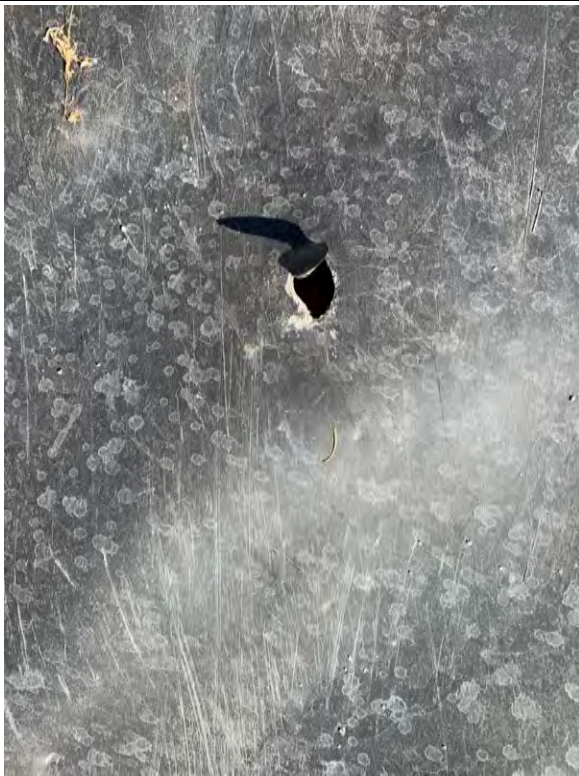
Photo No.	Date	
1	October 25, 2021	
View of hole found in tank battery liner.

Following the failed liner integrity inspection at the Site, WSP personnel advanced one borehole, (BH01), within the lined containment to assess for the presence or absence of soil impacts resulting from the July 20, 2021 produced water release within lined containment. Two delineation soil samples were collected from borehole BH01, at depths of approximately 0.5 feet and 4 feet bgs. Laboratory analytical results for the delineation soil samples indicated that benzene, BTEX, TPH-DRO/TPH-GRO, TPH and chloride concentrations were compliant with the Closure Criteria. In addition, all delineation soil samples were compliant with the most stringent Table 1 Closure Criteria. The release was contained laterally by the lined containment and all released fluids were recovered during initial response activities. The tear in the liner was subsequently repaired.

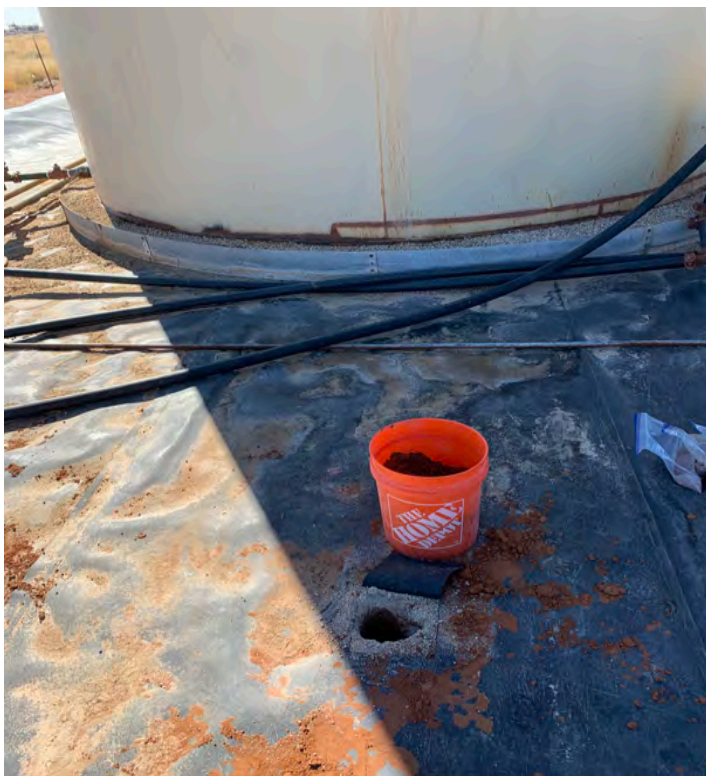
Photo No.	Date	
2	November 10, 2021	
View of borehole location inside tank battery containment during delineation activities.

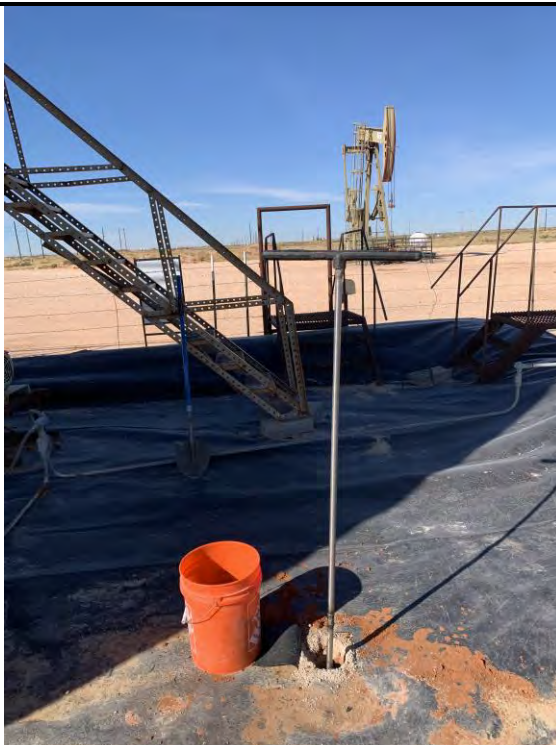
Photo No.	Date	
3	November 10, 2021	
View of borehole location inside tank battery containment

A photograph showing a view of a borehole location inside a tank battery containment. An orange bucket is placed next to the borehole. In the background, there is a metal structure and a yellow crane-like device under a clear blue sky.

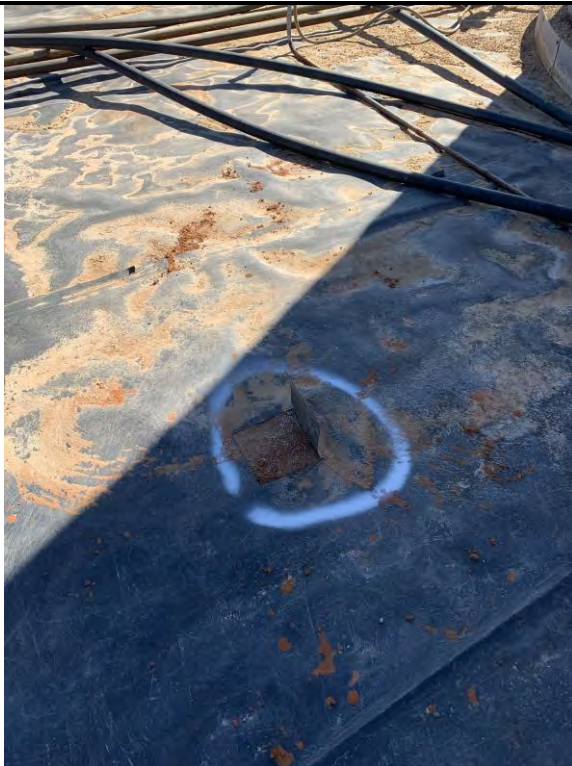
Photo No.	Date	
4	November 10, 2021	
View of borehole once delineation activities were complete.

A photograph showing a view of a borehole once delineation activities were complete. The borehole is marked with a white circle on a blue surface. There are some orange stains and debris around the borehole.
