## Release Notification

Site Name: R B Sullivan #3F	Site Type: Well Site
Date Release Discovered: 10/5/2021	API# (if applicable): 30-045-34304

## Executive Summary

On October 5, 2021, Hilcorp discovered the release of 15 barrels of produced water that leaked from a hole in the side of a below ground tank at the R B Sullivan #3F well site (Incident # nAPP2128435279). The hole in the tank was due to corrosion. The release was contained to the pit area which was unlined. The release did not spread beyond that tank containment area. The reported release volume is based on strapping data for the tank and the amount of liquid recovered.

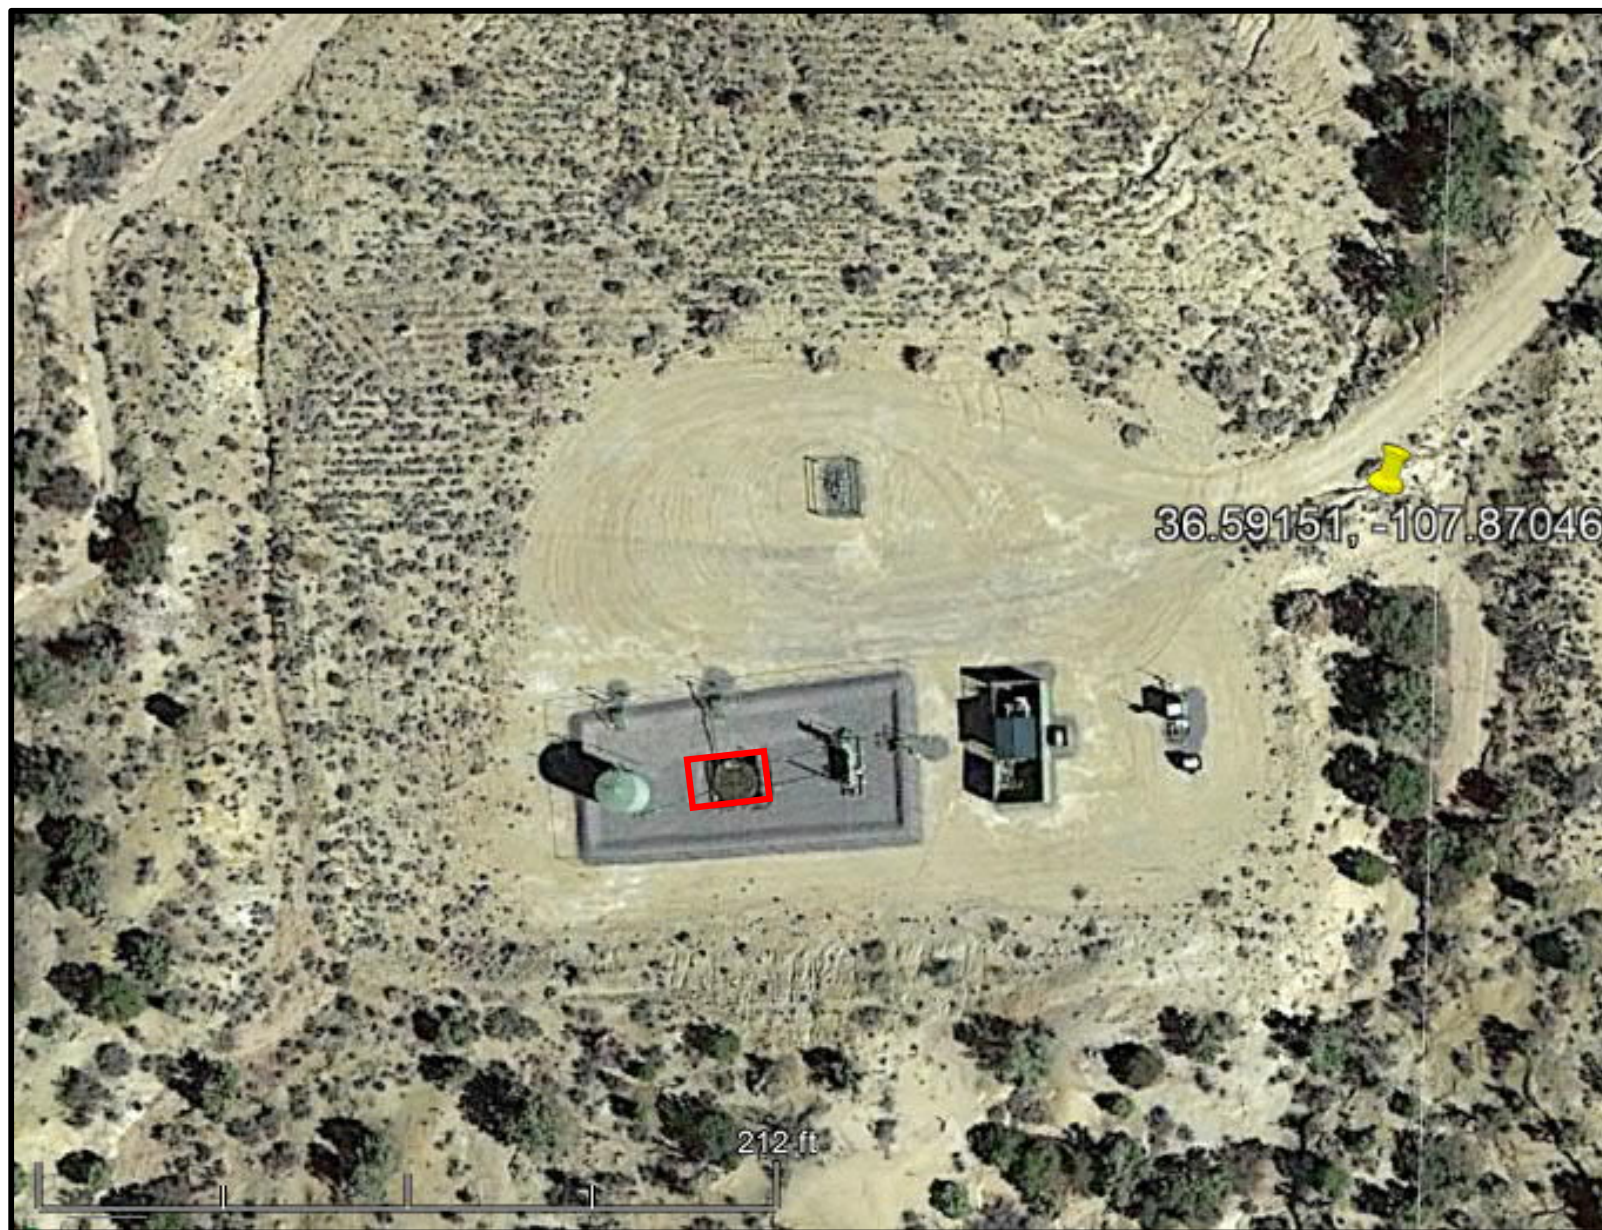
# Scaled Map

Release Area

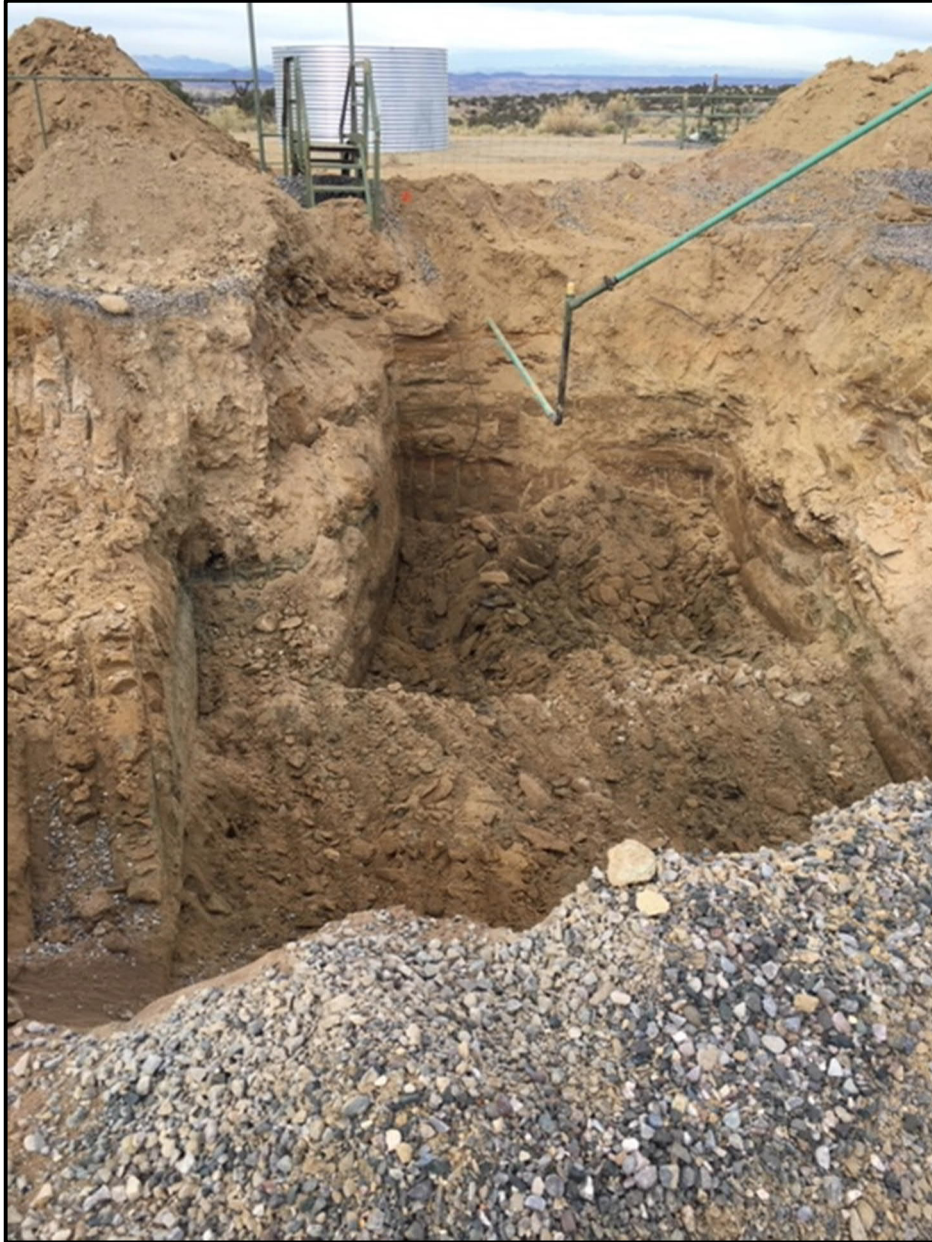
Looking north

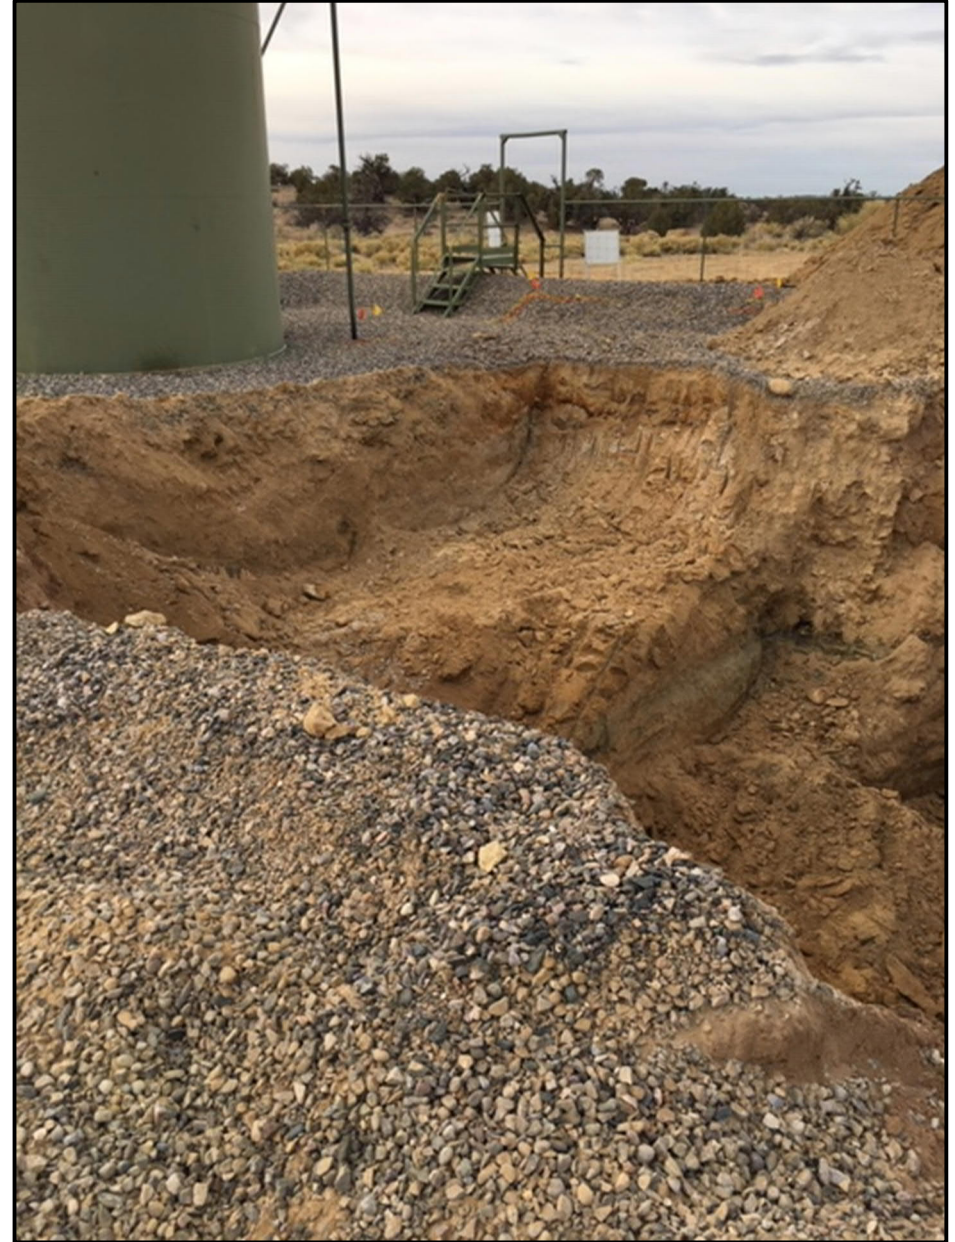
Looking southwest
