Site Assessment/Characterization

Remediation Plan

**Re: Remediation Work Plan
Sandrock Water Gathering
Incident Number nAPP2104155952
San Juan County, New Mexico**

WSP USA Inc. (WSP), on behalf of Hilcorp Energy Company (Hilcorp), presents the following Remediation Work Plan detailing site investigation activities completed to date and proposed actions to address impacted soil resulting from a release of produced water from the Sandrock Water Gathering Produced Water Pipeline (Site). The Site is located in Unit O, Section 22, Township 31 North, Range 13 West, in San Juan County, New Mexico (Figure 1).

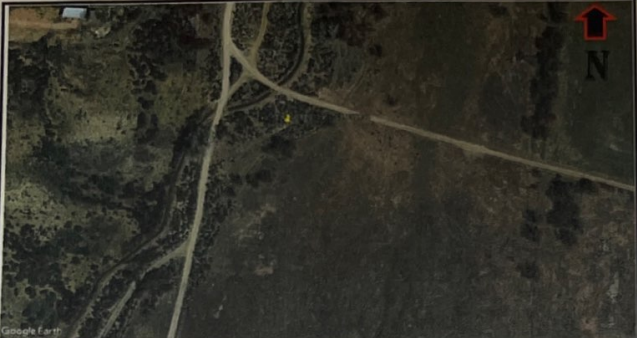
WSP USA INC	
		848 East 2nd Avenue Durango, CO 81301	
		BORING LOG/MONITORING WELL COMPLETION DIAGRAM	
		Boring/Well Number: BH01	Project: Sandrock Water Gathering
Date: 4/7/2021		Project Number:	
Logged By: Eric Carroll		Drilled By: Hilcorp	
Elevation: 6,000	Detector: PID	Drilling Method: Hollow Stem	Sampling Method: Continuous
Gravel Pack: 10-20 Silica Sand		Seal: Bentonite	Grout: Bentonite
Casing Type: Schedule 40 PVC	Diameter: 2"	Length: NA	Hole Diameter: 6"
Screen Type: Schedule 40 PVC	Slot: 0.010"	Diameter: 2"	Length: NA
		Total Depth: 9'	Depth to Water: 6-5

Penetration Resistance	Moisture Content	Vapor (ppm)	HC Staining?	Sample #	Depth (ft. bgs.)	Sample Run	Recovery	Soil/Rock Type	Lithology/Remarks	Well Completion
	m	5.6	✓	BH01 0-2'	0			SM	moist, loose, red brown, silty sand no stain/odor	
					1	1			CI ⁻ = 4.2 636	
					2					
	m	4.1	✓		3	2		SM	SAA	
					4				CI ⁻ = 3.2 392	
					5				SAA	
	m	3.2		BH01 4-5'	6	3		SM	CI ⁻ = 1.8 152	
					7					
	w	2.2			8	4		SC	wet, cohesive, sand, some clay	
					9				Dark brown GW @ 6.5'	
					10	5		SC	CI ⁻ 1.2 <124	
		2.1			11				SAA	
					12				CI ⁻ 0.4 <125	
					13					
					14					
					15

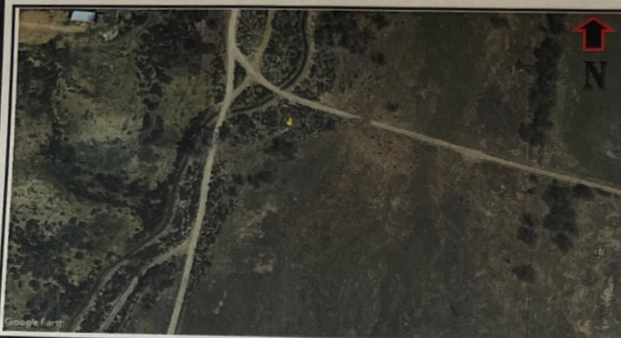
WSP USA INC						
				848 East 2nd Avenue Durango, CO 81301						
				BORING LOG/MONITORING WELL COMPLETION DIAGRAM						
				Boring/Well Number: BH02		Project: Sandrock Water Gathering				
Date: 4/7/2021		Project Number:								
Logged By: Eric Carroll		Drilled By: Hilcorp								
Elevation: 6,000		Detector: PID		Drilling Method: Hollow Stem						
Gravel Pack: 10-20 Silica Sand		Seal: Bentonite		Sampling Method: Continuous						
Casing Type: Schedule 40 PVC		Diameter: 2"		Length: NA						
Screen Type: Schedule 40 PVC		Slot: 0.010"		Diameter: 2"						
				Length: NA						
				Hole Diameter: 6"						
				Depth to Liquid: NA						
				Total Depth: 8'						
				Depth to Water: 6'						
Penetration Resistance	Moisture Content	Vapor (ppm)	HC Staining?	Sample #	Depth (ft. bgs.)	Sample Run	Recovery	Soil/Rock Type	Lithology/Remarks	Well Completion
	m	0.3	N	BH01 0-2	0	1		SM	moist dark brown, silty sand few clay, w/ organics CI ⁻ = 1.0 < 124

m	0.0	N		3	2		SM	SAA CI ⁻ = 0.8 < 124	
	m	0.0	N	BH01 4-5	5	3		SM	moist, dark brown, silty sand little clay CI ⁻ = 0.6 < 124	
	vm	0.0	N		7	4		SC	Gw @ 6'-6.5' wet Dark brown clayey sand	
					8					
					9					
					10					
					11					
					12					
					13					
					14					
					15

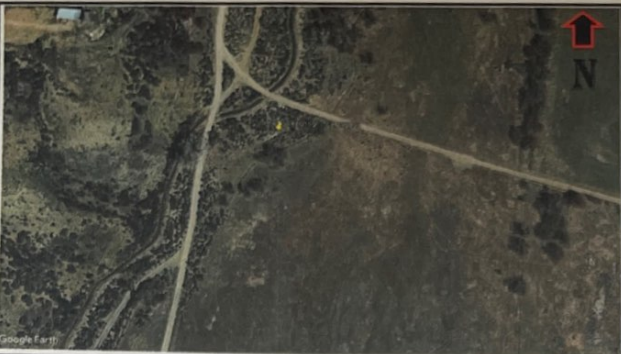
WSP USA INC						
				848 East 2nd Avenue Durango, CO 81301						
				BORING LOG/MONITORING WELL COMPLETION DIAGRAM						
				Boring/Well Number: BH03		Project: Sandrock Water Gathering				
Date: 4/7/2021		Project Number:								
Logged By: Eric Carroll		Drilled By: Hilcorp								
Elevation: 6,000		Detector: PID		Drilling Method: Hollow Stem						
				Sampling Method: Continuous						
Gravel Pack: 10-20 Silica Sand		Seal: Bentonite		Grout: Bentonite						
Casing Type: Schedule 40 PVC		Diameter: 2"		Length: 6'						
Screen Type: Schedule 40 PVC		Slot: 0.010"		Diameter: 2"						
				Total Depth: 5'						
				Depth to Liquid: NA						
				Depth to Water:						
Penetration Resistance	Moisture Content	Vapor (ppm)	HC Staining?	Sample #	Depth (ft. bgs.)	Sample Run	Recovery	Soil/Rock Type	Lithology/Remarks	Well Completion
	m	24.7	N		0			SM	moist dark brown silty sand Cl ⁻ = 0.8 < 124	
					1	1				
					2

3	2		SM	moist, red brown silty sand Cl ⁻ = 0.8 < 124	
					4					
					5	3		SC	moist, brown, silty sand, few clay Cl ⁻ 0.6 < 124	
					6					
					7					
					8					
					9					
					10					
					11					
					12					
					13					
					14					
					15

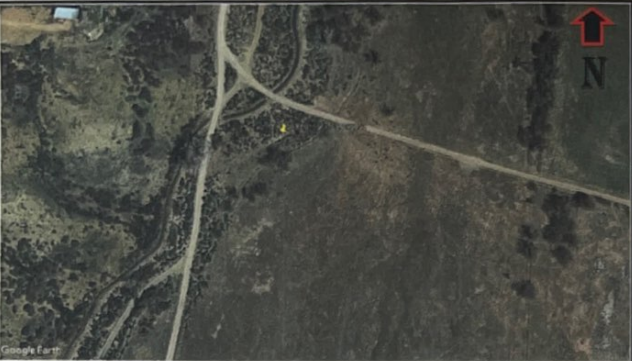
WSP USA INC						
				848 East 2nd Avenue						
				Durango, CO 81301						
				BORING LOG/MONITORING WELL COMPLETION DIAGRAM						
Boring/Well Number: BH04				Project: Sandrock Water Gathering						
Date: 4/7/2021				Project Number:						
Logged By: Eric Carroll				Drilled By: Hilcorp						
Drilling Method: Hollow Stem				Sampling Method: Continuous						
Gravel Pack: 10-20 Silica Sand				Seal: Bentonite						
Casing Type: Schedule 40 PVC				Grout: Bentonite						
Screen Type: Schedule 40 PVC				Diameter: 2" Length: NA						
Slot: 0.010"				Hole Diameter: 6" Depth to Liquid: NA						
Diameter: 2" Length: NA				Total Depth: 5' Depth to Water:						
Penetration Resistance	Moisture Content	Vapor (ppm)	HC Staining?	Sample #	Depth (ft. bgs.)	Sample Run	Recovery	Soil/Rock Type	Lithology/Remarks	Well Completion
	m	6.6	N		0			SM	moist, red brown silty sand	
					1				CI = 0.4 < 124	
					2					
					3			SM	SAA

4				CI = 0.4 < 124	
					5			SC	moist brown, sand, some silt and clay cohesive	
					6				CI = 0.4 < 124	
					7					
					8					
					9					
					10					
					11					
					12					
					13					
					14					
					15

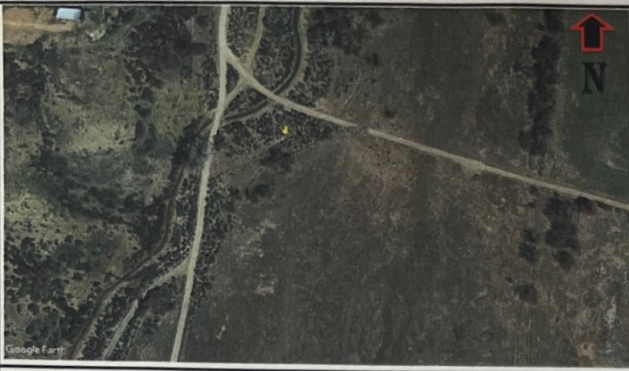
WSP USA INC								
		848 East 2nd Avenue								
		Durango, CO 81301								
		BORING LOG/MONITORING WELL COMPLETION DIAGRAM								
Boring/Well Number: BH05		Project: Sandrock Water Gathering								
Date: 4/7/2021		Project Number:								
Logged By: Eric Carroll		Drilled By: Hilcorp								
Drilling Method: Hollow Stem		Sampling Method: Continuous								
Elevation: 6,000	Detector: PID		Seal: Bentonite							
Gravel Pack: 10-20 Silica Sand		Grout: Bentonite								
Casing Type: Schedule 40 PVC		Diameter: 2"	Length: NA							
Screen Type: Schedule 40 PVC		Slot: 0.010"	Diameter: 2"							
		Length: NA	Total Depth: 5'							
			Depth to Liquid: NA							
			Depth to Water:							
Penetration Resistance	Moisture Content	Vapor (ppm)	HC Staining?	Sample #	Depth (ft. bgs.)	Sample Run	Recovery	Soil/Rock Type	Lithology/Remarks	Well Completion
	m	4.7	N	BH05 0-2	0			SM	moist, red brown, silty sand	
					1	1			CI- 0.4 < 124

2					
	m	3.1	N		3	2		SM	SAA	
					4				CI- 0.4 < 124	
	m	2.8	N	BH05 4-5	5	3		SC	moist brown, sand, some silt & clay cohesive	
					6				CI- 0.2 < 124	
					7					
					8					
					9					
					10					
					11					
					12					
					13					
					14					
					15

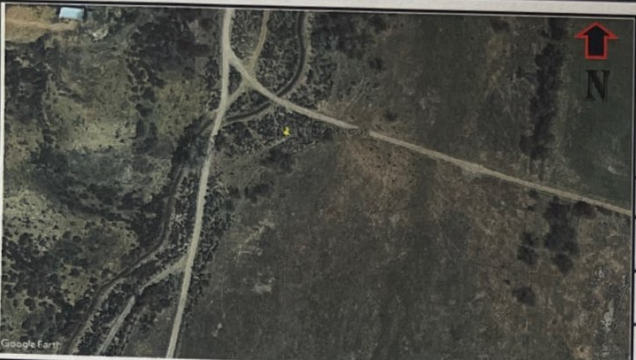
WSP USA INC								
		848 East 2nd Avenue								
		Durango, CO 81301								
		BORING LOG/MONITORING WELL COMPLETION DIAGRAM								
Boring/Well Number: BH06		Project: Sandrock Water Gathering								
Date: 4/7/2021		Project Number:								
Logged By: Eric Carroll		Drilled By: Hilcorp								
Drilling Method: Hollow Stem		Sampling Method: Continuous								
Seal: Bentonite		Grout: Bentonite								
Diameter: 2" Length: NA		Hole Diameter: 6"	Depth to Liquid: NA							
Diameter: 2" Length: NA		Total Depth: 5'	Depth to Water:							
Elevation: 6,000 Detector: PID										
Gravel Pack: 10-20 Silica Sand										
Casing Type: Schedule 40 PVC										
Screen Type: Schedule 40 PVC Slot: 0.010"										
Penetration Resistance	Moisture Content	Vapor (ppm)	HC Staining?	Sample #	Depth (ft. bgs.)	Sample Run	Recovery	Soil/Rock Type	Lithology/Remarks	Well Completion
	m	3.6	N	BH06 0-2	0			SM	moist, red brown, silty sand

1	1			CI ⁻ = 4.0 580	
					2					
	m	3.4	N		3	2			SAA	
					4				CI ⁻ = 2.8 312	
	m	3.1	N	BH06 4-5	5	3			moist, brown, sand, some clay & silt, cohesive	
					6				CI ⁻ = 1.4 < 124	
					7					
					8					
					9					
					10					
					11					
					12					
					13					
					14					
					15

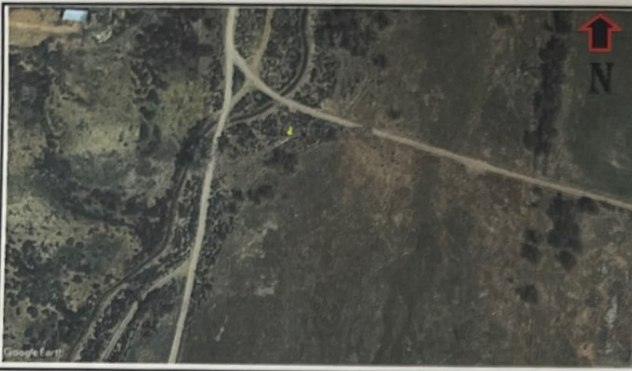
WSP USA INC								
		848 East 2nd Avenue								
		Durango, CO 81301								
		BORING LOG/MONITORING WELL COMPLETION DIAGRAM								
Boring/Well Number: BH07		Project: Sandrock Water Gathering								
Date: 4/7/2021		Project Number:								
Logged By: Eric Carroll		Drilled By: Hilcorp								
Elevation: 6,000	Detector: PID	Drilling Method: Hollow Stem	Sampling Method: Continuous							
Gravel Pack: 10-20 Silica Sand		Seal: Bentonite	Grout: Bentonite							
Casing Type: Schedule 40 PVC	Diameter: 2"	Length: NA	Hole Diameter: 6"							
Screen Type: Schedule 40 PVC	Slot: 0.010"	Diameter: 2"	Length: NA							
		Total Depth: 5'	Depth to Liquid: NA							
		Depth to Water:								
Penetration Resistance	Moisture Content	Vapor (ppm)	HC Staining?	Sample #	Depth (ft. bgs.)	Sample Run	Recovery	Soil/Rock Type	Lithology/Remarks	Well Completion
	m	1.7	N	BH07 0-2	0				moist, red brown, silty sand	
					1				CI = 1.8 152

2	1				
	m	1.1	N		3	2			SAA =	
					4				CI = 1.6 124	
	m	0.8	N	BH07 4-5	5	3			moist, brown, sand, some clay	
					6				& silt, cohesive	
					7				CI = 0.8 < 124	
					8					
					9					
					10					
					11					
					12					
					13					
					14					
					15

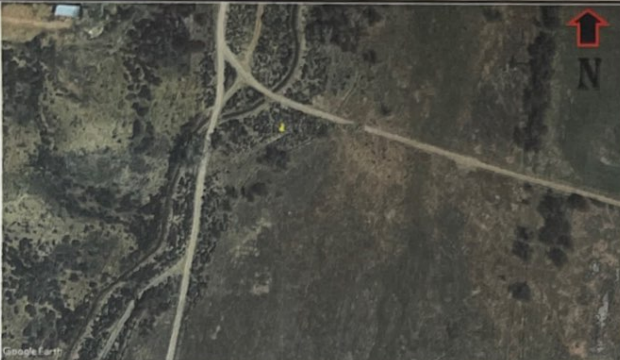
WSP USA INC	
		848 East 2nd Avenue	
		Durango, CO 81301	
		BORING LOG/MONITORING WELL COMPLETION DIAGRAM	
Boring/Well Number: BH08		Project: Sandrock Water Gathering	
Date: 4/7/2021		Project Number:	
Logged By: Eric Carroll		Drilled By: Hilcorp	
Drilling Method: Hollow Stem		Sampling Method: Continuous	
Gravel Pack: 10-20 Silica Sand		Seal: Bentonite	
Casing Type: Schedule 40 PVC		Grout: Bentonite	
Screen Type: Schedule 40 PVC		Diameter: 2"	Length: NA
Slot: 0.010"		Diameter: 2"	Length: NA
Elevation: 6,000		Detector: PID	
Hole Diameter: 6"		Depth to Liquid: NA	
Total Depth: 5'		Depth to Water:

Penetration Resistance	Moisture Content	Vapor (ppm)	HC Staining?	Sample #	Depth (ft. bgs.)	Sample Run	Recovery	Soil/Rock Type	Lithology/Remarks	Well Completion
	m	3.9	N	BH08 0-2	0				moist, red brown, silty sand	
					1	1			CI = 1.6 < 124	
					2					
	m	2.7	N		3	2			SAA	
					4				CI = 1.2 < 124	
	m	2.4	N	BH08 4-5	5	3			moist, brown, cohesive, sand	
					6				some clay & silt	
					7				CI = 0.6 < 124	
					8					
					9					
					10					
					11					
					12					
					13					
					14					
					15

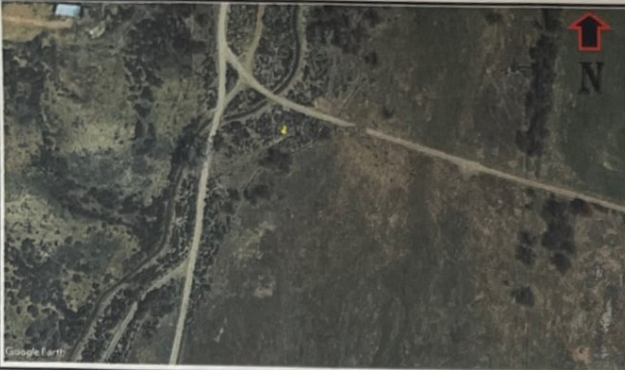
WSP USA INC						
				848 East 2nd Avenue						
				Durango, CO 81301						
				BORING LOG/MONITORING WELL COMPLETION DIAGRAM						
Boring/Well Number: BH09				Project: Sandrock Water Gathering						
Date: 4/7/2021				Project Number:						
Logged By: Eric Carroll				Drilled By: Hilcorp						
Elevation: 6,000		Detector: PID		Drilling Method: Hollow Stem		Sampling Method: Continuous				
Gravel Pack: 10-20 Silica Sand				Seal: Bentonite		Grout: Bentonite				
Casing Type: Schedule 40 PVC				Diameter: 2"		Length: NA				
Screen Type: Schedule 40 PVC				Slot: 0.010"		Diameter: 2"				
						Length: NA				
						Total Depth: 5'				
						Depth to Liquid: NA				
						Depth to Water:				
Penetration Resistance	Moisture Content	Vapor (ppm)	HC Staining?	Sample #	Depth (ft. bgs.)	Sample Run	Recovery	Soil/Rock Type	Lithology/Remarks	Well Completion
	m	6.9	N	BH09 0-2	0				moist, red brown, loose sand	
					1	1			CI = 1.8 152

2					
	m	4.9	N		3	2			moist, red brown, loose, sand	
					4				CI = 1.4 <124	
	m	4.7	N	BH09 4-5	5	3			moist, brown, cohesive, sand	
					6				Some clay & silt	
					7				CI = 0.8 <124	
					8					
					9					
					10					
					11					
					12					
					13					
					14					
					15

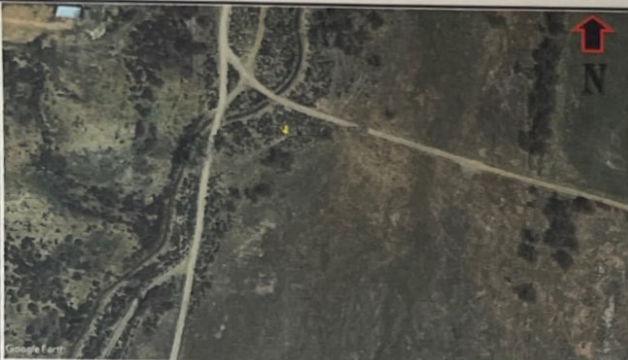
WSP USA INC								
		848 East 2nd Avenue								
		Durango, CO 81301								
		BORING LOG/MONITORING WELL COMPLETION DIAGRAM								
Boring/Well Number: BH10		Project: Sandrock Water Gathering								
Date: 4/7/2021		Project Number:								
Logged By: Eric Carroll		Drilled By: Hilcorp								
Elevation: 6,000	Detector: PID	Drilling Method: Hollow Stem	Sampling Method: Continuous							
Gravel Pack: 10-20 Silica Sand		Seal: Bentonite	Grout: Bentonite							
Casing Type: Schedule 40 PVC		Diameter: 2" Length: NA	Hole Diameter: 6" Depth to Liquid: NA							
Screen Type: Schedule 40 PVC Slot: 0.010"		Diameter: 2" Length: NA	Total Depth: 5' Depth to Water:							
Penetration Resistance	Moisture Content	Vapor (ppm)	HC Staining?	Sample #	Depth (ft. bgs.)	Sample Run	Recovery	Soil/Rock Type	Lithology/Remarks	Well Completion
	m	8.7	N	BH10 0-2	0	1		SM	moist, red brown, loose, silty sand	
					1				CI ⁻ = 2.0 180

m	7.6	N		3	2		SM	SAA CI ⁻ = 1.6 124	
					4					
	m	5.11	N	BH10 4-5	5	3		SC	moist, brown, cohesive, sand some silt & clay	
					6				CI ⁻ = 0.8 < 124	
					7					
					8					
					9					
					10					
					11					
					12					
					13					
					14					
					15

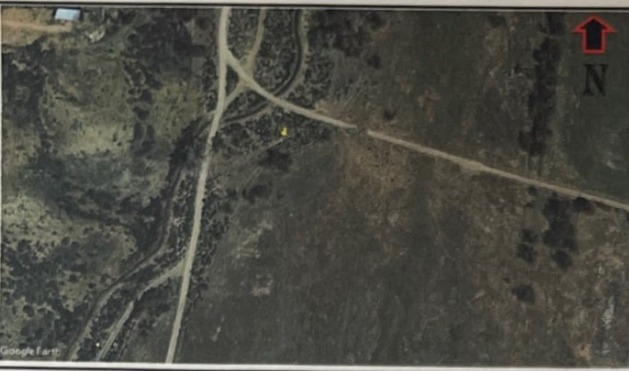
WSP USA INC						
				848 East 2nd Avenue						
				Durango, CO 81301						
				BORING LOG/MONITORING WELL COMPLETION DIAGRAM						
Boring/Well Number: <i>BH11</i>				Project: Sandrocks Water Gathering						
Date: 4/7/2021				Project Number:						
Logged By: Eric Carroll				Drilled By: Hilcorp						
Drilling Method: Hollow Stem				Sampling Method: Continuous						
Elevation: 6,000				Detector: PID						
Gravel Pack: 10-20 Silica Sand				Seal: Bentonite						
Casing Type: Schedule 40 PVC				Grout: Bentonite						
Screen Type: Schedule 40 PVC				Diameter: 2" Length: <i>NA</i>						
Slot: 0.010"				Hole Diameter: 6" Depth to Liquid: <i>NA</i>						
				Diameter: 2" Length: <i>NA</i>						
				Total Depth: 5' Depth to Water:						
Penetration Resistance	Moisture Content	Vapor (ppm)	HC Staining?	Sample #	Depth (ft. bgs.)	Sample Run	Recovery	Soil/Rock Type	Lithology/Remarks	Well Completion
	<i>m</i>	<i>0.2</i>	<i>N</i>		0				<i>moist, red brown, loose, sand</i>

1				<i>Cl⁻ = 0.2 <124</i>	
					2					
	<i>m</i>	<i>0.1</i>	<i>N</i>		3				<i>SAA</i>	
					4				<i>Cl⁻ = 0.2 <124</i>	
					5				<i>SAA</i>	
	<i>m</i>	<i>0.1</i>	<i>N</i>		6				<i>Cl⁻ = 0.2 <124</i>	
					7					
					8					
					9					
					10					
					11					
					12					
					13					
					14					
					15
