Release Notification

Site Name	Smith 8" Line	Site Type	Natural gas pipeline
Date Release Discovered	7/12/2021	API# (if applicable)

**RE: Closure Request
Smith 8" Line
Incident Number nAPP2120765301
Eddy County, New Mexico**

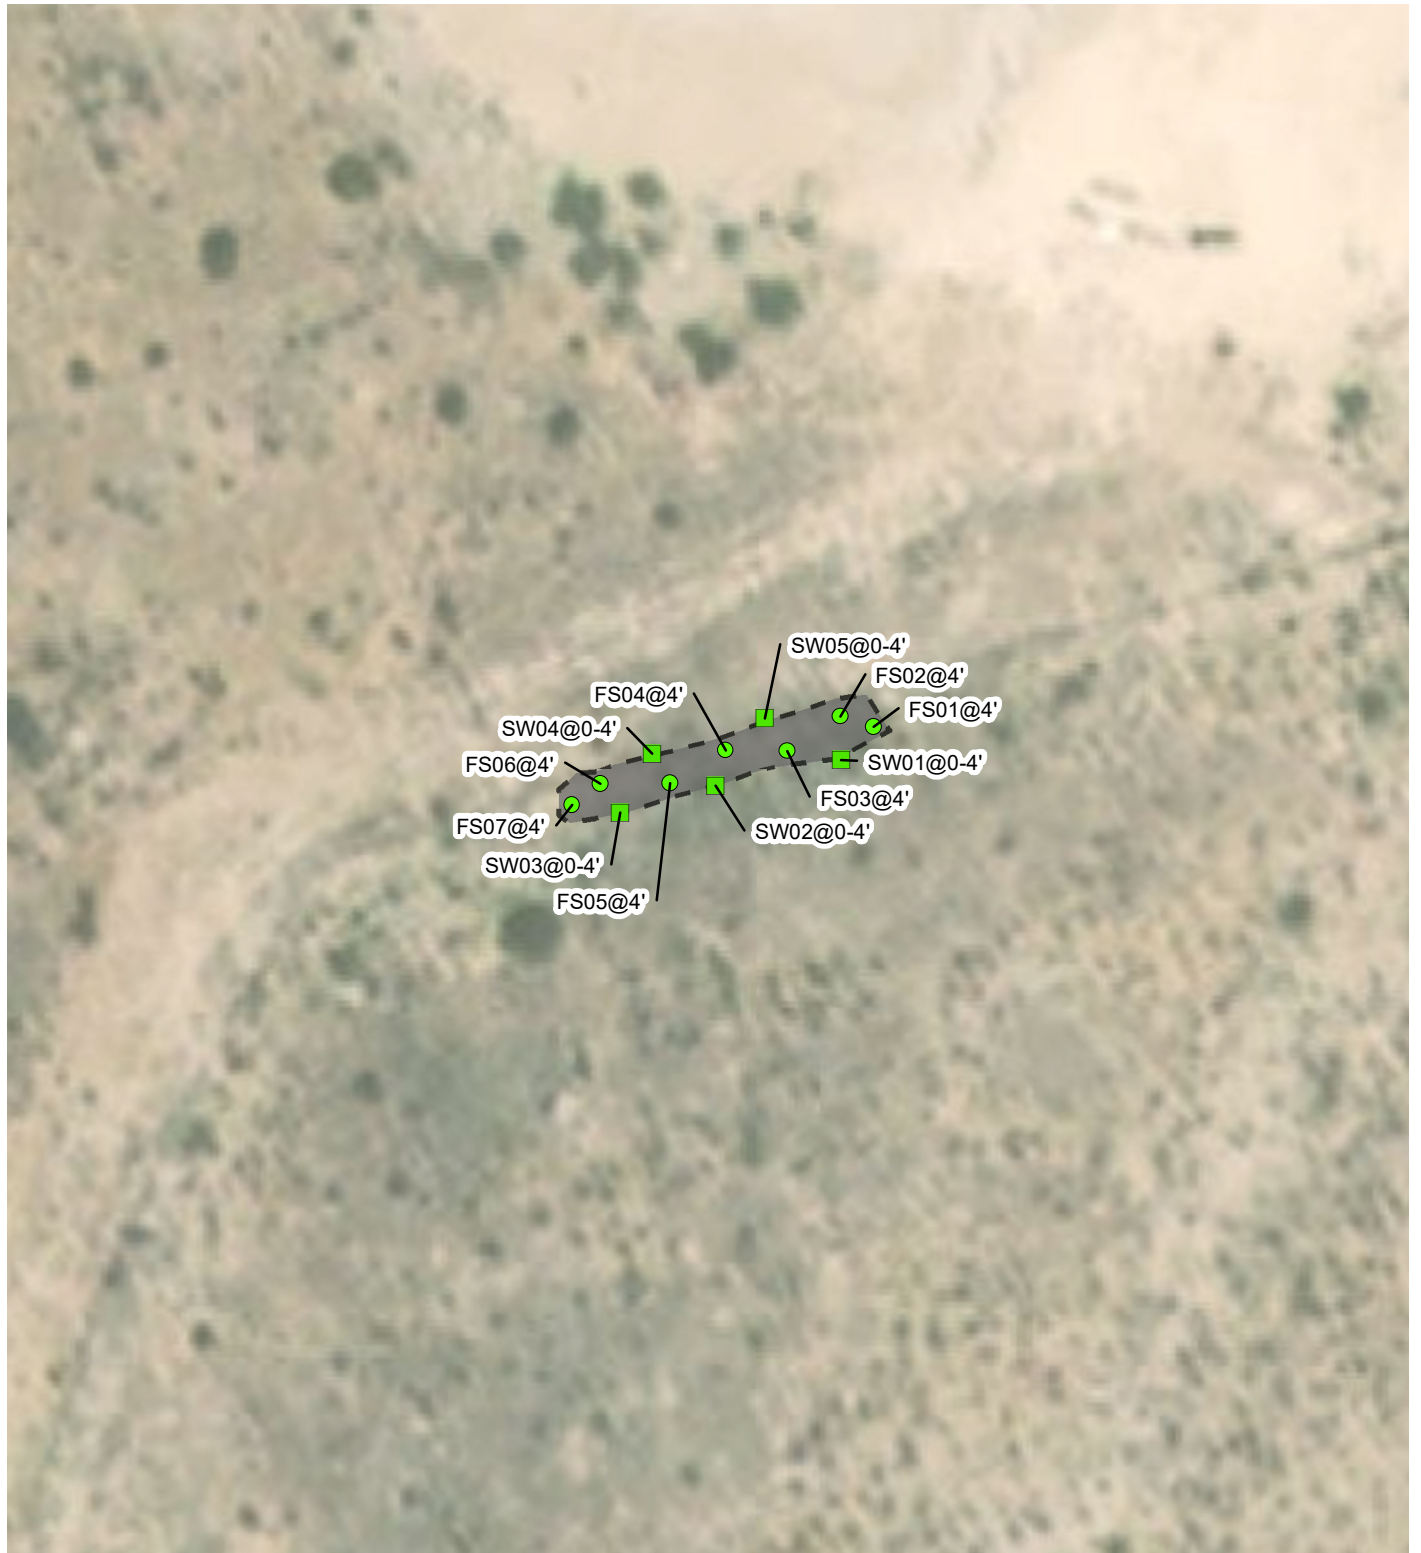
FIGURE 2
EXCAVATION SOIL SAMPLE LOCATIONS
 SMITH 8" LINE
 UNIT H SEC 1 T22S R23E
 EDDY COUNTY, NEW MEXICO
 FRONTIER FIELD SERVICES, LLC.

WSP collected 5-point composite soil samples to represent at most 200 square feet from the floor and sidewalls of the excavation. The 5-point composite samples were collected by placing five equivalent aliquots of soil into a 1-gallon, resealable plastic bag and homogenizing the samples by thoroughly mixing. Soil samples SW01 through SW05 were collected from the sidewalls of the excavation at depths ranging from the ground surface to 4 feet bgs. Soil samples FS01 through FS07 were collected from the floor of the excavation at 4 feet bgs. The excavation soil samples were placed directly into pre-cleaned glass jars, labeled with the location, date, time, sampler initials, method of analysis, and immediately placed on ice. The soil samples were transported at or below 4 degrees Celsius (°C), under strict chain-of-custody (COC) procedures to Eurofins Laboratories (Eurofins) in Carlsbad, New Mexico, for analysis of BTEX following United States Environmental Protection Agency (EPA) Method 8021B; TPH following EPA Method 8015M/D; and chloride following EPA Method 300.0. The excavation extent and excavation soil sample locations are presented on Figure 2. Photographic documentation is included in Attachment 2.

- FLOOR SAMPLE IN COMPLIANCE WITH APPLICABLE CLOSURE CRITERIA
- SIDEWALL SAMPLE IN COMPLIANCE WITH APPLICABLE CLOSURE CRITERIA
- EXCAVATION EXTENT

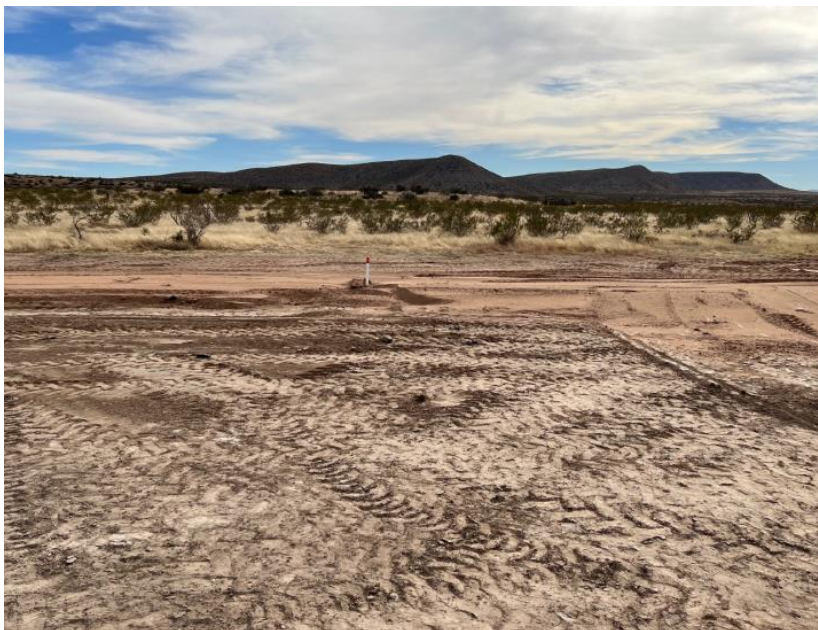
Photo No.	Date	
3	December 7, 2021	
View of the excavation following restoration activities.

A wide-angle photograph of an excavation site. The foreground is a flat, sandy area with some sparse, dry vegetation. In the background, there are low, rolling hills under a blue sky with scattered white clouds. A small white marker is visible in the distance.
