State of New Mexico
Energy Minerals and Natural
Resources Department
Oil Conservation Division
1220 South St. Francis Dr.
Santa Fe, NM 87505

Site Name: San Juan 29-7 Unit 112M	Site Type: Well Site
Date Release Discovered: 11/12/2021	API# (if applicable) 30-039-22398

Executive Summary

On October 22, 2021, Hilcorp personnel collected a 5-point composite BGT closure sample at the San Juan 29-7 Unit 112M well site. The BGT had been previously removed, but the permit was not properly closed out at the time.

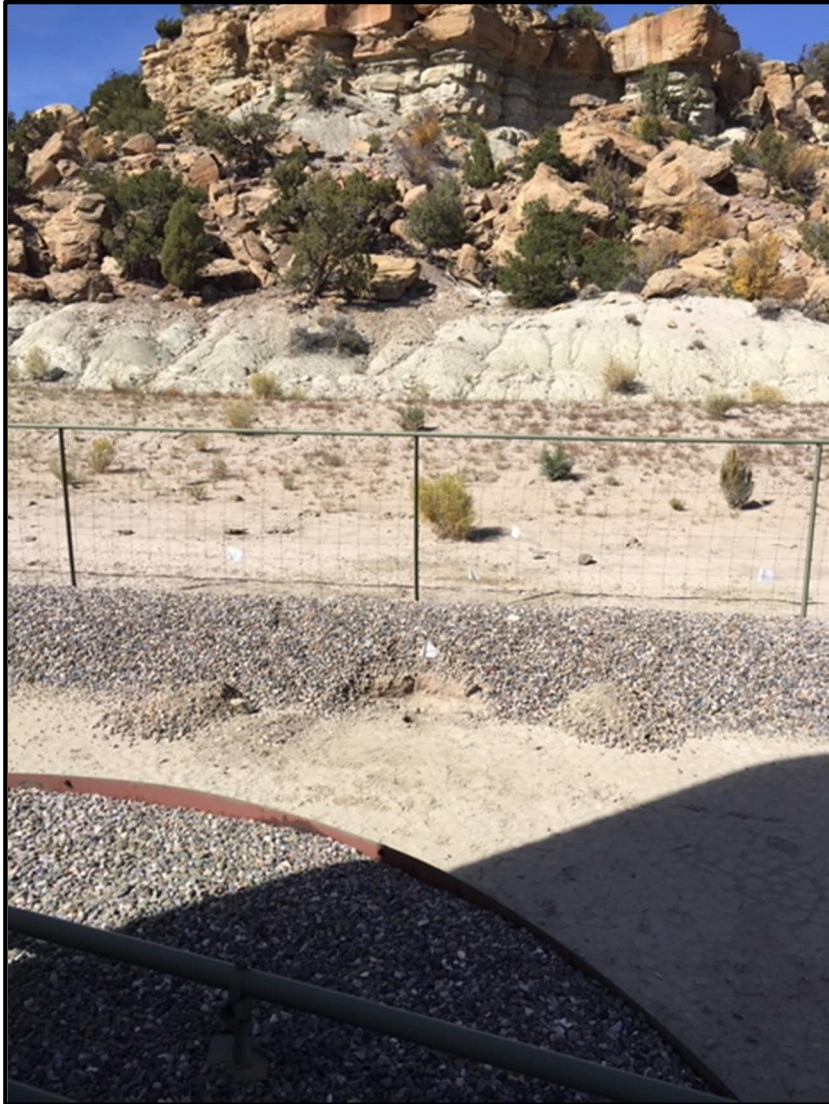
Site Photographs: sample locations noted with white flagging
Samples collected 10-22-2021, 1:25 PM

Looking northwest

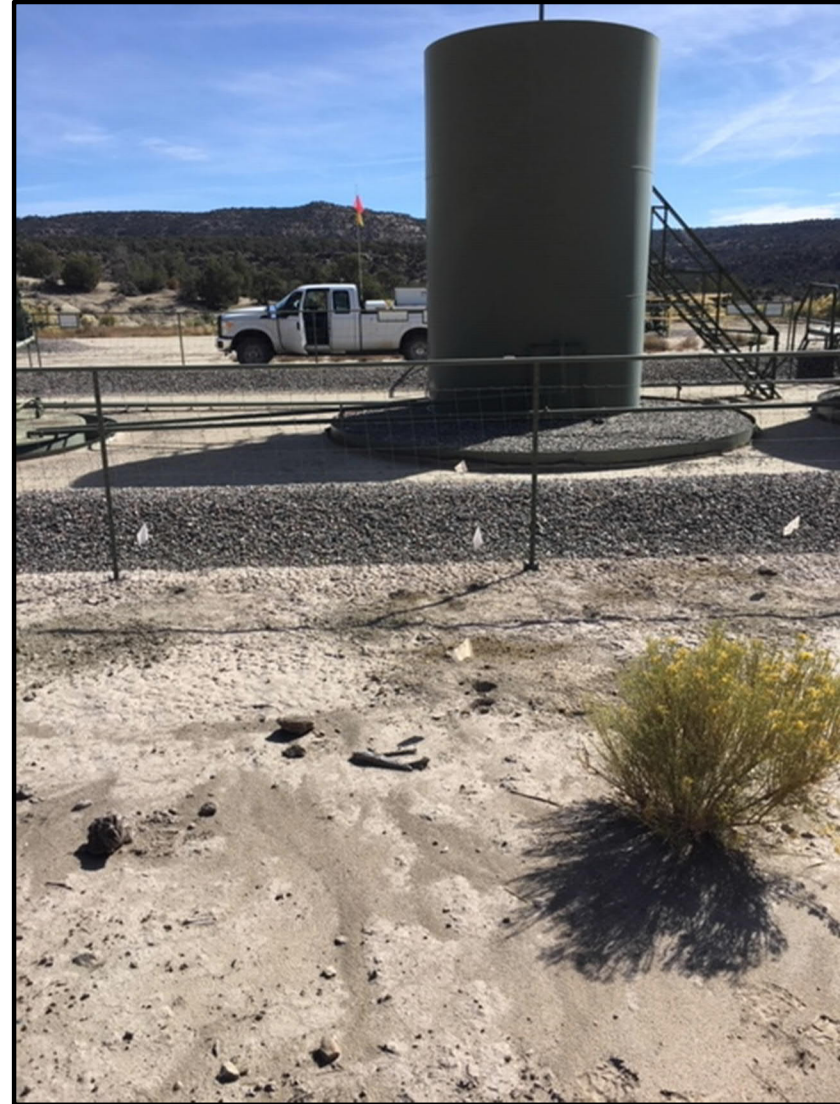
Looking southeast

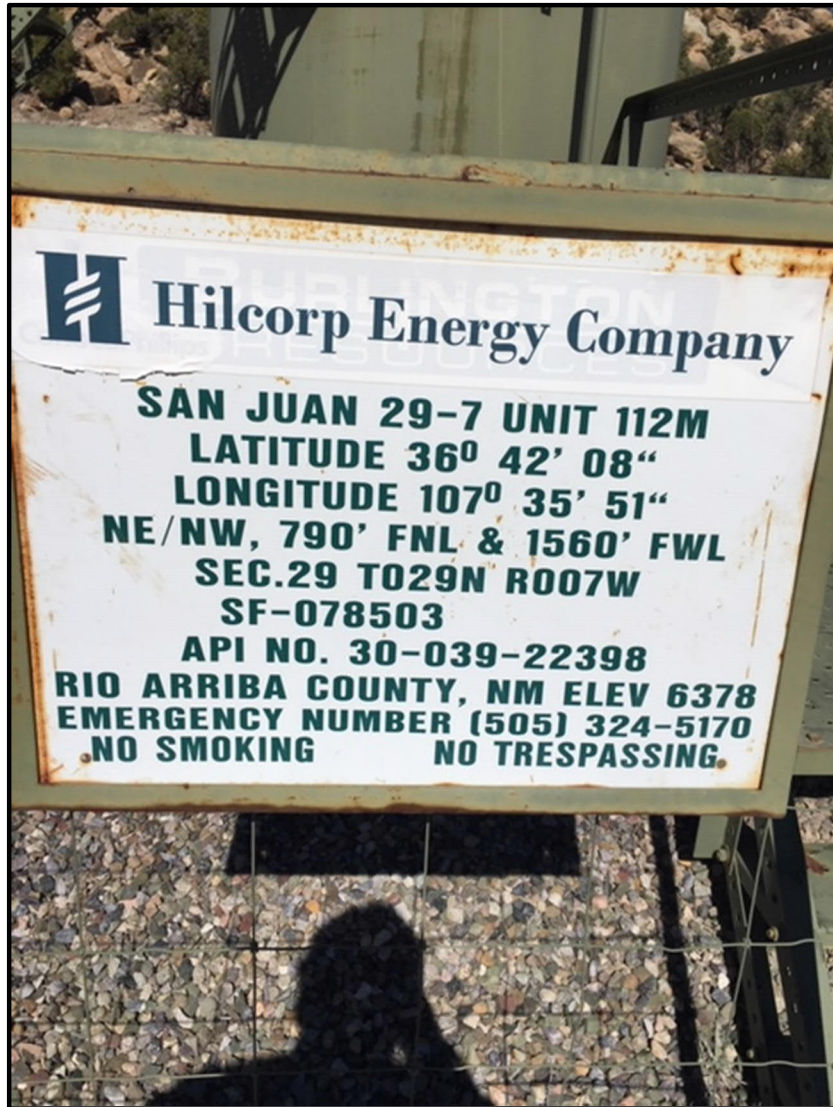
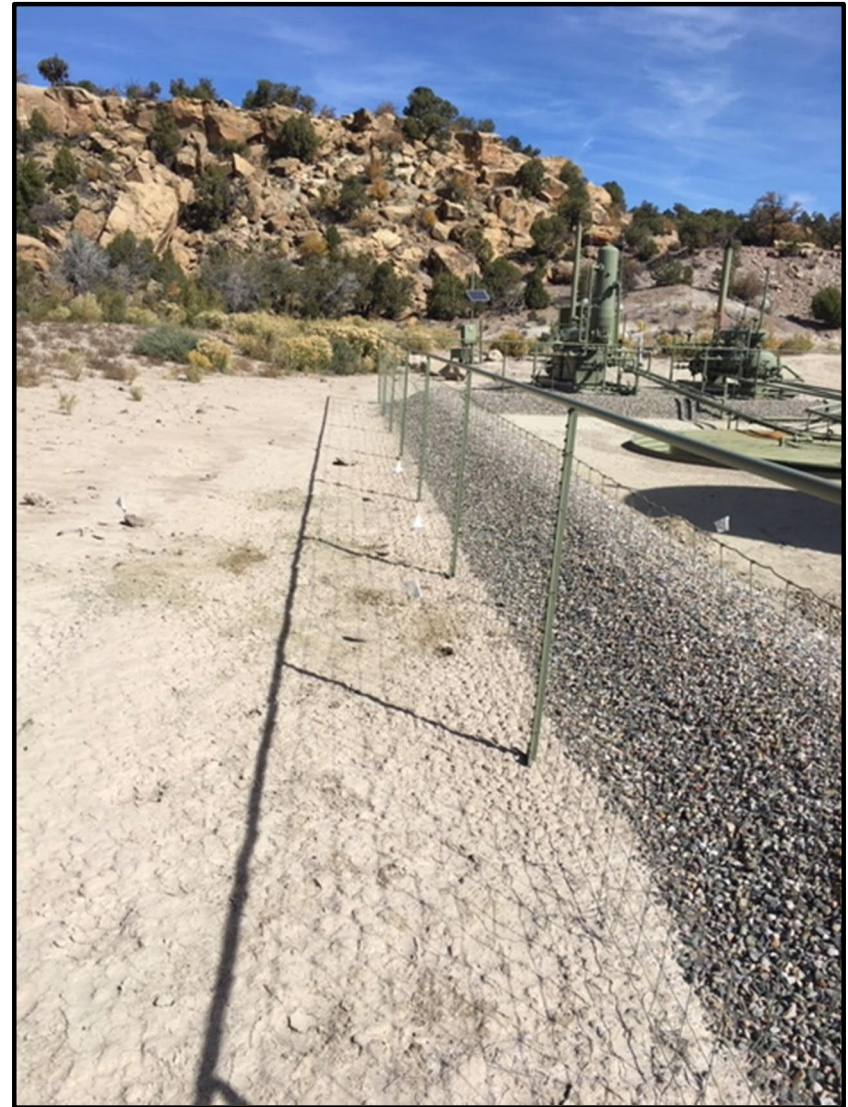
Site Photographs: sample locations noted with white flagging
Samples collected 10-22-2021, 1:25 PM

Looking northeast
