I Release Notification

Site Name Tribal C 1	Site Type Well Site (Plugged)
Date Release Discovered 10/8/2021	API# (if applicable) 30-039-06655

During BGT closure activities of a P&A well on October 8, 2021, Hilcorp Energy Company (Hilcorp) discovered a release of <1 bbl of historic hydrocarbons at the Tribal C 1 (API No. 30-039-06655). The release was due historic contamination. The release was isolated to only surface staining within the BGT pit. The visibly-impacted surface area measured approximately 14 ft x 14 ft (196 ft²) on the surface. No fluids were recovered at the time of the incident.

Executive Summary

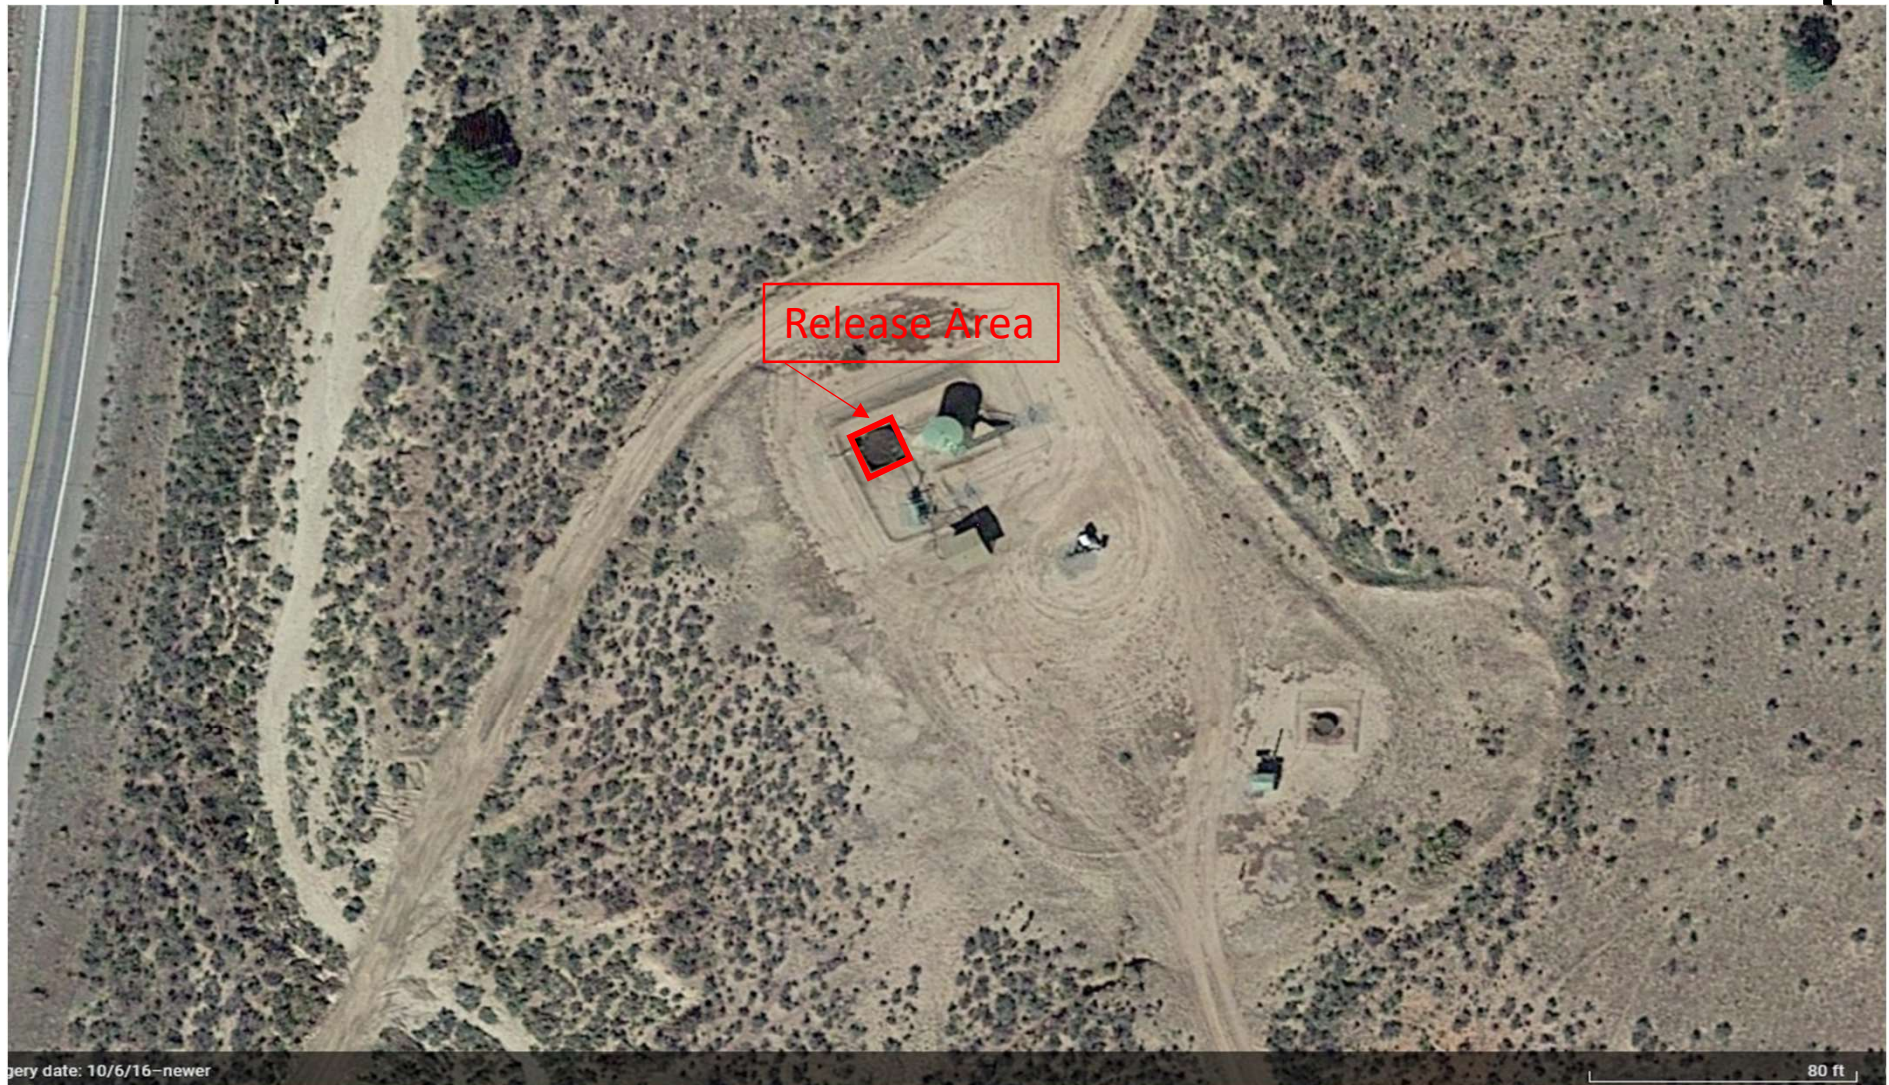
Scaled Map

Note 1: The surface extent of the Tribal C 1 release is represented by the red square shown in image above. Note that all spilled liquids remained within secondary containment.

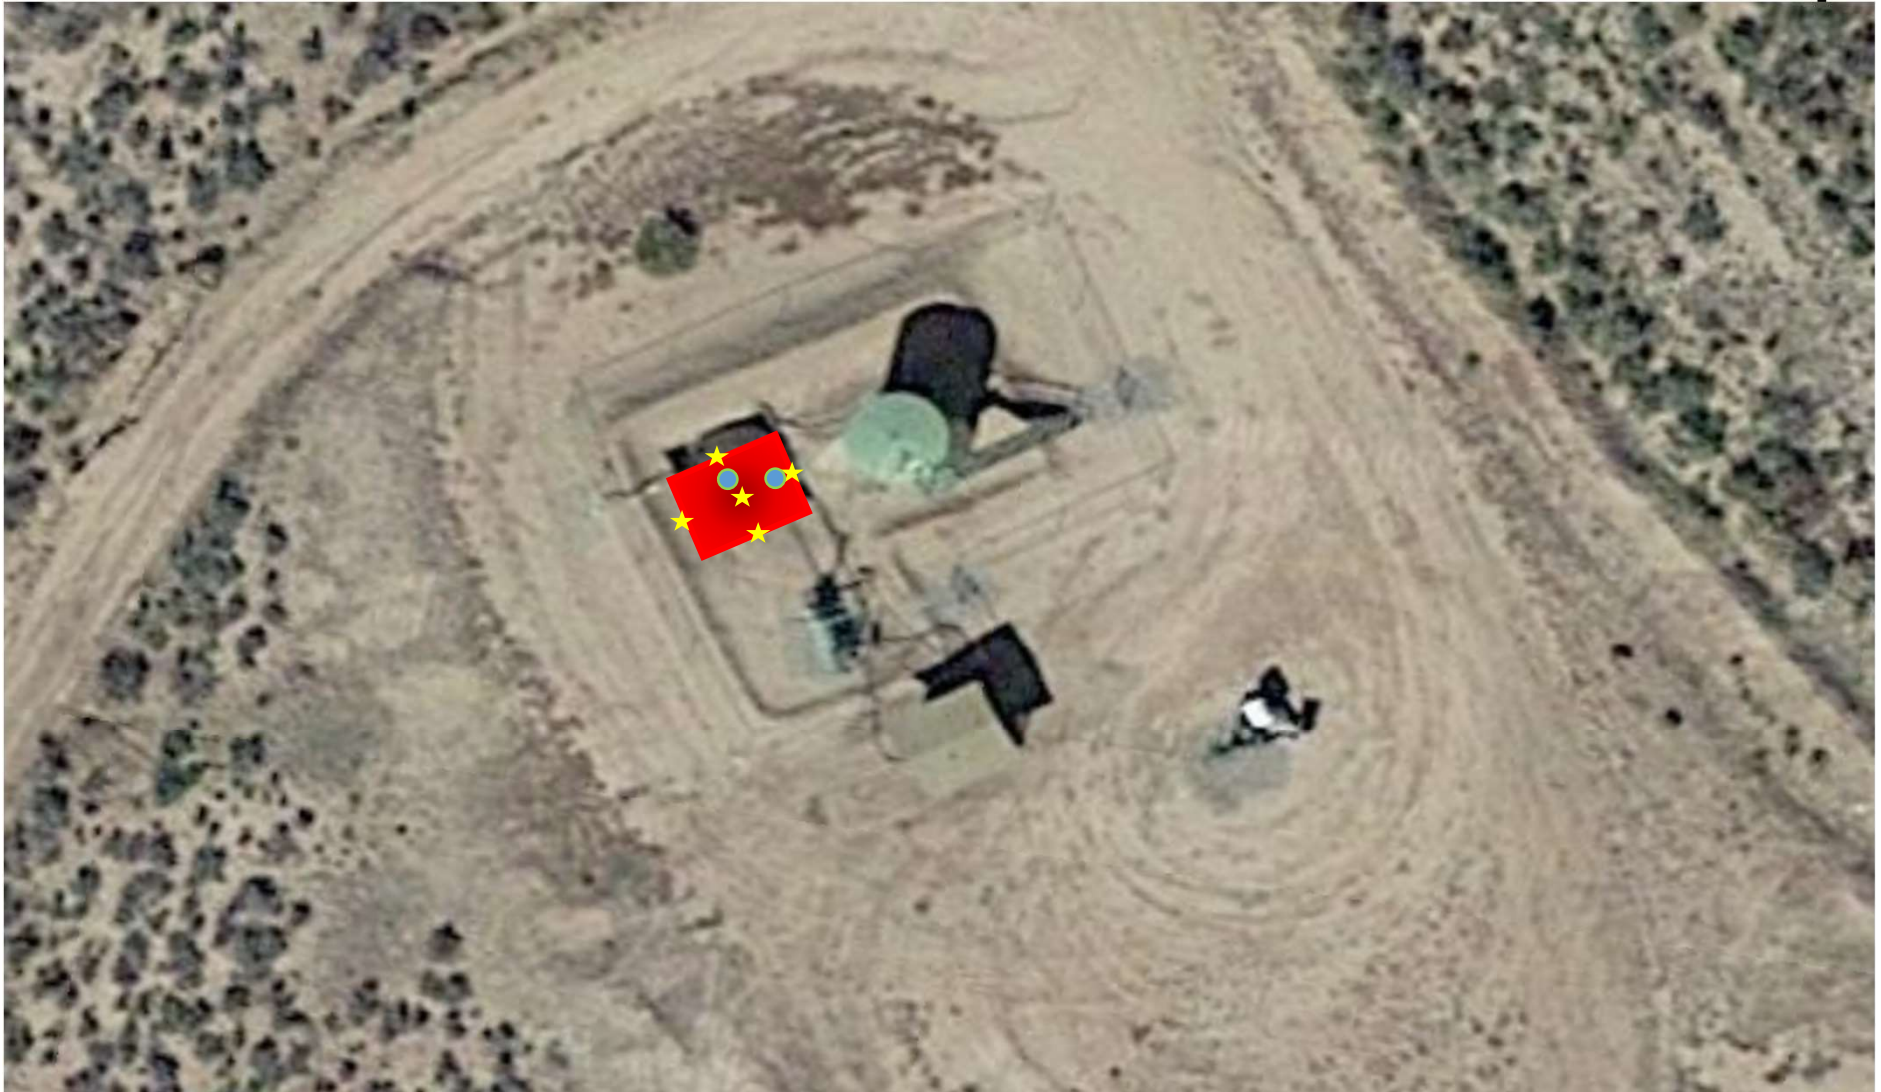
Scaled Map – Close-up

Area of Release
-

5-pt Composite Sample Location
-

Discrete Samples

Note 1: The total impacted material excavated was approximately 19 cubic yards.

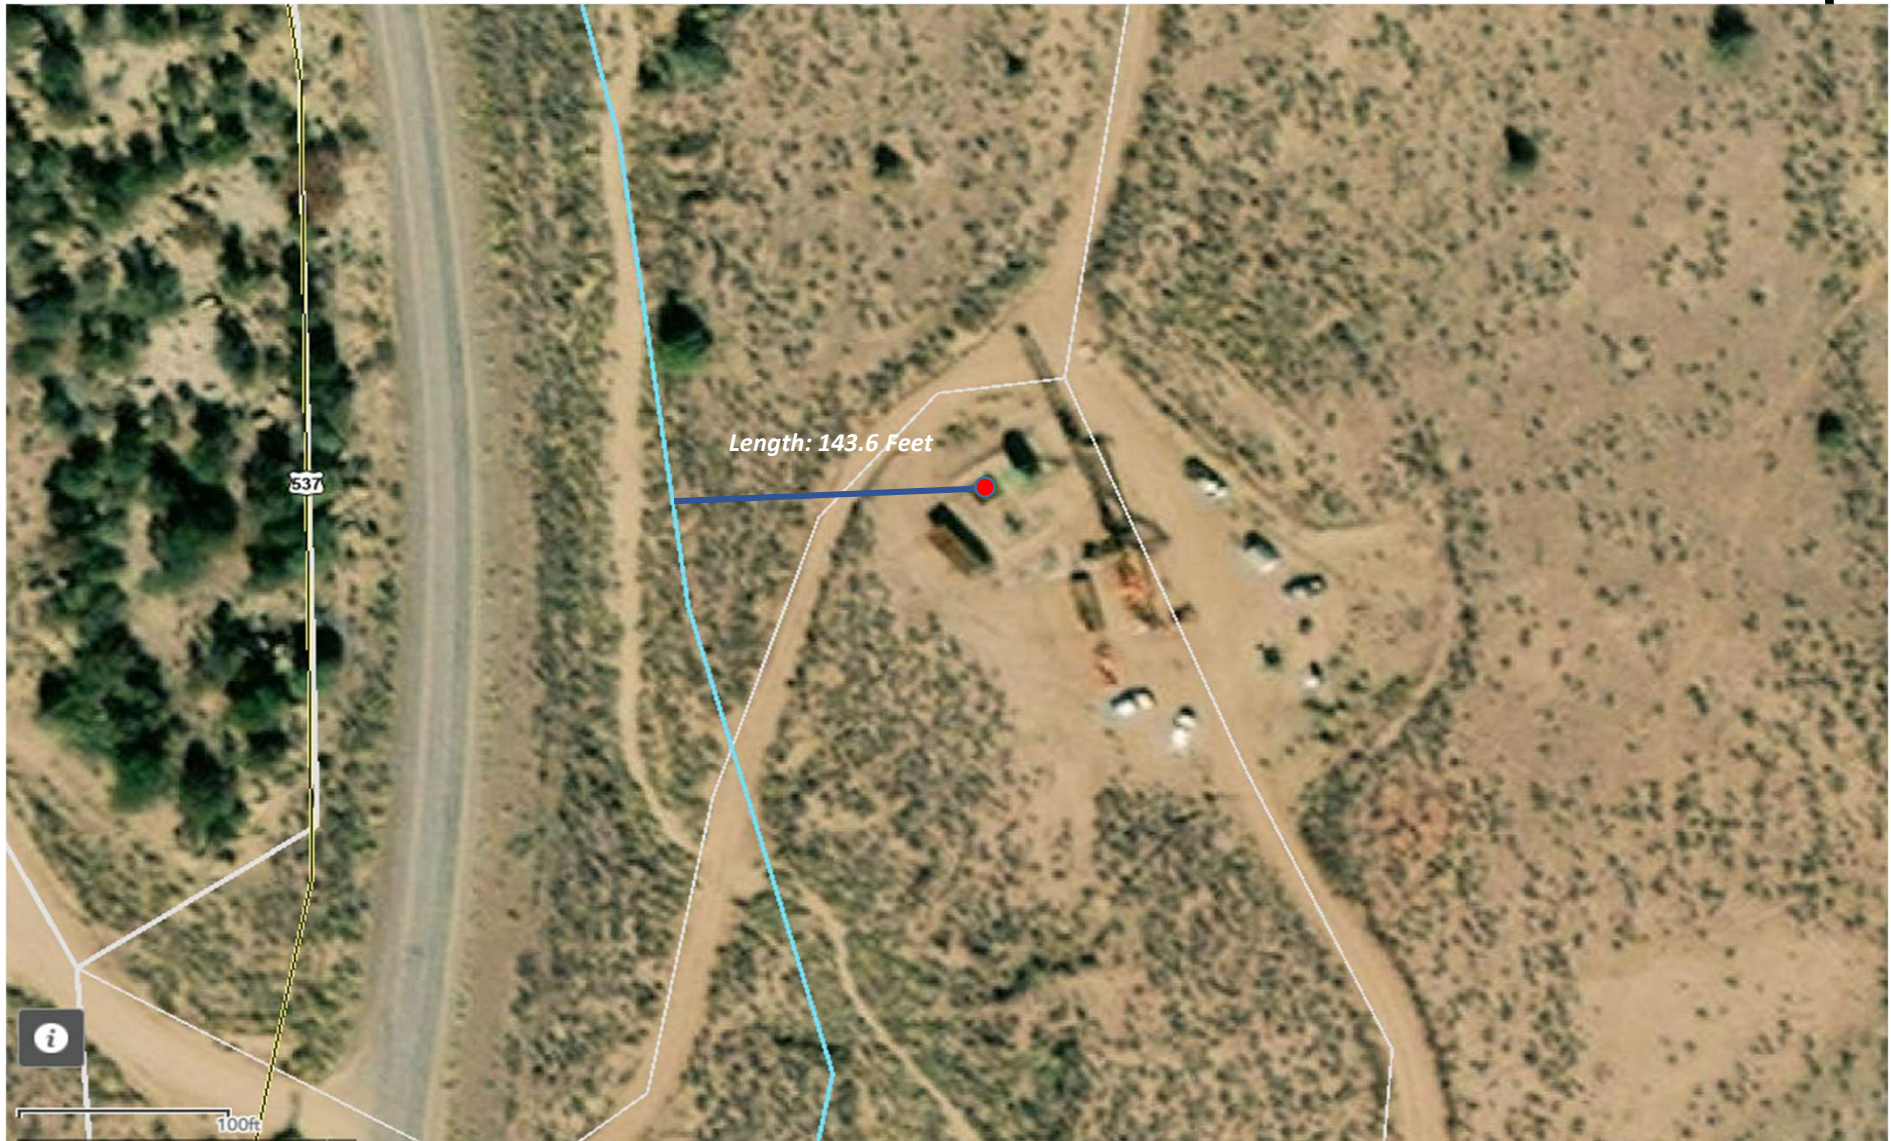
Determination of water sources and significant watercourses within ½ mile of the lateral extent of the release

Note 1: Release point shown to be within 300 ft of a significant water course; therefore, the most stringent Table 1 Closure Criteria will be utilized.

Note 2: The lateral extents of the release point are not shown to be within 300 feet of a mapped wetland.

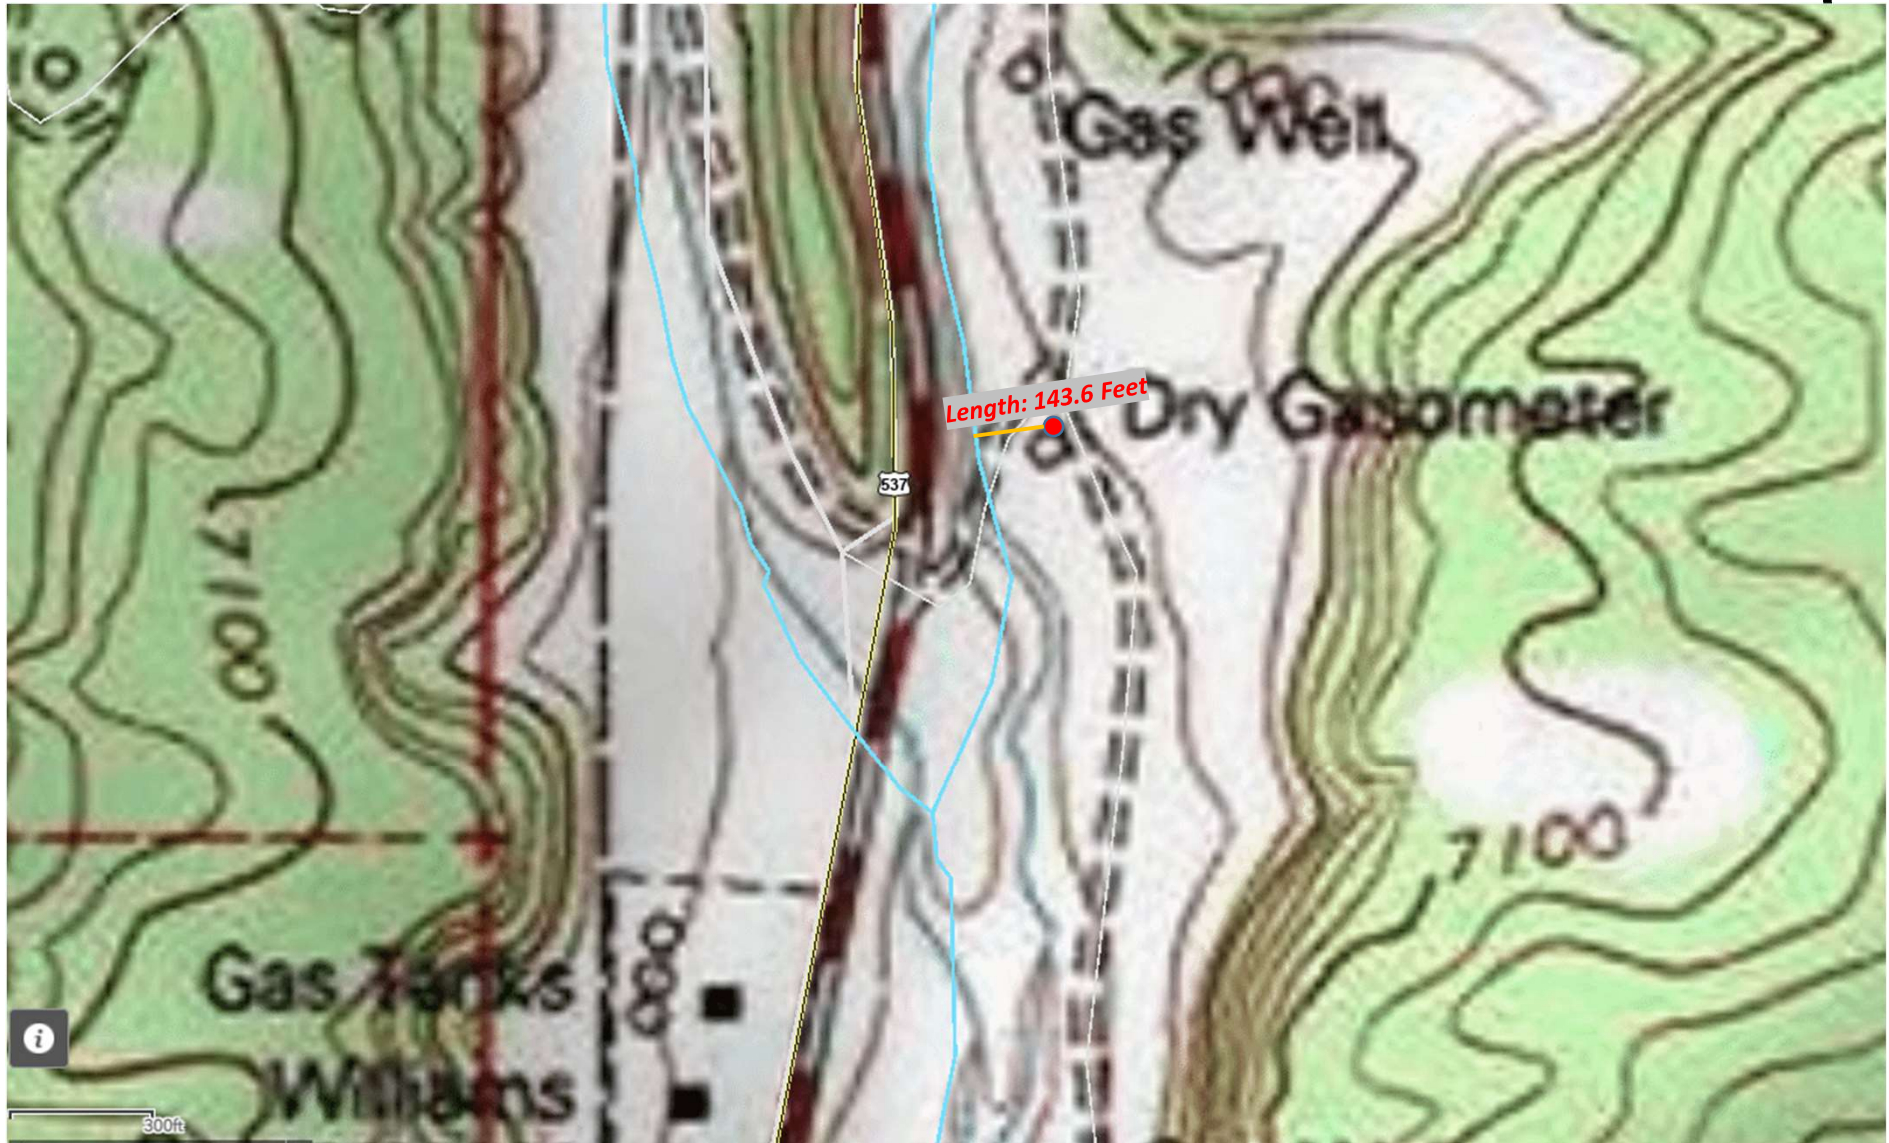
Determination of water sources and significant watercourses within
 $\frac{1}{2}$ mile of the lateral extent of the release

Note: Release point is shown to be within 300 ft of a significant water course.

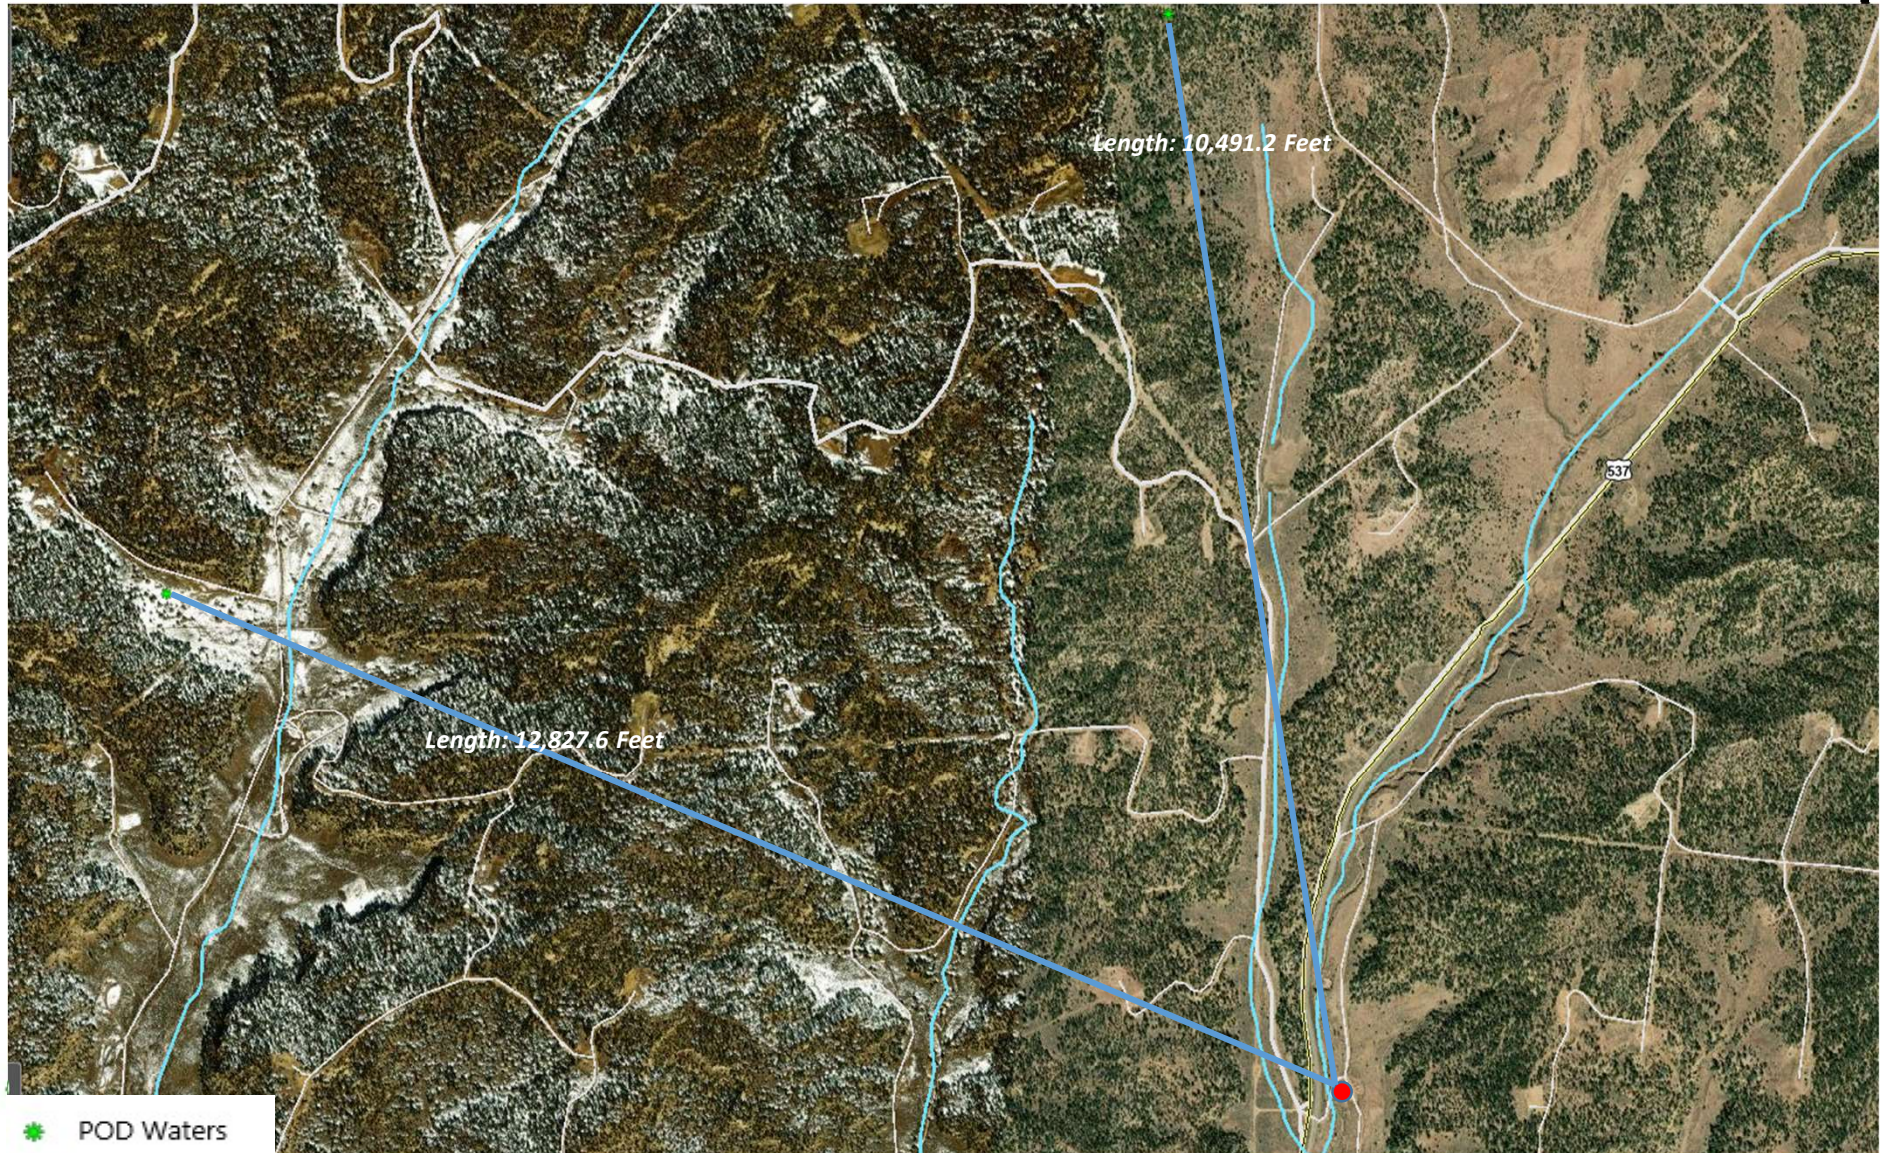
Distance to mapped water wells

Note: The lateral extents of the release point are not shown to be within 500 ft of a spring or domestic freshwater well used by less than 5 households (or stock watering) or within 1,000 ft of any freshwater water well or spring.

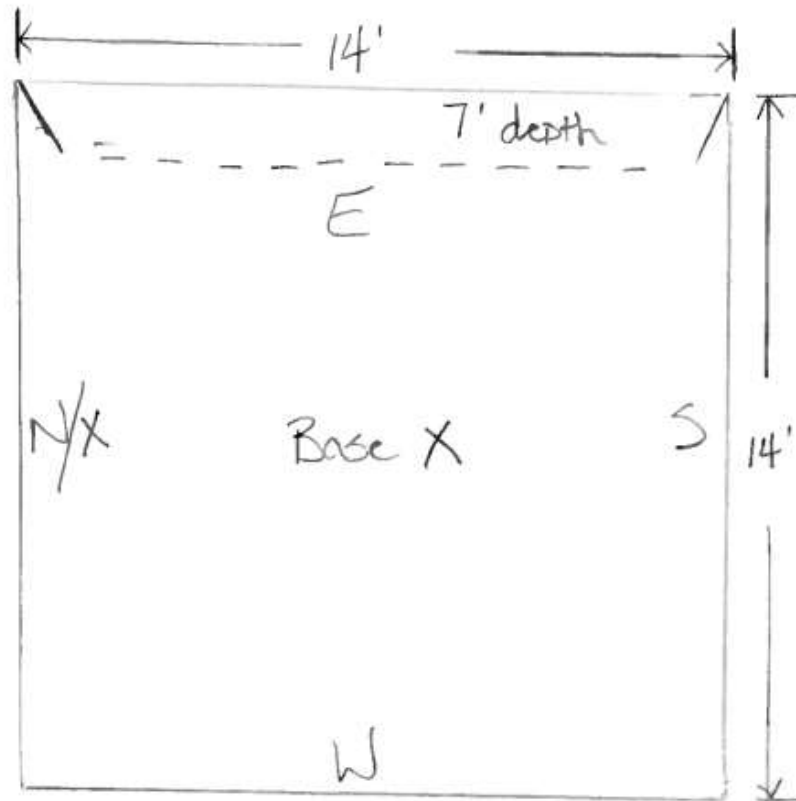
Sample field notes

Sample pts. = N, S, E, W, Base (5pt.)

X = Discrete Sample

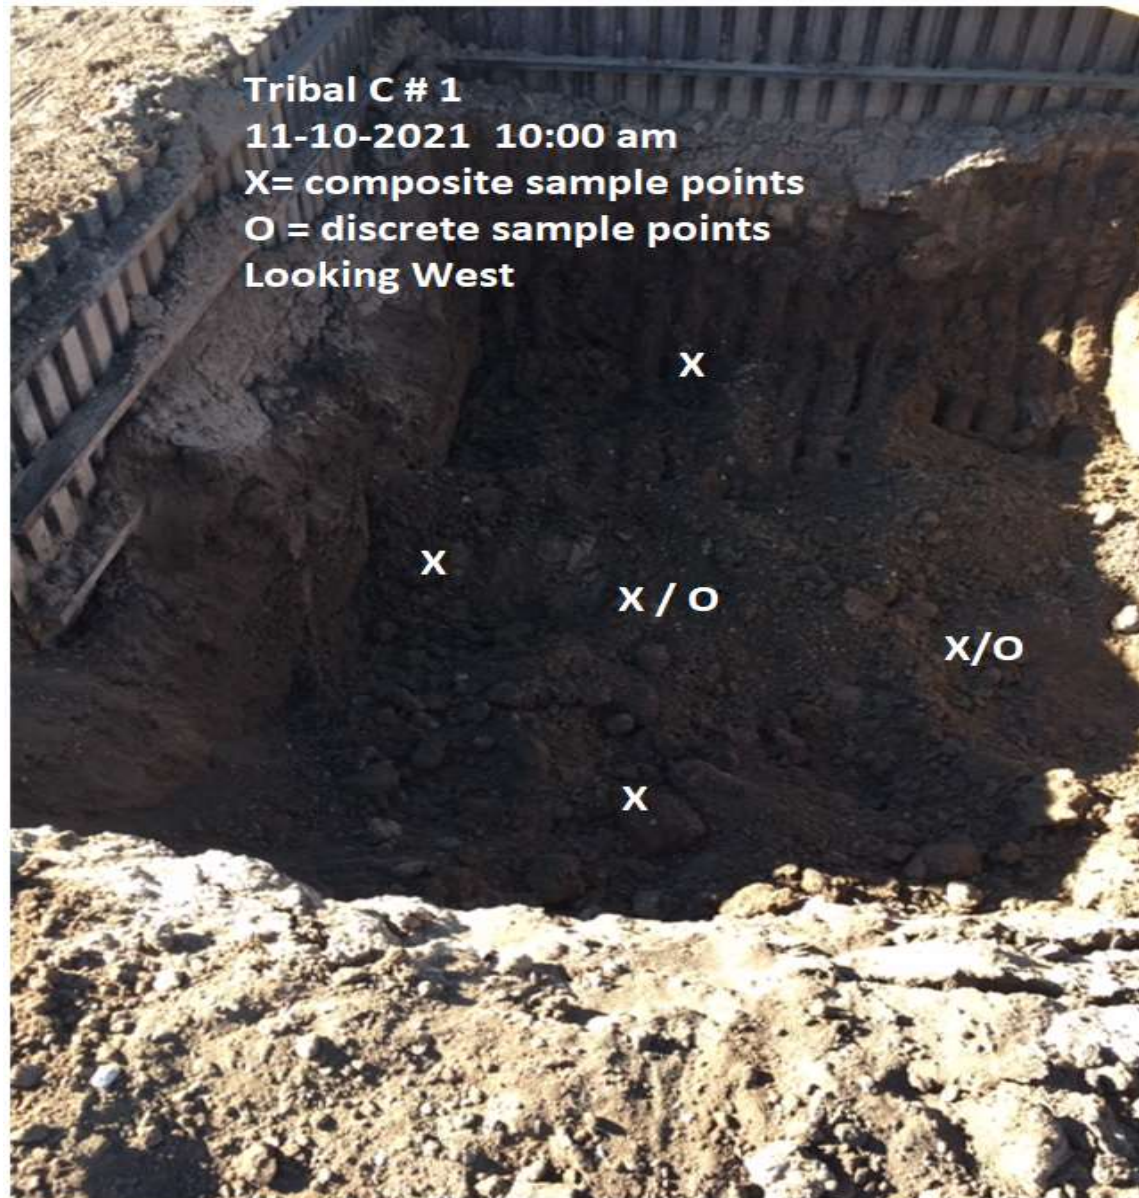
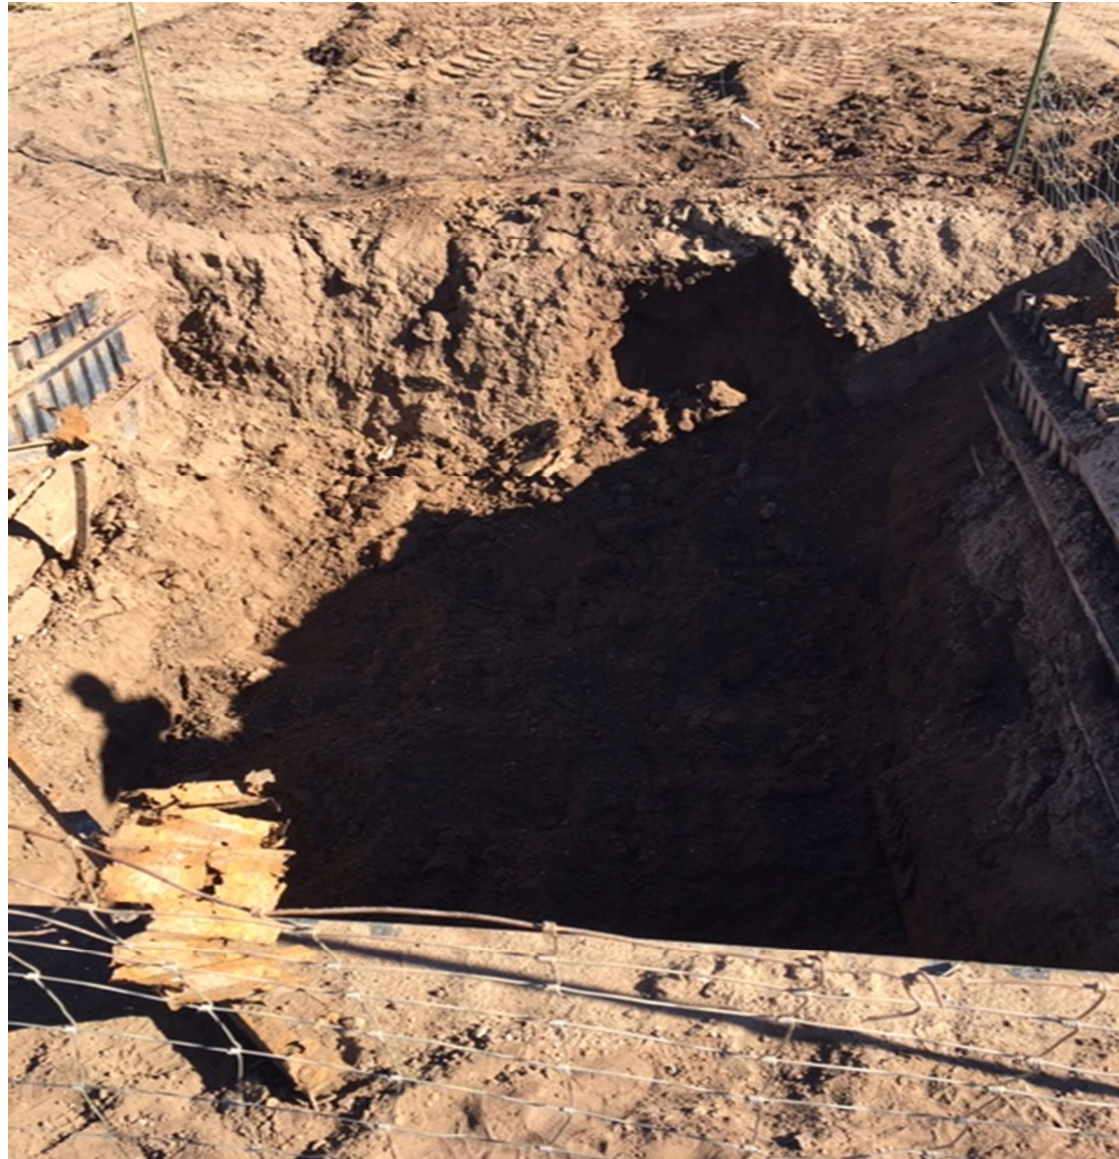
Sample locations – 11/10/21 at 10:00 am, 36.510440°N 107.1900283°W

North view of BGT pit.

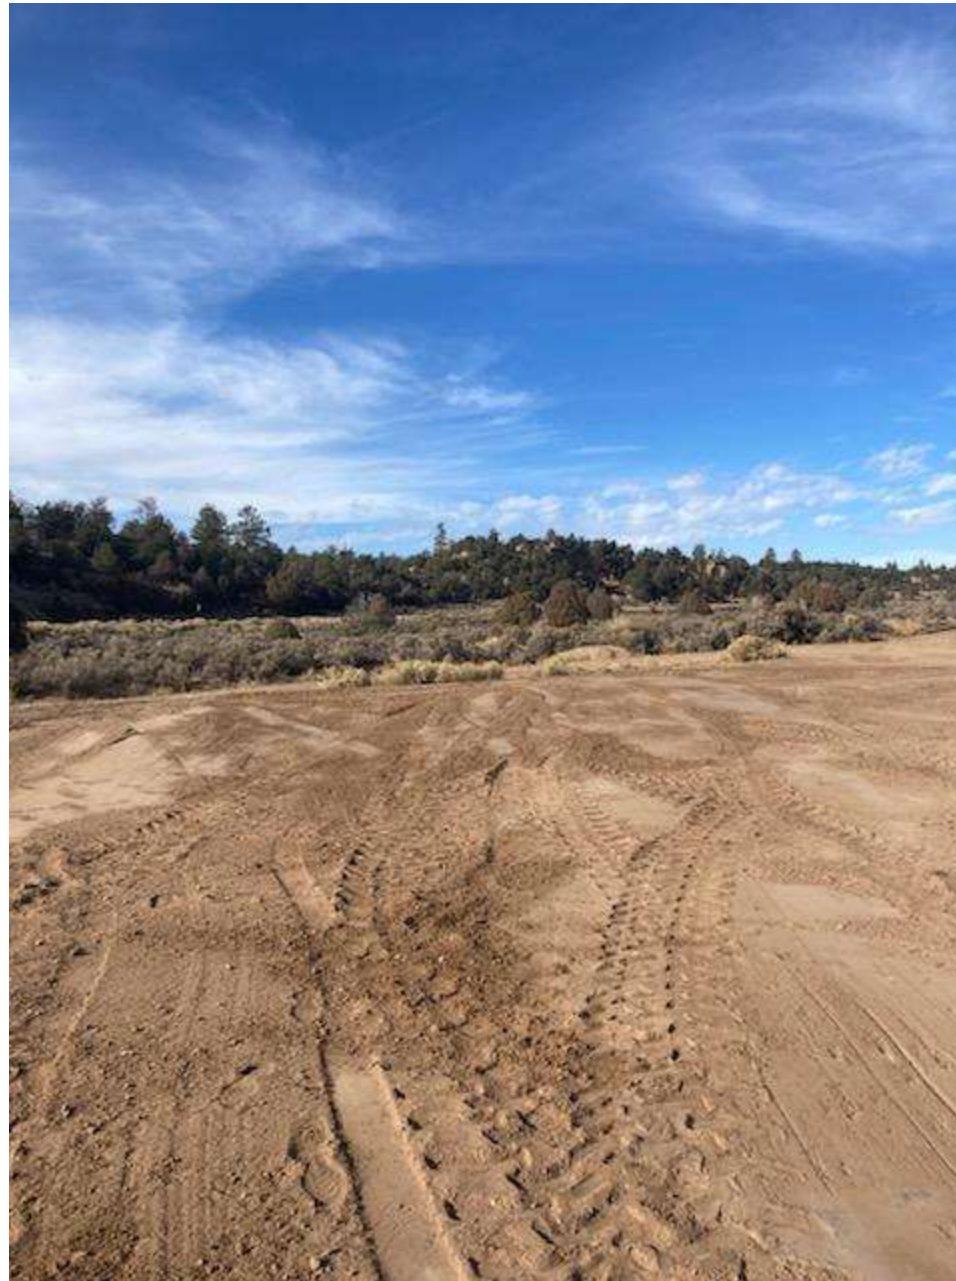
Backfill Photographs— 11/22/21 at 10:30 am, 36.510440°N 107.1900283°W

North view

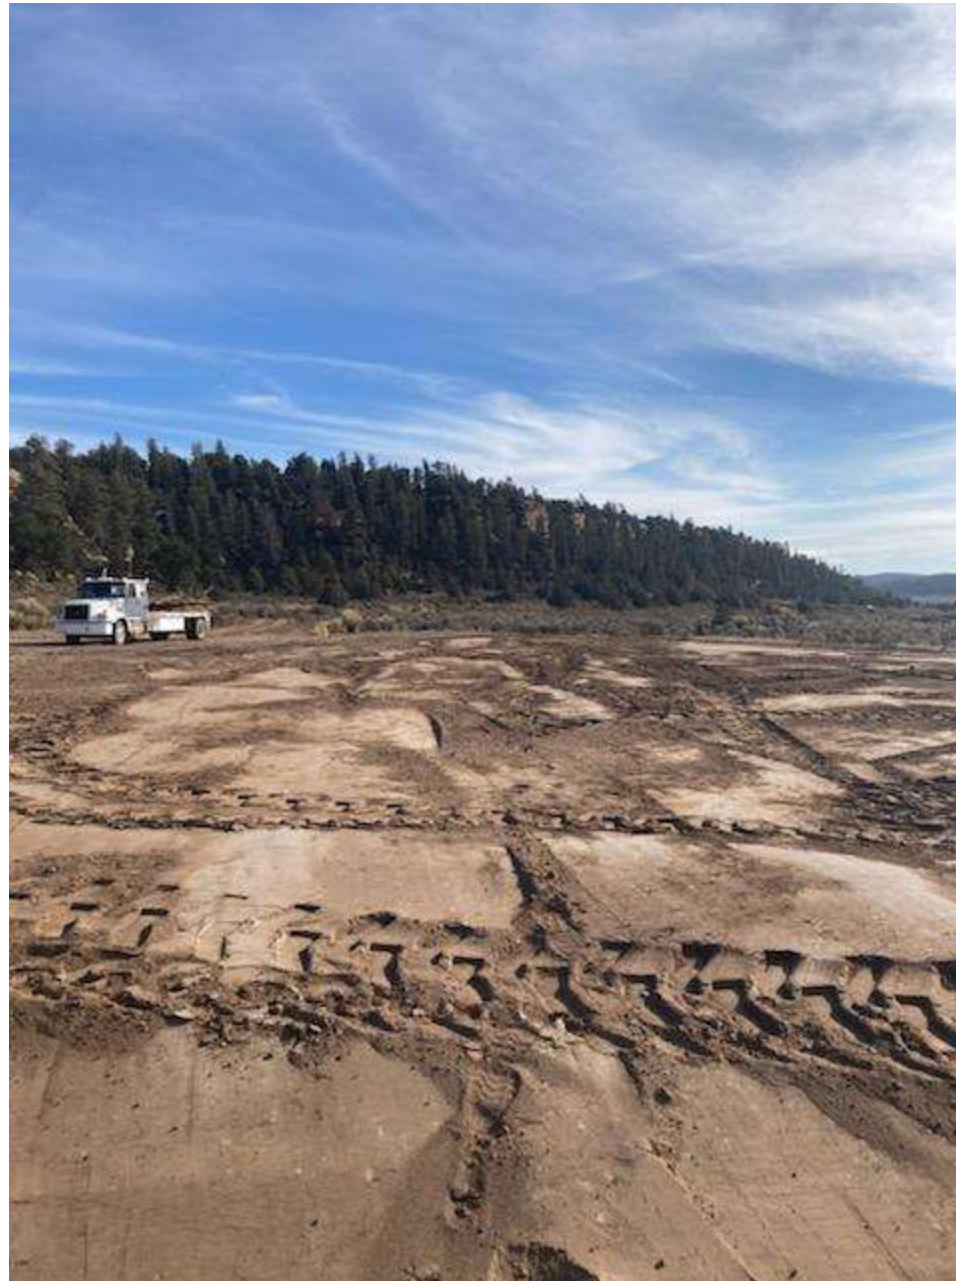
Backfill Photographs— 11/22/21 at 10:30 am, 36.510440°N 107.1900283°W

South view

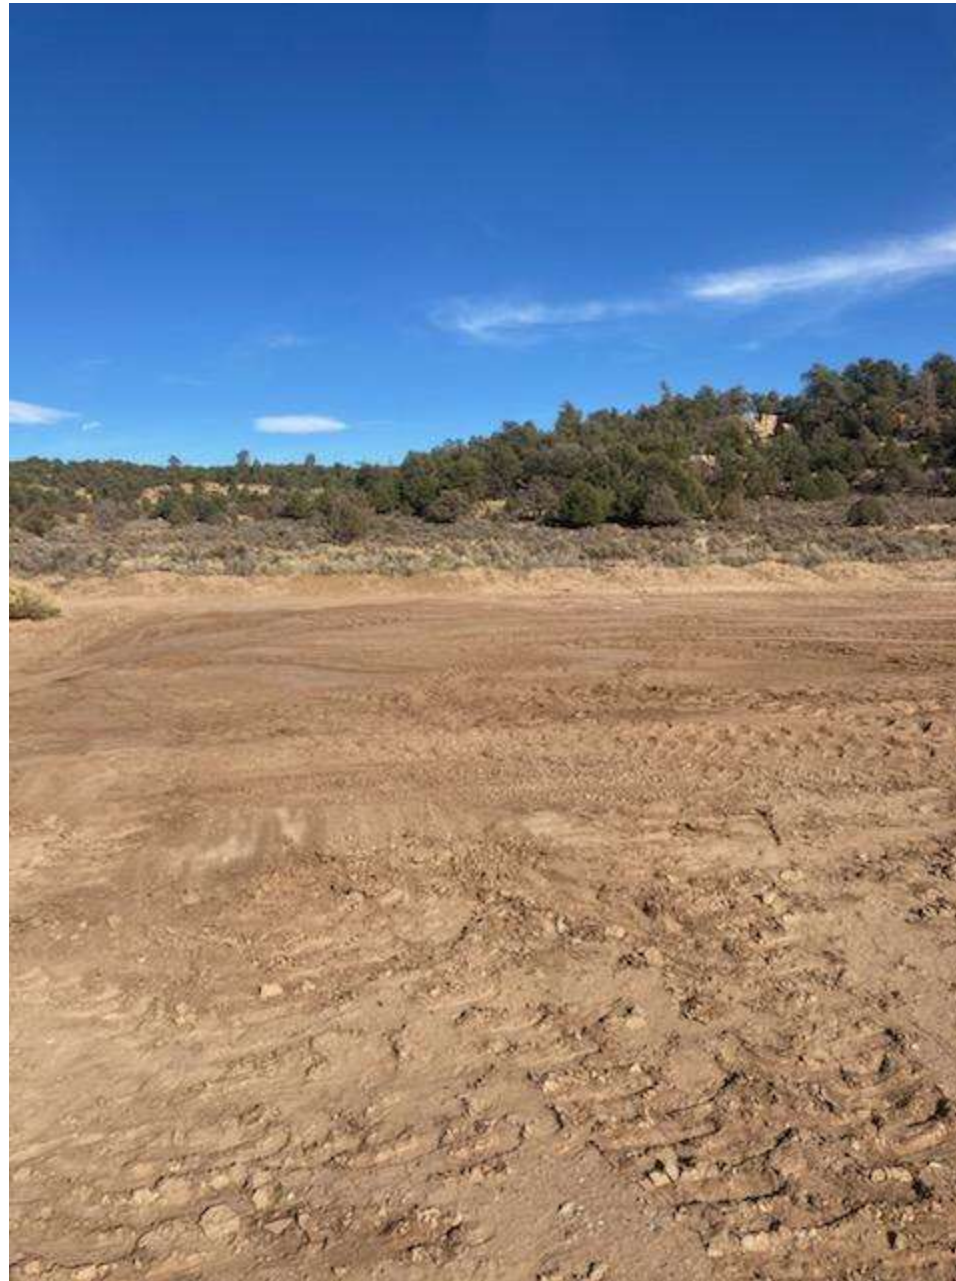
Backfill Photographs— 11/22/21 at 10:30 am, 36.510440°N 107.1900283°W

East view

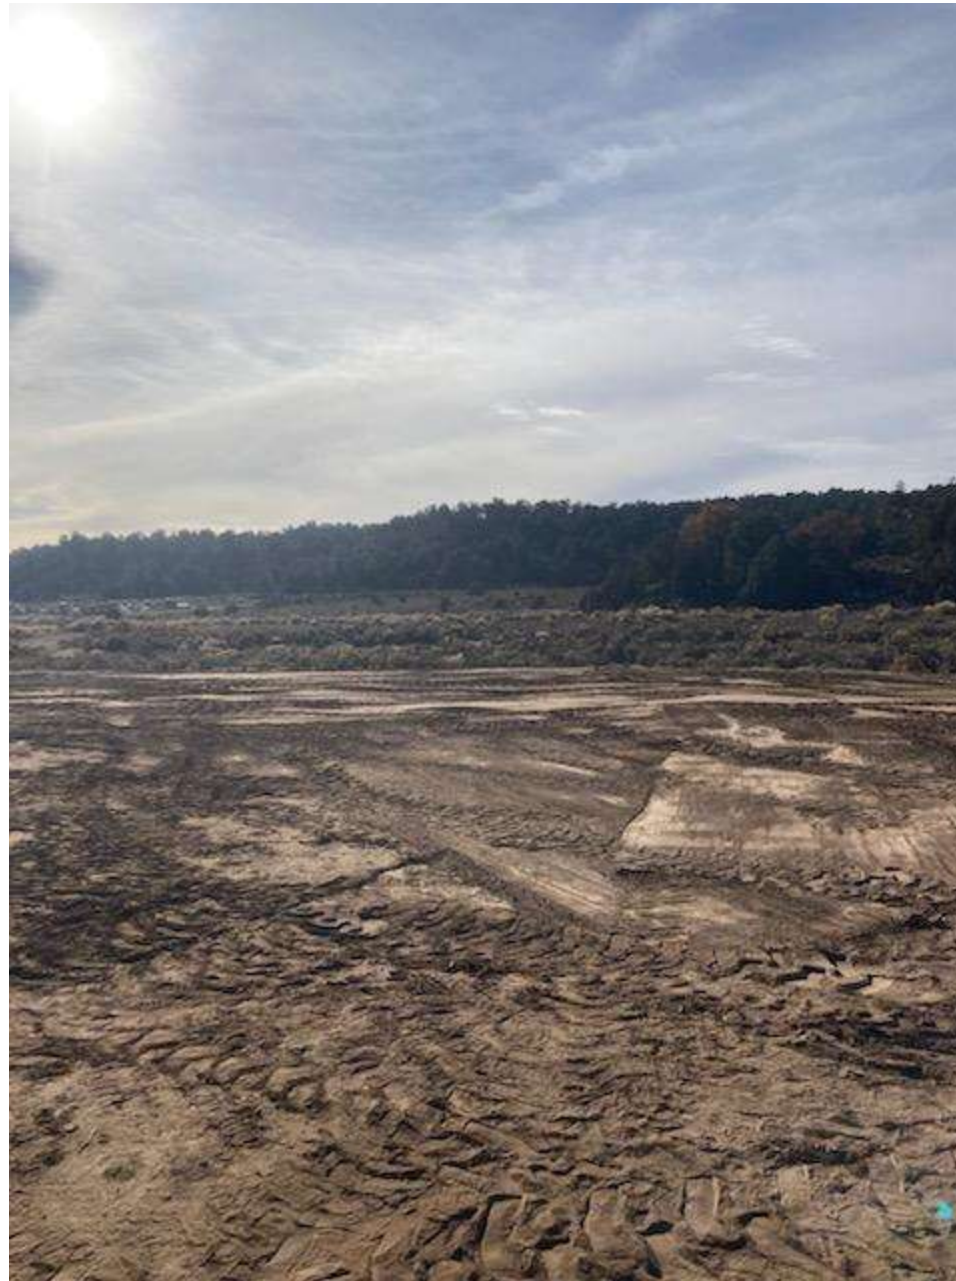
Backfill Photographs— 11/22/21 at 10:30 am, 36.510440°N 107.1900283°W

West view
