Closure

Re: Closure Report
Jon-Bob #1 Water Transfer Line
API No. 30-025-24973
GPS: Latitude 32.7964058 Longitude -103.7295532
UL "H", Sec. 35, T17S, R32E
Lea County, NM
NMOCD Incident. No. NAPP2113931748

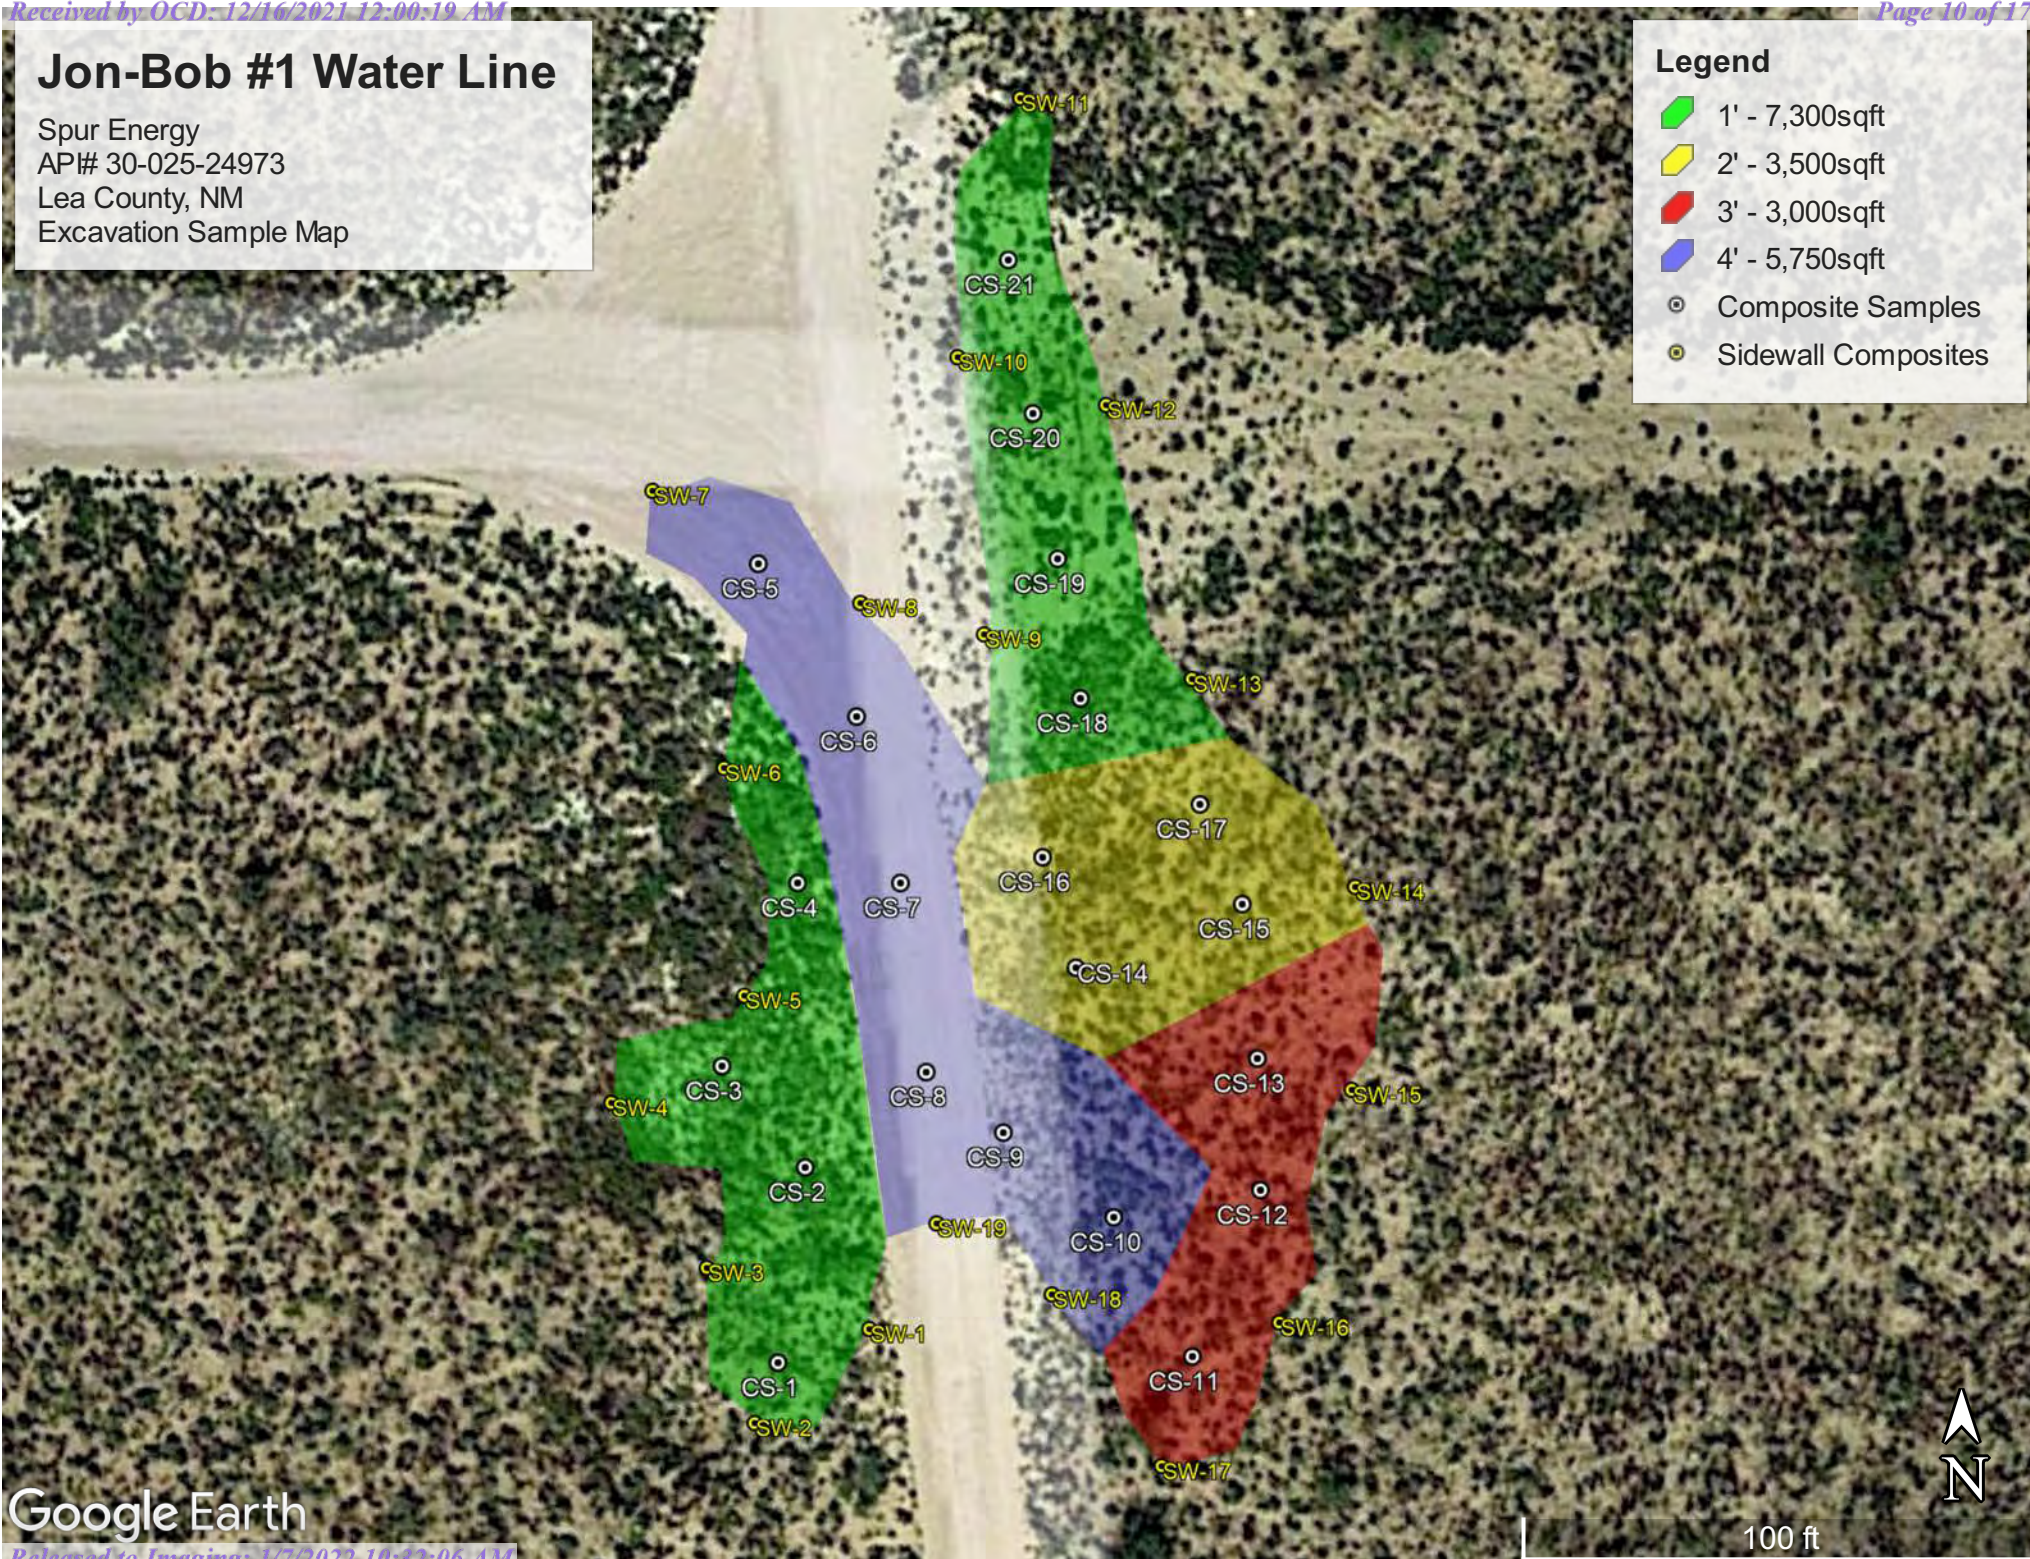
- 1' - 7,300sqft
- 2' - 3,500sqft
- 3' - 3,000sqft
- 4' - 5,750sqft
- Composite Samples
- Sidewall Composites

On September 8th, 2021, Pima mobilized personnel and equipment to the site to begin remediation activities. We excavated each contaminated area in the pasture and the lease road to the correct depths then collected samples from the bottoms and sidewalls to confirm that all the contamination had been removed. The results of this sampling event can be found in the following table.

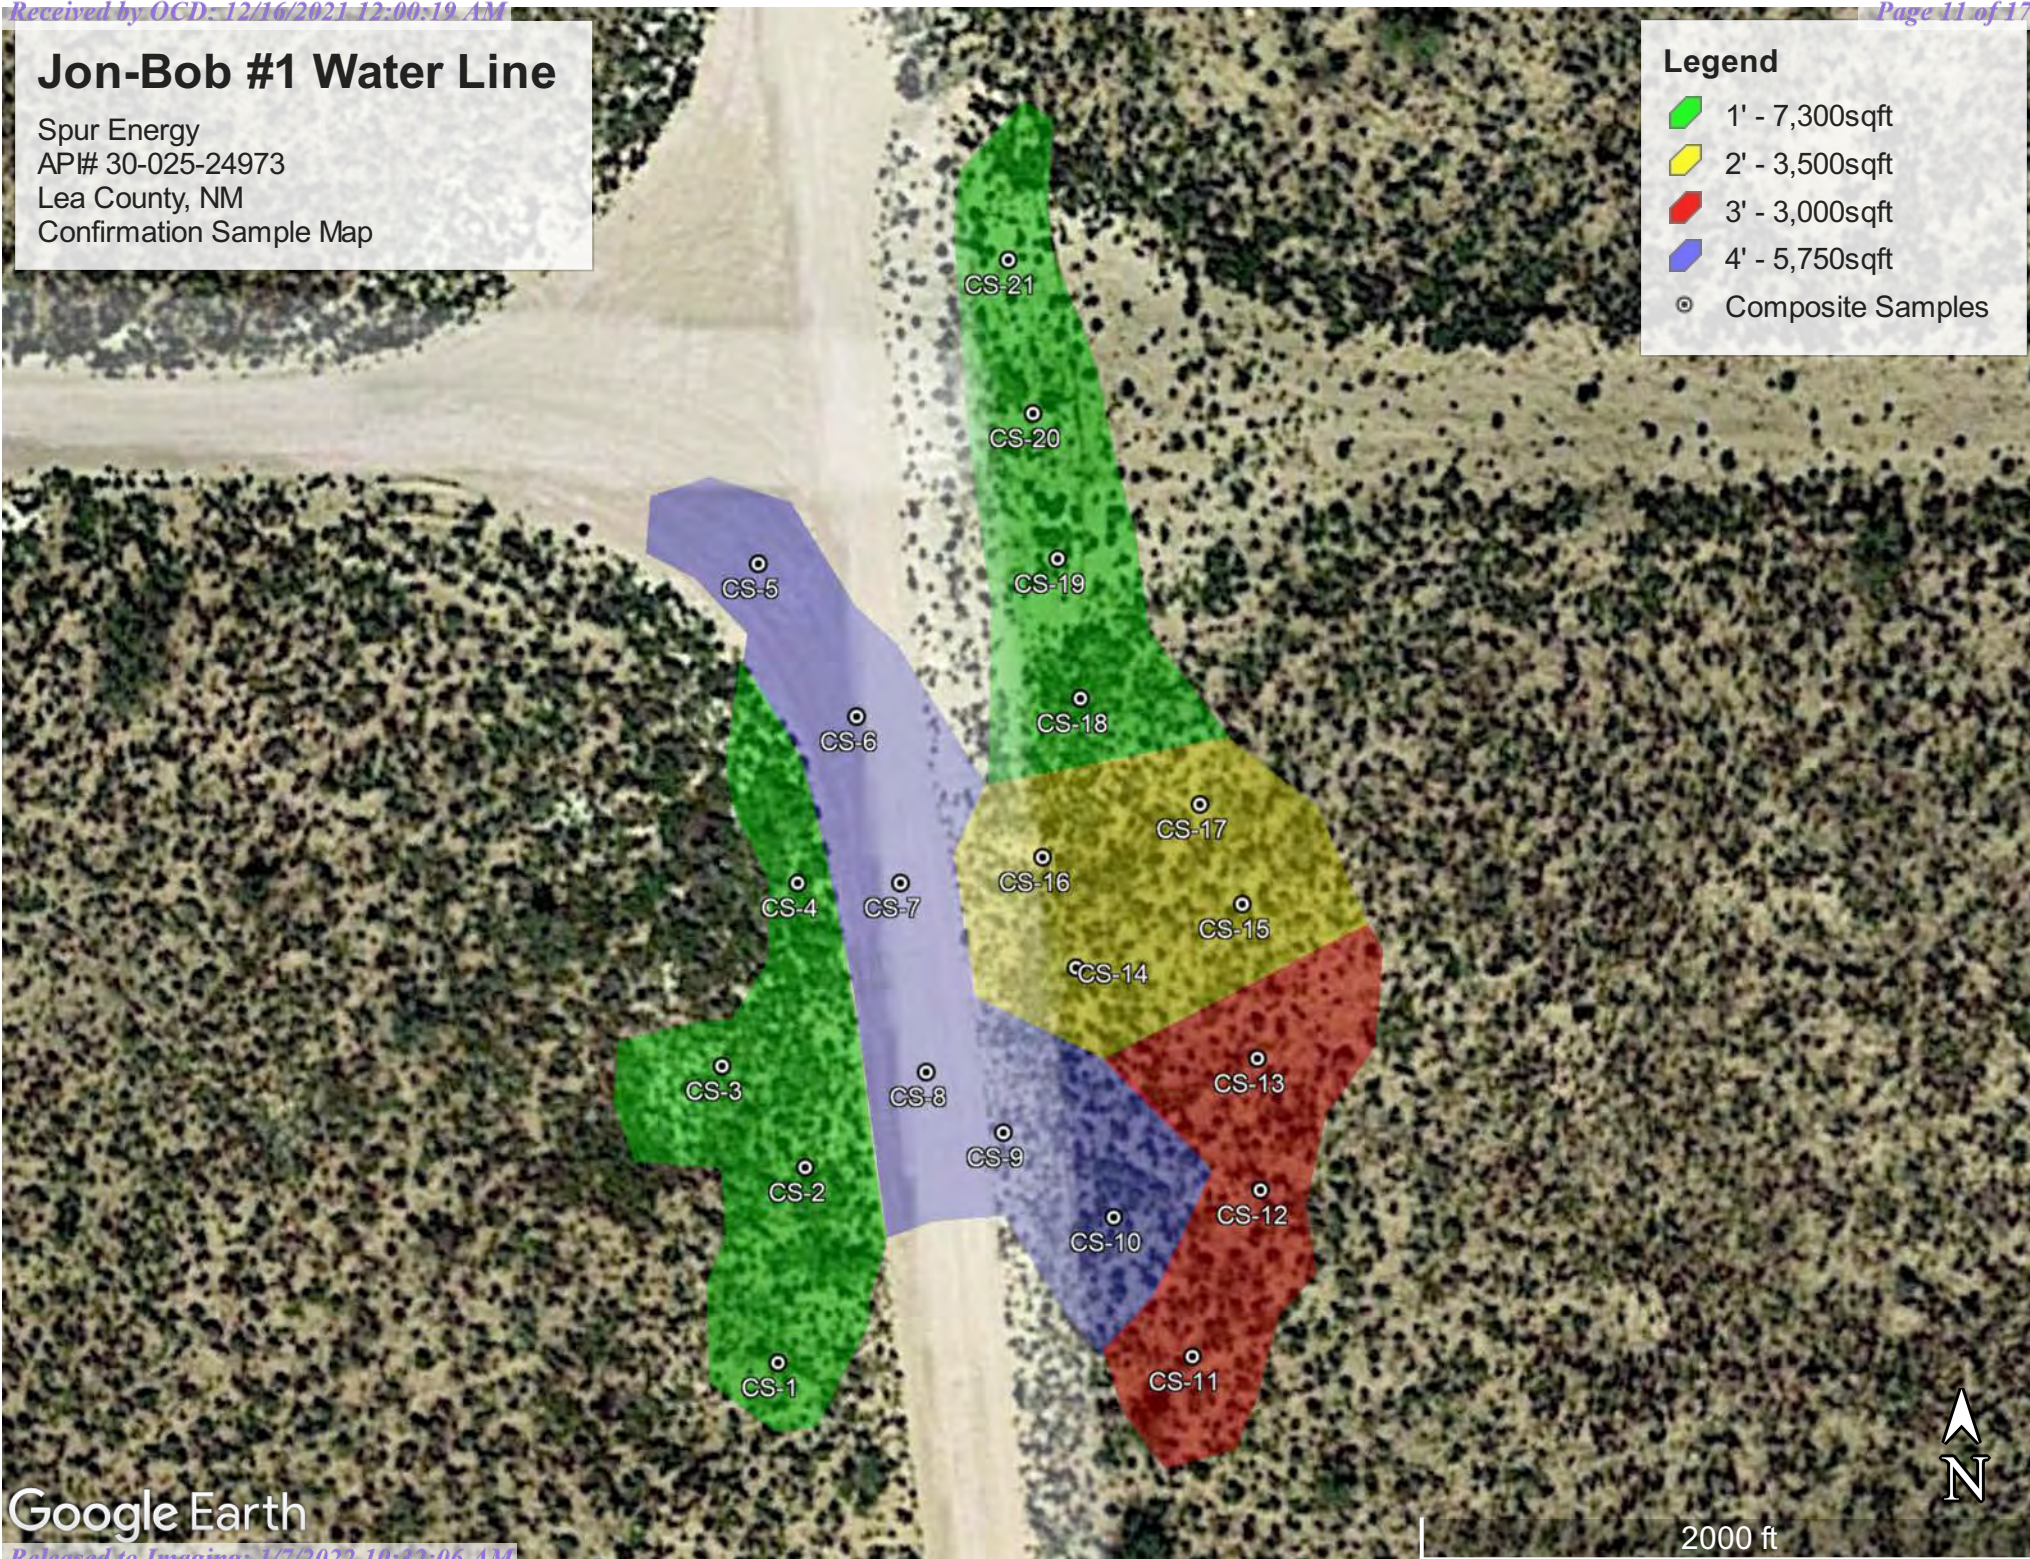
Spur Energy
AP# 30-025-24973
Lea County, NM
Confirmation Sample Map

- 1' - 7,300sqft
- 2' - 3,500sqft
- 3' - 3,000sqft
- 4' - 5,750sqft
- Composite Samples

On October 15th, 2021, after sending a 48-hour notification, Pima returned to the site to collect confirmation samples of each remediated area. The results of this sampling event can be found in the following table.

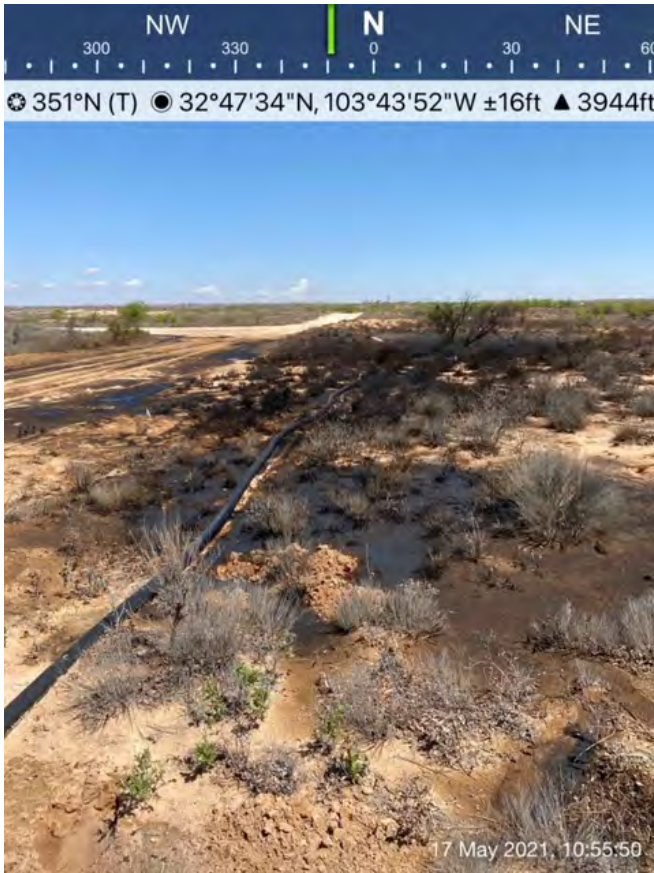
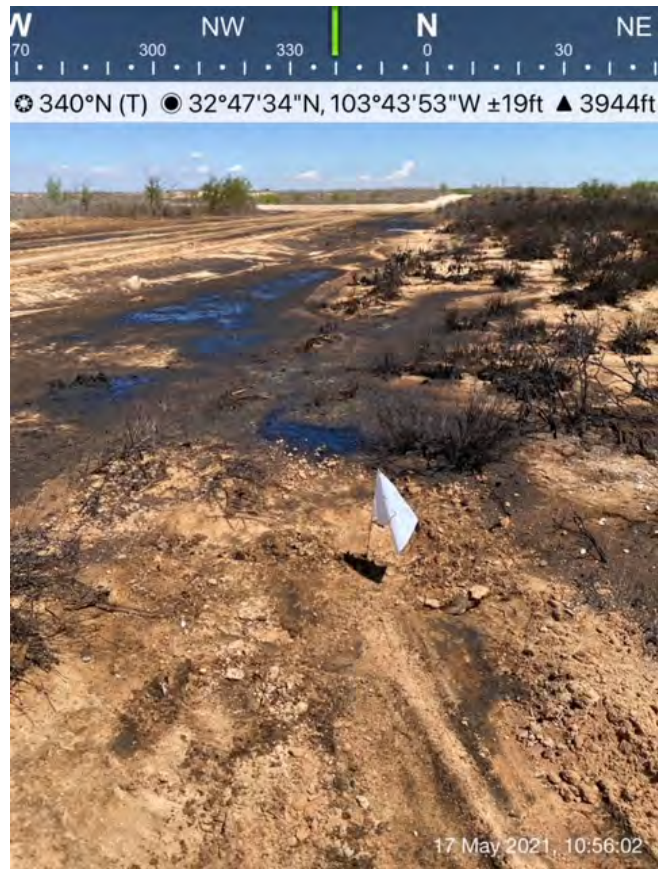
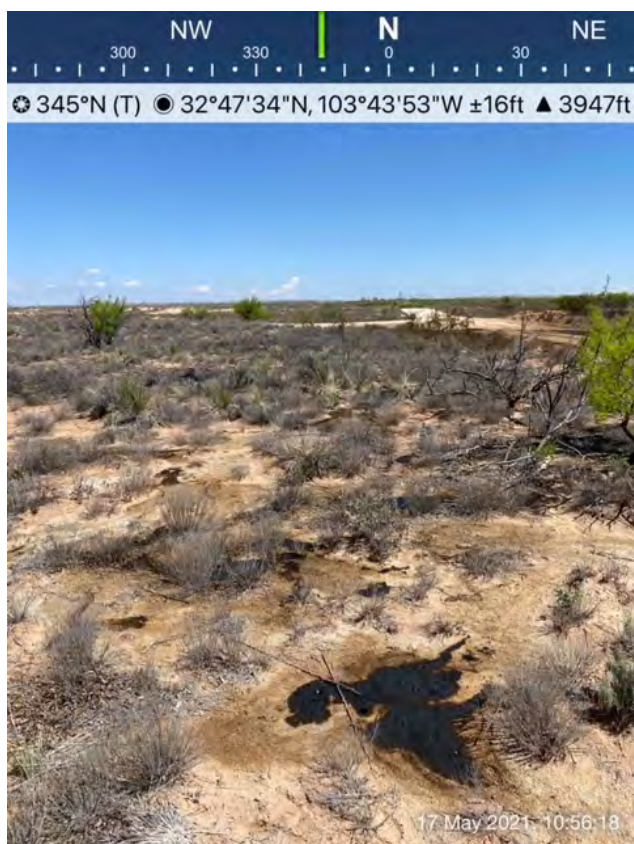
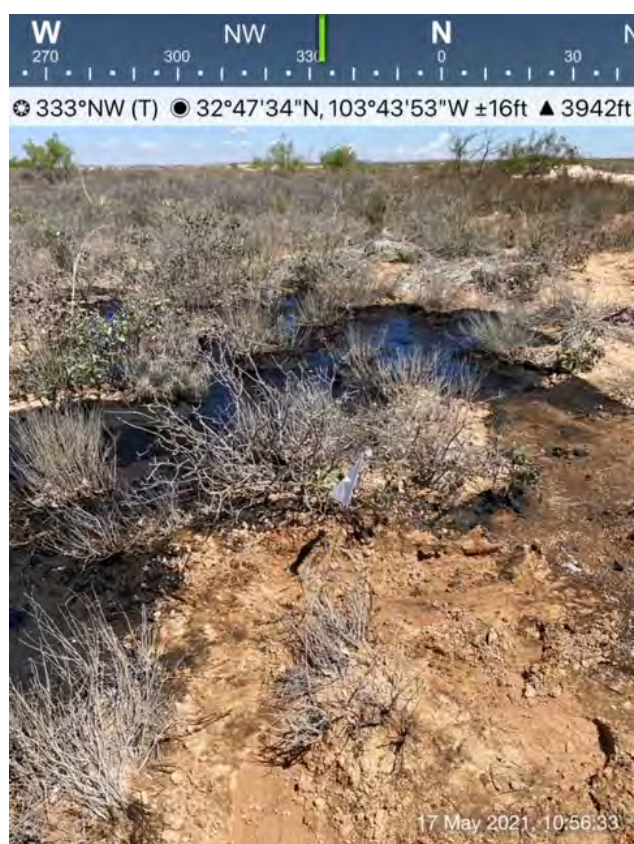
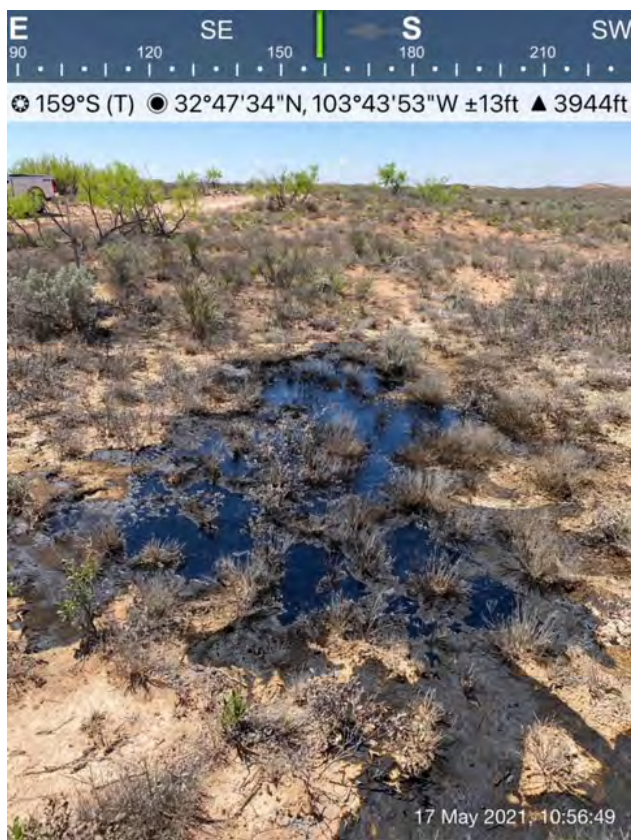
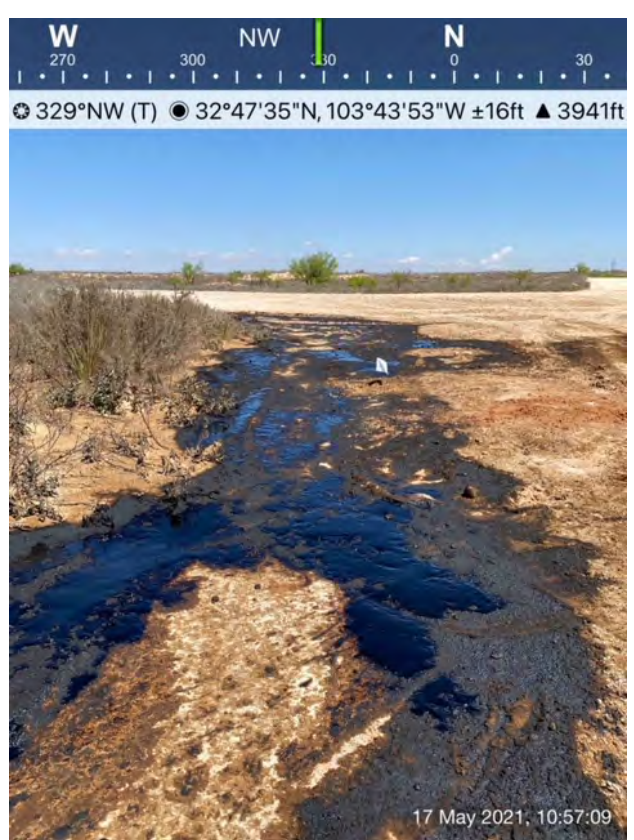
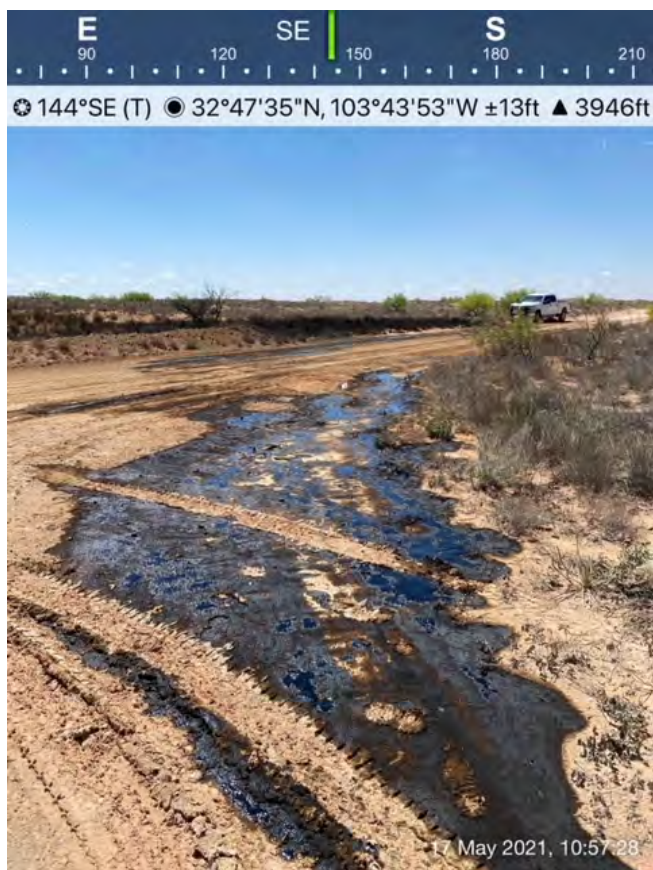
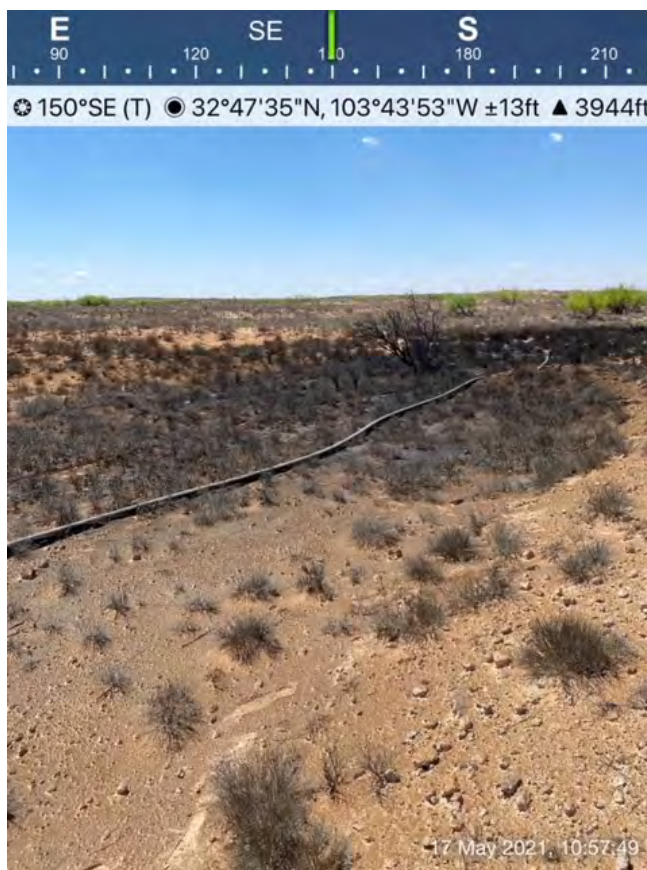
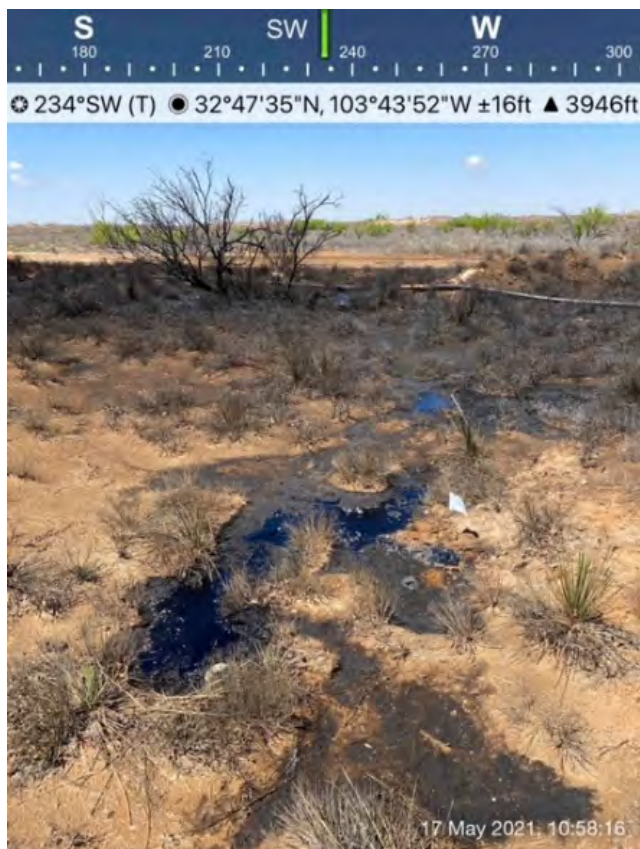
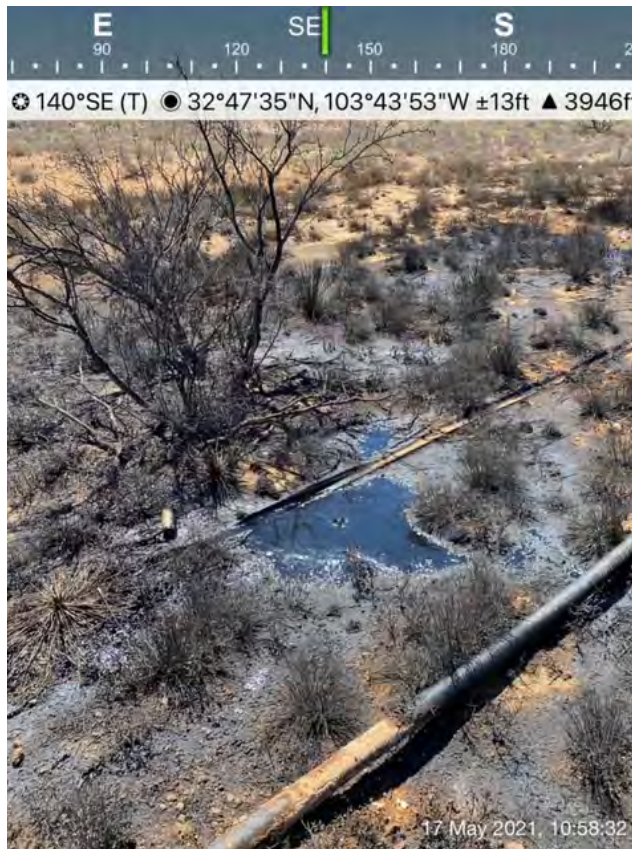
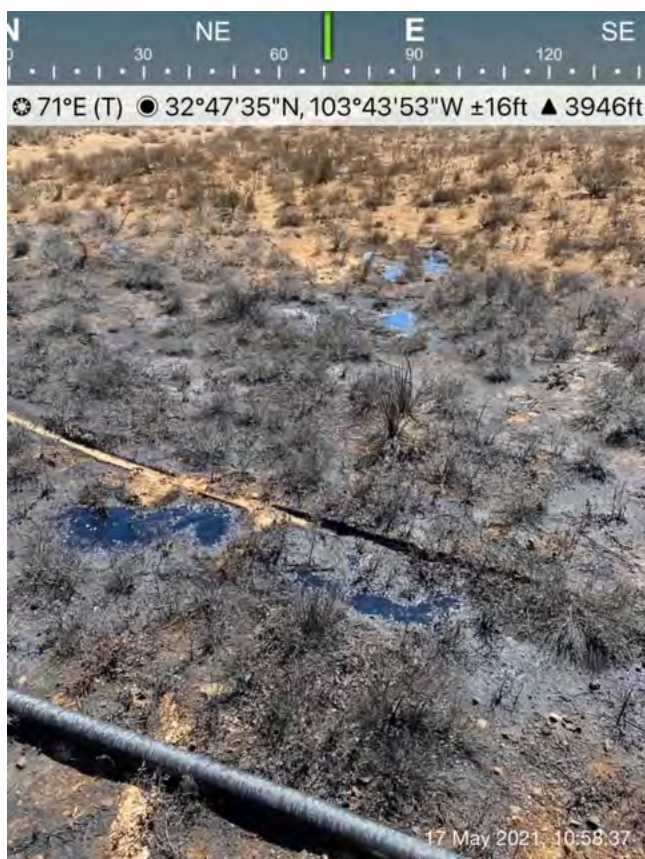
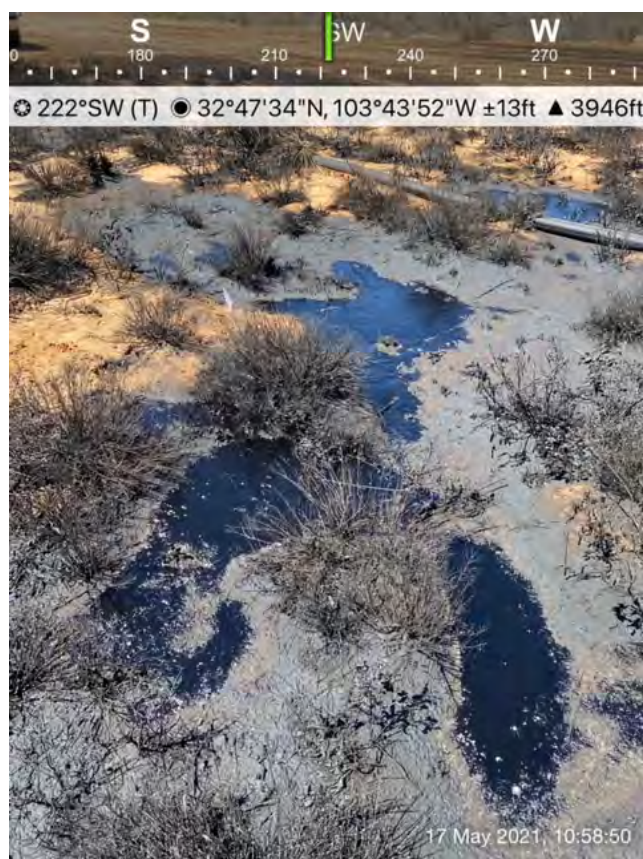
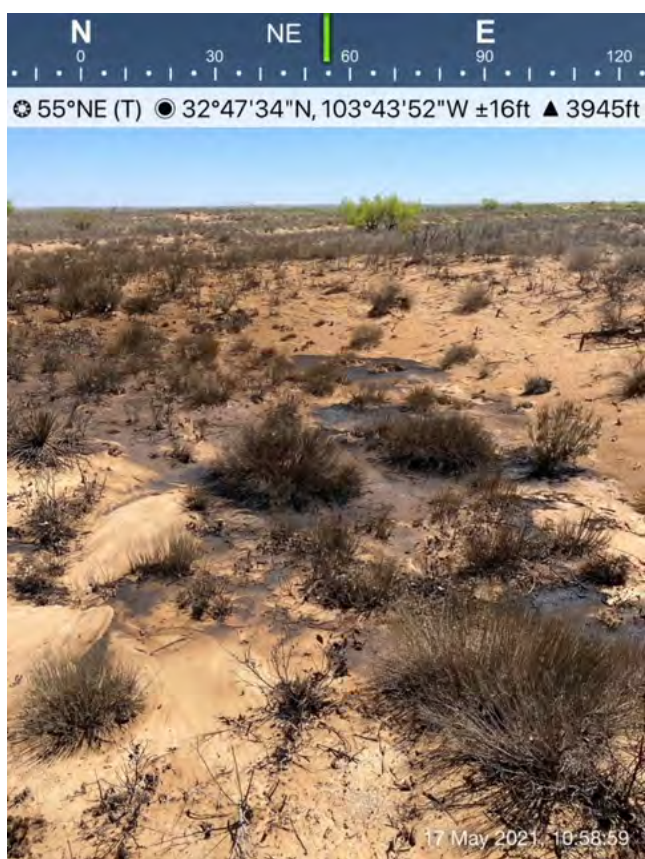
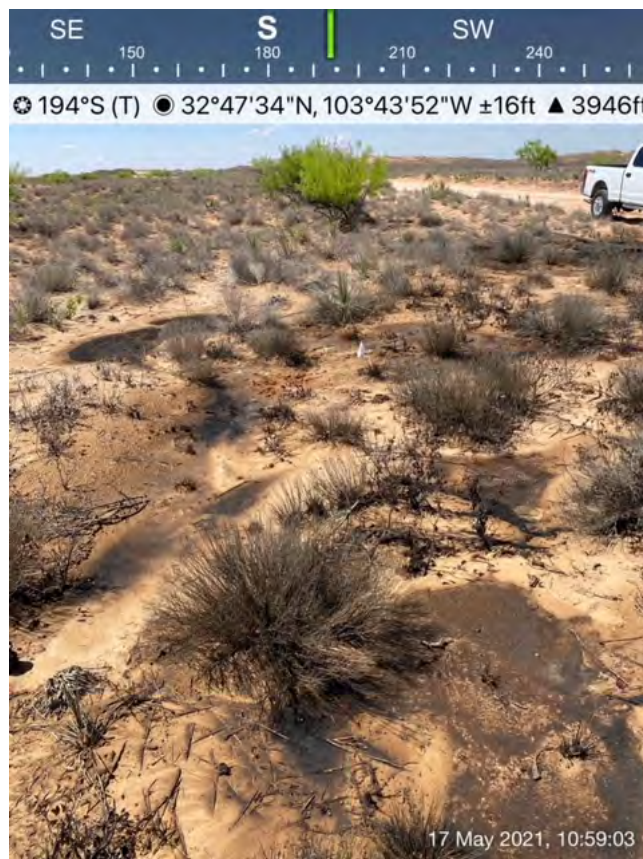
Pre-Treatment

On May 17th, 2021, Pima Environmental mobilized to the site to conduct a site assessment and obtain soil samples with a hand auger. Upon first look, there are some visual staining from the release. We sampled based on the noticeable staining and wet areas from the spill.
