Release Notification

Site Name	Aztec CDP	Site Type	Compressor Station
Date Release Discovered	July 28, 2021	API# (if applicable)

**RE: CLOSURE REPORT
nAPP2121443113
Aztec CDP BGT Release Excavation Clearance
SW¼ SW¼, Section 08, T32N, R10W
San Juan County, New Mexico**

Aztec CDP Excavation Clearance Report

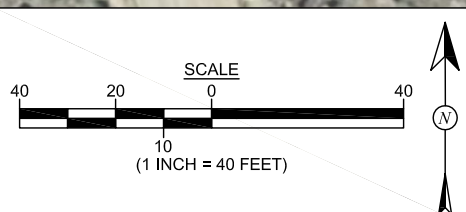
FIGURE 3

APPROXIMATE EXCAVATION AREA
24 FT x 28 FT x 18 FT DEEP

NORTH WALL
NORTH BOTTOM
EAST WALL
WEST WALL
BOTTOM
SOUTH WALL

NOTE: DIMENSIONS ARE APPROXIMATE BASED
ON FIELD SKETCHES FROM HARVEST PERSONNEL.

**EXCAVATION AREA AND SOIL
SAMPLE LOCATIONS MAP**
HARVEST MIDSTREAM
AZTEC CDP FACILITY
SW¼ SW¼, SECTION 8, T32N, R10W
SAN JUAN COUNTY, NEW MEXICO
N36.994450, W107.913570

the north and south walls on August 31, 2021. Final soil sampling was conducted on September 7, 2021, from the north wall and north bottom of the excavation. Sample locations are presented on Figure 3, and project notification is attached.

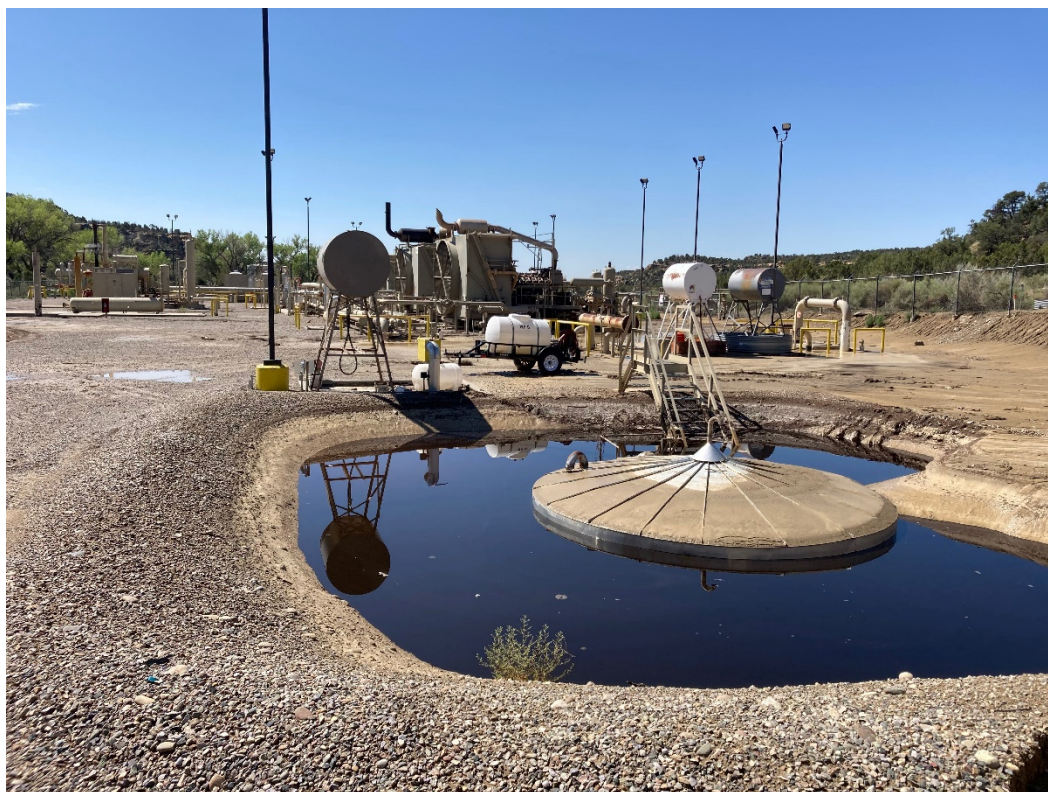
Location flooded due to heavy rains which filled the waste water containment with water. The water level was higher than the top of the below grade tank which allowed water to fill the tank through the vent. When the tank filled, the oil that was in the tank from the skid drains floated to the top and was forced out of the tank. The oil stayed within the containment.

Photo 1: Aztec CDP BGT Release into unlined secondary containment

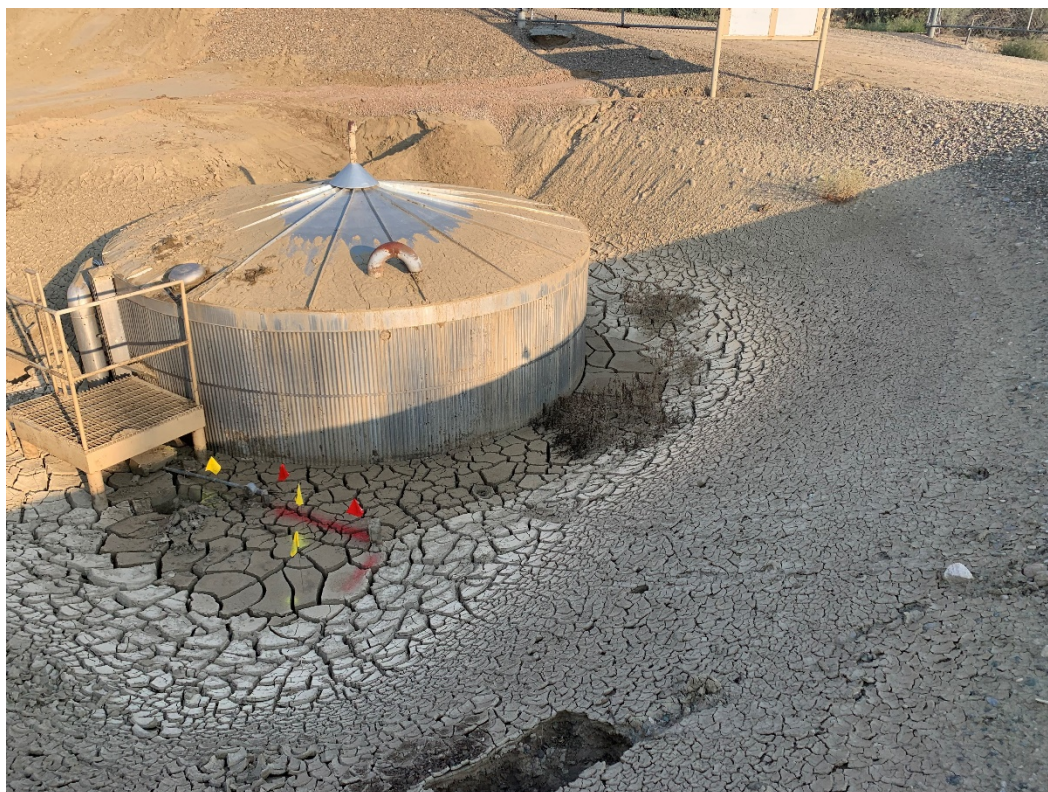
Photo 2: Aztec CDP BGT cleanup – post liquid removal

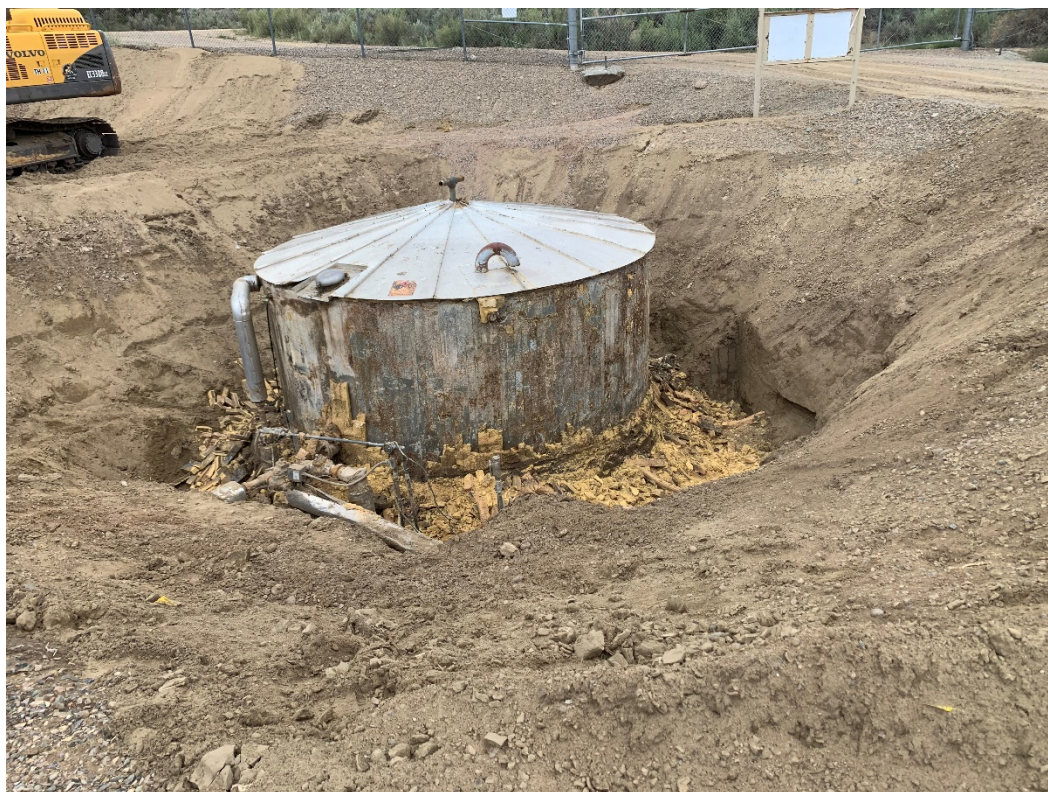
Photo 3: Aztec CDP BGT cleanup in progress

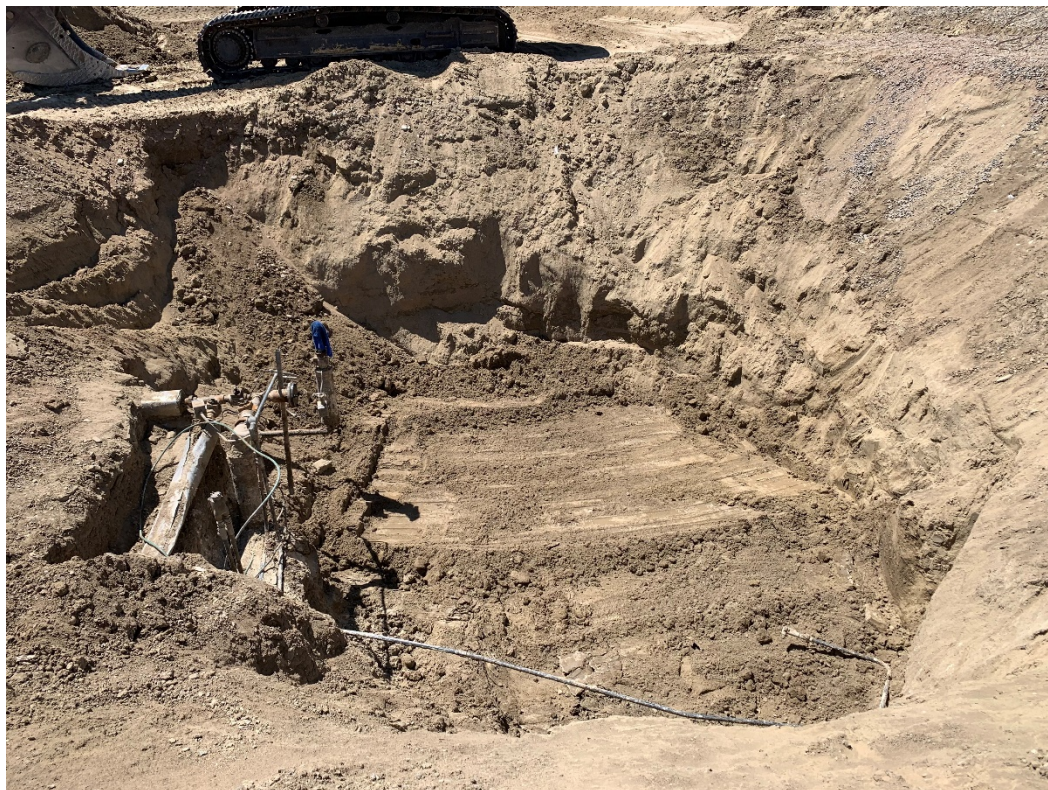
Photo 4: Aztec CDP BGT cleanup – tank removed

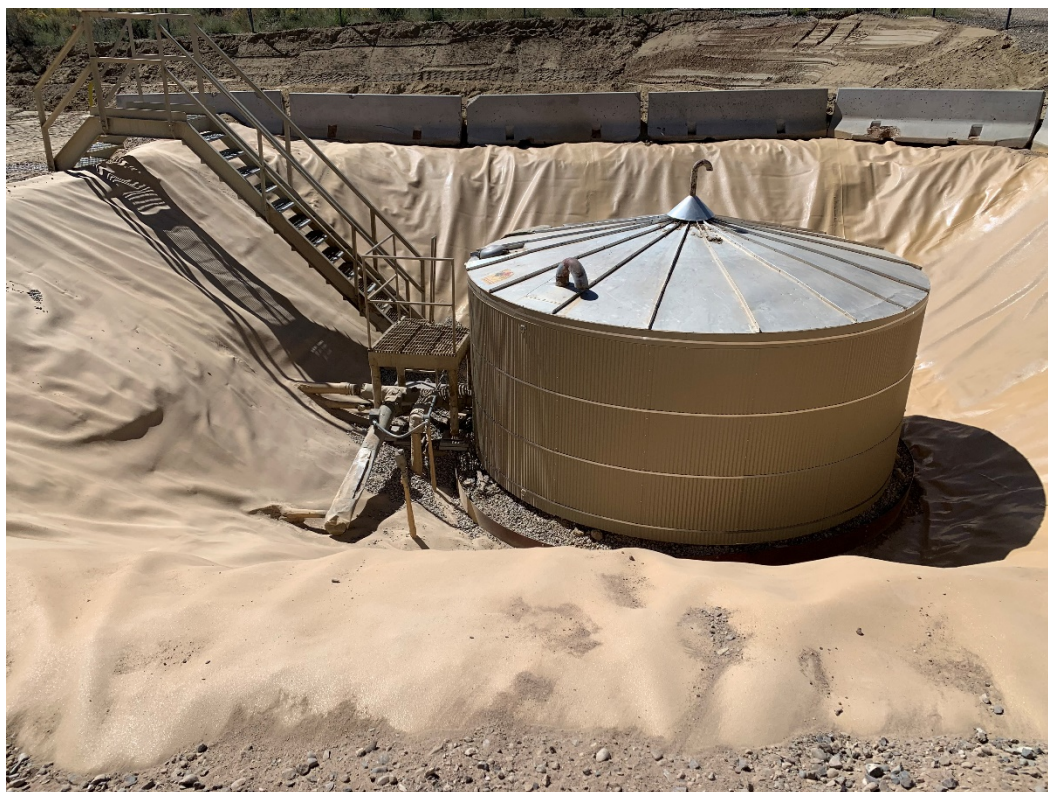
Photo 5: Aztec CDP BGT cleanup – liner installed

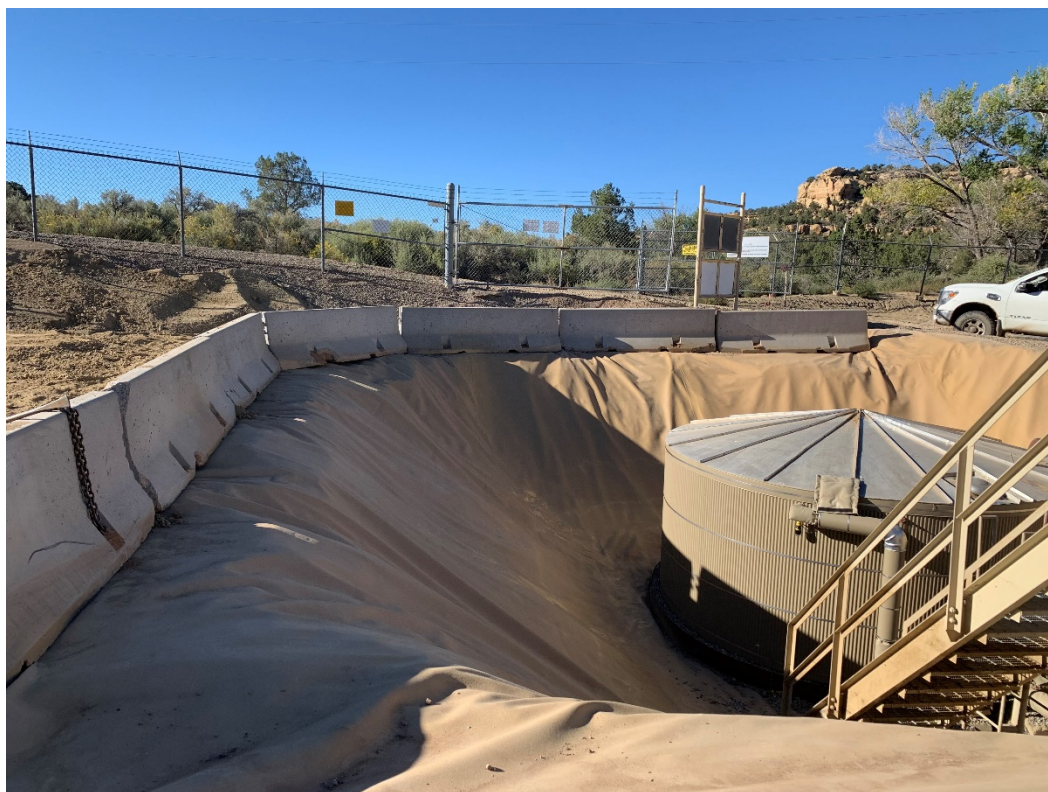
Photo 6: Aztec CDP BGT cleanup complete

Harvest completed excavation and final clearance of oil-contaminated soil in the secondary containment at the Aztec CDP BGT location in August and September 2021. A total of 24 bbls of liquids, 264 cy of contaminated soil, and 212 cubic yards of cleanfill were transported to the Envirotech Landfarm for disposal and documentation is attached. The size of the final excavation was 24 ft x 28 ft x 18 ft deep. Laboratory analytical results reported benzene, total BTEX, TPH (as GRO/DRO/MRO), and chloride concentrations in final confirmation samples as below applicable NMOCD action levels. The excavation has been backfilled with clean soil, a liner has been installed in the secondary containment area, and the BGT has been re-installed. Photographs and field notes are attached. No further action is recommended at this time.

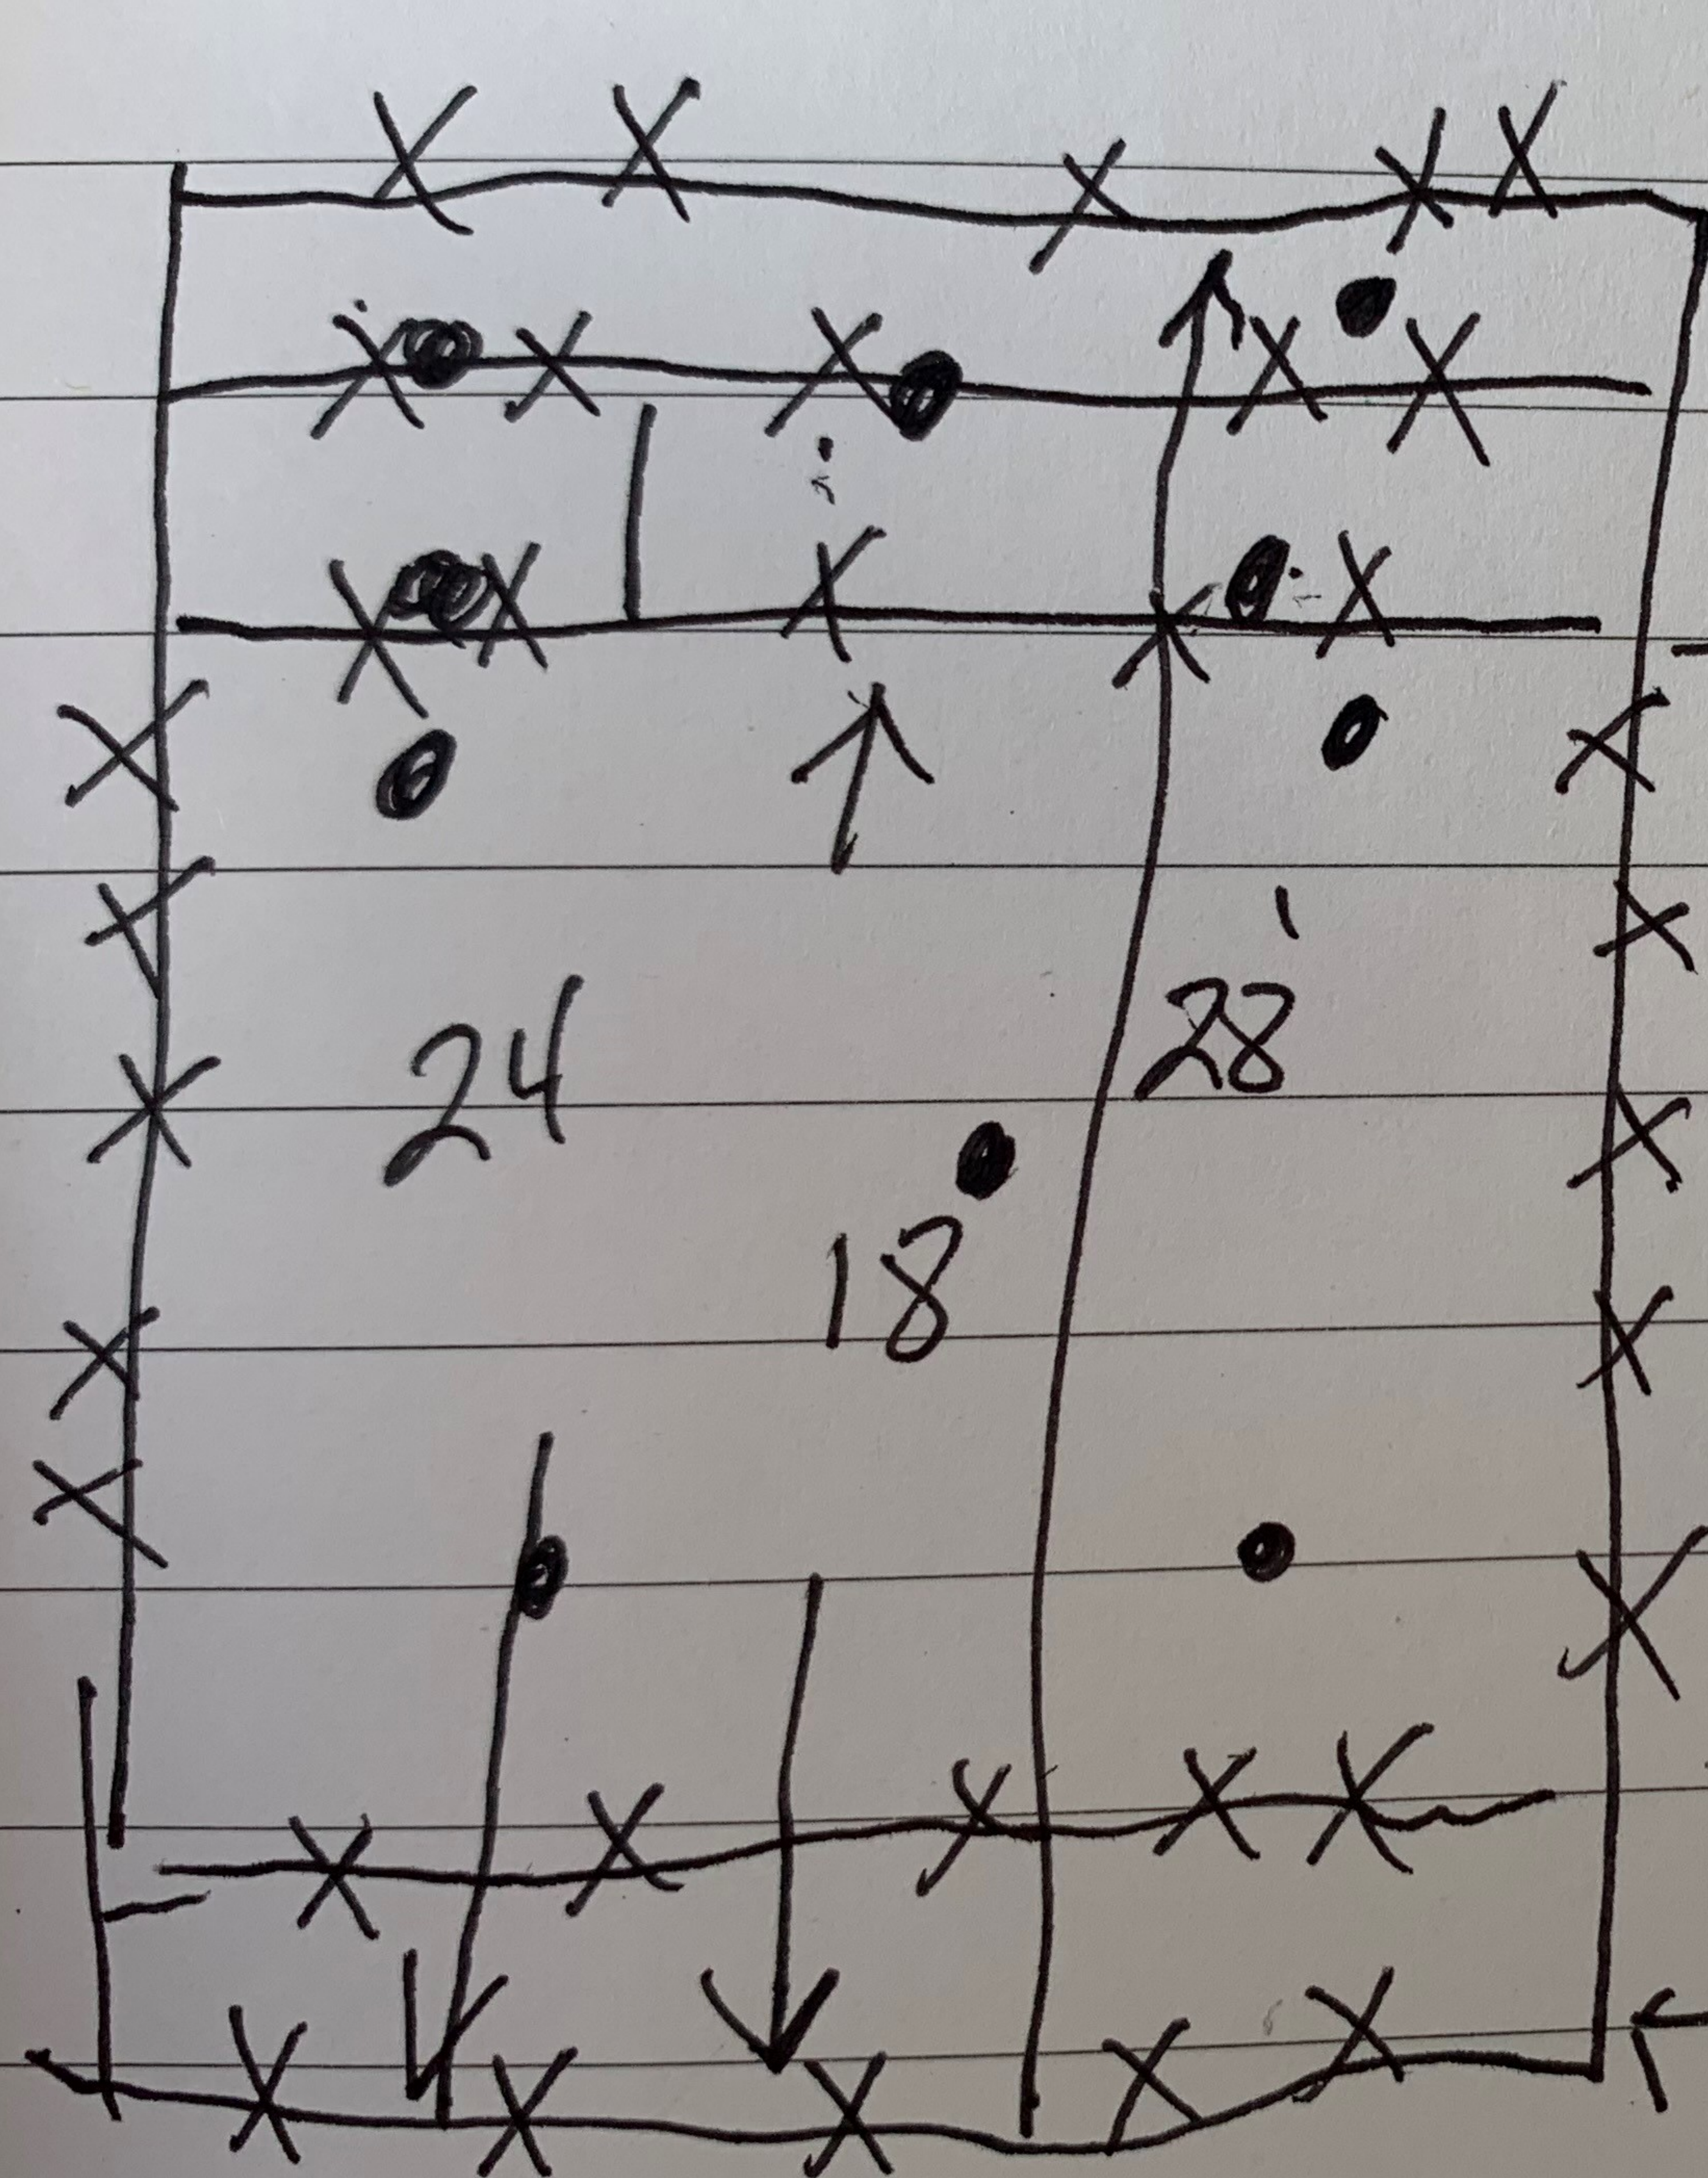
9-7-21

3rd 28' Sample
2nd 24' Sample
1st - 18' Sample
