Remediation Plan

On January 11, 2020, a crude oil release occurred at the COG Craig State #3 H and was attributed to a failure of the LACT unit air eliminator. Approximately eight (8) barrels (bbls) of crude was released with five (5) bbls recovered for a net loss of three (3) bbls of crude. The release was contained onsite adjacent to the LACT unit affecting an area measuring approximately thirty-six (36) feet (ft) in length by sixteen (16) ft in width to an estimated maximum depth of seven (7) ft below ground surface (bgs).

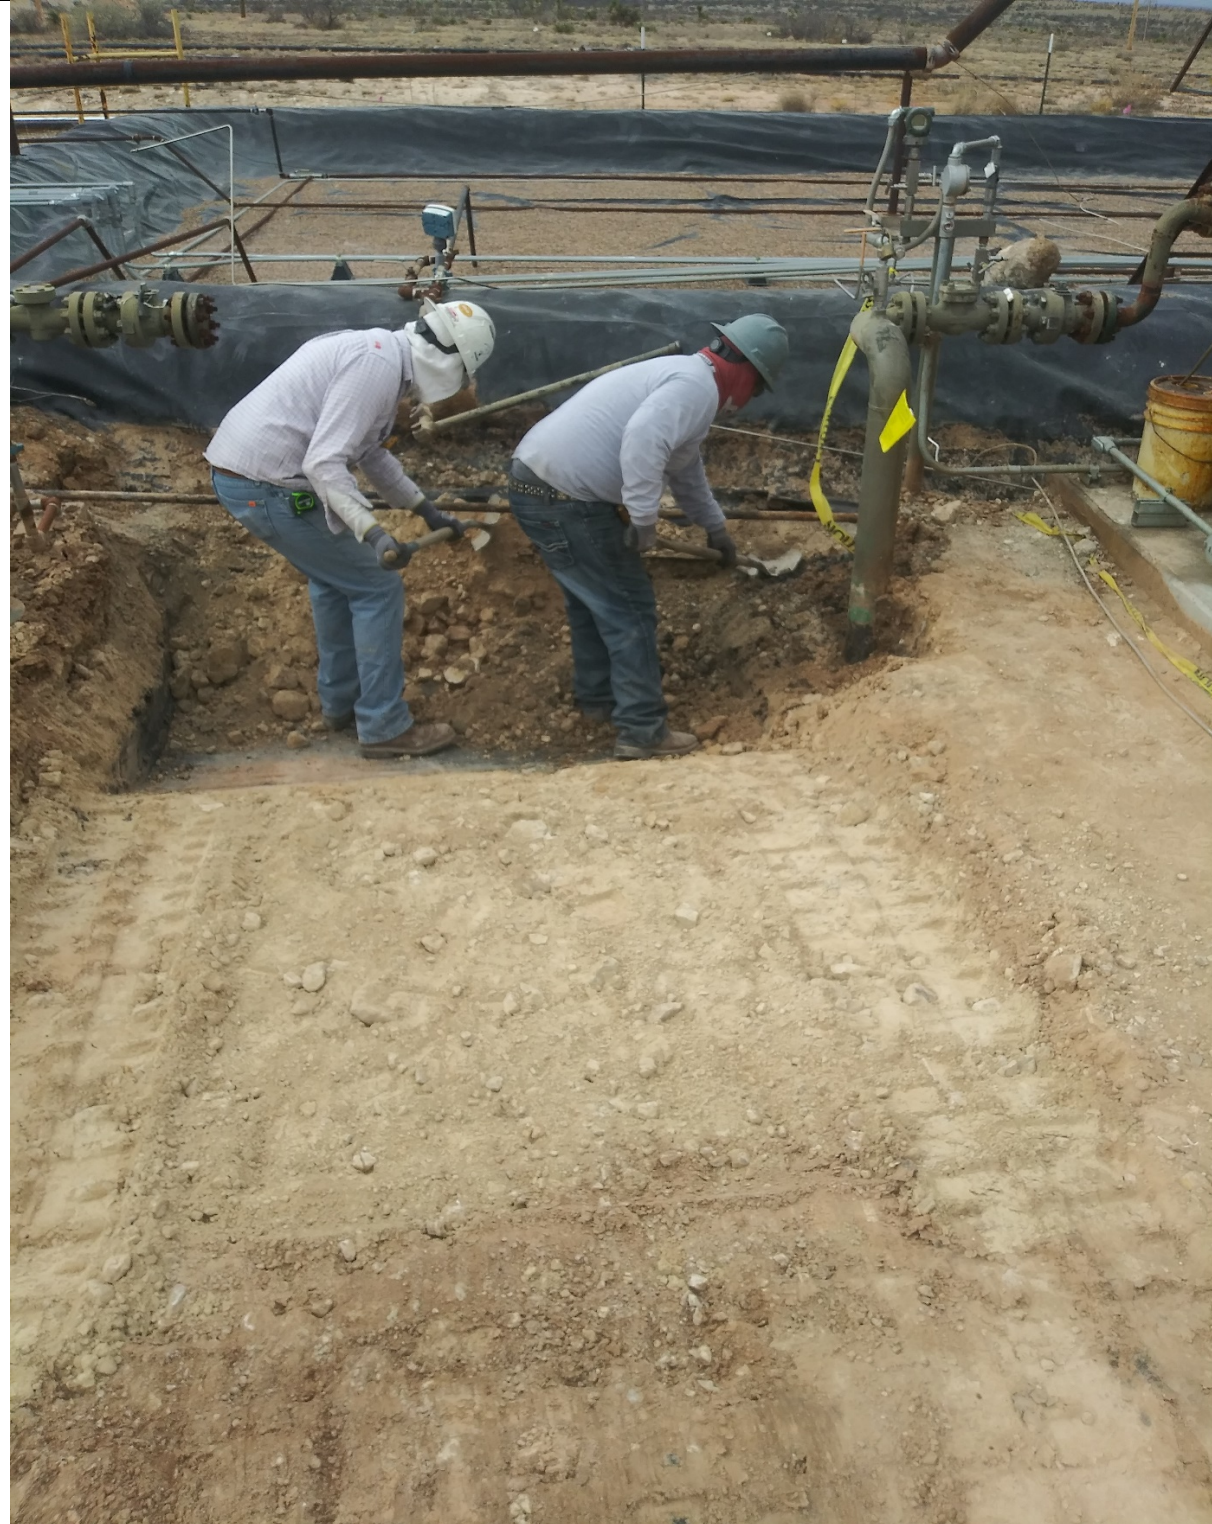
Direction: West

Description: View of excavation along southern part of release by LACT unit.

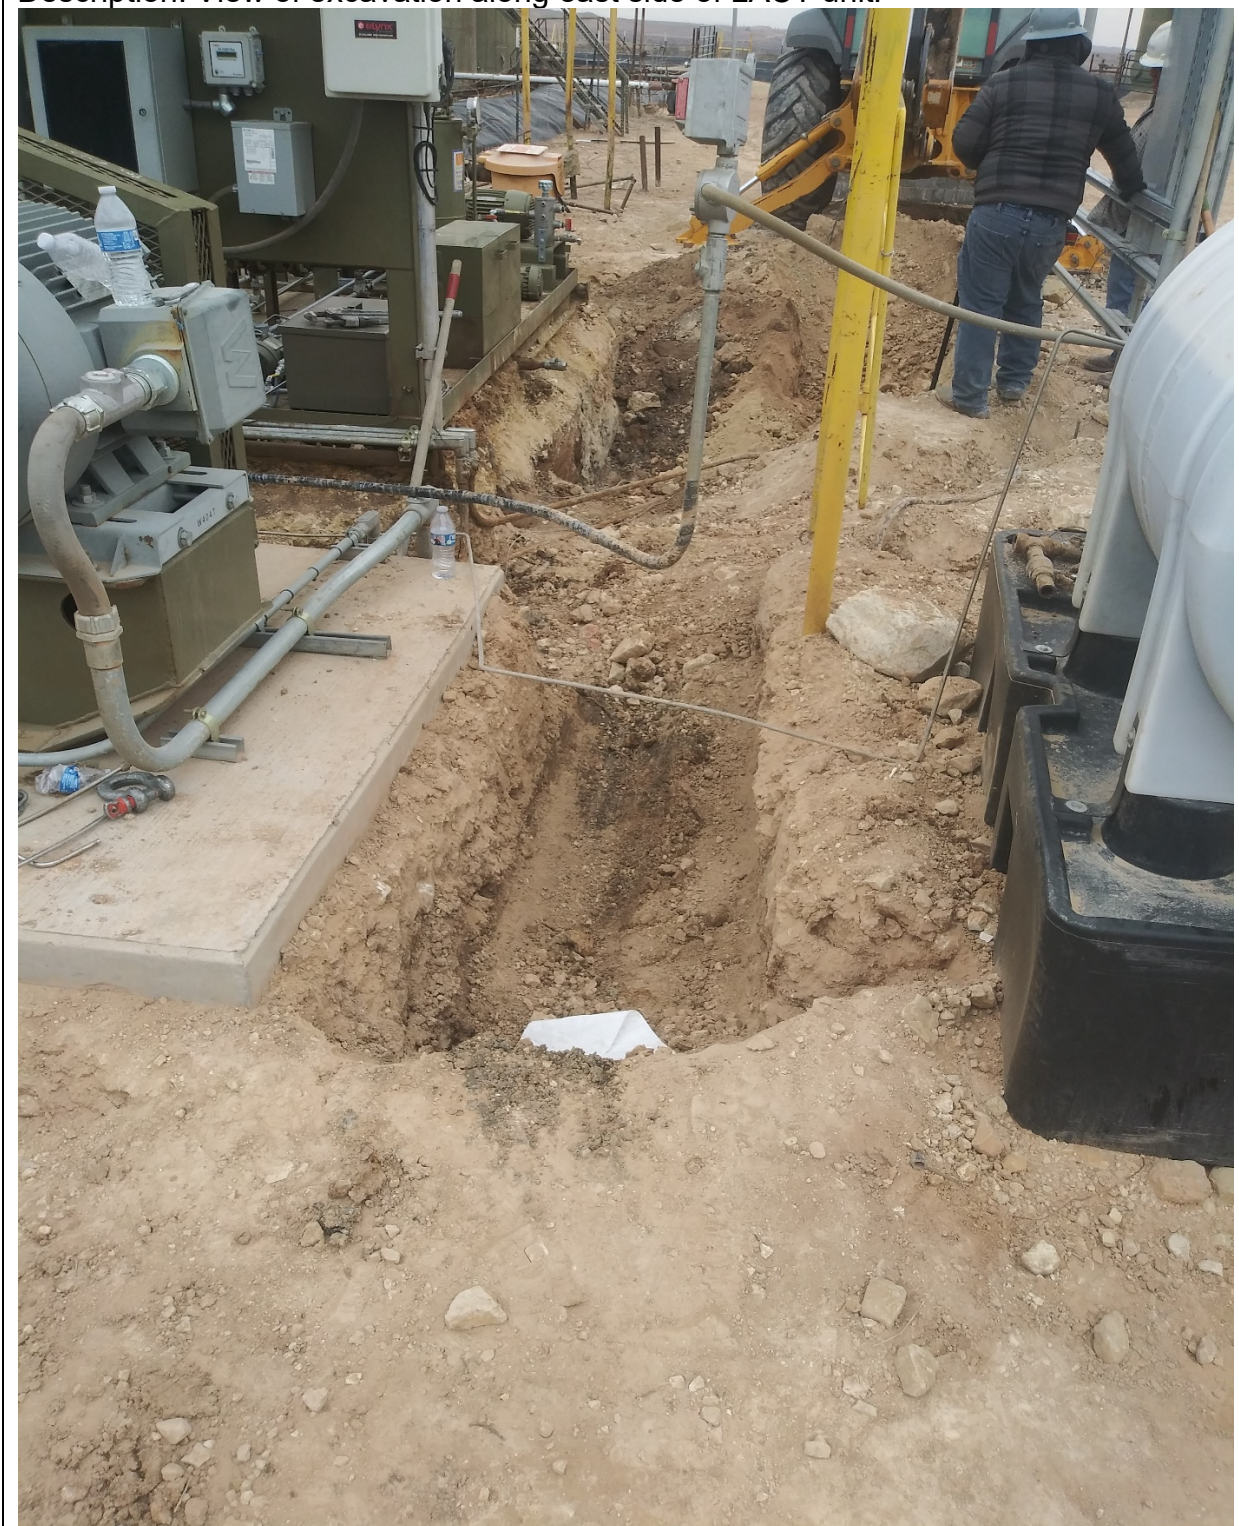
Photograph No 2.

Direction: North

Description: View of excavation along east side of LACT unit.

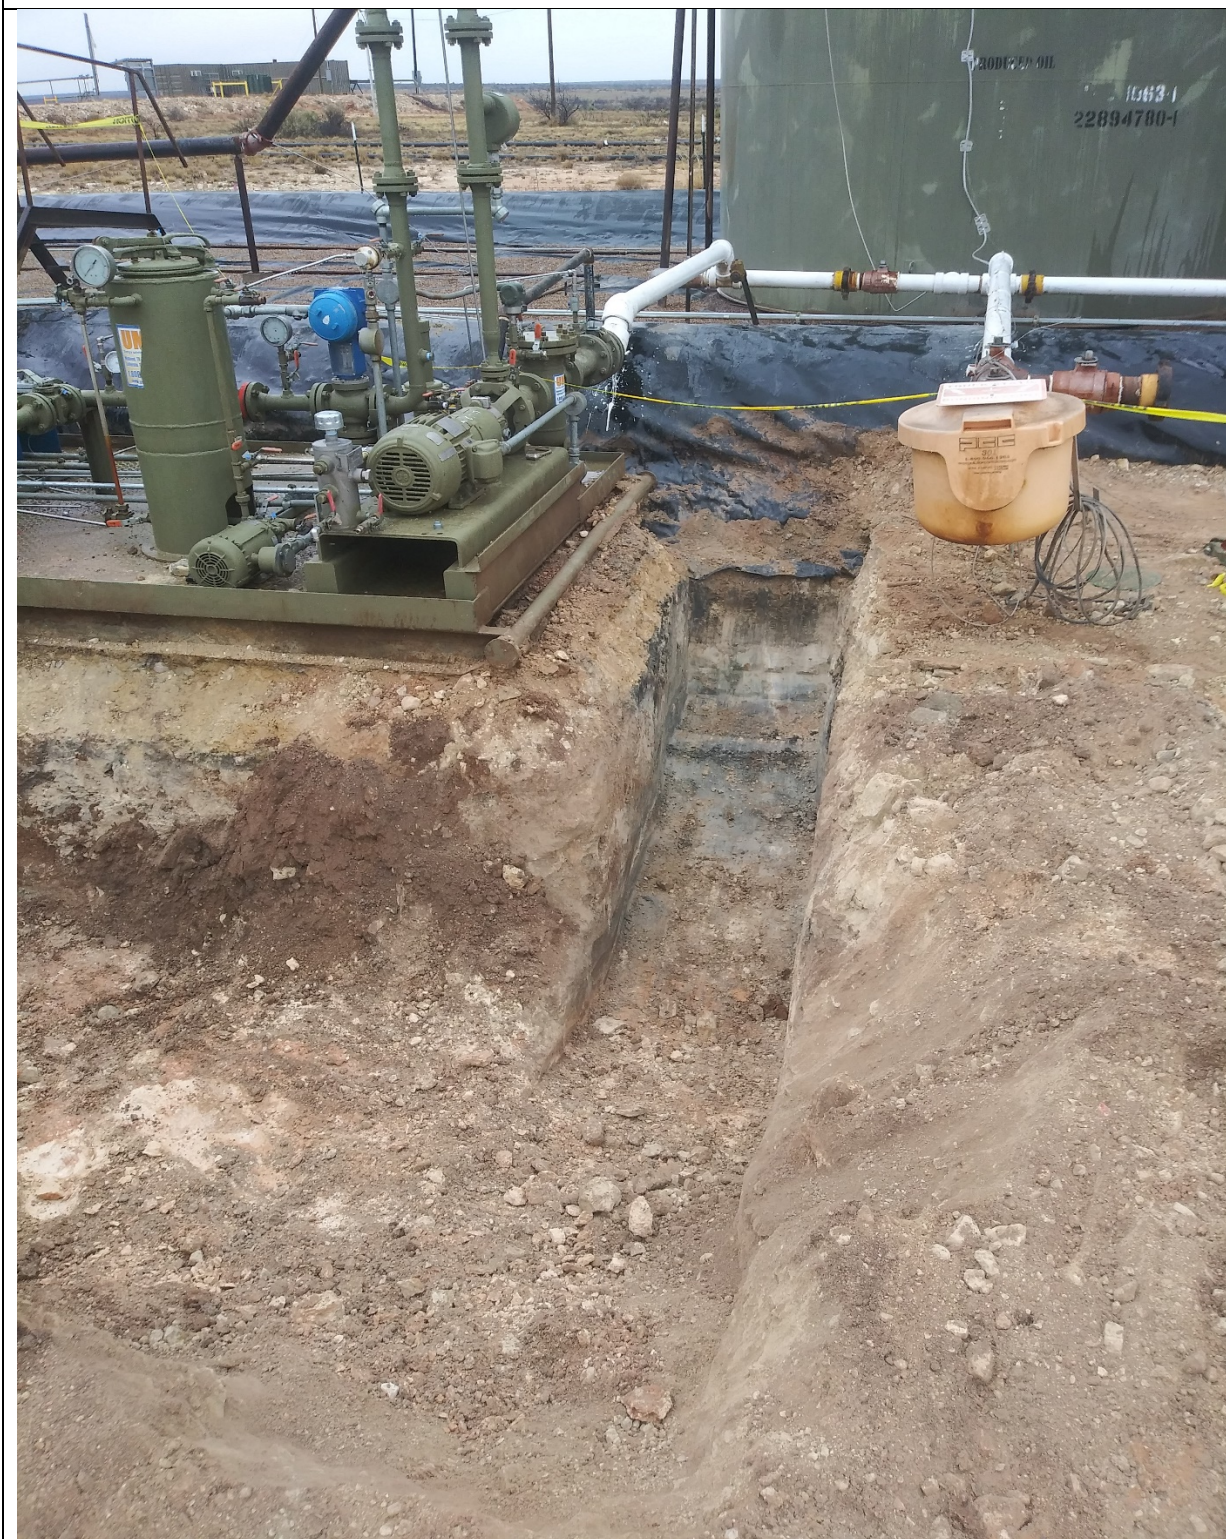
Photograph No 3.

Direction: West

Description: View of excavation along northern part of release by LACT unit.

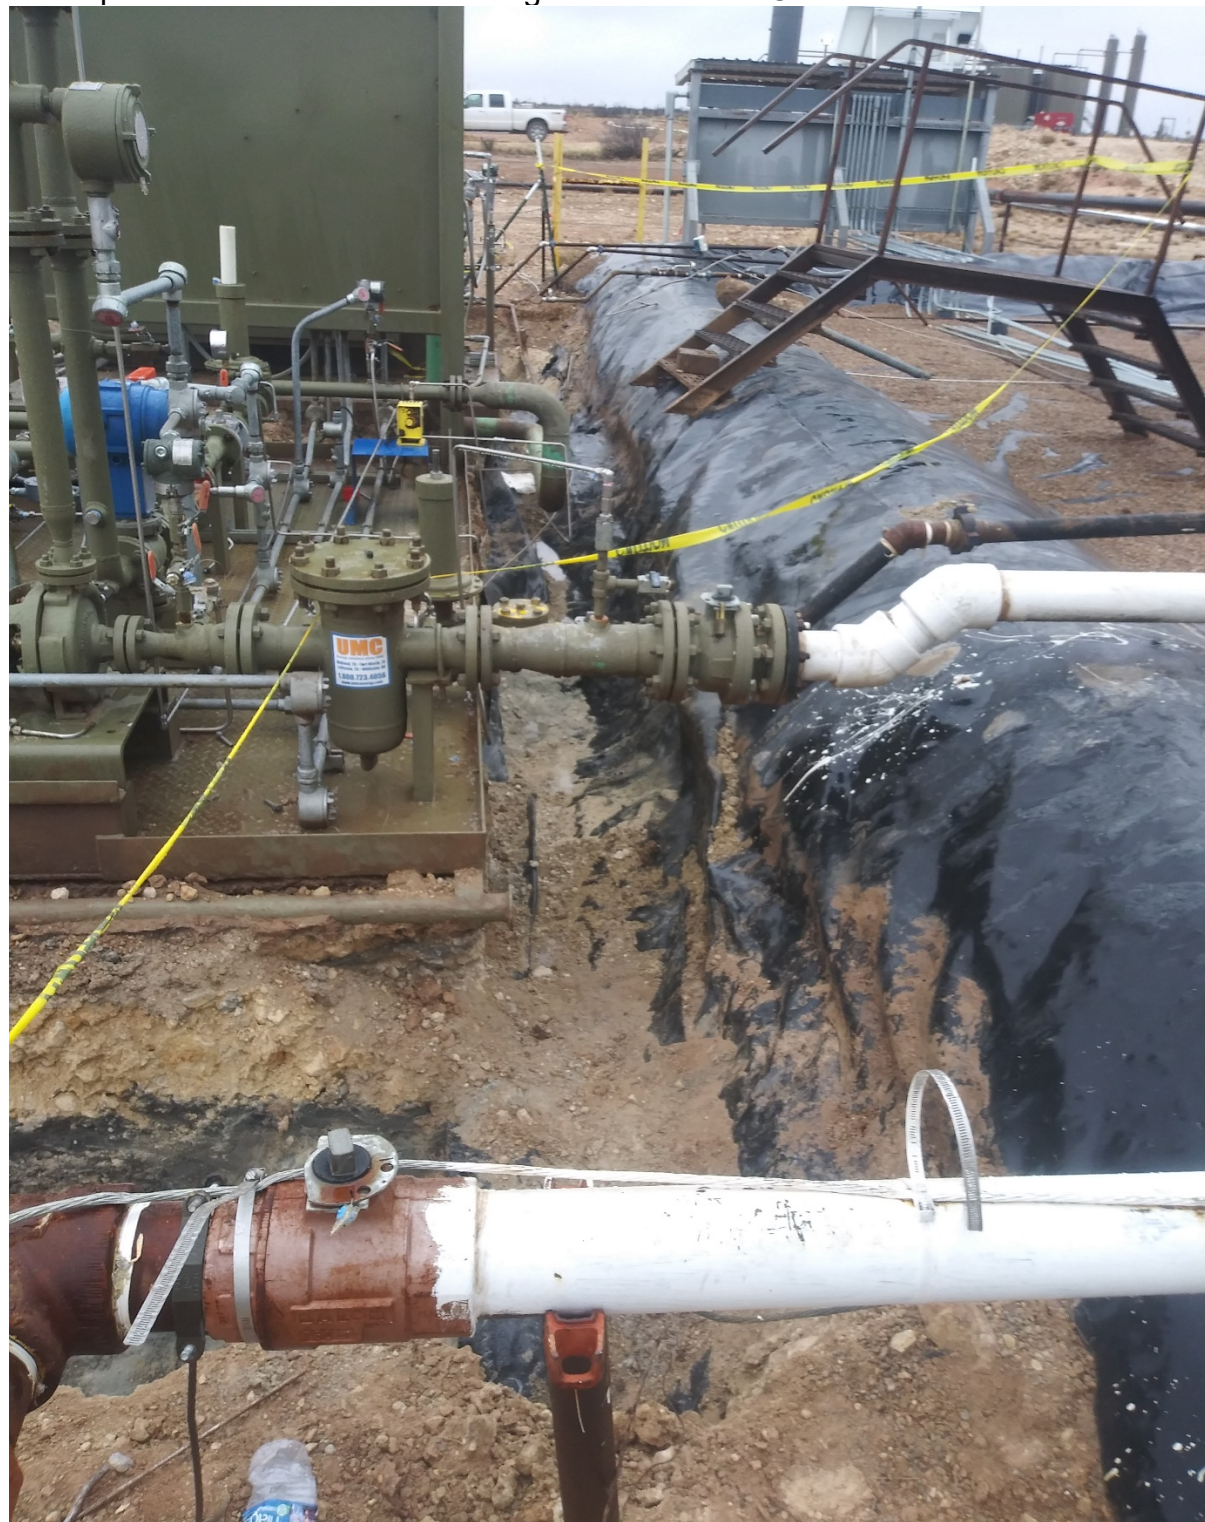
Photograph No 4.

Direction: South

Description: View of excavation along west side of LACT unit.

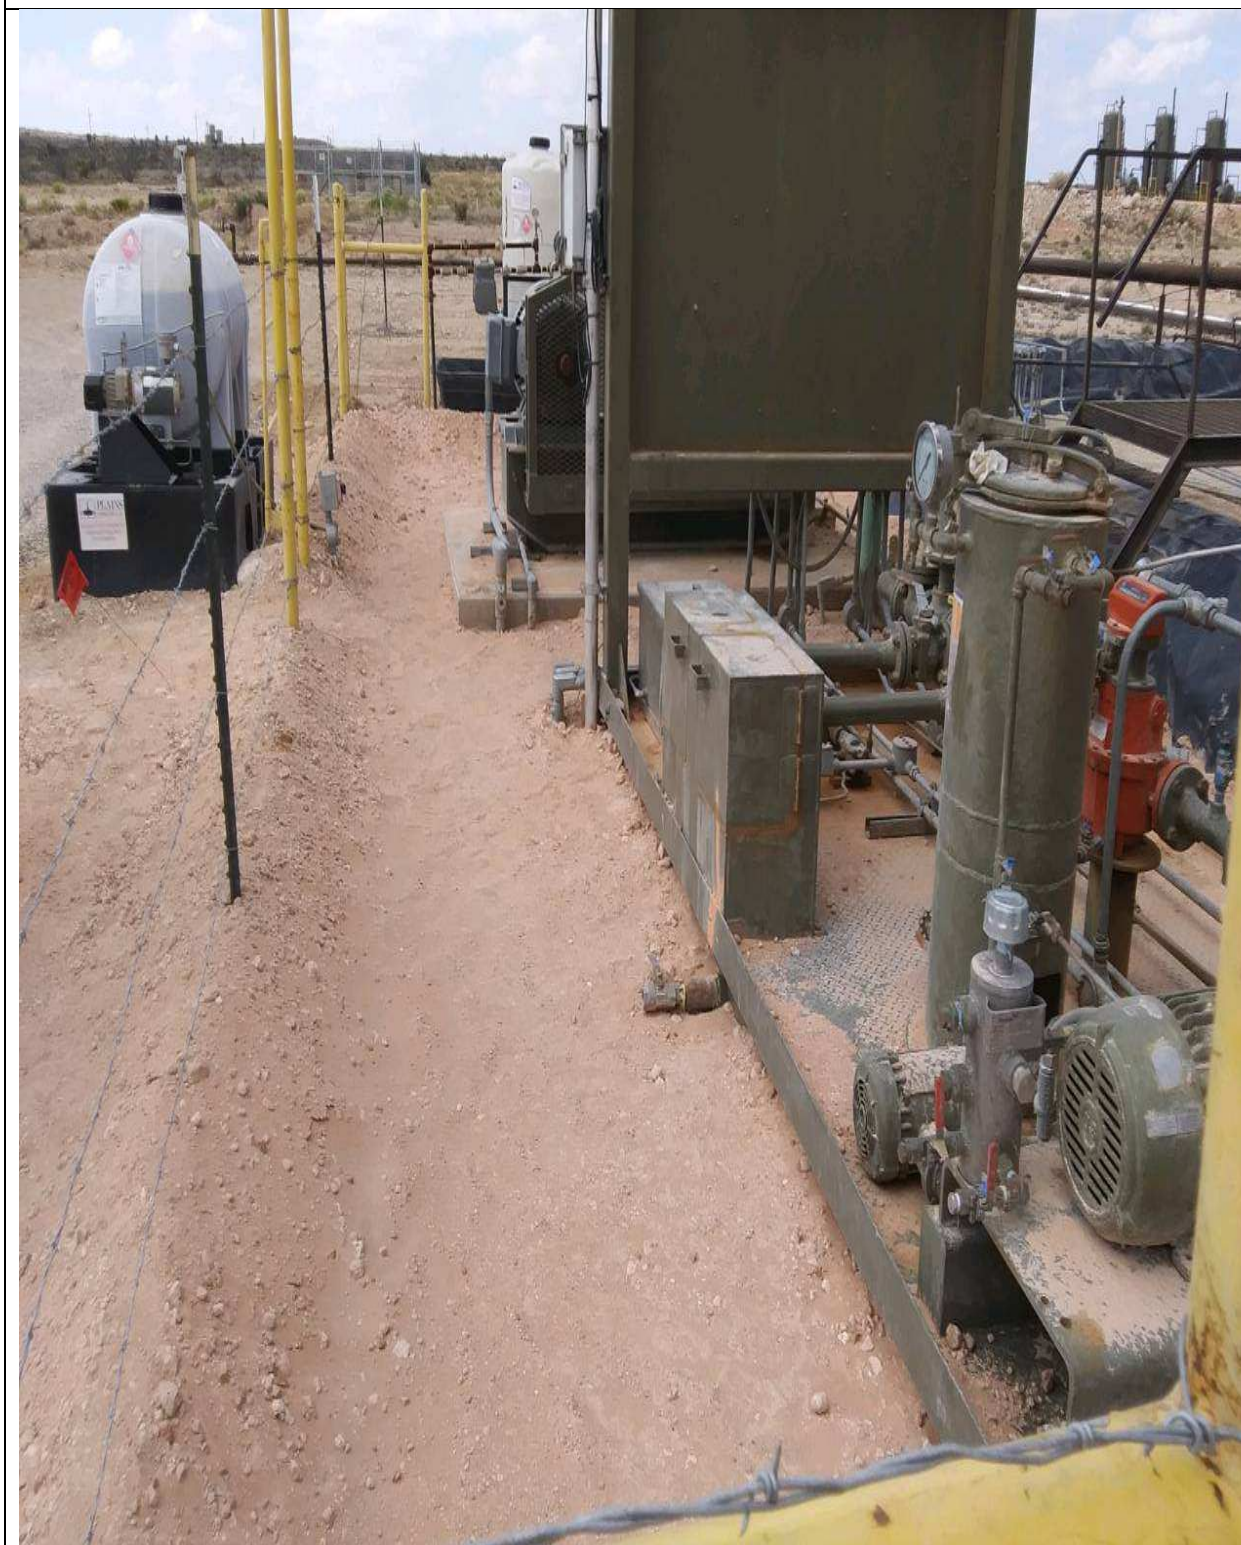
Photograph No 5.

Direction: South

Description: View of backfilled excavation on east side of LACT unit.

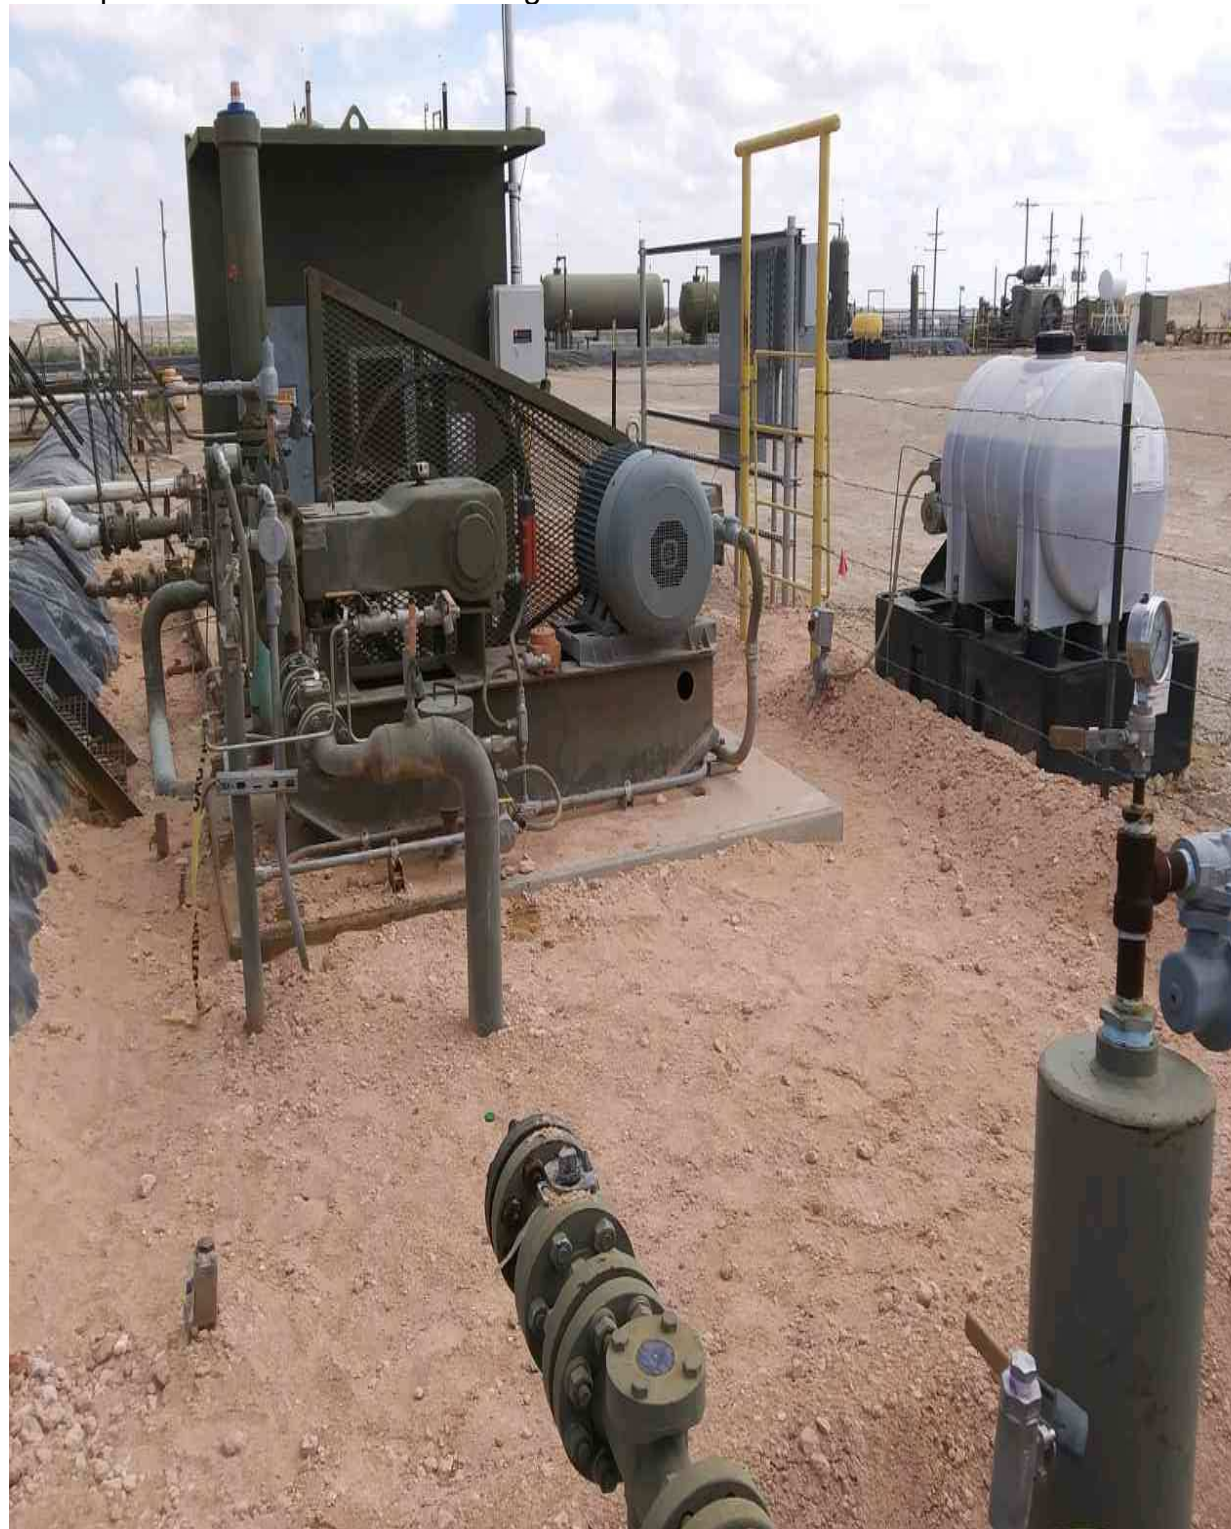
Photograph No 6.

Direction: Northeast

Description: View of excavation along south side of LACT unit.
