**RE: Closure Request
Eata Fajita C CTB
Incident Number NAPP2129830369
Lea County, New Mexico**

FIGURE 2
 DELINEATION SOIL SAMPLE LOCATIONS
 EATA FAJITA C CTB
 UNIT 0 SEC 8 T24S R33E
 LEA COUNTY, NEW MEXICO
 COG OPERATING, LLC

PHOTOGRAPHIC LOG		
COG Operating, LLC	Eata Fajita C CTB Lea County, New Mexico	NAPP2129830369

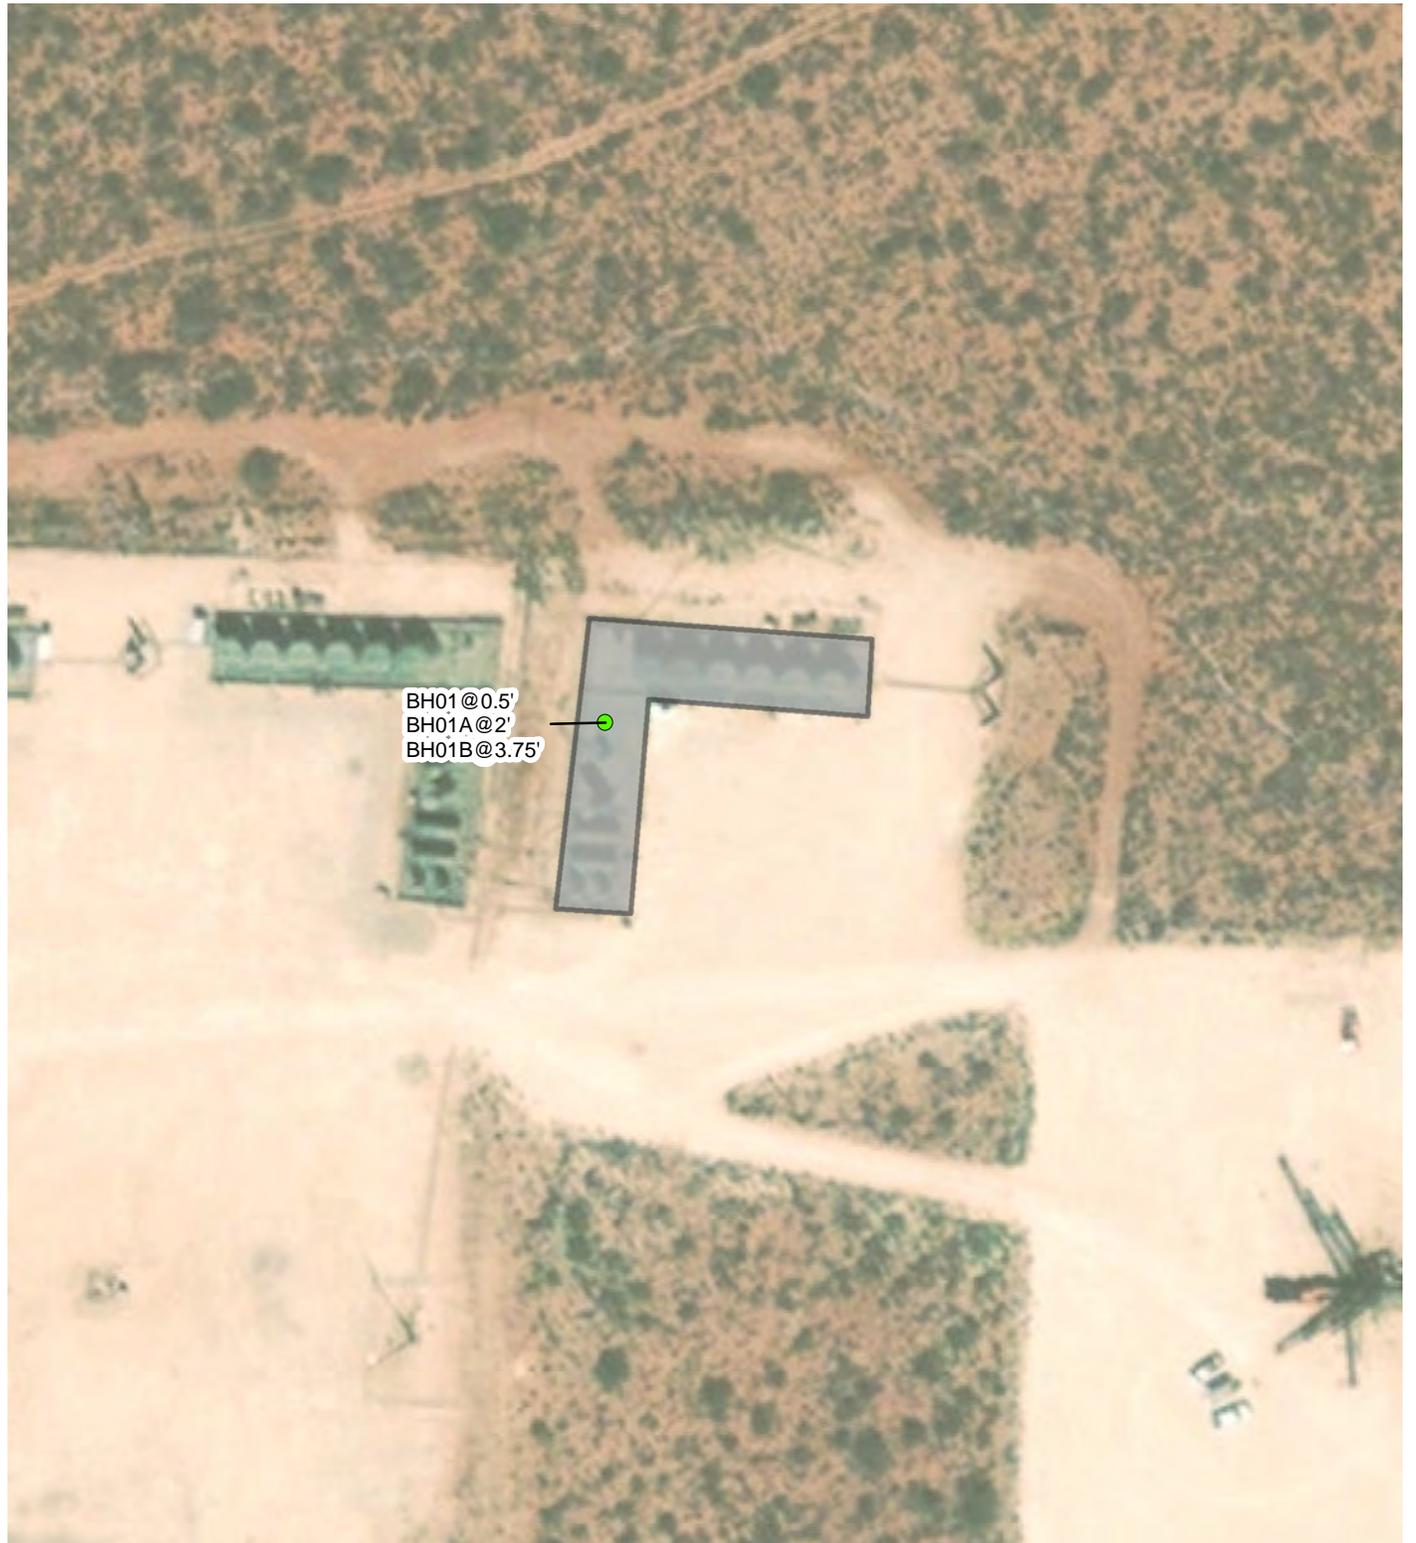
Laboratory analytical results for delineation soil samples BH01, BH01A, and BH01B indicated that benzene, BTEX, TPH-DRO/TPH-GRO, TPH, and chloride concentrations were compliant with the Closure Criteria. In addition, all delineation soil samples were compliant with the most stringent Table 1 Closure Criteria. Laboratory analytical results are summarized in Table 1 and the complete laboratory analytical report is included as Attachment 4.

- DELINEATION SOIL SAMPLE IN COMPLIANCE WITH APPLICABLE CLOSURE CRITERIA
- CONTAINMENT

NOTE: INCIDENT NUMBER NAPP2129830369
 SAMPLE ID@DEPTH BELOW GROUND SURFACE (FEET)

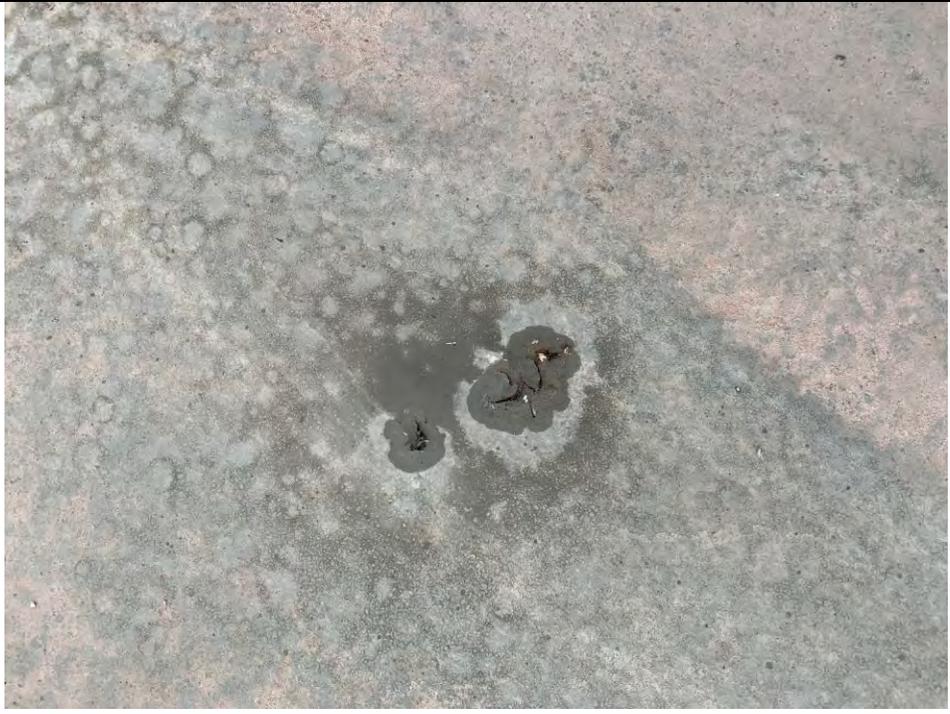
Photo No.	Date	
1	November 2, 2021

On October 7, 2021, a release was caused by a hole in a fire tube due to corrosion. Approximately 7.3 barrels (bbls) of produced water released into the lined tank battery containment. A vacuum truck was immediately dispatched to the Site to recover free-standing fluids; all 7.3 bbls of the released produced water were recovered from within the lined containment. COG reported the release to the New Mexico Oil Conservation Division (NMOCD) and submitted a Release Notification Form C-141 on October 25, 2021. The release was assigned Incident Number NAPP2129830369. A 48-hour advance notice of liner inspection was provided via email on October 27, 2021 to the NMOCD District I office. A liner integrity inspection was conducted by WSP personnel on November 2, 2021 following the fluid recovery and upon inspection, the liner was determined to be insufficient.

View of hole identified in tank battery liner during inspection.

Following the failed liner integrity inspection at the Site, WSP personnel advanced one borehole, (BH01), within the lined containment to assess for the presence or absence of soil impacts resulting from the October 7, 2021 produced water release within lined containment. Three delineation soil samples were collected from borehole BH01, at depths of approximately 0.5 feet, 2 feet, and 3.75 feet bgs. Laboratory analytical results for the delineation soil samples indicated that benzene, BTEX, TPH-DRO/TPH-GRO, TPH, and chloride concentrations were compliant with the Closure Criteria. In addition, all delineation soil samples were compliant with the most stringent Table 1 Closure Criteria. The release was contained laterally by the lined containment and all released fluids were recovered during initial response activities. The tear in the liner was subsequently repaired.

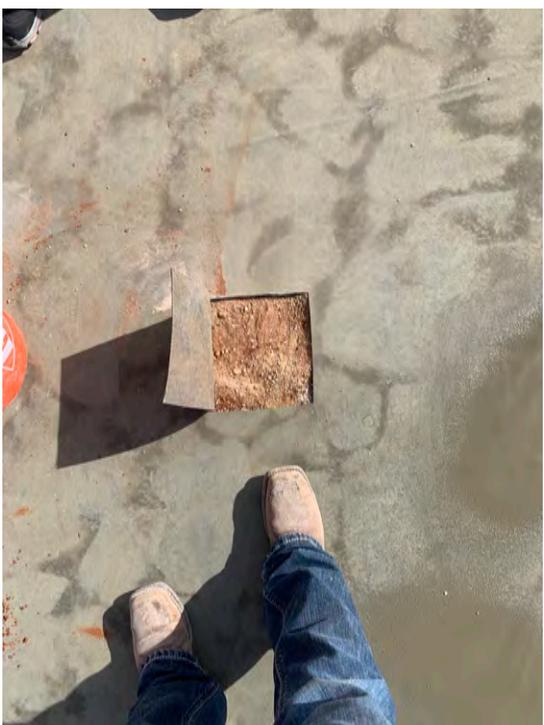
Photo No.	Date	
2	November 23, 2021

View of BH01 location inside tank battery containment prior to delineation activities.

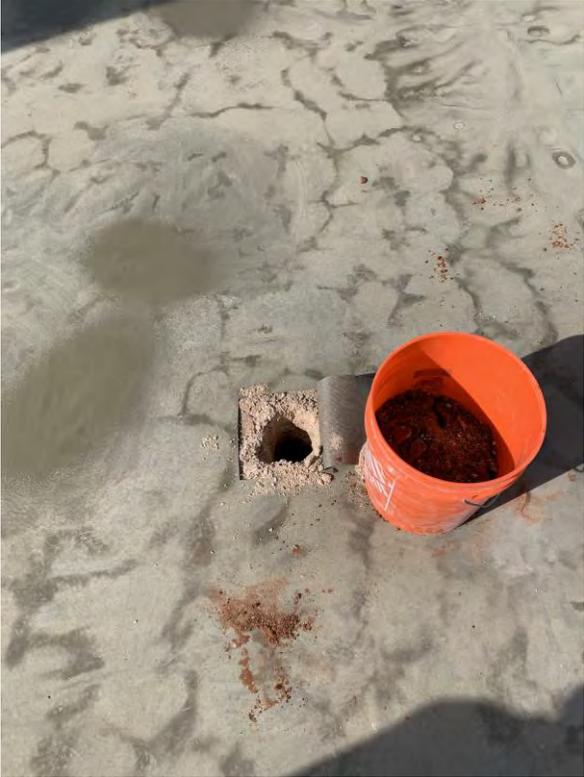
Photo No.	Date	
3	November 23, 2021	
View of BH01 location inside tank battery containment.

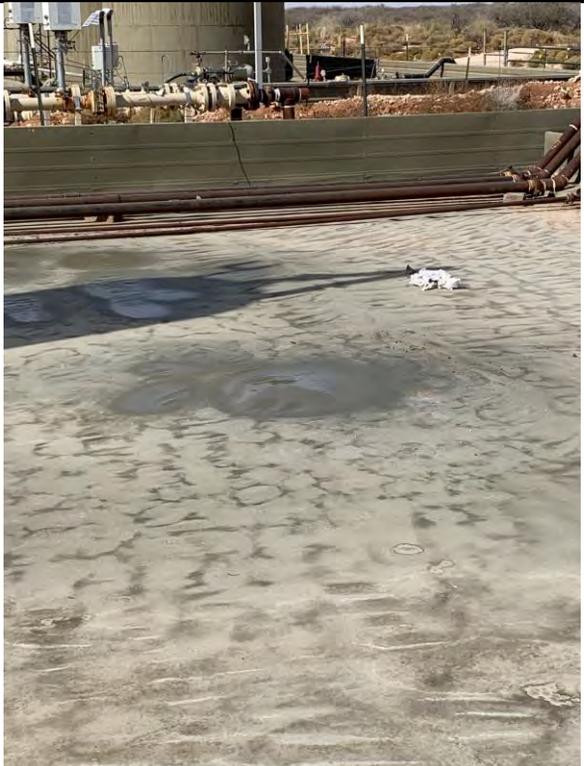
Photo No.	Date	
4	November 23, 2021	
View of patched liner at the completion of delineation activities.
