Release Notification

Site Name Pan Am Pardue AIZ Federal #1	Site Type Battery
Date Release Discovered 04/07/2021	API# (if applicable) 30-015-10728

EOG RESOURCES
EDDY COUNTY, NEW MEXICO
PAN AM AIZ FEDERAL No. 1

Attachment B Photographic Log

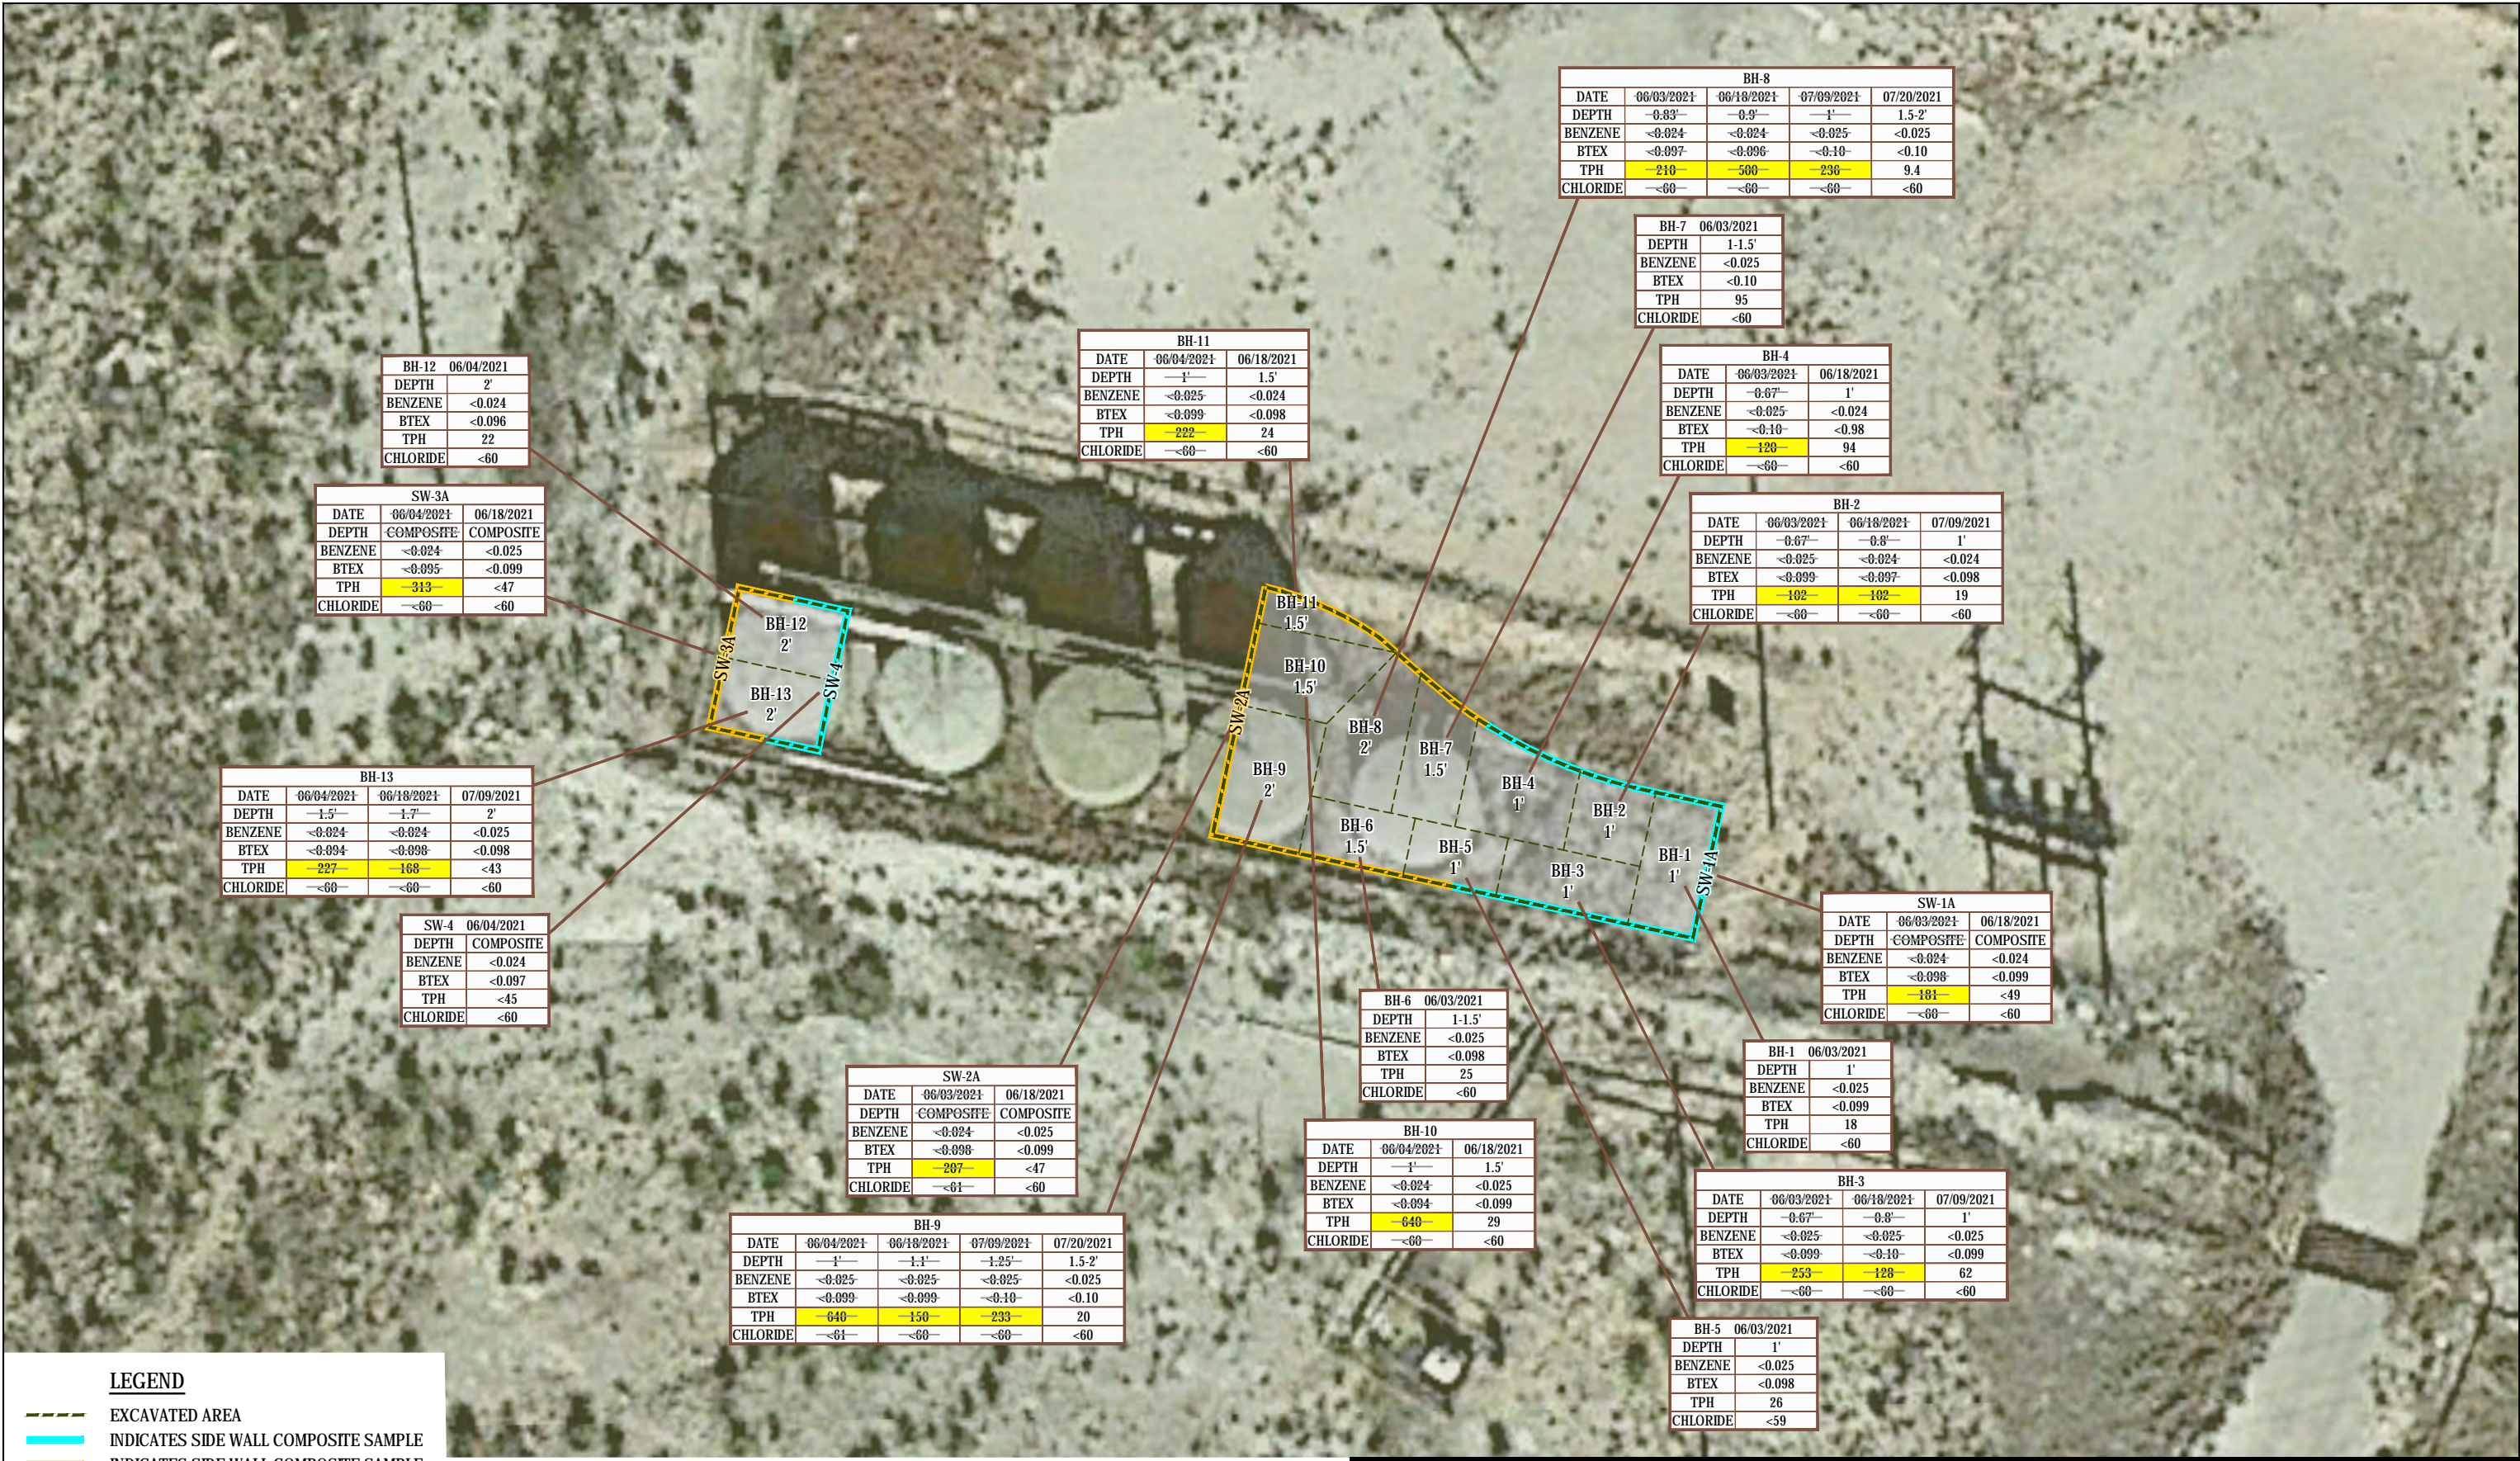
FIGURE 2

All soil samples were analyzed for BTEX by EPA Method 8021B, TPH by Method 8015B Modified, and chloride by EPA Method 300 by Hall Environmental Analysis Laboratory (HEAL) in Albuquerque, New Mexico. Five of the seven soil samples exceeded applicable NMAC Table 3.1 Closure Criteria, TP1, TP3, TP5, TP6 and TP7. Figure 2, Site Assessment: Soil Analytical Results Map, depicts the locations of the initial delineation samples and analytical concentrations. Analytical results are provided in Table 1, on Figure 2, and in the Laboratory Analytical Reports provided in Attachment C.

SITE ASSESSMENT:
SOIL ANALYTICAL RESULTS MAP

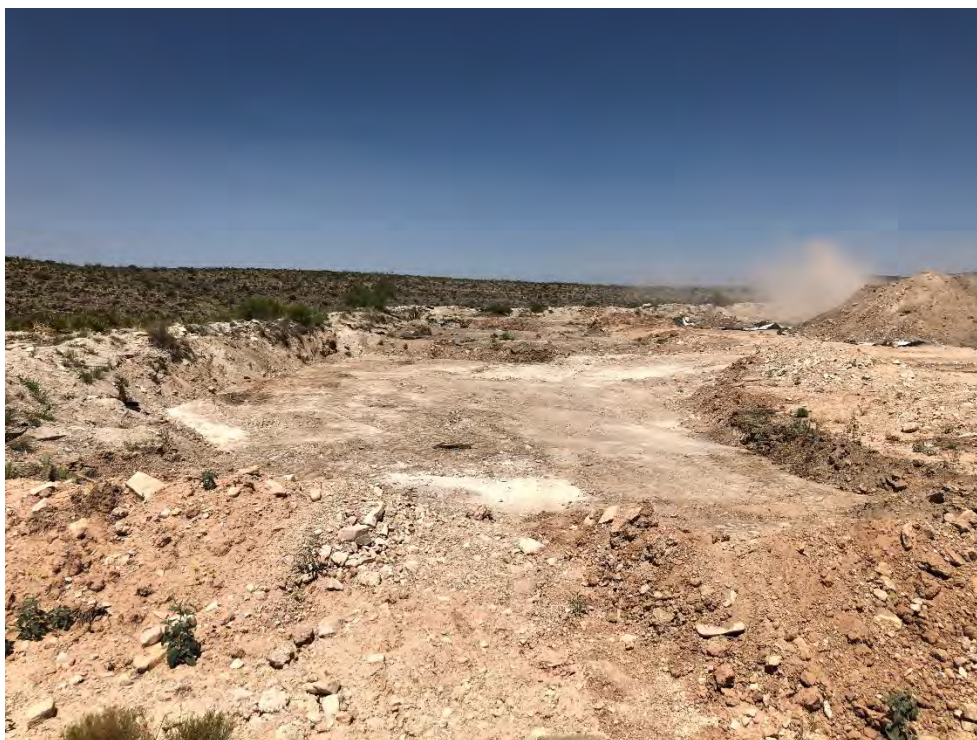
Photo 1 – Area A

Site Photograph
EOG Pan Am AIZ Federal #1
Release Site.
