Re: Remediation Summary and Closure Report
10200 Line (10.7.21)
GPS: Latitude 32.215871 Longitude -104.222542
UL "I", Sec. 18, T24S, R27E
Eddy County, New Mexico
NMOCD Ref. No. nAPP2128133962

Tasman Geosciences, Inc. (Tasman), on behalf of DCP Midstream, LP (DCP), has prepared this Remediation Summary and Closure Report for the condensate and natural gas Release Site known as the 10200 Line (10.7.21). Details of the release are summarized below:

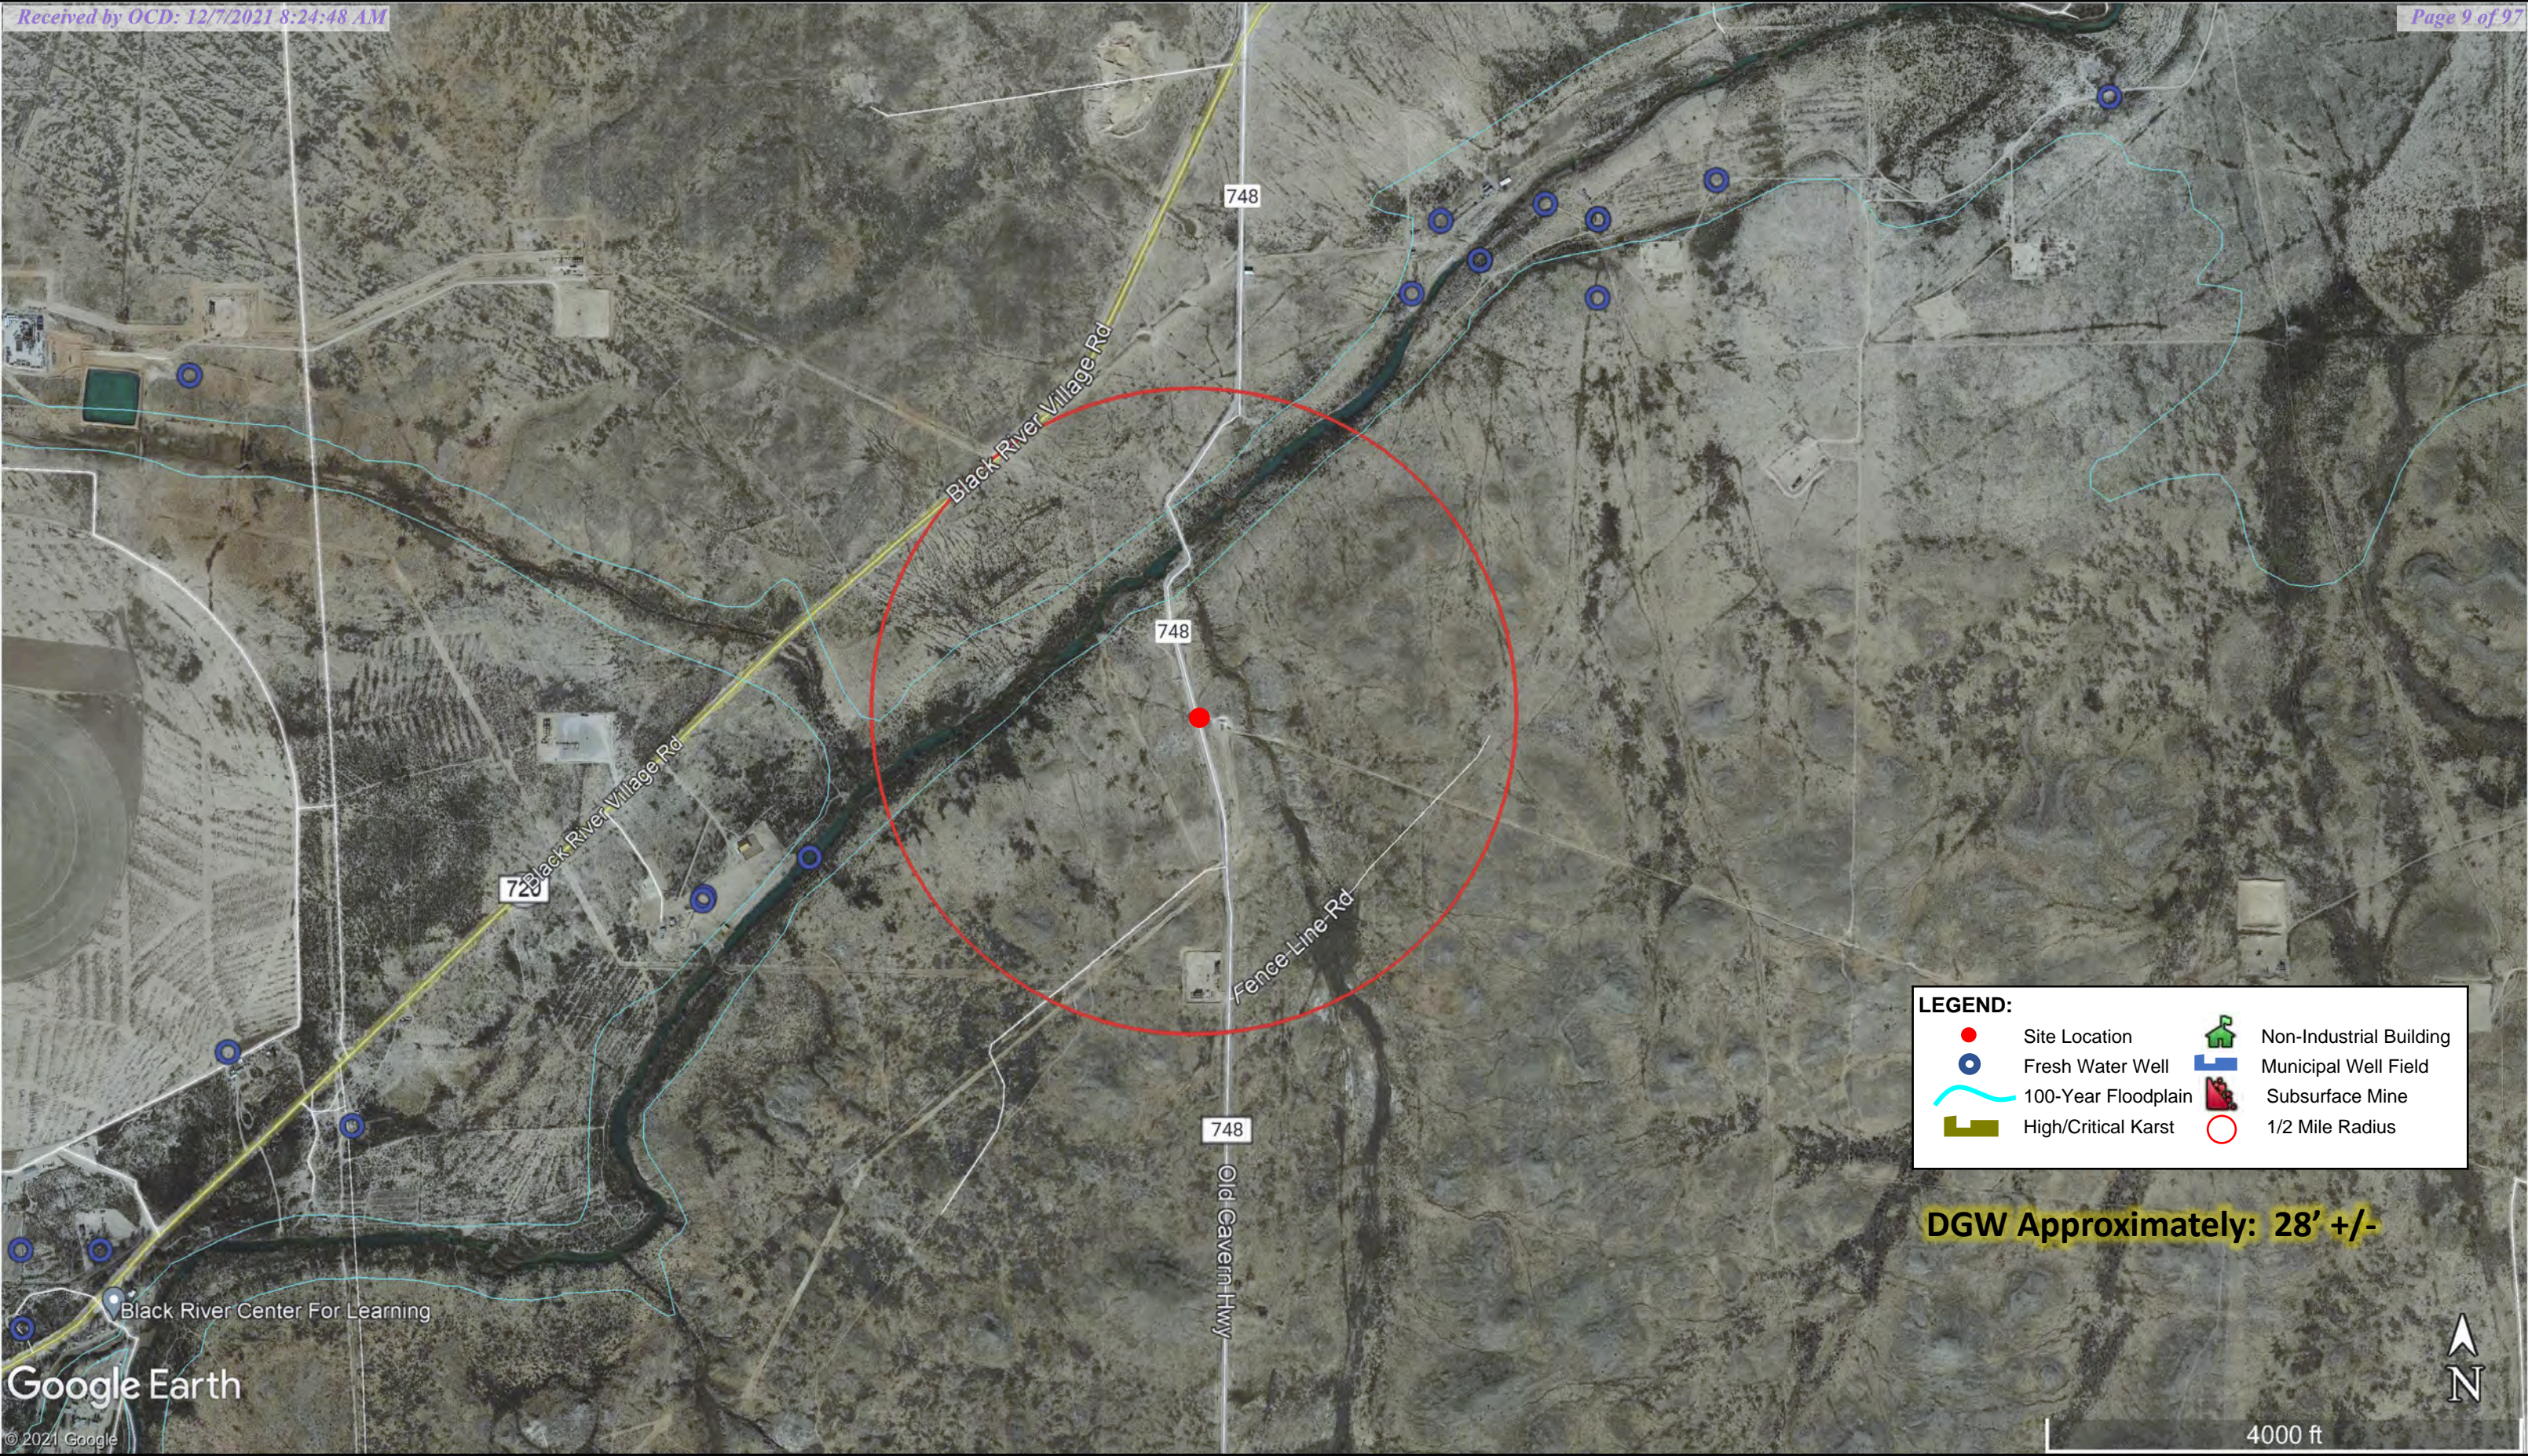
A release Site Characterization Map is provided as Figure 1. General site conditions upon arrival to the site and remedial action photographs are provided as Appendix C. A copy of the initial release notification form (Form C-141) is provided in Appendix D.

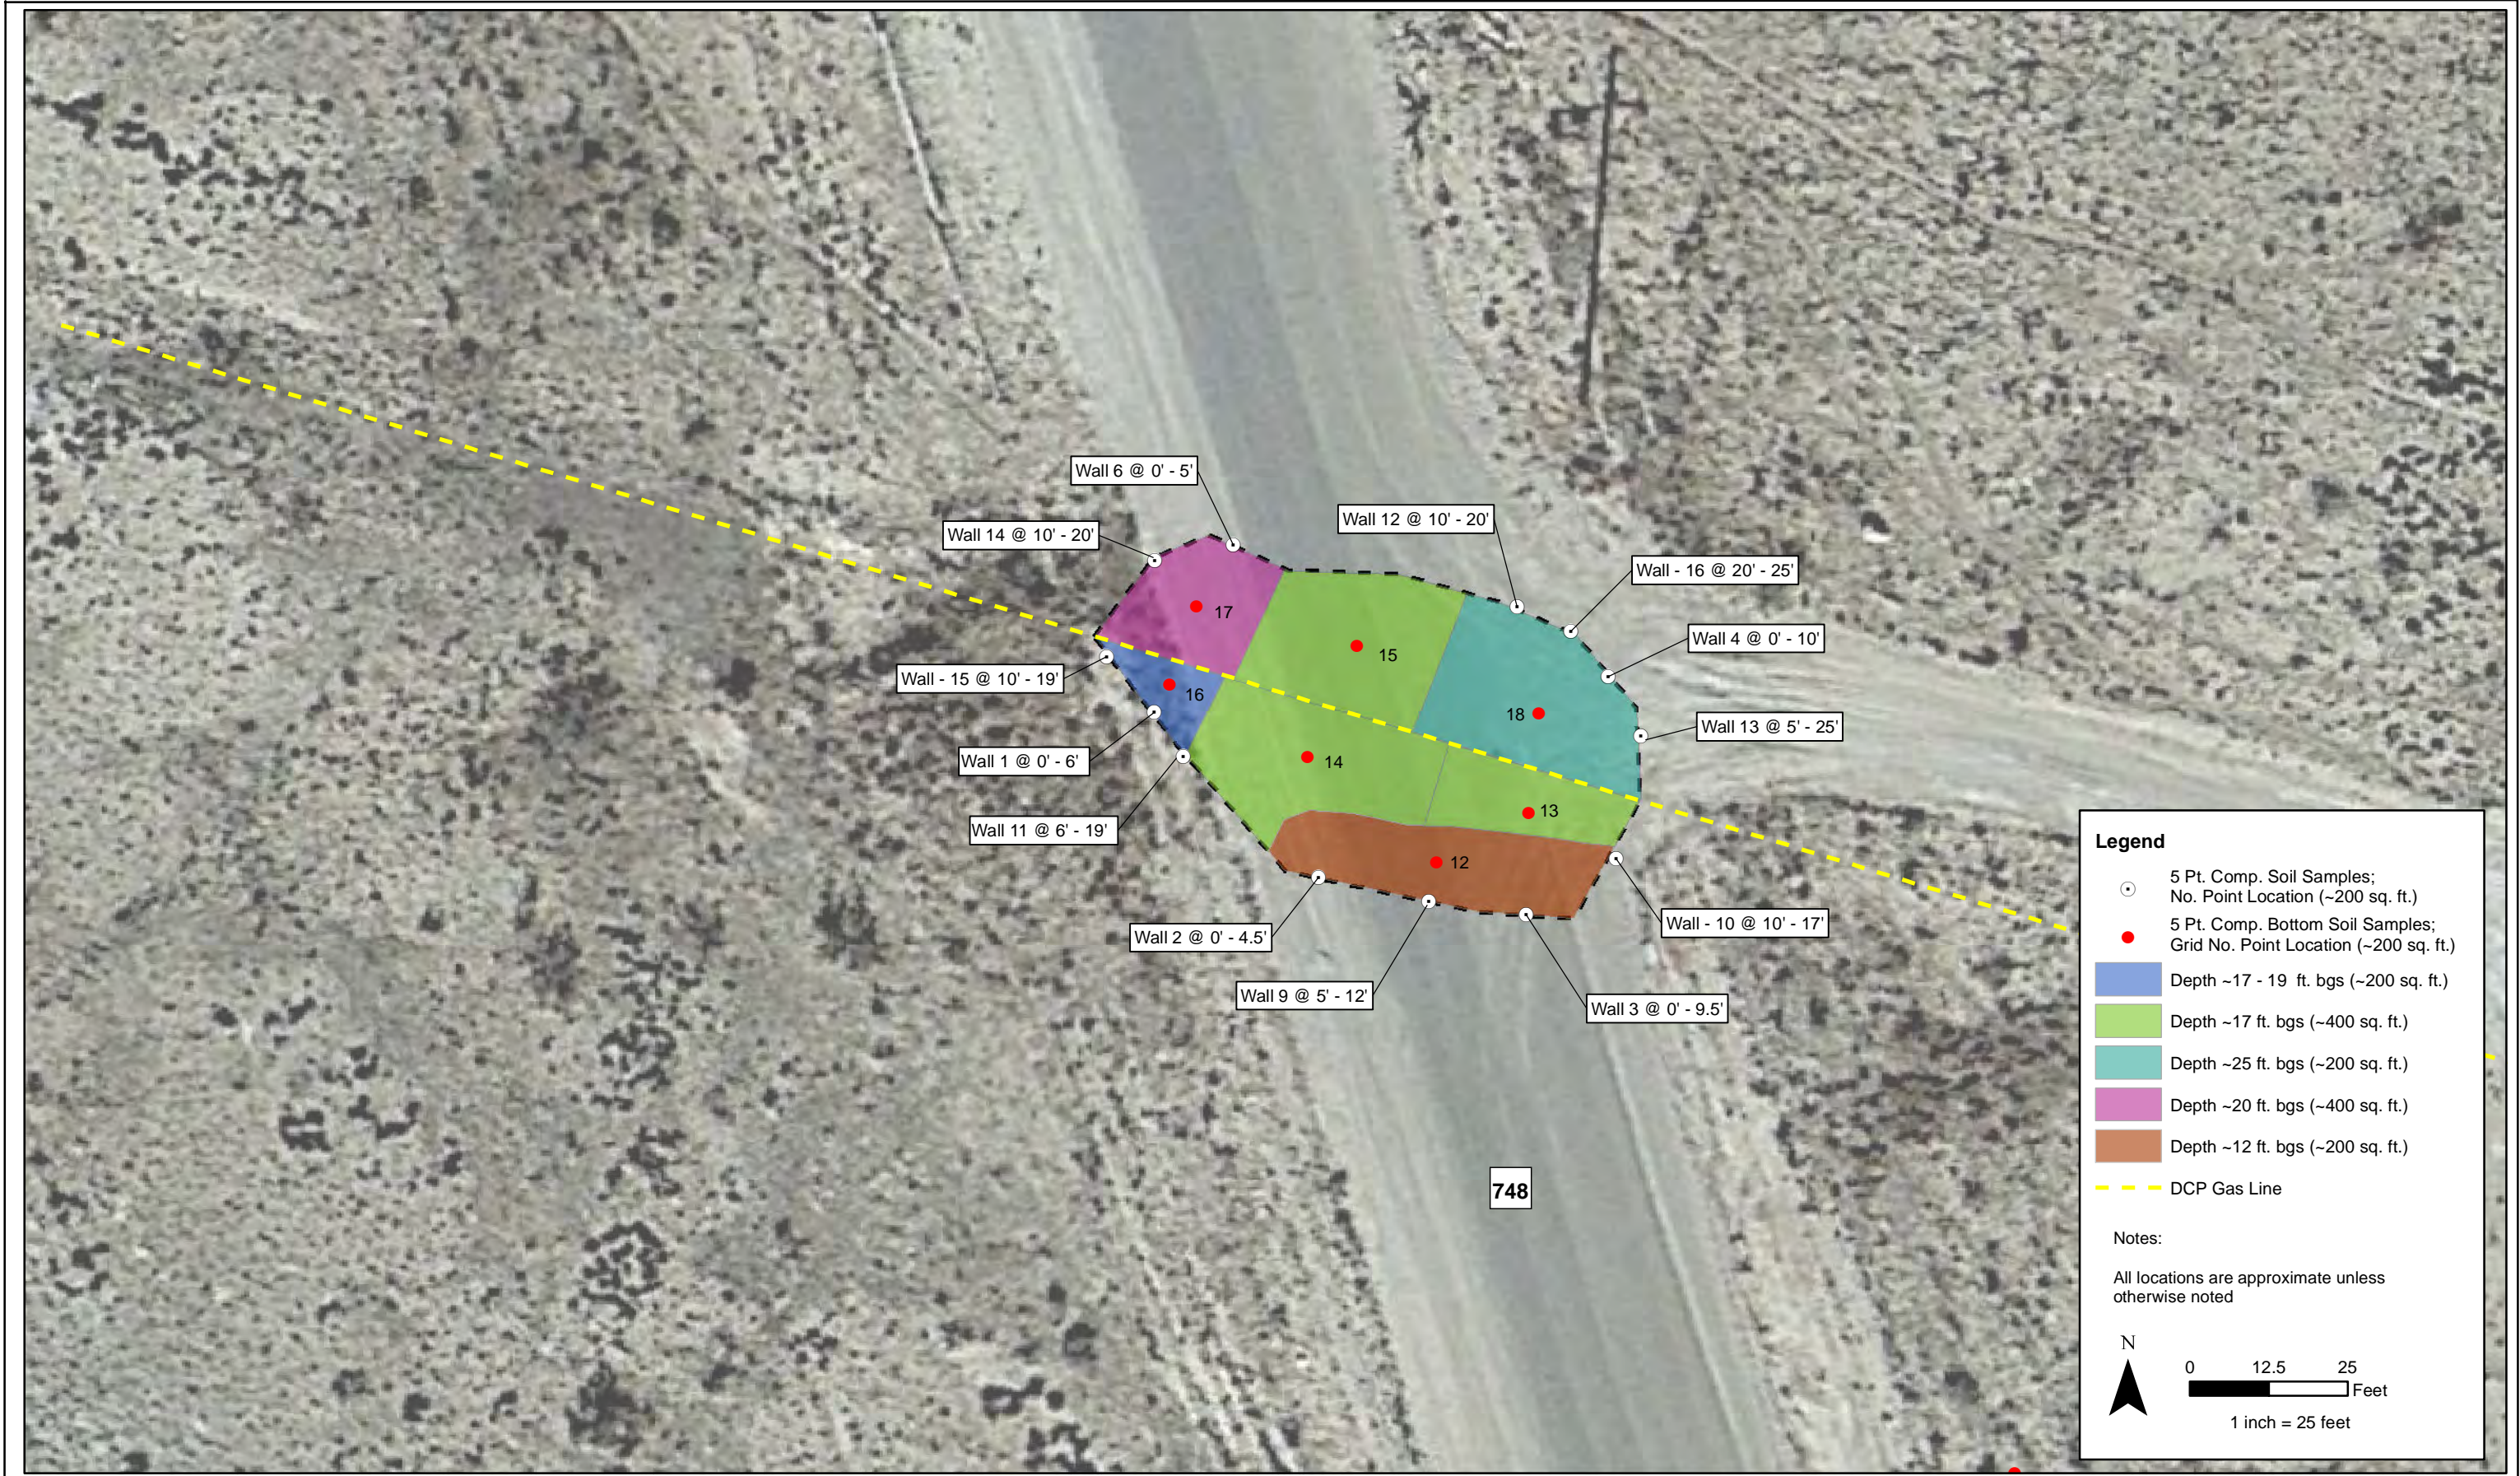
Figure
2

A summary of the laboratory analytical results for the excavation bottom and sidewall soil confirmation samples, and monitoring wells is presented in the tables above. The locations of the bottom and sidewall soil samples used as confirmation samples as well as the approximate final bottom depths throughout the excavation are presented on Figure 2. The location of the groundwater monitoring wells is also presented in Figure 2. Laboratory analytical reports are provided in Appendix B. General site conditions upon arrival to the site and remedial action photographs are provided as Appendix C.

Soil Confirmation Sample
Location Map
