Release Notification

Release Closure Report

Jicarilla O 3E

NMOCD Incident #nAPP2103256004

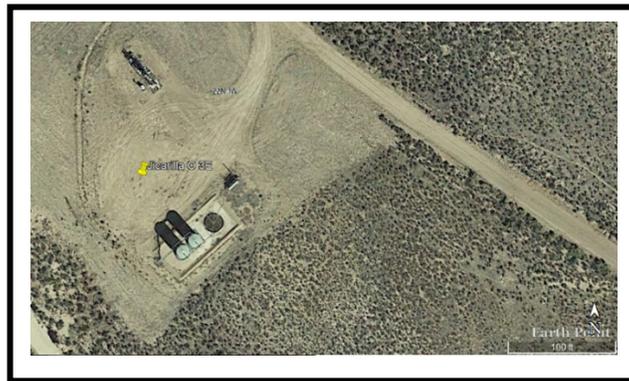
Site Area

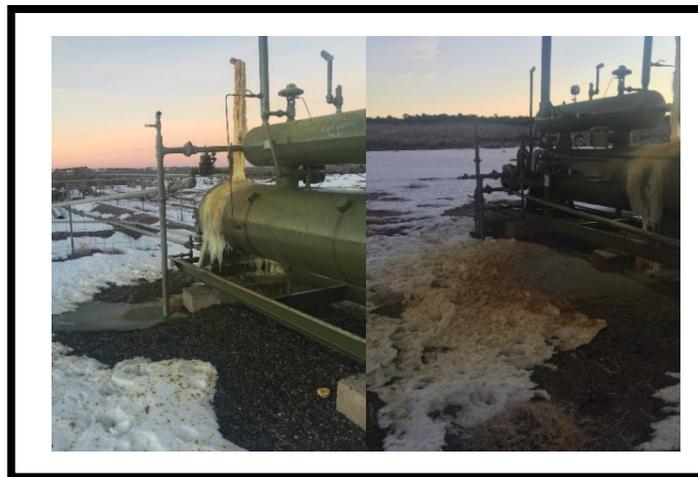
The cause of the release was on the separator from the pressure release valve (PRV) that froze. The valve stayed opened and continued to release. The affected area was around the separator and on the separator. Jicarilla requested LOGOS to remove separator and remediate due to historic staining. As the roustabout crew cleaned the area, LOGOS had an estimated of 22 yards of contaminated soil removed which caused this to be more than 5bbls.

**Site Area: Spill
January 12, 2021**

On January 12, 2021, LOGOS wiped separator down and scooped up the larger amounts of produced oil and placed in the steel BGT. The ground was frozen with snow patches. On January 13, 2021, LOGOS hydro-vac'd 2bbls of contaminated material. The crew placed a mix of contaminated soil and gravel from the affected area into the steel below grade tank (BGT). The crew hauled and disposed 10bbls at the Envirotech land farm.

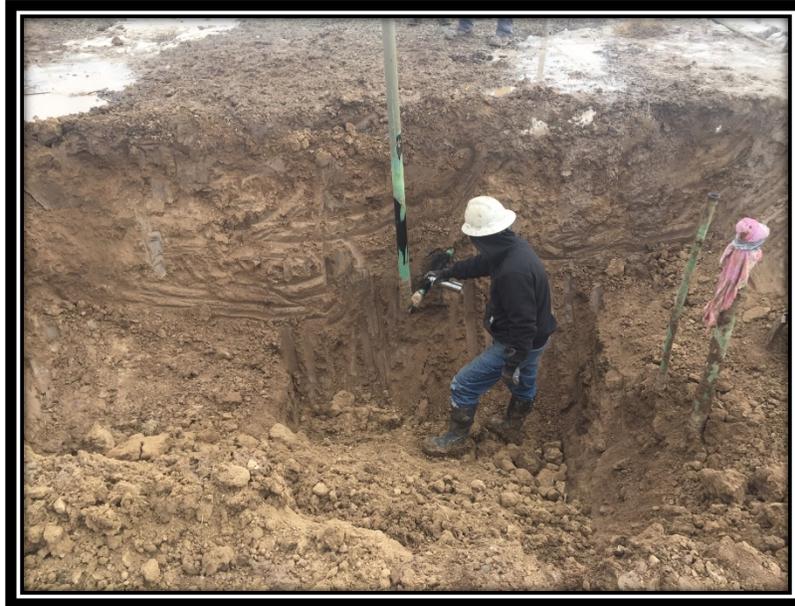
The excavation was monitored utilizing field screening methods conducted by Envirotech on February 1, 2021. At that time, the excavation measured approximately 15 feet by 10 feet with a depth ranging from 2 feet to 5 feet bgs. Field screening results are summarized below and in **Appendix C, Field Notes with EPA 418.1 Field Screening Reports**.

Picture 1: Excavation Activities (View 1)

Logos contractors performed excavation of the site on January 29 through February 1, 2021. Twenty-two (22) cubic yards of petroleum contaminated soil (PCS) were transported to Envirotech's NMOCD permitted soil remediation facility. Waste disposal documentation is provided in **Appendix B, Waste Disposal Documentation**.

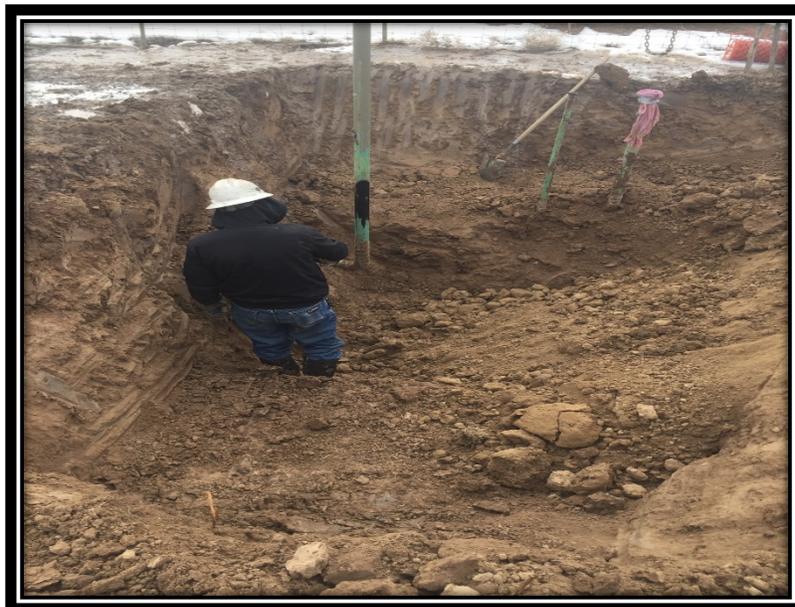
Picture 2: Excavation Activities (View 2)
