**Re: Release Characterization and Remediation Work Plan
ConocoPhillips
MCA 470 Flowline Release
Unit Letter H, Section 33, Township 17 South, Range 32 East
Lea County, New Mexico
Incident ID NRM1935447155**

Release Characterization and Remediation Work Plan
January 11, 2022

ConocoPhillips

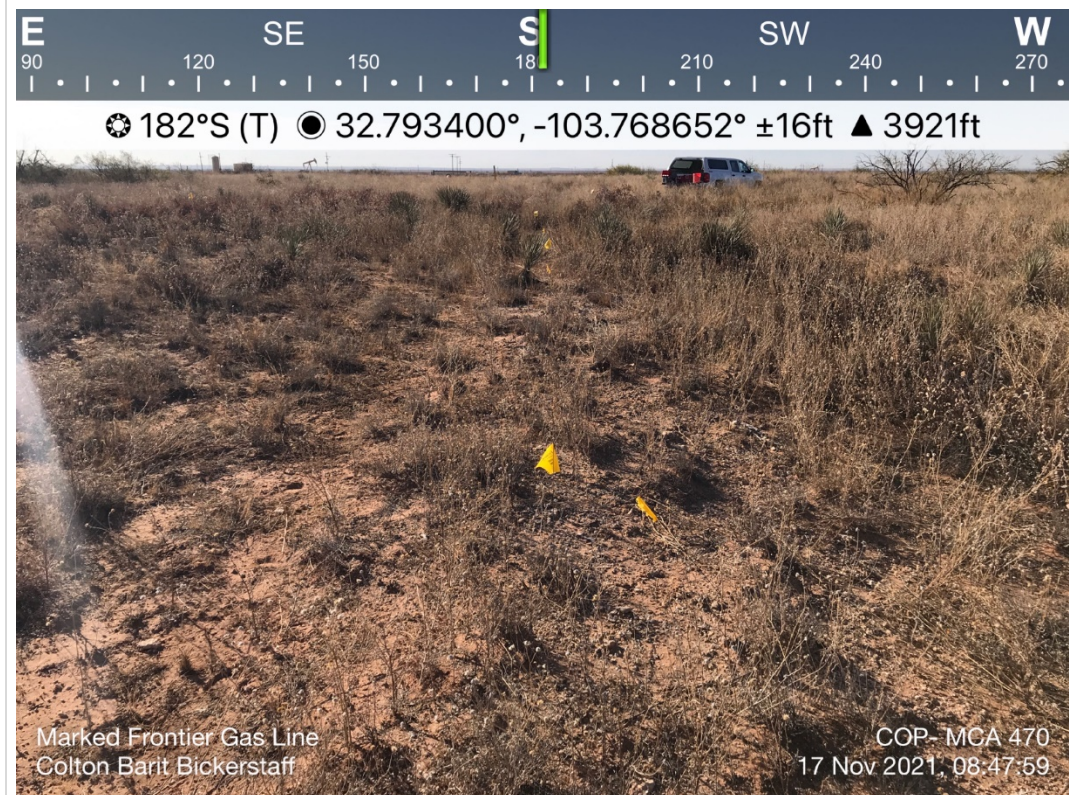
TETRA TECH, INC. PROJECT NO. 212C-MD-02617	DESCRIPTION	One-call marked Frontier gas line.	2
	SITE NAME	ConocoPhillips MCA 470	11/17/2021

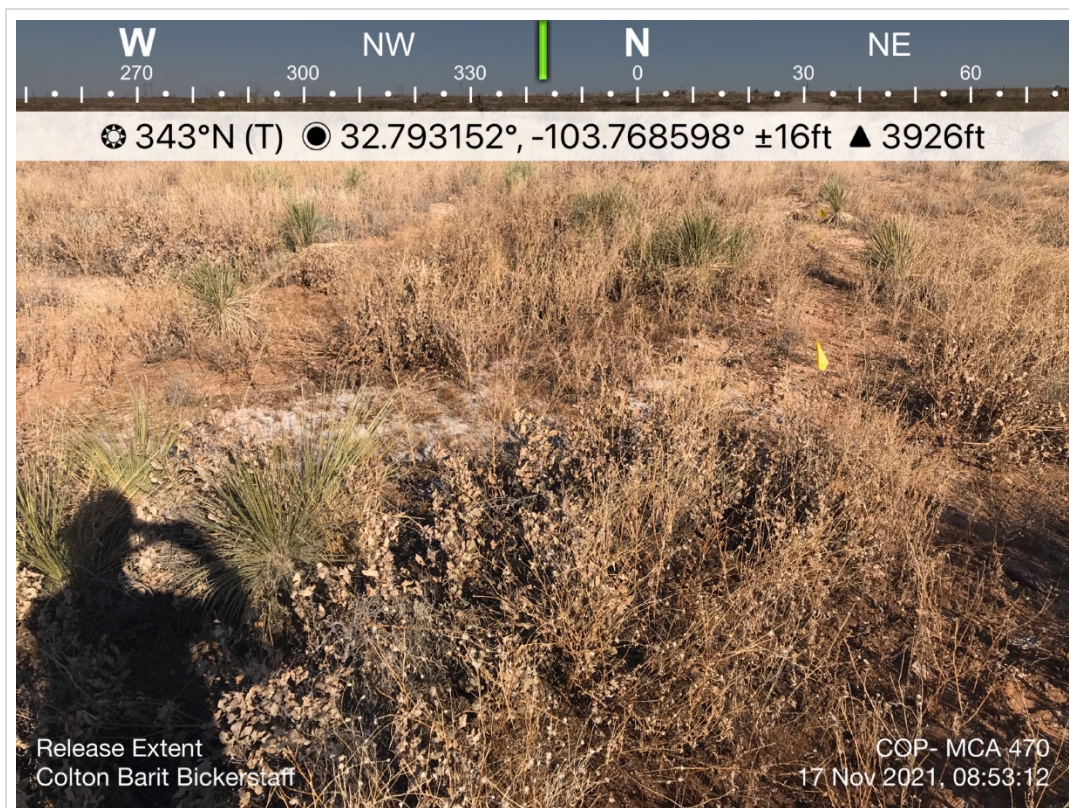
TETRA TECH, INC. PROJECT NO. 212C-MD-02617	DESCRIPTION	Impacted release area with salt staining and TPH staining present.	3
	SITE NAME	ConocoPhillips MCA 470	11/17/2021

Based on the analytical results, ConocoPhillips proposes to remove the impacted material as depicted in Figure 4. Screening samples will be collected during the excavation process to determine if the remediation footprint for the site will be modified based on field conditions. Impacted soils will be excavated using heavy equipment (backhoes, hoe rams, and track hoes) to a maximum depth of 4 ft below surface or until a representative sample from the walls and bottom of the excavation is below the RRAL. The area of the release extent that runs along the buried line within the release extent will be hand-dug to a depth of 4 ft or the maximum extent practicable.

Excavated soils will be transported offsite and disposed of at an NMOCD-approved or permitted facility. Confirmation floor and sidewall samples will be collected for verification of remedial activities, and analyzed for TPH, BTEX and chloride. Once the sample results are received, NMOCD will be notified and the excavation will then be backfilled with clean material to surface grade. The estimated volume of material to be remediated is 135 cubic yards.

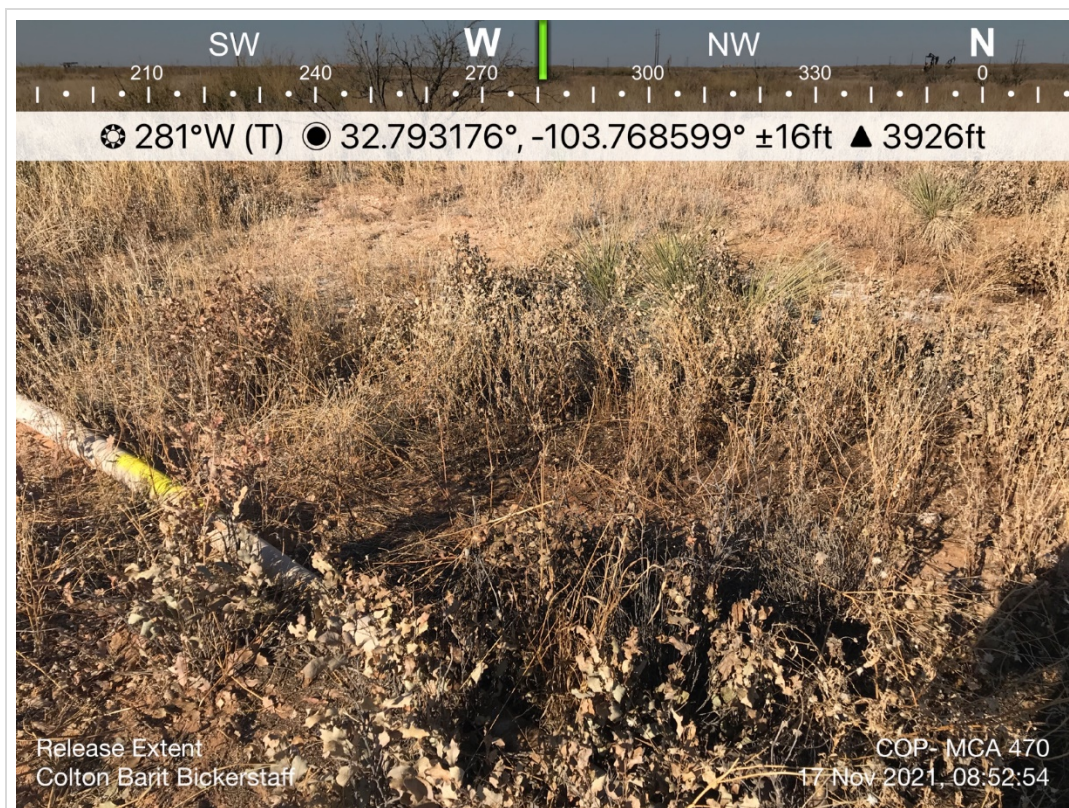
TETRA TECH, INC. PROJECT NO. 212C-MD-02617	DESCRIPTION	Impacted release area, near the release point.	5
	SITE NAME	ConocoPhillips MCA 470	11/17/2021

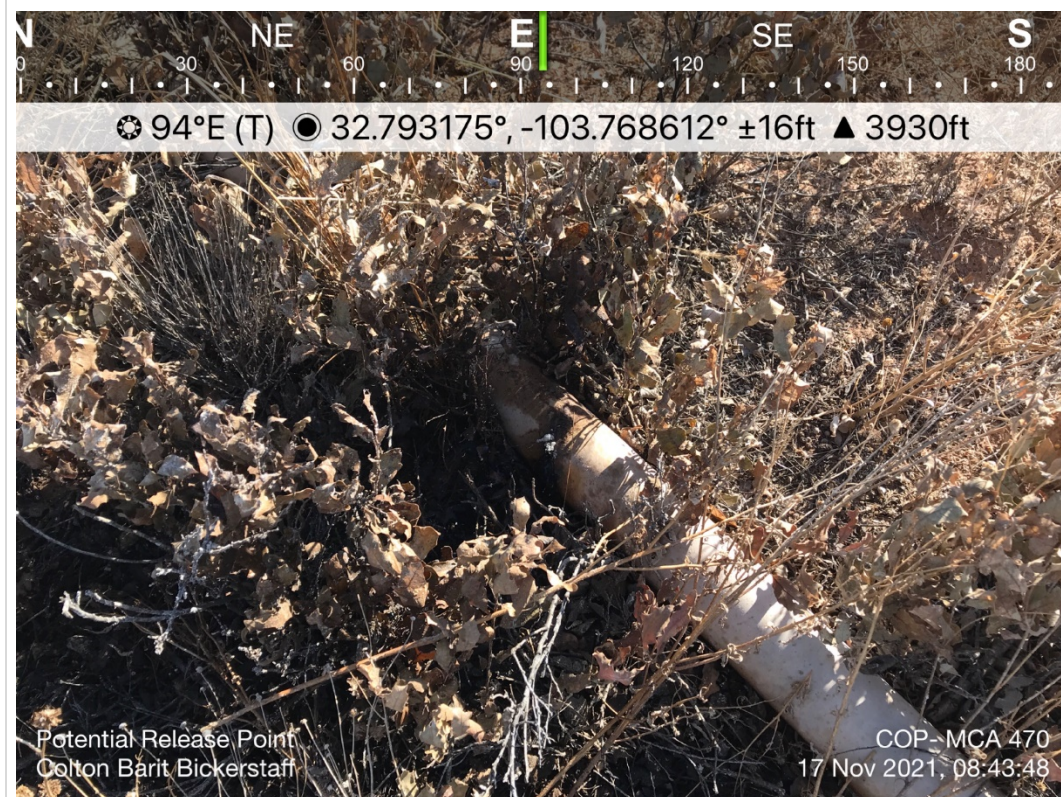
Cause of Release **MSO was checking his weekend route and found a flowline leak in the field. The line was traced back to the MCA 470. The leak resulted in a 6 bbl oil spill**

TETRA TECH, INC. PROJECT NO. 212C-MD-02617	DESCRIPTION	Ruptured flowline	6
	SITE NAME	ConocoPhillips MCA 470	11/17/2021

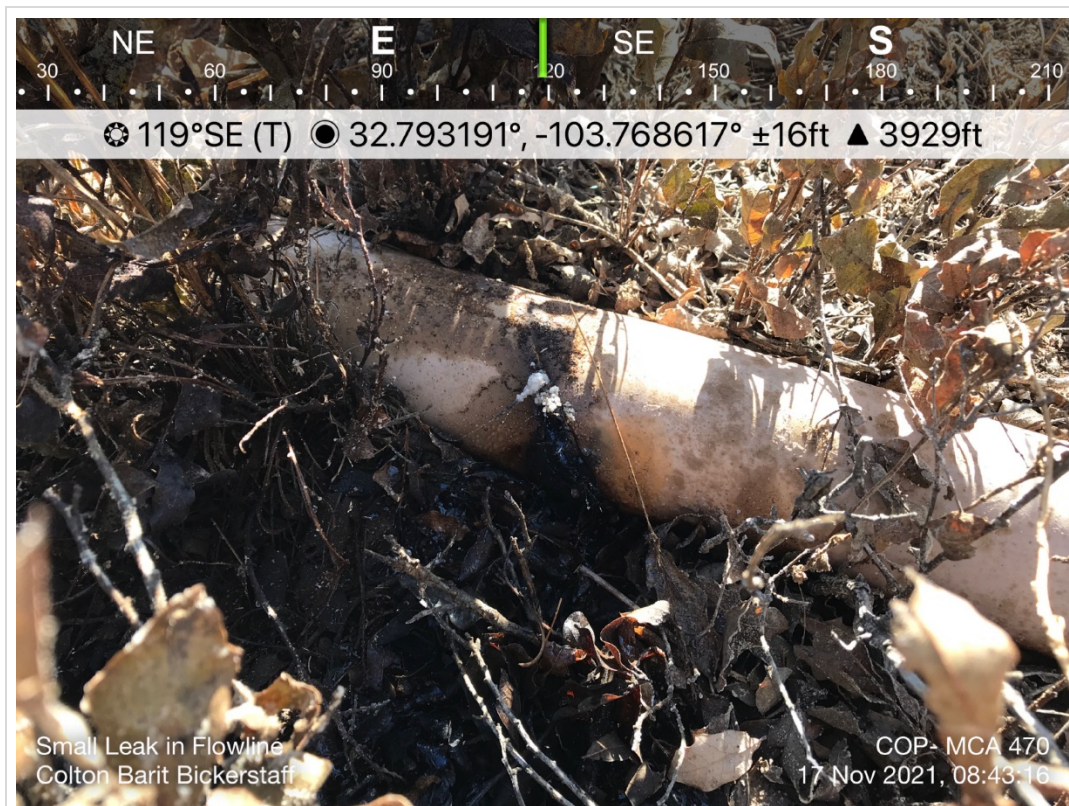
TETRA TECH, INC. PROJECT NO. 212C-MD-02617	DESCRIPTION	Ruptured flowline	7
	SITE NAME	ConocoPhillips MCA 470	11/17/2021

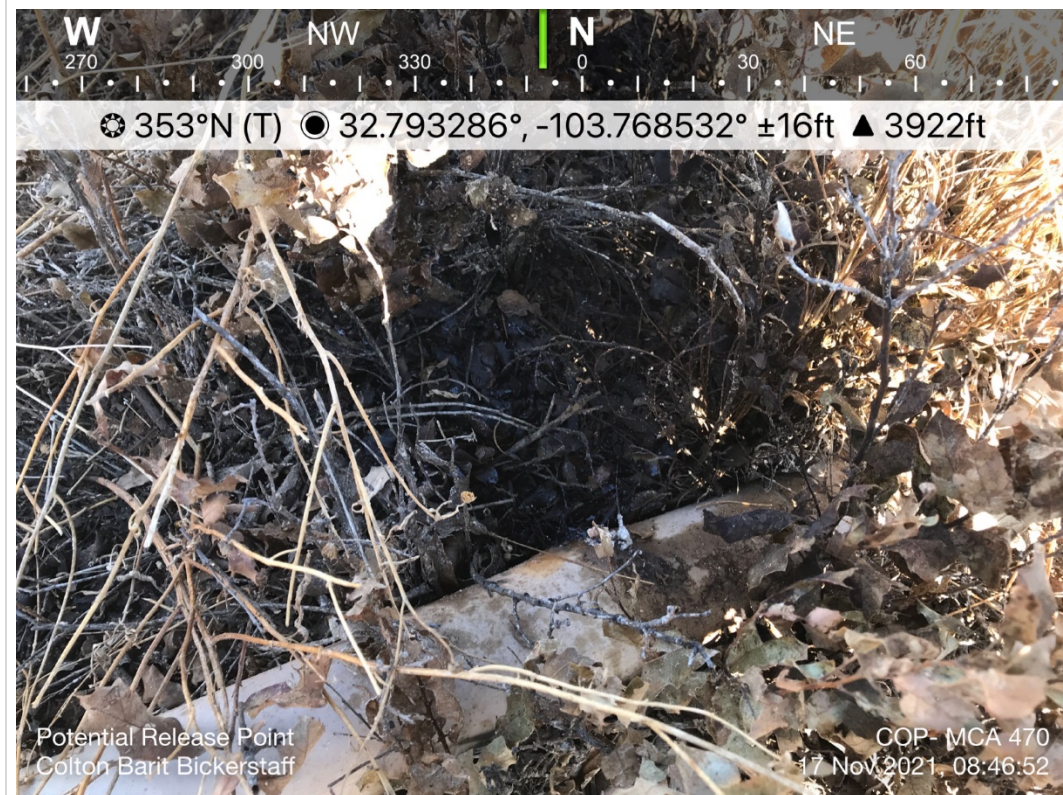
TETRA TECH, INC. PROJECT NO. 212C-MD-02617	DESCRIPTION	Ruptured flowline	8
	SITE NAME	ConocoPhillips MCA 470	11/17/2021
