Vertex Project #: 21E-02589-001

**Spill Closure Report:** Rushing Intersection (Section 7, Township 19 South, Range 25 East)  
API: N/A  
County: Eddy  
Incident Report: nAPP2123949031

**2021 Spill Assessment and Closure**  
January 2022

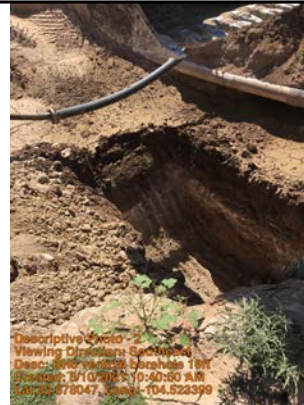
BH5 vertical borehole 20ft

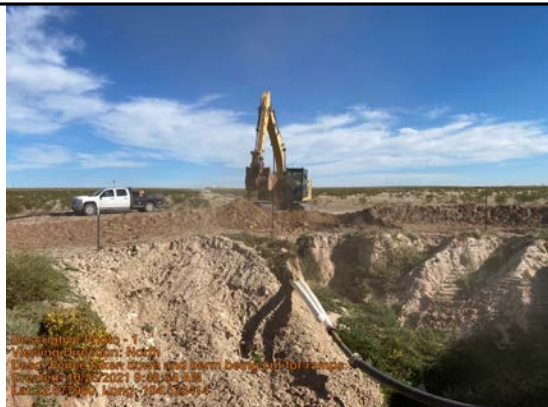
Fence taken down and berm being cut for ramps

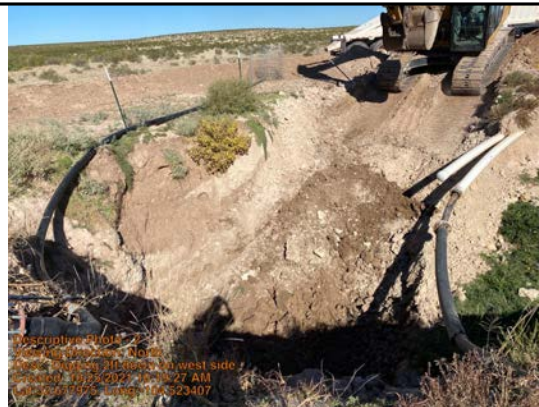
Digging 2ft down on west side

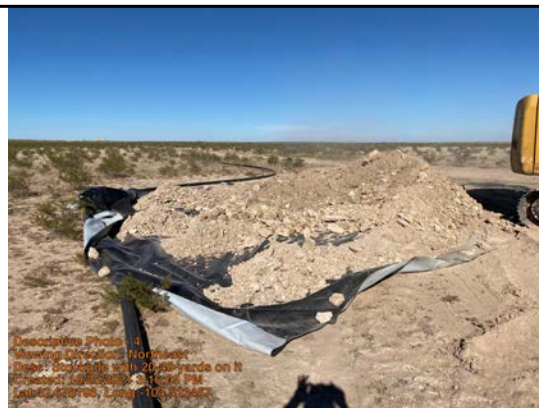
Stockpile with 20-40 yards on it

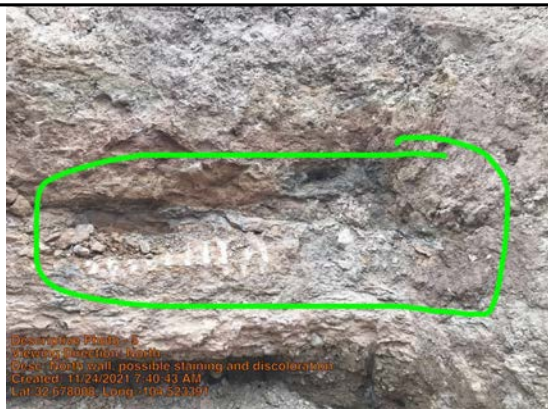
Observative Photo - 7  
Viewing Direction: North  
Date: 11/24/2021 7:40:43 AM  
Created: 11/24/2021 7:40:43 AM  
Lat: 32.578000, Long: -104.522500

**7:40** I see maybe a small amount of staining/discoloration on the north wall. And possibly the South wall.

North wall, possible staining and discoloration

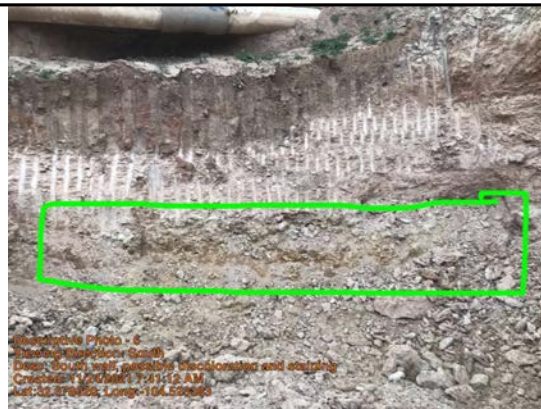
Observative Photo - 8  
Viewing Direction: South  
Date: 11/24/2021 7:41:13 AM  
Created: 11/24/2021 7:41:13 AM  
Lat: 32.578000, Long: -104.522500

South wall, possible discoloration and staining

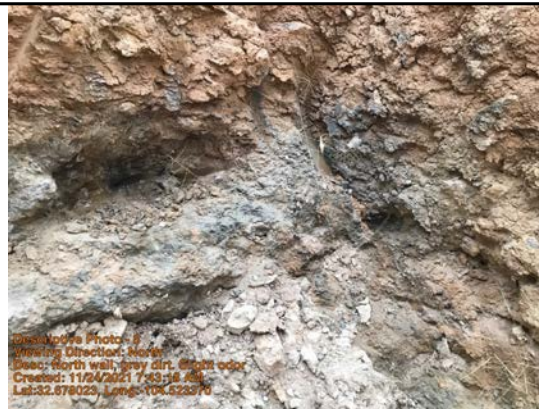
North wall, grey dirt. Slight odor

An additional sampling notification was provided to NMOCD on December 2, 2021, and is included in Attachment 6. One additional confirmatory sample was collected from the north wall of the excavation where staining was visually observed by the landowner and was addressed. The area of soil staining was removed from underneath the flowlines and field screened to confirm the sample was below allowable concentration levels.

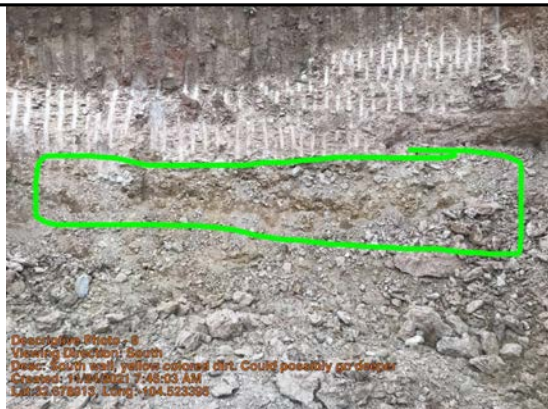
South wall, yellow colored dirt. Could possibly go deeper

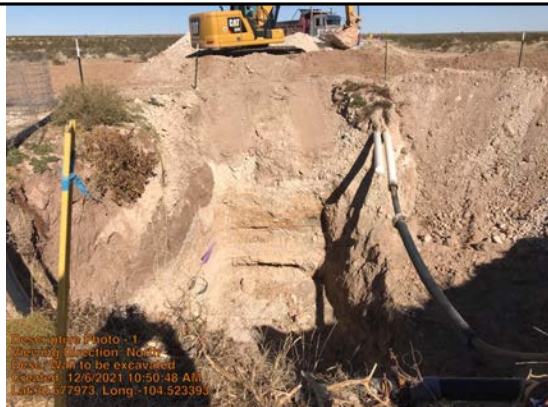
- 10:40** On location to excavate portion of wall that was said to have visual staining. Area will be taken out, sampled, and field screened to verify clean and sent in for lab analysis
- 12:25** Staining in wall area still visible. Will continue excavation to remove staining when we arrive back on location

Wall to be excavated

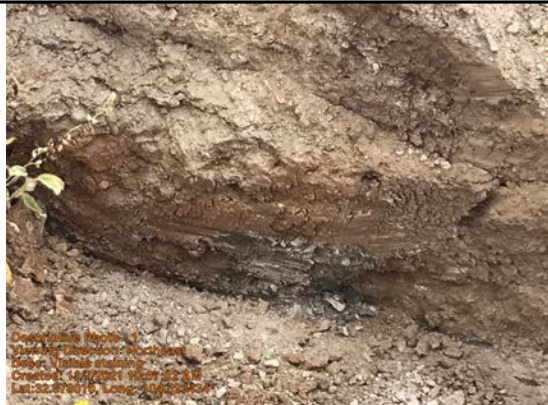
Visible staining

**9:33** Finish excavation of visible staining in north sidewall

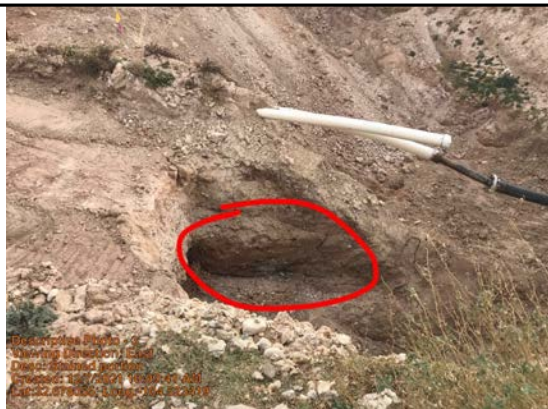
Stained portion

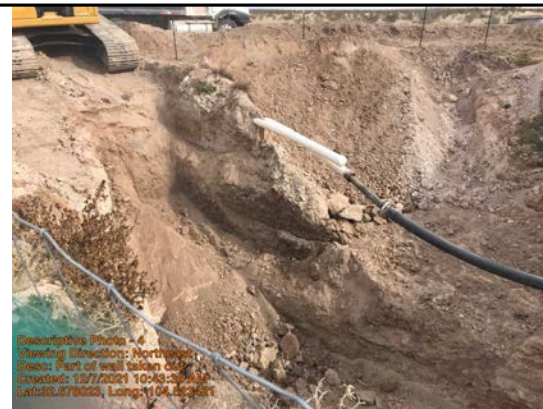
Part of wall taken out

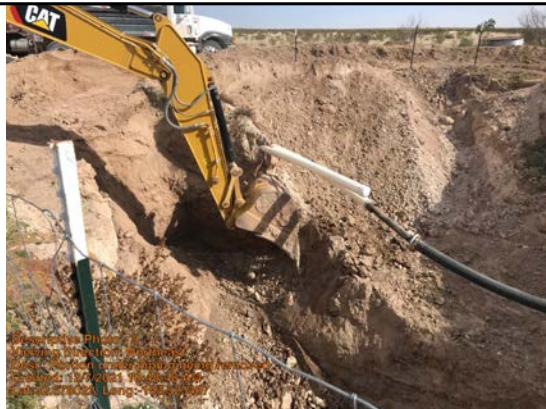
**10:50** Soil has a definite change in color as staining is removed. Collection of sample to be taken from underneath flowlines

Portion under piping being removed

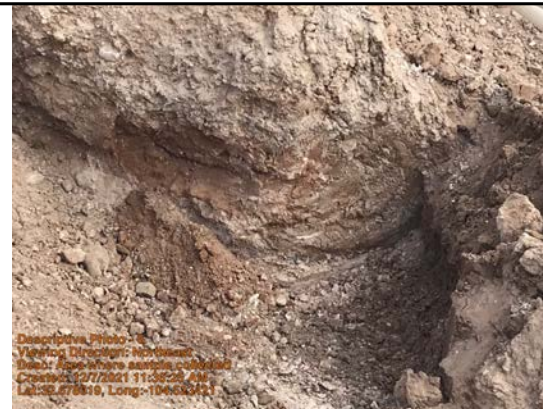
**11:27** Wall sample taken at a depth of 10 feet to assess the area with visible staining. Low PID reading at 0.5. Titration ran at 85 and petroflag came back at 26

Area where sample collected

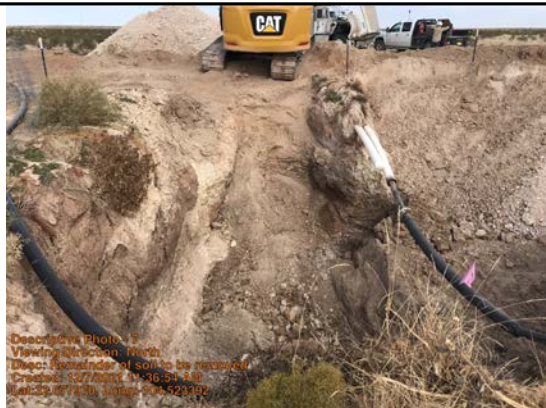
Remainder of soil to be removed
