**RE: Closure Request  
Tusk Federal 002H  
Incident Number NAPP2131927902  
Lea County, New Mexico**

WSP USA Inc. (WSP) on behalf of COG Operating, LLC (COG), presents the following Closure Request detailing site assessment and soil sampling activities at the Tusk Federal 002H (Site) in Unit D, Section 25, Township 19 South, Range 34 East, in Lea County, New Mexico (Figure 1). The purpose of the site assessment and soil sampling activities was to assess for the presence or absence of impacts to soil following a release of crude oil within lined containment at the Site. Based on field observations, field screening activities, and soil sample laboratory analytical results, COG is submitting this Closure Request and requesting no further action (NFA) for Incident Number NAPP2131927902.

COG Operating, LLC	Tusk Federal 002H Lea County, New Mexico	NAPP2131927902
--------------------	---	----------------

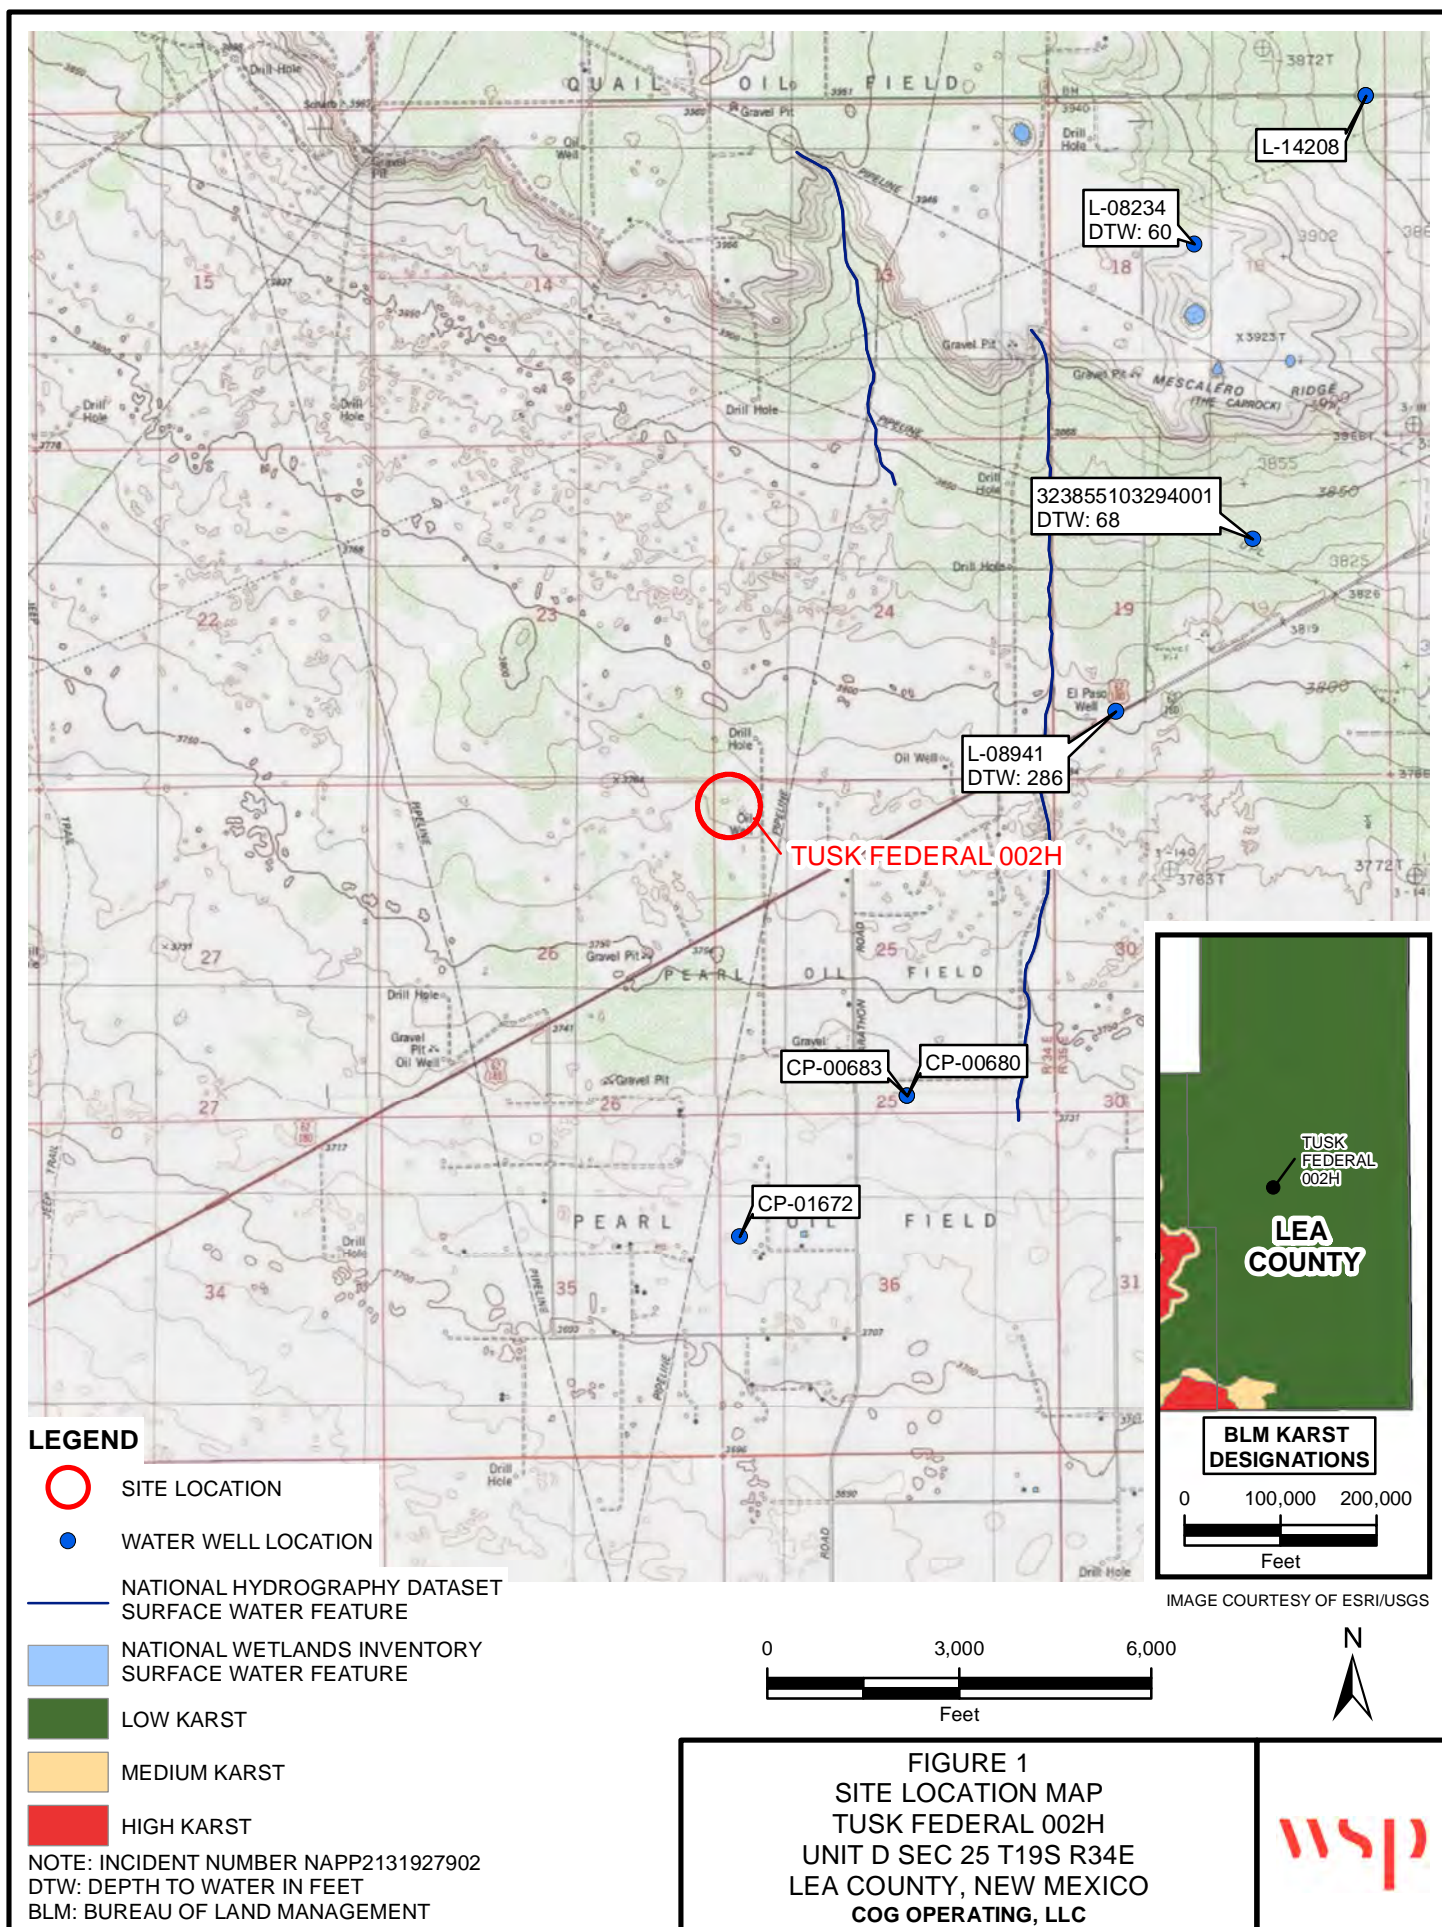
well with depth to groundwater data is New Mexico Office of the State Engineer (NMOSE) well L-08941. The well is located approximately 6,247 feet northeast of the site. The groundwater well has a reported depth to groundwater of 286 feet bgs and a total depth of 600 feet bgs. Ground surface elevation at the groundwater well location is 3,804 feet amsl, which is approximately 27 feet higher in elevation than the Site. All wells used for depth to groundwater determination are depicted on Figure 1 and referenced well records are provided in Attachment 1.

The closest continuously flowing or significant watercourse to the Site is an unnamed dry wash, located approximately 5,548 feet northeast of the Site. The Site is greater than 200 feet from a lakebed, sinkhole, or playa lake and greater than 300 feet from an occupied residence, school, hospital, institution, church, or wetland. The Site is greater than 1,000 feet to a freshwater well or spring and is not within a 100-year floodplain or overlying a subsurface mine. The Site is not underlain by unstable geology (low potential karst designation area). Site receptors are identified on Figure 1.

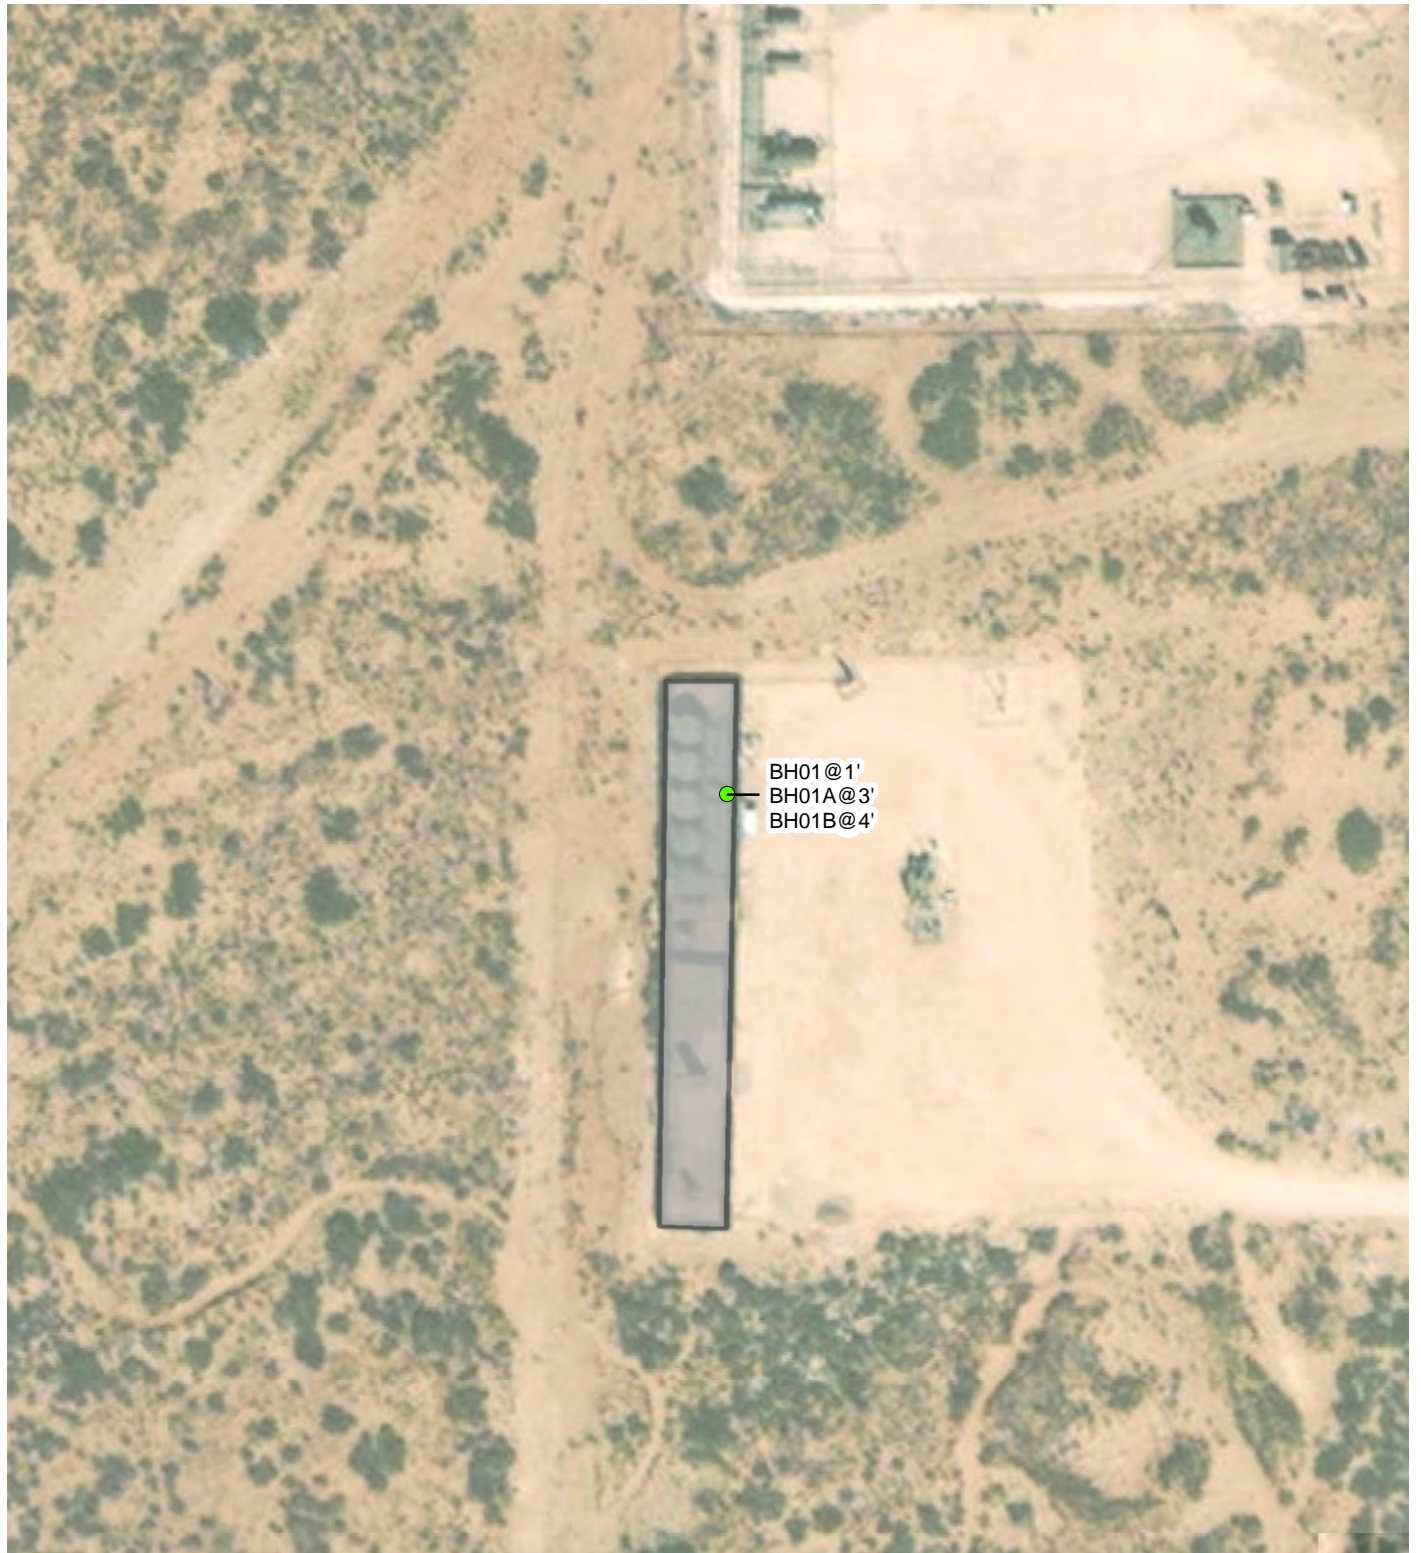
**FIGURE 2**  
**DELINEATION SOIL SAMPLE LOCATIONS**  
TUSK FEDERAL 002H  
UNIT D SEC 25 T19S R34E  
LEA COUNTY, NEW MEXICO  
COG OPERATING, LLC

On December 8, 2021, WSP personnel visited the Site to evaluate the release and conduct site assessment activities. WSP personnel advanced one borehole (BH01) via hand-auger at the location of the tear in the liner identified during the liner integrity inspection. Three soil samples were collected from the borehole at depths of approximately 1 foot, 3 feet, and 4 feet bgs. Soil from the borehole was field screened for volatile aromatic hydrocarbons and chloride utilizing a calibrated photo-ionization detector (PID) and Hach® chloride QuanTab® test strips, respectively. Field screening results and observations from the borehole were documented on a lithologic/soil sampling log, which is included as Attachment 2. The borehole was backfilled with the soil removed and a COG contractor repaired the tear in the liner. The borehole location is depicted on Figure 2. Photographic documentation was conducted during the Site visit. A photographic log is included in Attachment 3.

Laboratory analytical results for delineation soil samples BH01, BH01A, and BH01B indicated that benzene, BTEX, TPH-DRO/TPH-GRO, TPH, and chloride concentrations were compliant with the Site Closure Criteria. In addition, delineation soil samples BH01A and BH01B collected at 3 feet and 4 feet bgs were compliant with the most stringent Table 1 Closure Criteria. Laboratory analytical results are summarized in Table 1 and the complete laboratory analytical report is included as Attachment 4.

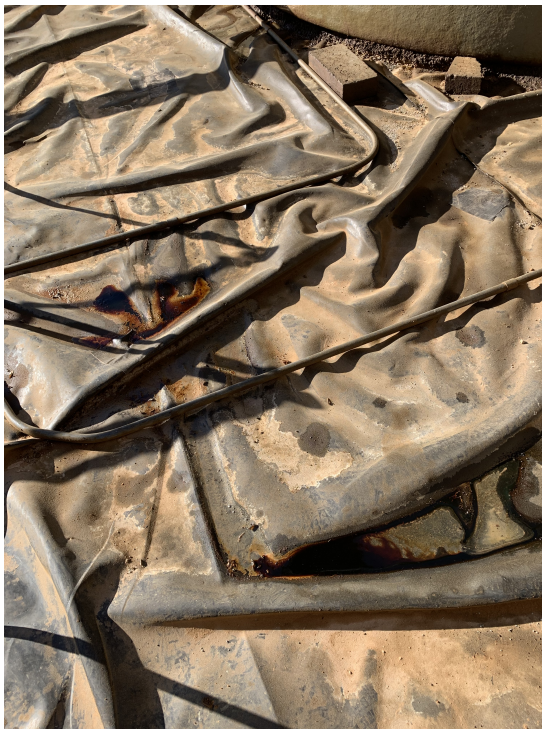
On October 26, 2021, a valve was left open while sealing a tank, causing approximately 25 barrels (bbls) of crude oil to release into the lined containment. A vacuum truck was immediately dispatched to the Site to recover free-standing fluids; all 25 bbls of the released crude oil was recovered from within the lined containment. COG reported the release immediately to the New Mexico Oil Conservation Division (NMOCD) via email on October 26, 2021, and submitted a Release Notification Form C-141 on November 9, 2021. The release was assigned Incident Number NAPP2131927902. A 48-hour advance notice of liner inspection was provided via email on November 16, 2021 to the NMOCD District I office. A liner integrity inspection was conducted by WSP personnel on November 18, 2021 and upon inspection, the liner was determined to be insufficient.

Photo No.	Date	
1	November 18, 2021	
View of hole found in the compromised liner.

Following the failed liner integrity inspection at the Site, WSP personnel advanced one borehole (BH01) within the lined containment to assess for the presence or absence of impacted soil resulting from the October 26, 2021 crude oil release within lined containment. Three delineation soil samples were collected from borehole BH01, at depths of approximately, 1 foot, 3 feet, and 4 feet bgs. Laboratory analytical results for the delineation soil samples indicated that benzene, BTEX, TPH-DRO/TPH-GRO, TPH and chloride concentrations were compliant with the Site Closure Criteria. In addition, delineation soil samples BH01A and BH01B collected at 3 feet and 4 feet bgs were compliant with the most stringent Table 1 Closure Criteria. The release was contained laterally by the lined containment and all released fluids were recovered during initial response activities. The tear in the liner was subsequently repaired.

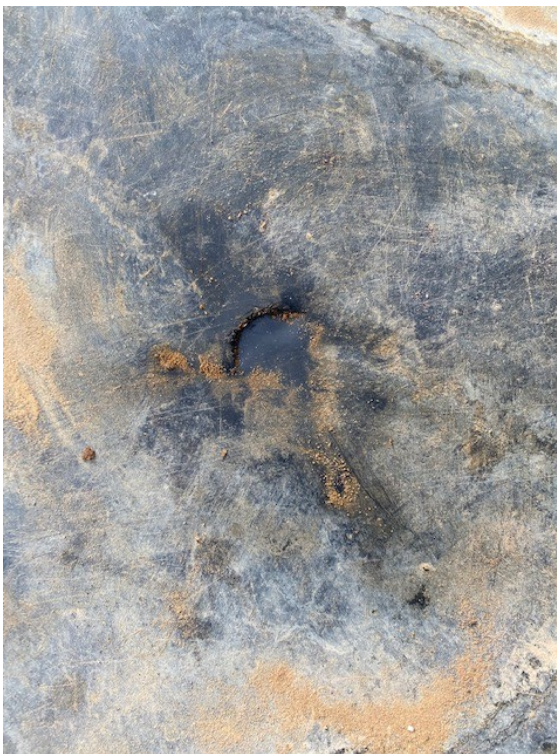
Photo No.	Date	
2	November 18, 2021	
View of hole found in the compromised liner.

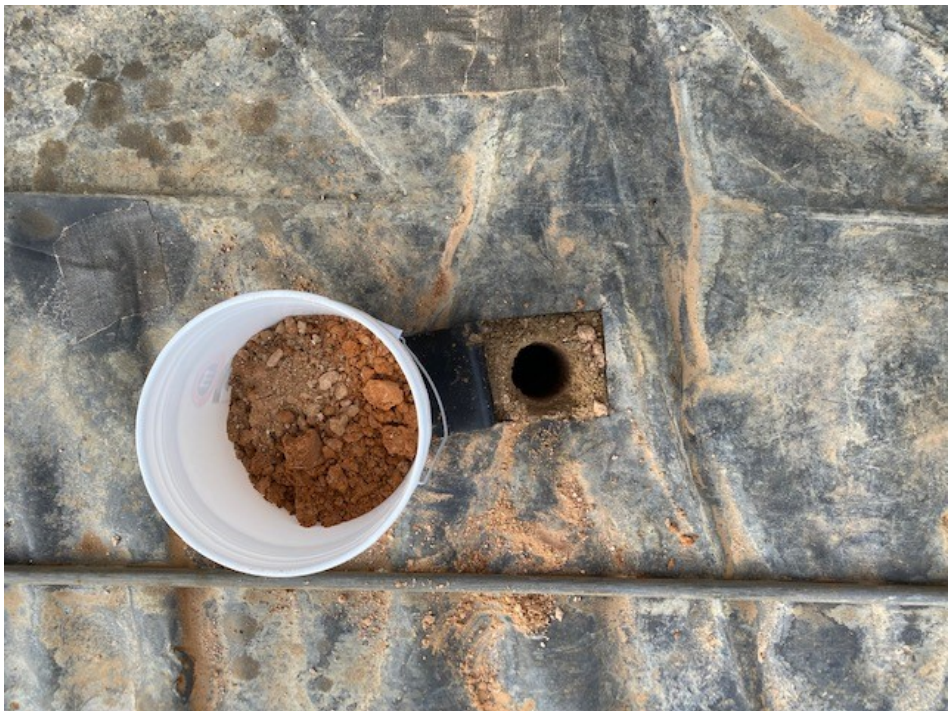
Photo No.	Date	
3	December 8, 2021	
View of borehole location inside the liner.
