Incident ID	nAPP2125031738
District RP	
Facility ID	
Application ID

Based on laboratory analytical results and field activities conducted to date, Etech recommends Mewbourne Oil Company, provide copies of this *Remediation Summary & Soil Closure Request* to the appropriate agencies and request closure be granted to the Slider 18 release site.

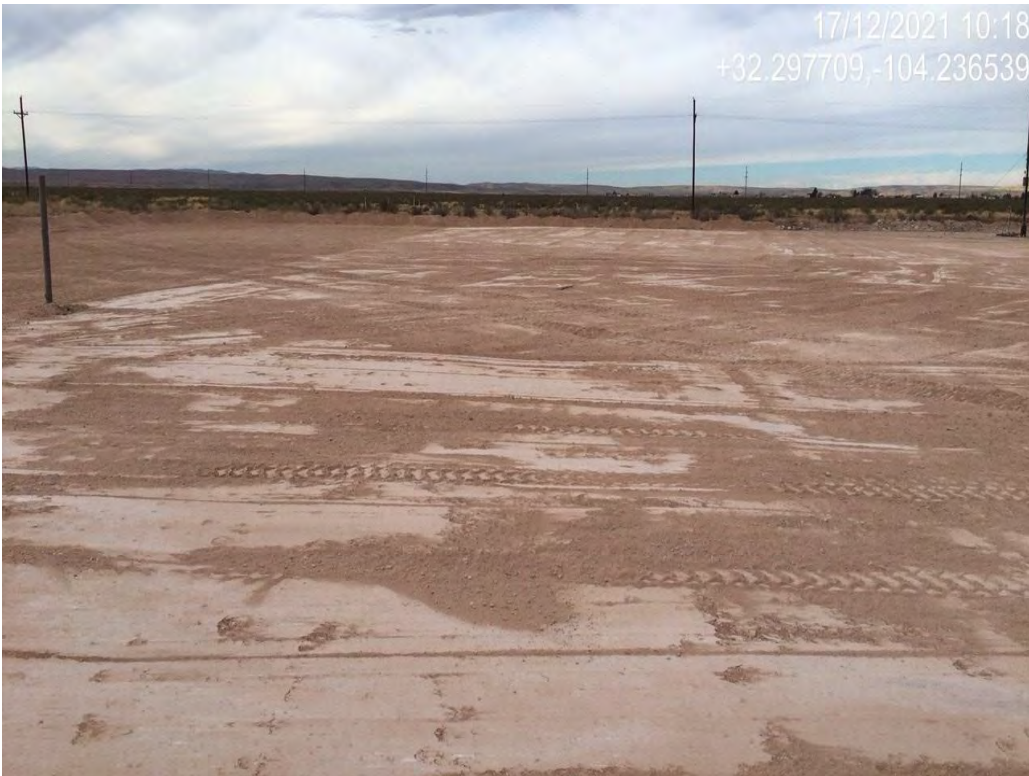
<b>Photo Number:</b> 10

<b>Photo Direction:</b> South	
<b>Photo Description:</b>  View of the remediated area after backfill and regrading.

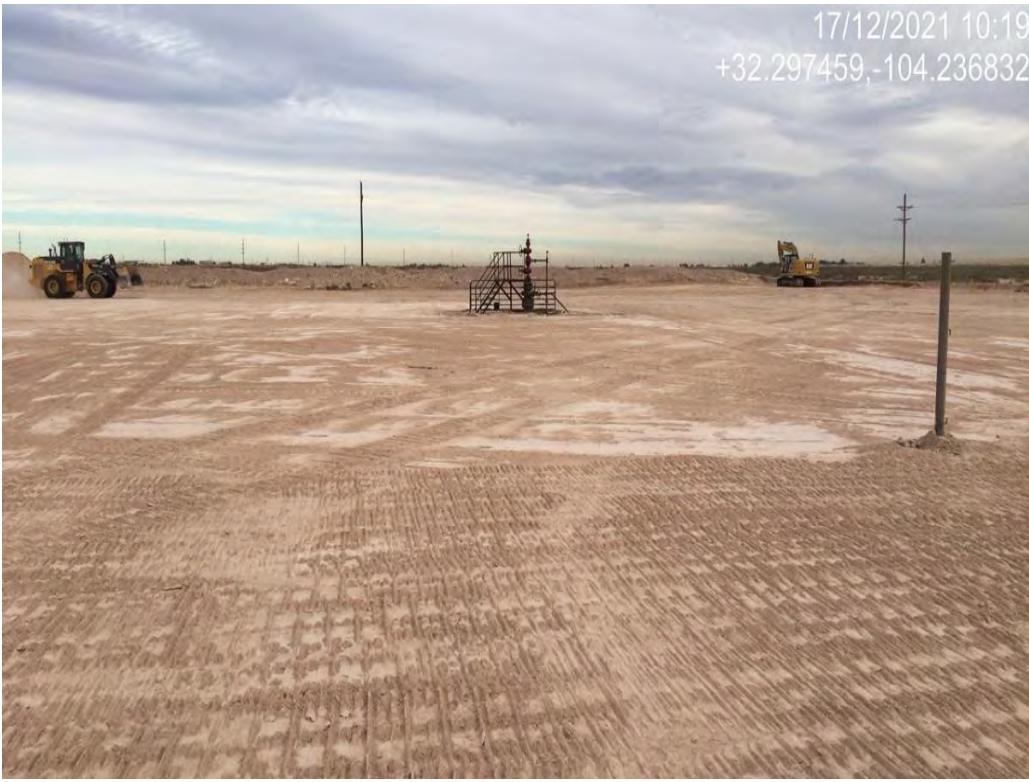
<b>Photo Number:</b> 11

<b>Photo Direction:</b> North	
<b>Photo Description:</b>  View of the remediated area after backfill and regrading.

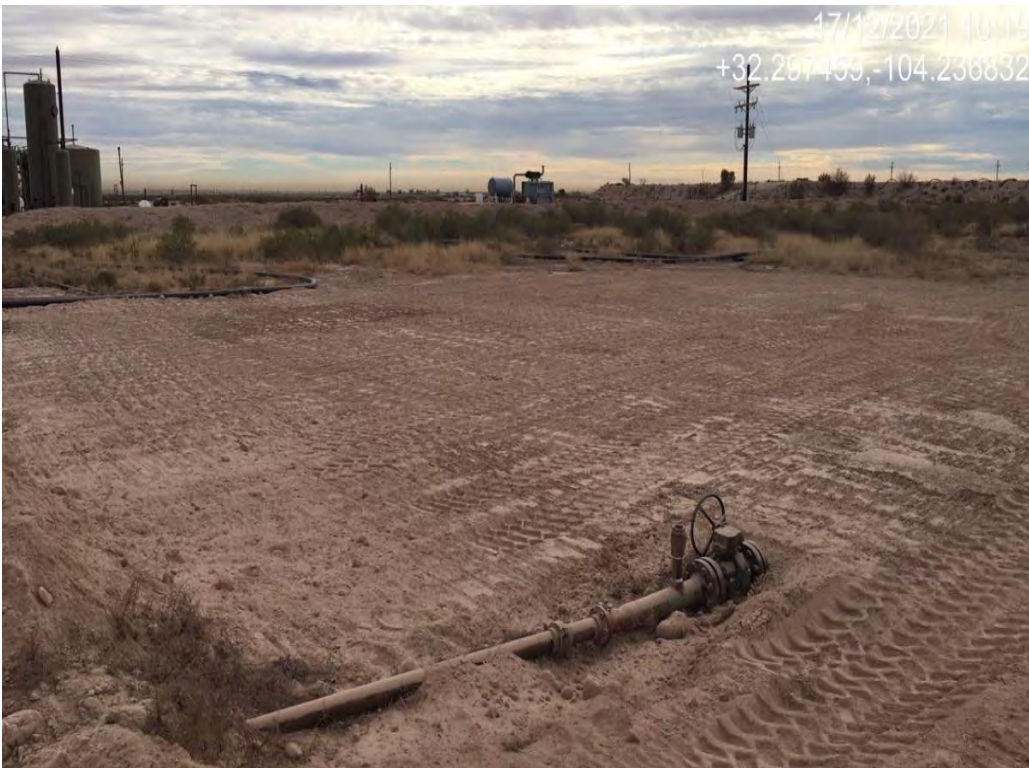
<b>Photo Number:</b> 12

<b>Photo Direction:</b> Southeast	
<b>Photo Description:</b>  View of the remediated area after backfill and regrading.
