**RE: Closure Request  
White Falcon 16 State 001H  
Incident Number NAPP2130853724  
Lea County, New Mexico**

WSP USA Inc. (WSP), on behalf of COG Operating, LLC (COG), presents the following Closure Request detailing site assessment and soil sampling activities at the White Falcon 16 State 001H (Site) in Unit D, Section 16, Township 25 South, Range 35 East, in Lea County, New Mexico (Figure 1). The purpose of the site assessment and soil sampling activities was to assess for the presence or absence of impacts to soil following a crude oil flare fire at the Site. Based on field observations, site assessment activities, and soil sample analytical results, COG is submitting this Closure Request, and requesting no further action (NFA) for Incident Number NAPP2130853724.

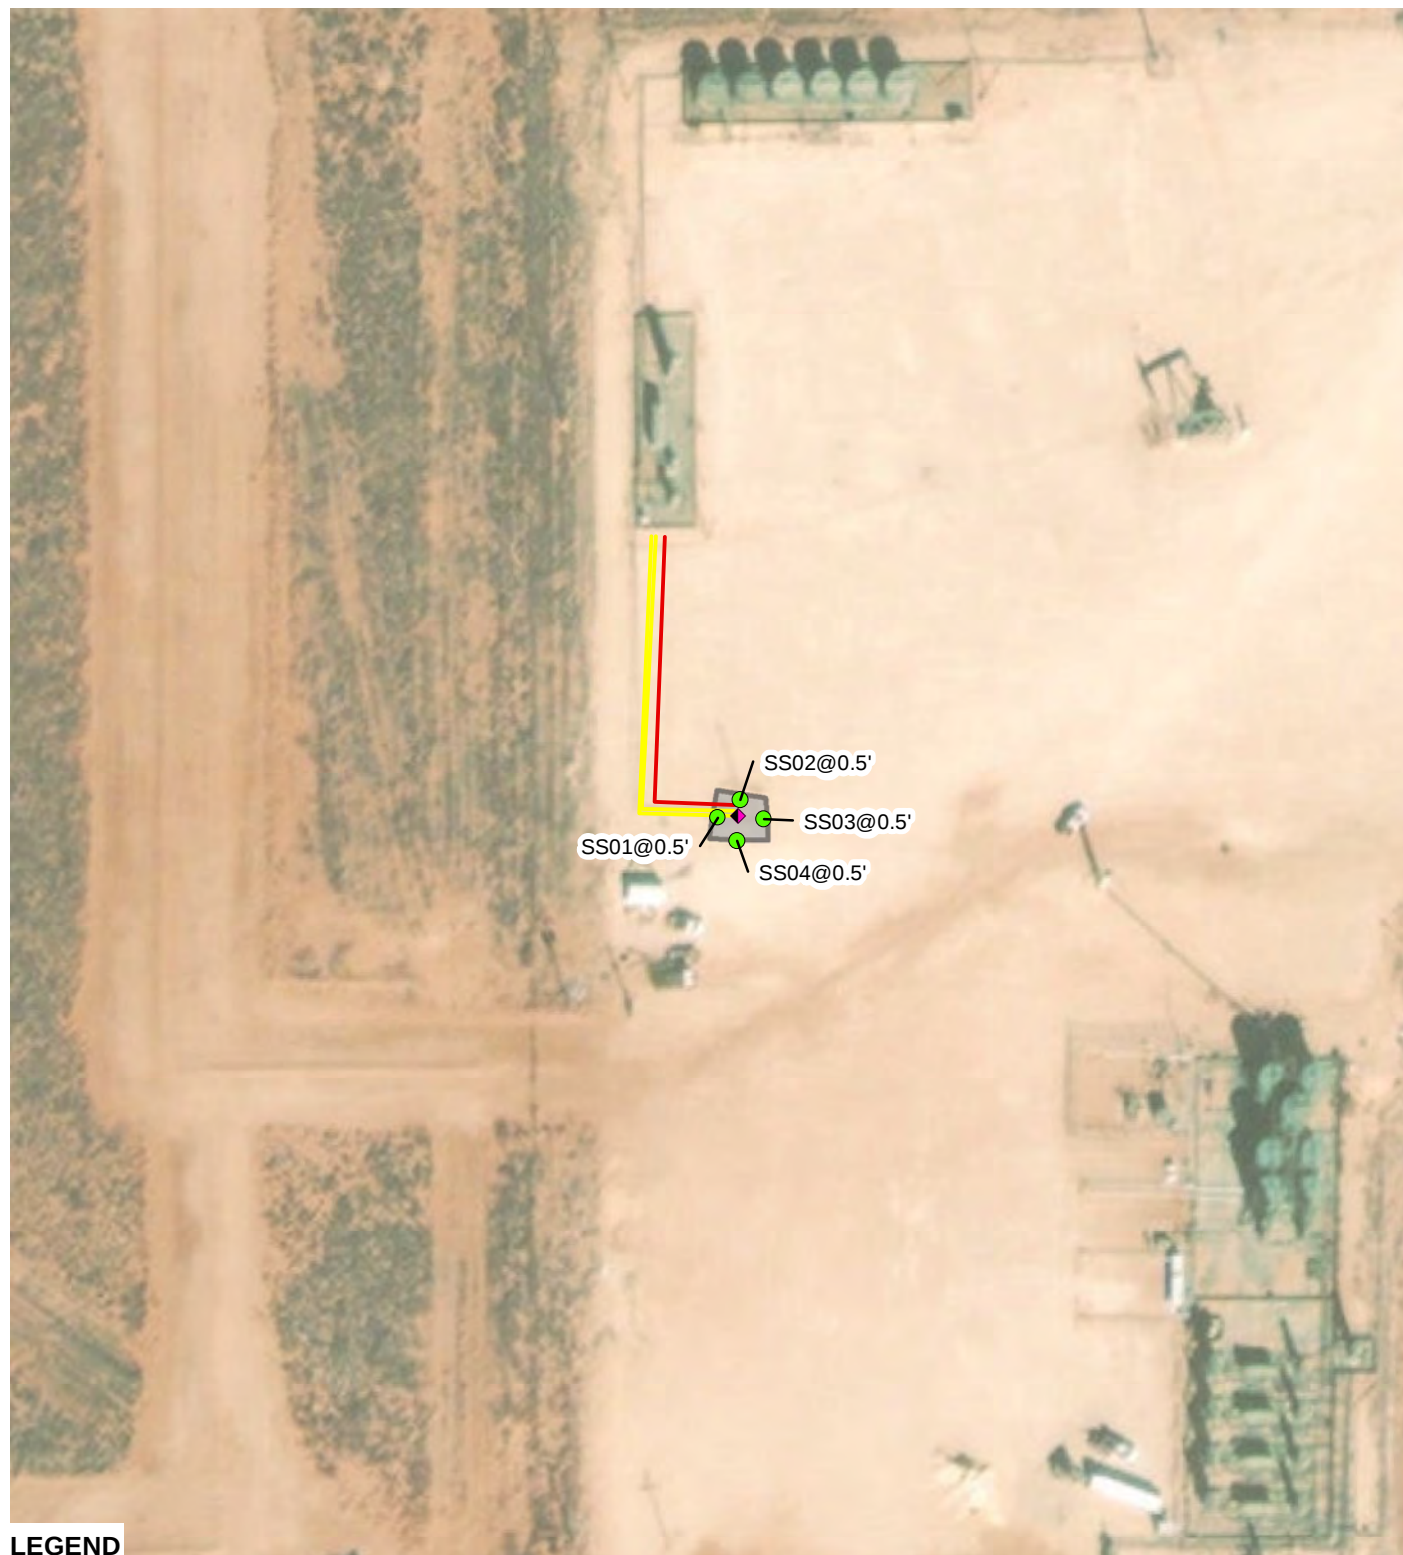
**FIGURE 2**  
**SOIL SAMPLE LOCATIONS**  
**WHITE FALCON 16 STATE 001H**  
**UNIT D SEC 16 T25S R35E**  
**LEA COUNTY, NEW MEXICO**  
**COG OPERATING, LLC**

Laboratory analytical results for assessment soil samples SS01 through SS04, collected near the flare stack, indicated that benzene, BTEX, TPH-GRO/TPH-DRO, TPH, and chloride concentrations were compliant with the Site Closure Criteria. In addition, all assessment soil samples were compliant with the most stringent Table 1 Closure Criteria. Laboratory analytical results are summarized in Table 1 and the complete laboratory analytical report is included as Attachment 3.

● PRELIMINARY SOIL SAMPLE IN COMPLIANCE WITH APPLICABLE CLOSURE CRITERIA

◆ FLARE STACK

■ FLARE STACK PERIMETER

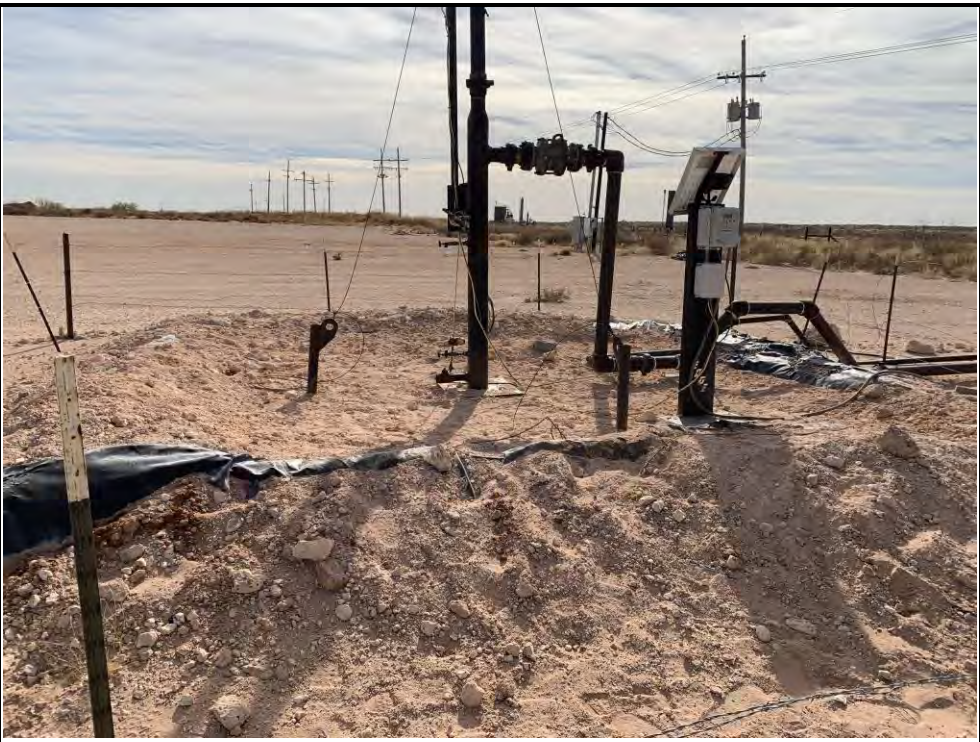
| Photo No. | Date | |
|---|---|---|
| View of release area during the initial site visit. | | A photograph showing a desert landscape with a large, dark, irregularly shaped area of disturbed earth or a spill in the foreground. In the background, there are several tall, dark metal structures, possibly part of a well or a pumpjack, and a line of power poles stretching across the horizon under a cloudy sky. |
