Incident ID	NRM2030456172
District RP	
Facility ID	
Application ID

**RE: Closure Request
Fruitbasket Lateral
Incident Number NRM2030456172
Lea County, New Mexico**

WSP USA Inc. (WSP), on behalf of Lucid Energy Group (Lucid), is pleased to present the following Closure Request detailing site assessment and delineation activities at the Fruitbasket Lateral (Site) located in Unit D, Section 30, Township 21 South, Range 34 East, in Lea County, New Mexico (Figure 1). The purpose of the site assessment and delineation activities was to assess the presence or absence of impacts to soil following a release of natural gas at the Site. Based on the delineation activities and results of the soil sampling event, Lucid is submitting this Closure Request, describing site assessment and delineation activities that has occurred and requesting no further action (NFA) for Incident Number NRM2030456172.

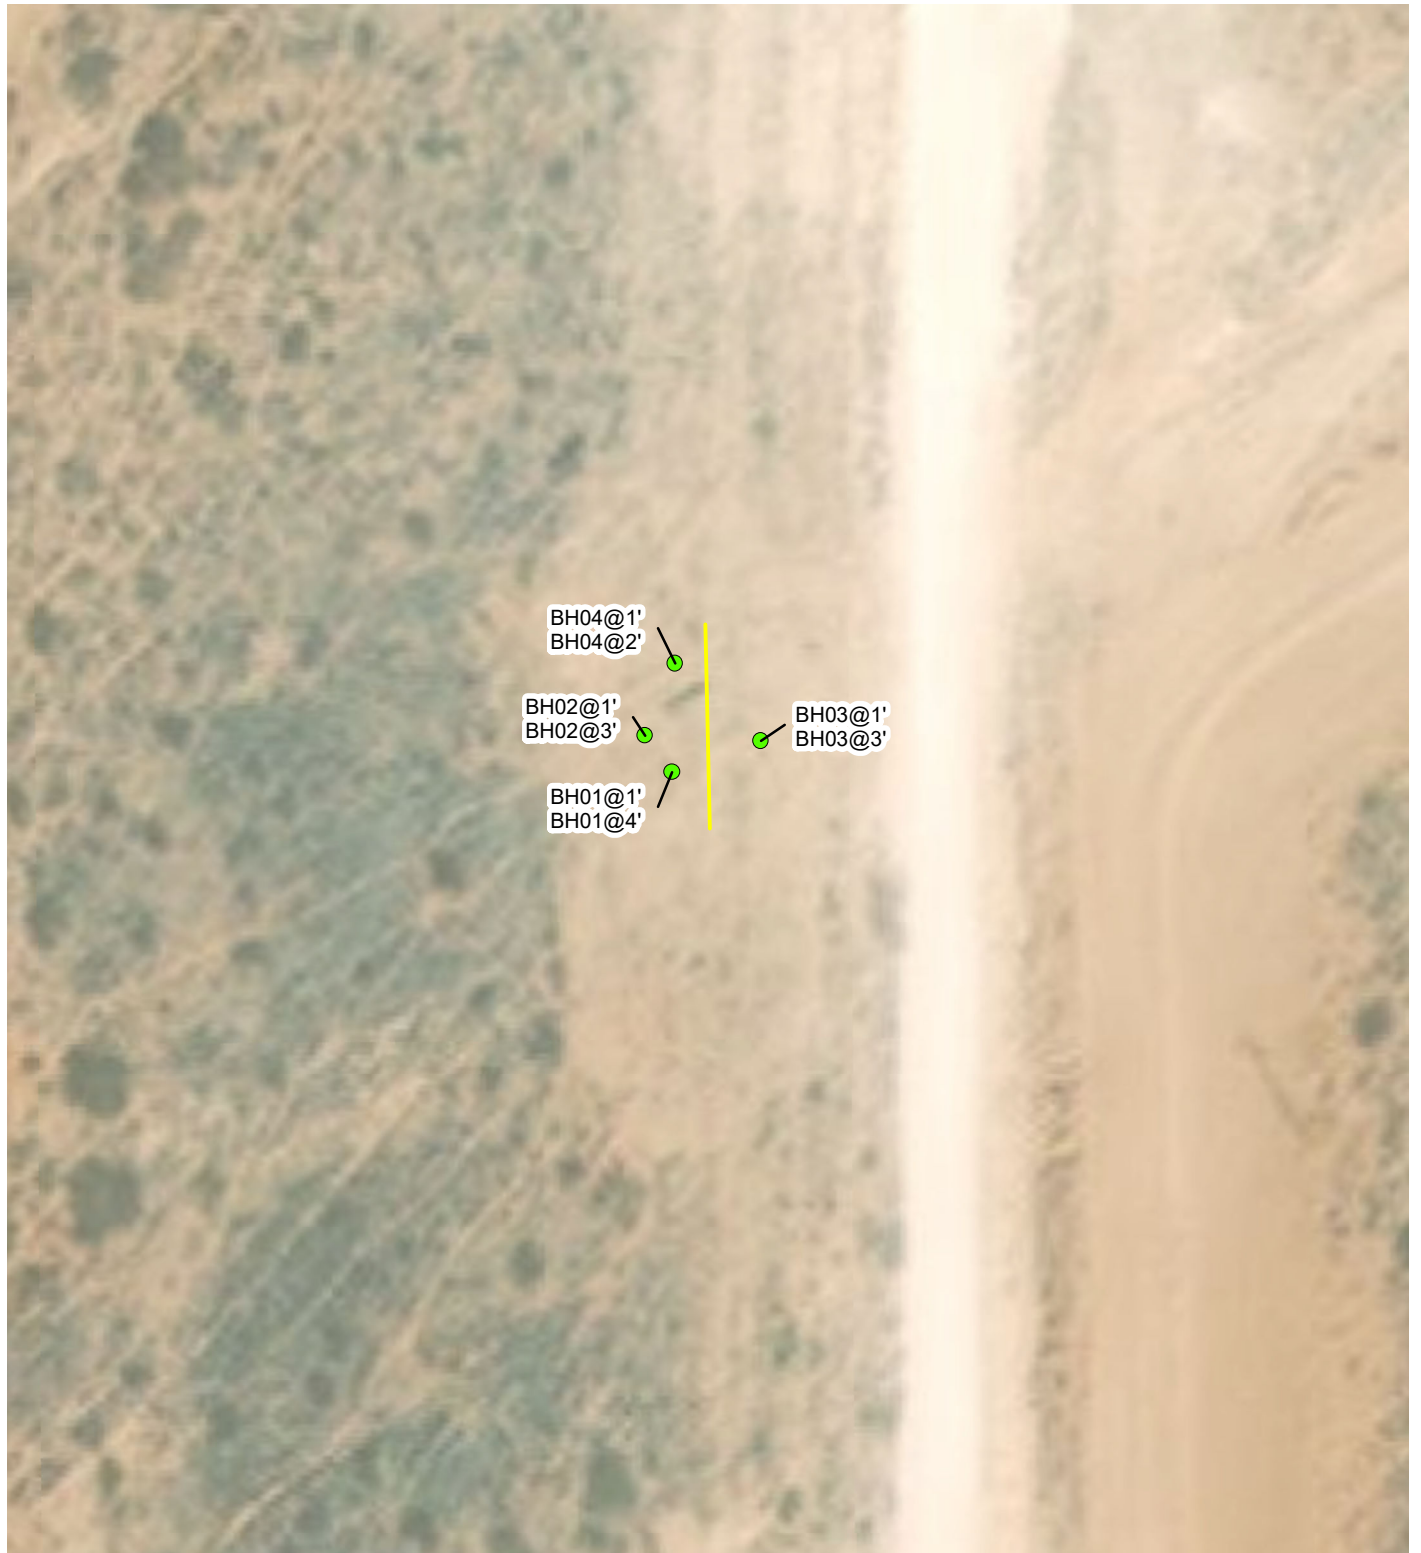
FIGURE 2
DELINEATION SOIL SAMPLE LOCATIONS
FRUITBASKET LATERAL
UNIT D SEC 13 T23S R32E
LEA COUNTY, NEW MEXICO
LUCID ENERGY GROUP

DELINEATION SOIL SAMPLE IN COMPLIANCE
WITH APPLICABLE CLOSURE CRITERIA

NOTE: INCIDENT NUMBER NRM2030456172
SAMPLE ID@DEPTH BELOW GROUND SURFACE (FEET)

samples were transported at or below 4 degrees Celsius (°C), under strict chain-of-custody (COC) procedures to Eurofins Laboratories (Eurofins) in Carlsbad, New Mexico, for analysis of BTEX following United States Environmental Protection Agency (EPA) Method 8021B; TPH following EPA Method 8015M/D; and chloride following EPA Method 300.0. The delineation sample locations were mapped utilizing a handheld GPS unit and are presented on Figure 2. Field screening results and observations for the delineation soil samples were recorded on lithologic/soil sampling logs and are presented in Attachment 2. Photographic documentation is provided in Attachment 3.

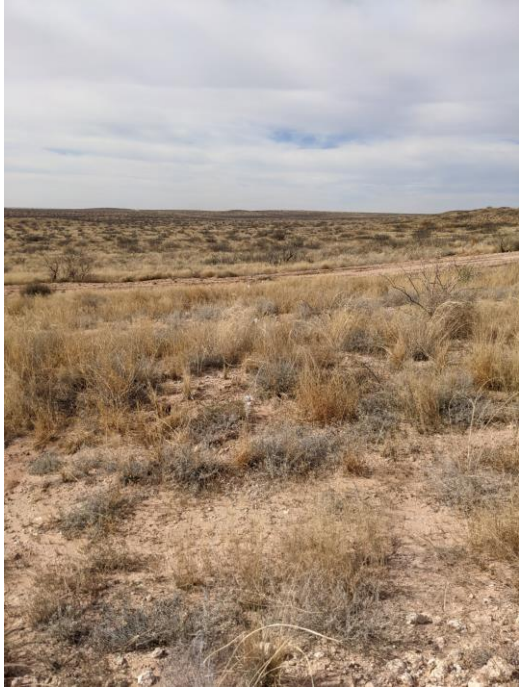
Photo No.	Date	
1	December 17, 2021	
View of the subject release area during delineation activities.

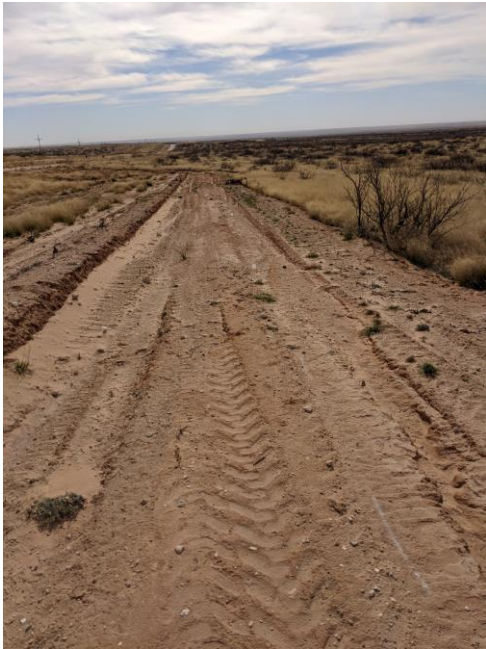
Photo No.	Date	
2	December 17, 2021	
View of the subject release area during delineation activities.
