Remediation Plan

**Re: Release Characterization and Remediation Work Plan
ConocoPhillips
Heritage Concho
Patron 23 Federal 4H Release
Unit Letter K, Section 14, Township 25 South, Range 29 East
Eddy County, New Mexico
2RP-5609
Incident ID# NAB1924840999**

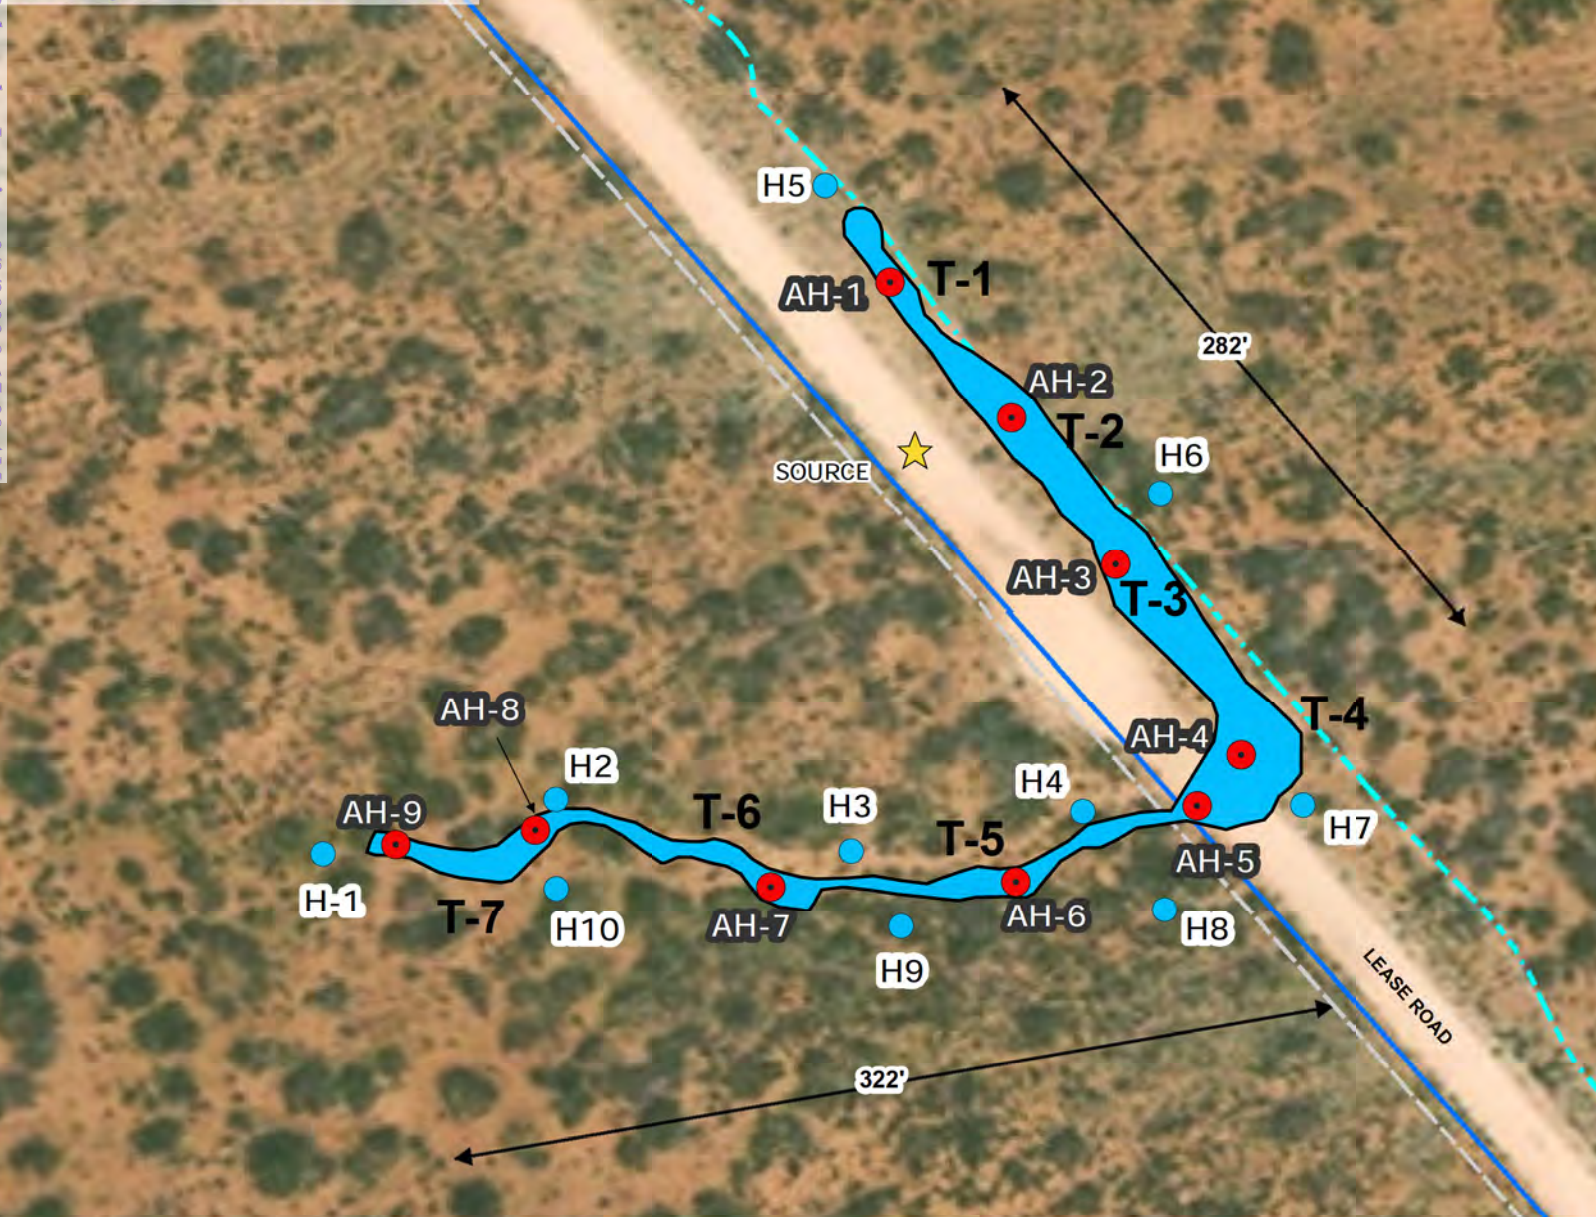
FIGURE
3

AUGER HOLE & HORIZONTAL COORDINATE LOCATIONS	LATITUDE	LONGITUDE
AH-1	32.126682°	-103.956125°
AH-2	32.126539°	-103.955972°
AH-3	32.126382°	-103.955840°
AH-4	32.126173°	-103.955678°
AH-5	32.126112°	-103.955725°
AH-6	32.126012°	-103.955925°
AH-7	32.125980°	-103.956202°
AH-8	32.126027°	-103.956478°
AH-9	32.125996°	-103.956333°
H-1	32.125979°	-103.956721°
H-2	32.126059°	-103.956457°
H-3	32.126027°	-103.956114°
H-4	32.126093°	-103.955859°
H-5	32.126788°	-103.956204°
H-6	32.126466°	-103.955795°
H-7	32.126120°	-103.955606°
H-8	32.125991°	-103.955755°
H-9	32.125948°	-103.955948°
H-10	32.125959°	-103.956448°

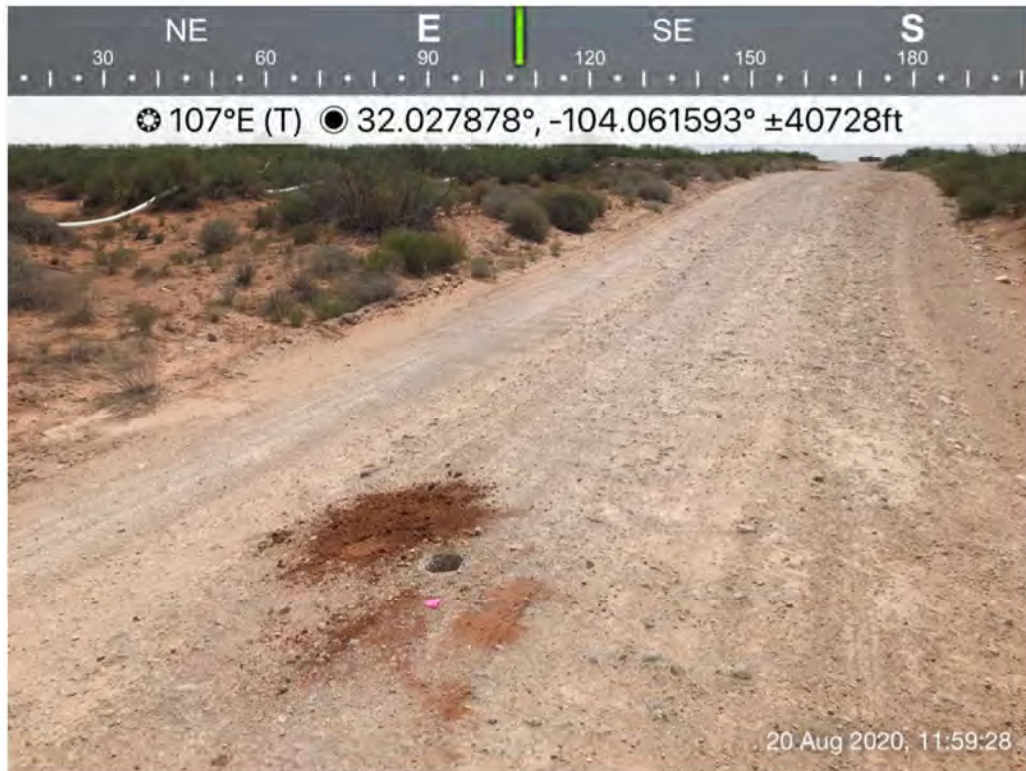
View of Release – View East

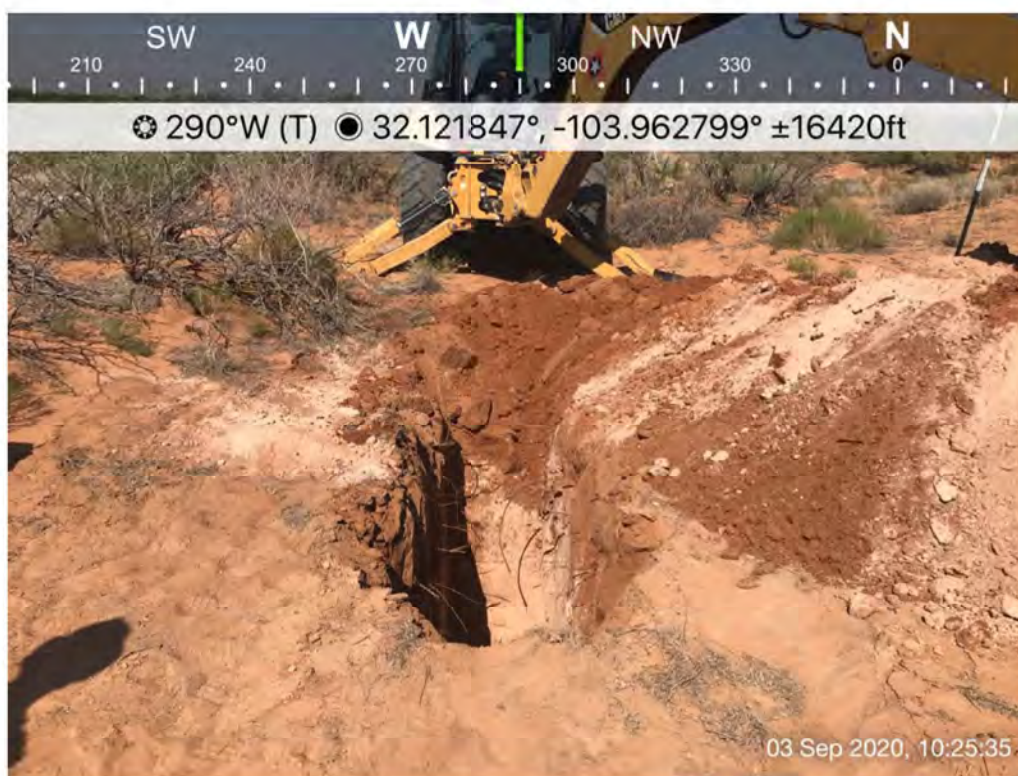
View of Trenching Activities – View West

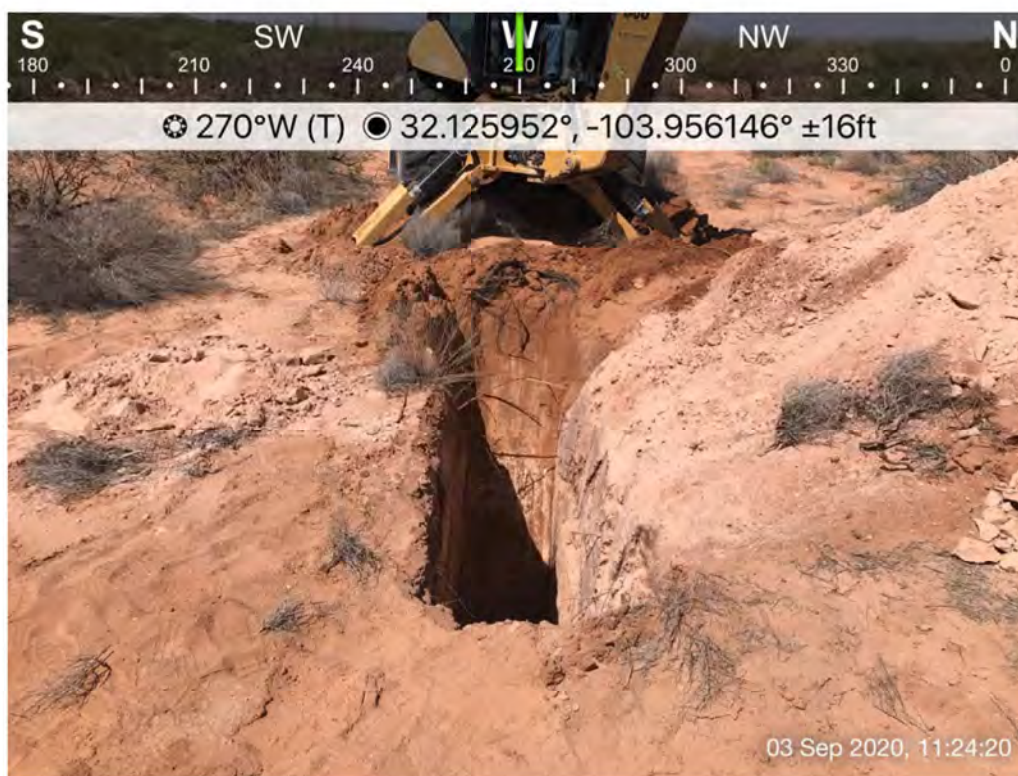
View of Trenching Activities – View West

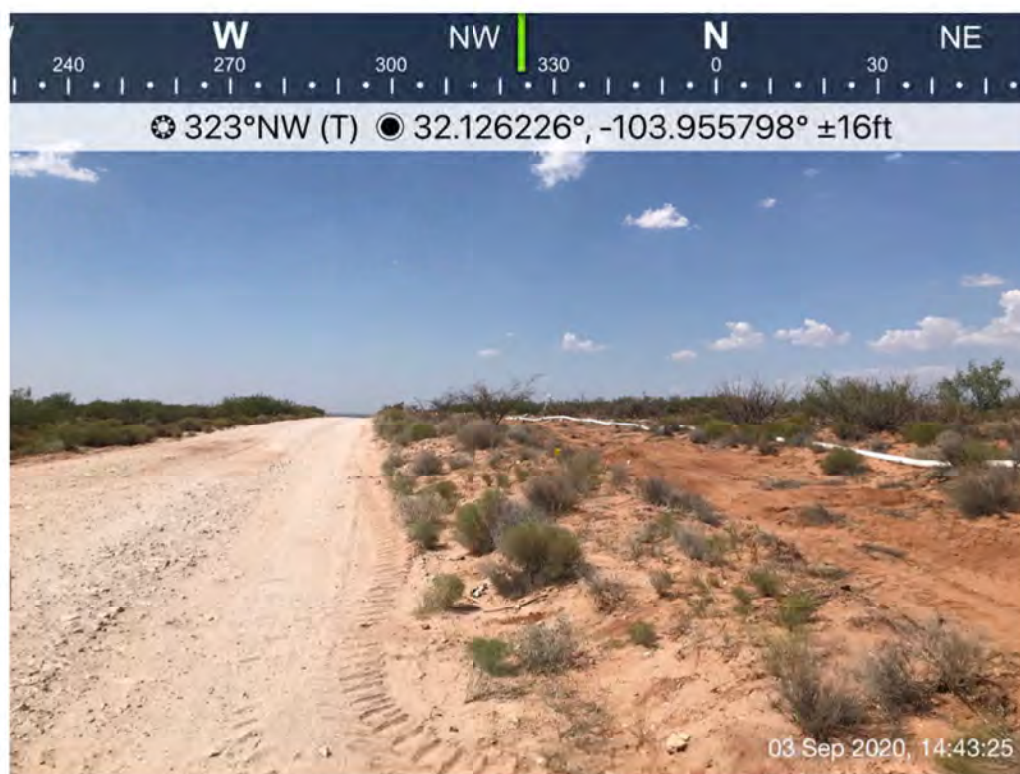
View of Release After Trenching Activities – View Northwest

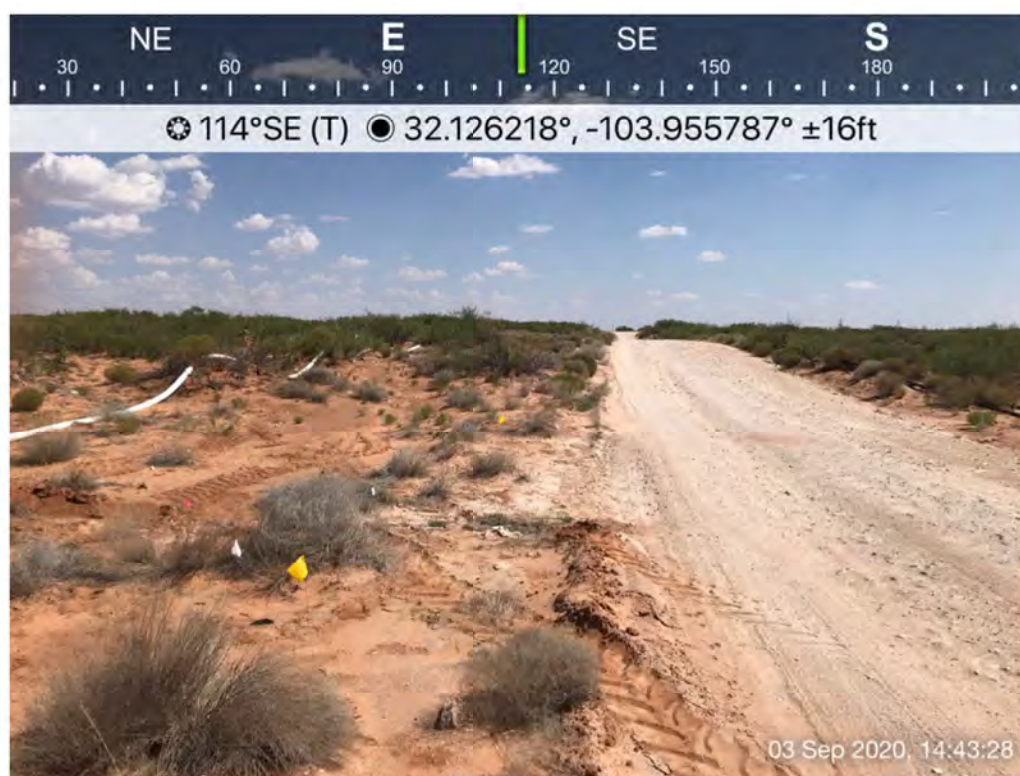
View of Release After Trenching Activities – View Southeast

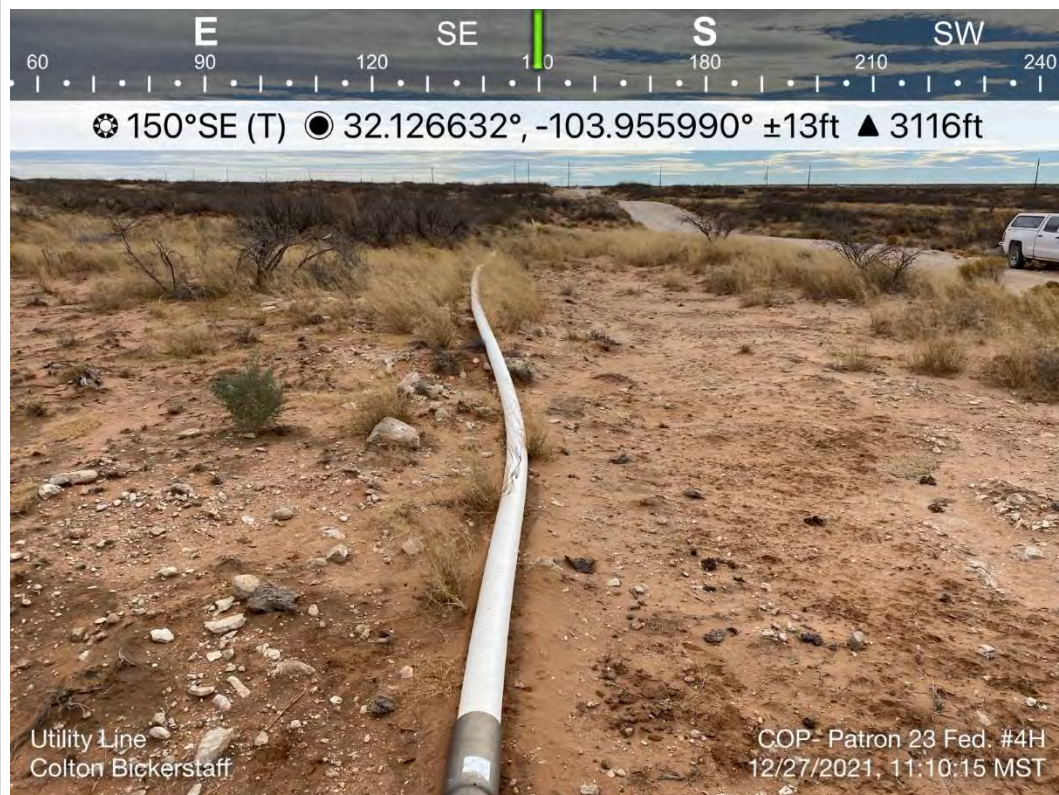
TETRA TECH, INC. PROJECT NO. 212C-MD-02646	DESCRIPTION	View southeast. Single line on east side of dirt road.	2
	SITE NAME	Patron 23 Federal 4H	12/27/2021

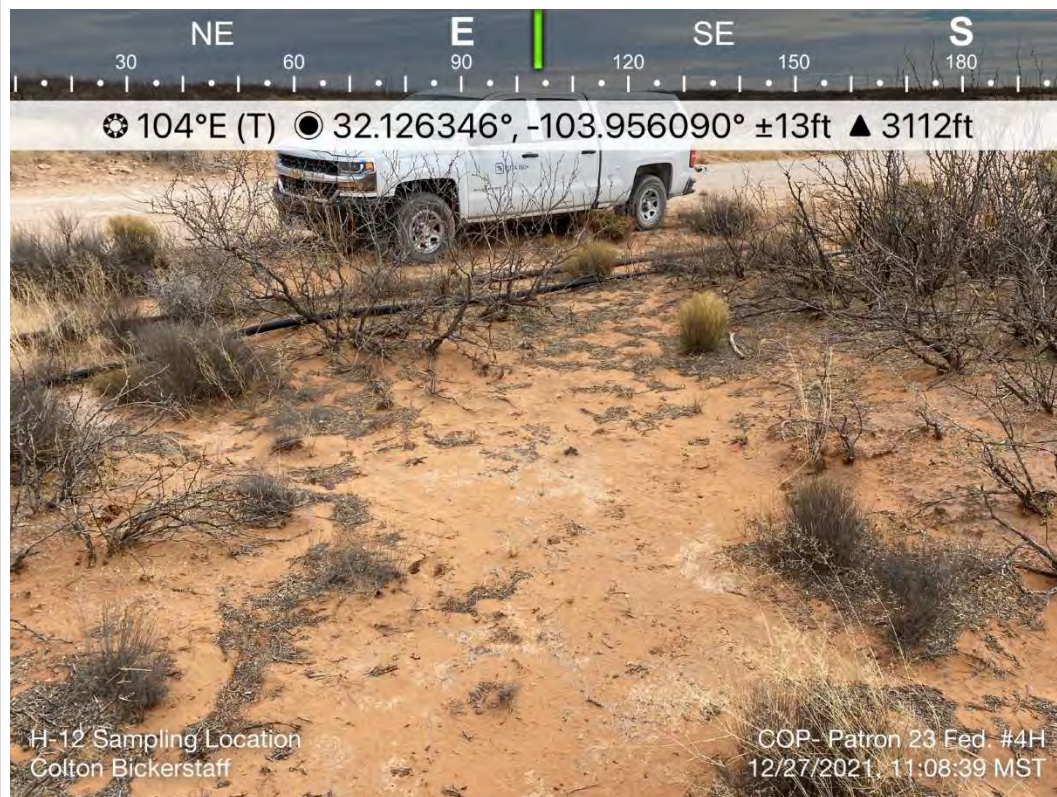
TETRA TECH, INC. PROJECT NO. 212C-MD-02646	DESCRIPTION	View east. H-12 sample location.	4
	SITE NAME	Patron 23 Federal 4H	12/27/2021

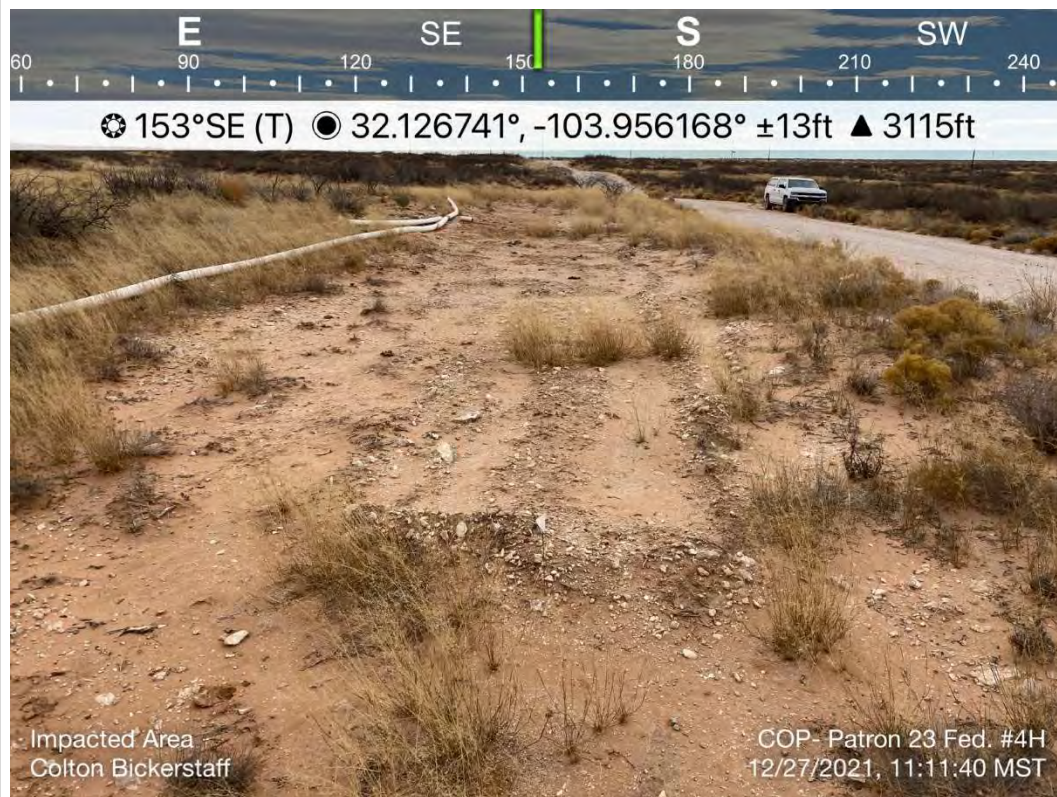
TETRA TECH, INC. PROJECT NO. 212C-MD-02646	DESCRIPTION	View south-southeast. Northeastern section of release extent.	6
	SITE NAME	Patron 23 Federal 4H	12/27/2021

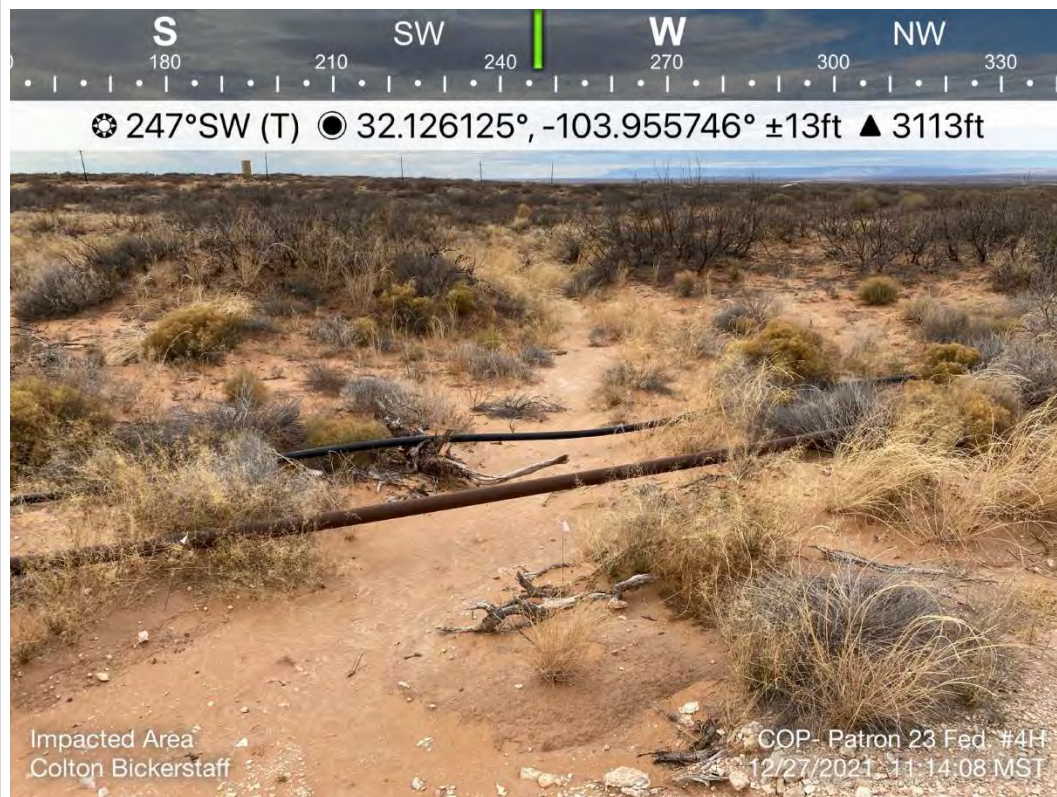
TETRA TECH, INC. PROJECT NO. 212C-MD-02646	DESCRIPTION	View west-southwest. Central section of release extent.	8
	SITE NAME	Patron 23 Federal 4H	12/27/2021
