| Incident ID | NAPP2110650720 |

**RE: Liner Inspection and Closure Report  
Chaser 8 State #002  
API No. 30-015-37807  
GPS: Latitude 32.8501129 Longitude -104.0916519  
UL "H", Section 8, Township 17S, Range 29E  
NMOCD Reference No. NAPP2110650720**

Pima Environmental Services, LLC (Pima) has been contracted by Spur Energy Partners, LLC. (Spur) to perform a liner inspection and prepare this closure report for a release that happened at the Chaser 8 State #002 (Chaser). An initial C141 was submitted on April 16<sup>th</sup>, 2021, and can be found in Appendix B. This incident was assigned Incident ID NAPP2110650720, by the New Mexico Oil Conservation Division (NMOCD).

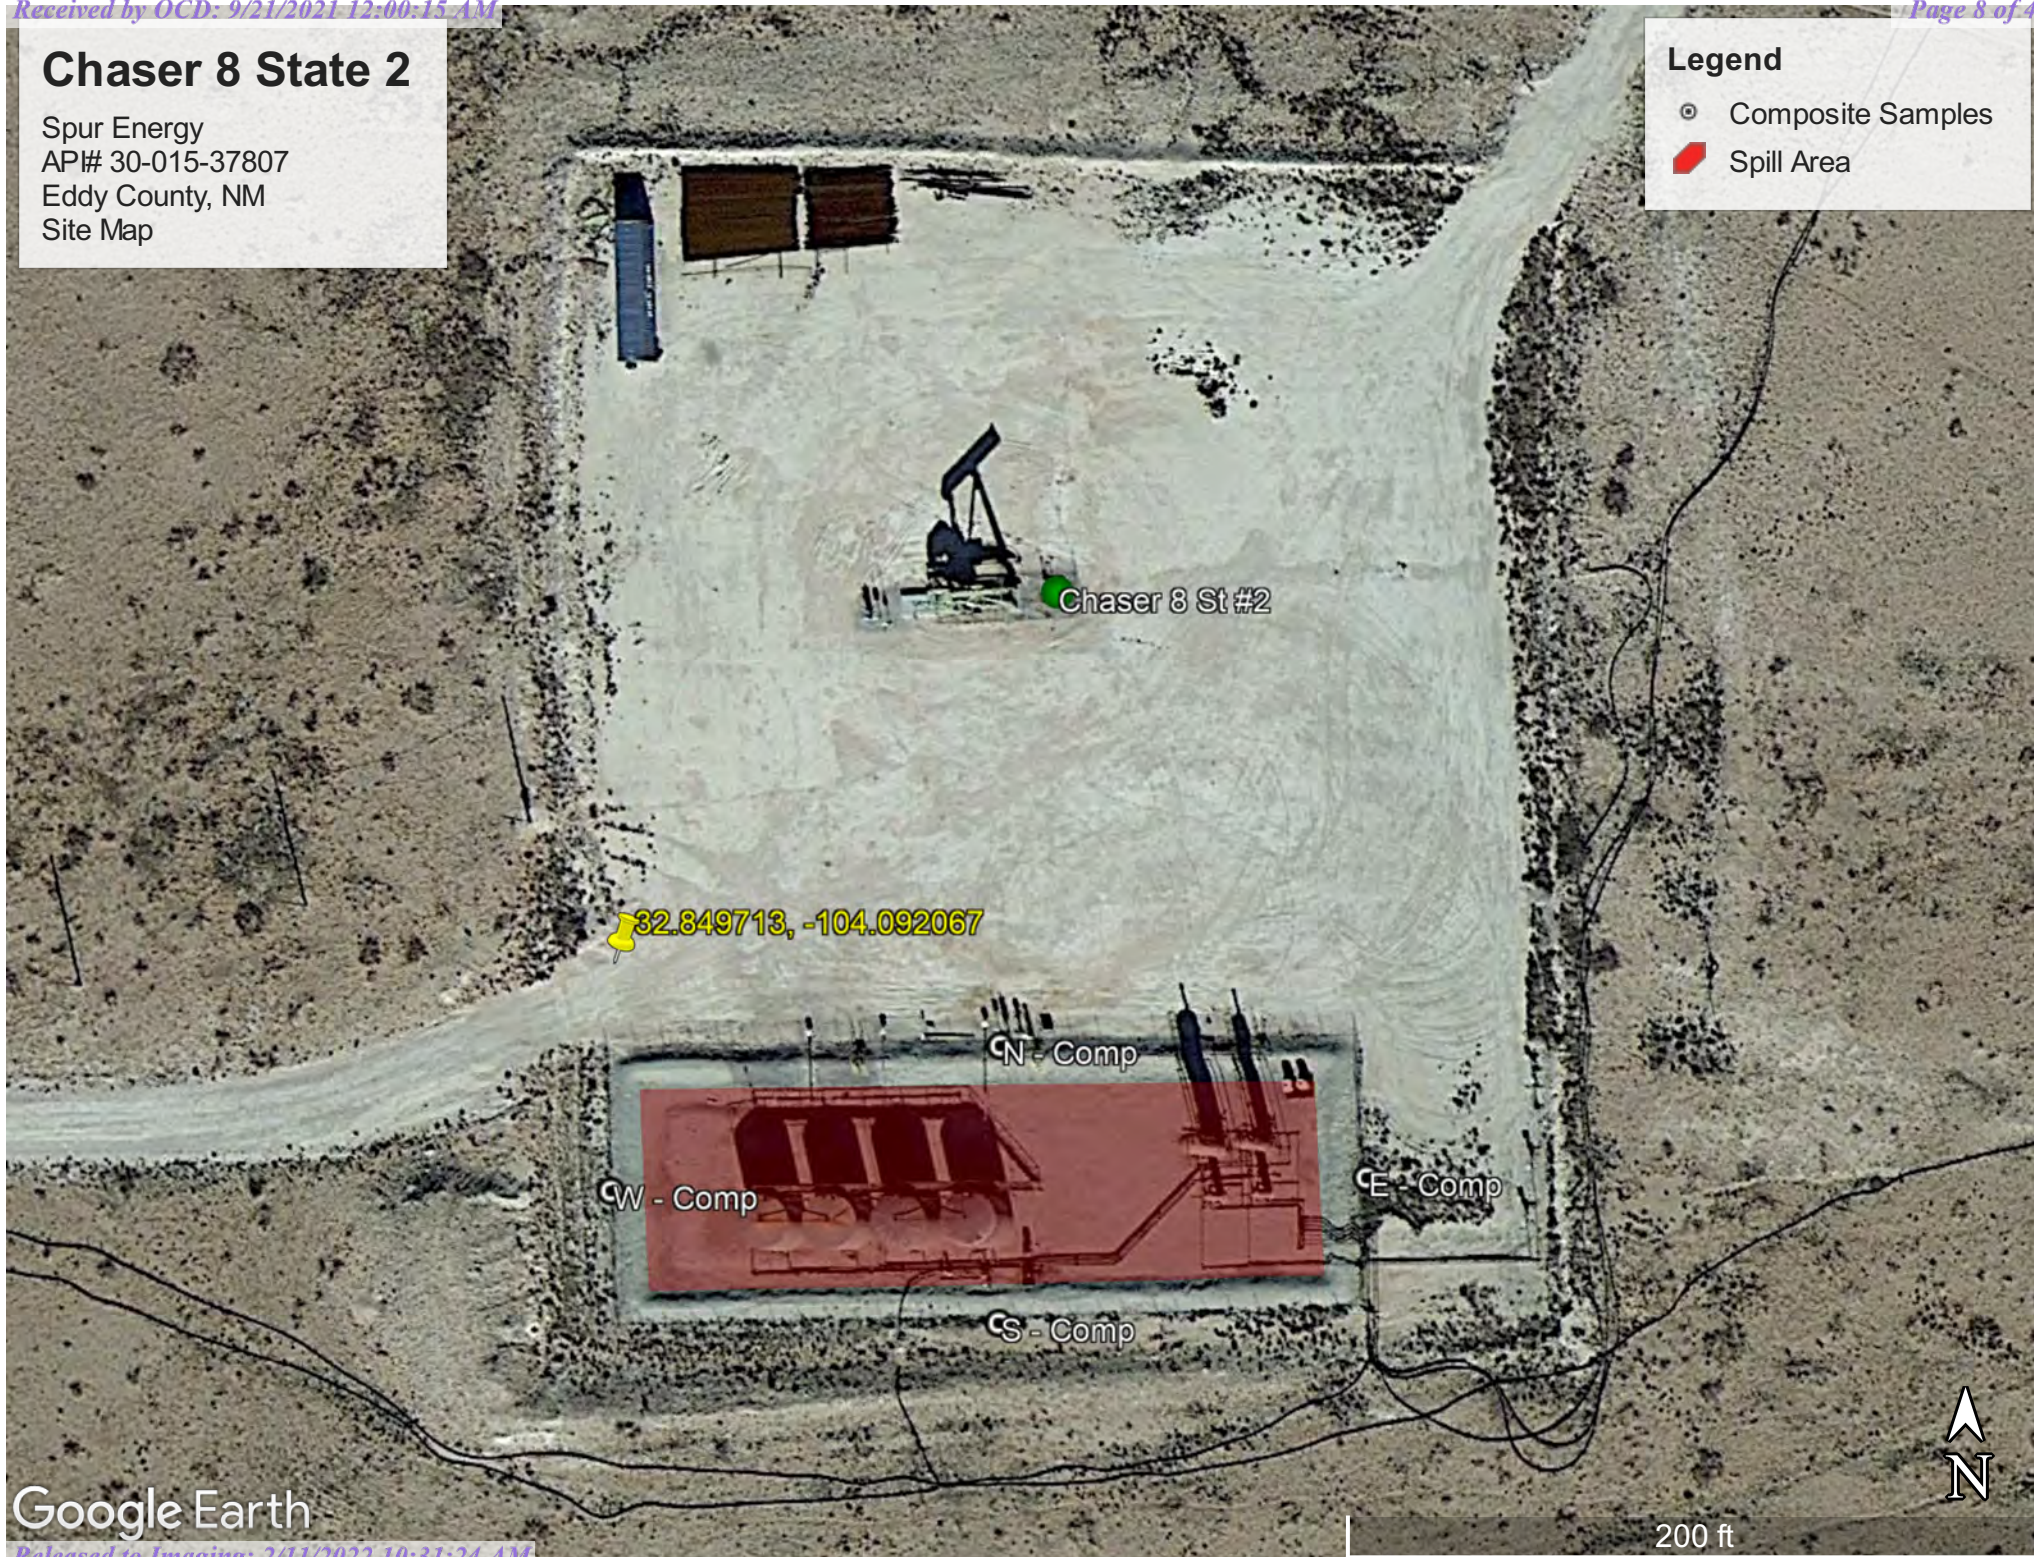
4 - Site Map

Spur Energy  
AP# 30-015-37807  
Eddy County, NM  
Site Map

- Composite Samples
- Spill Area

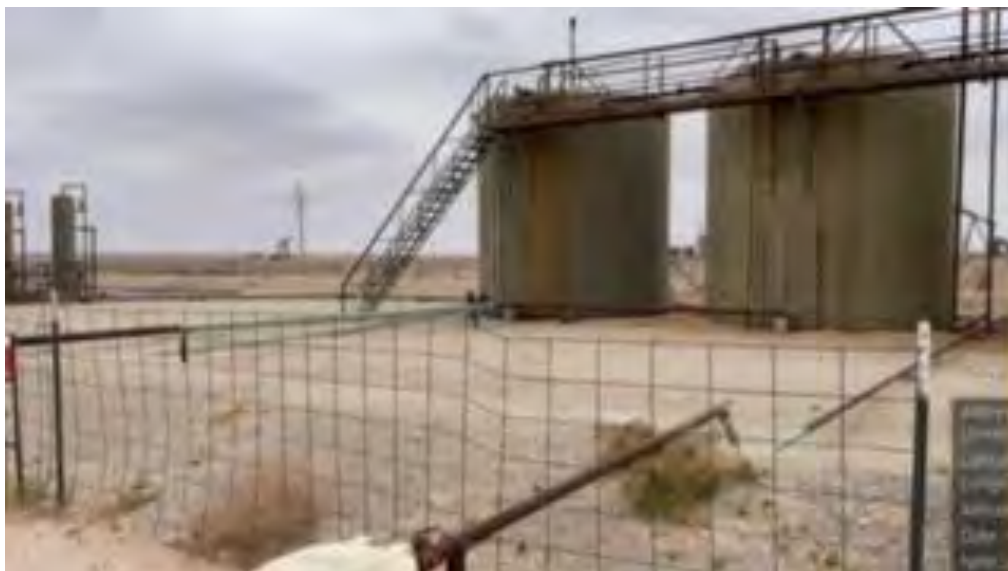
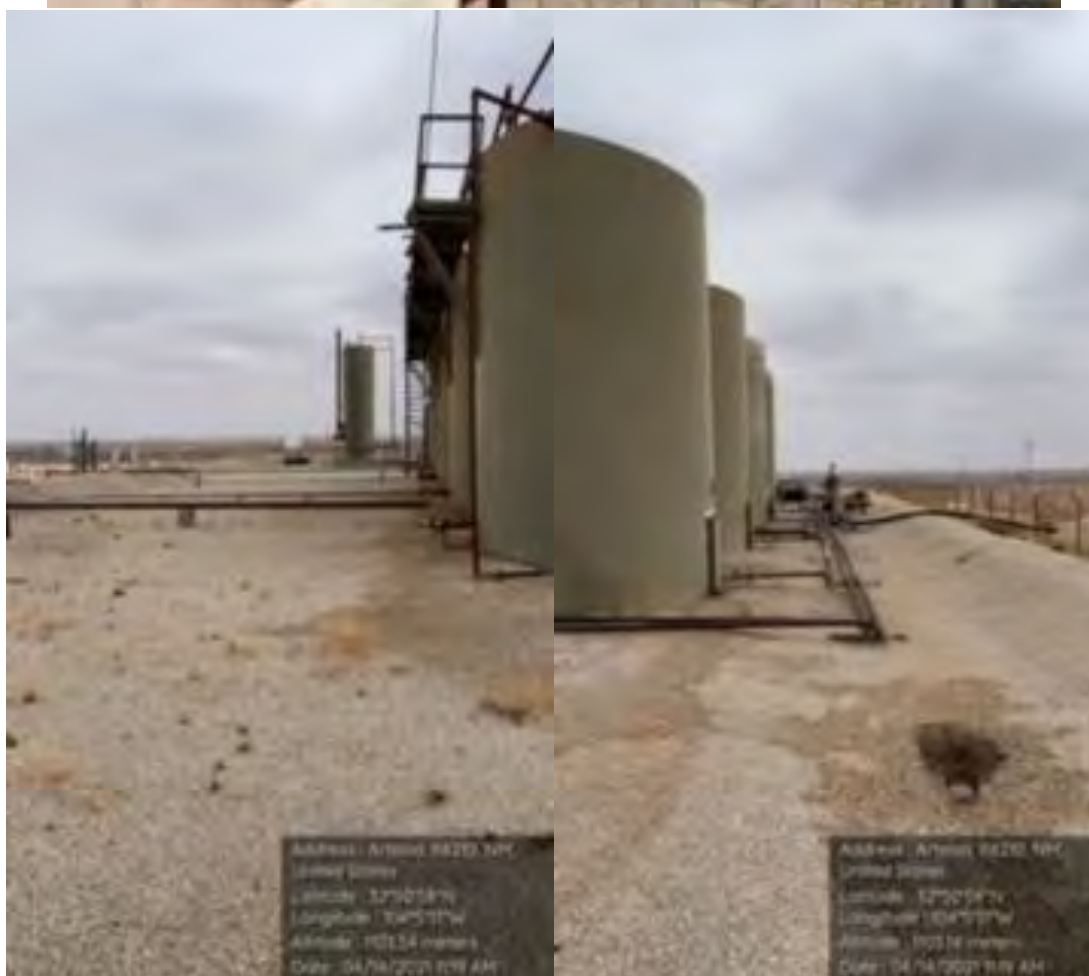
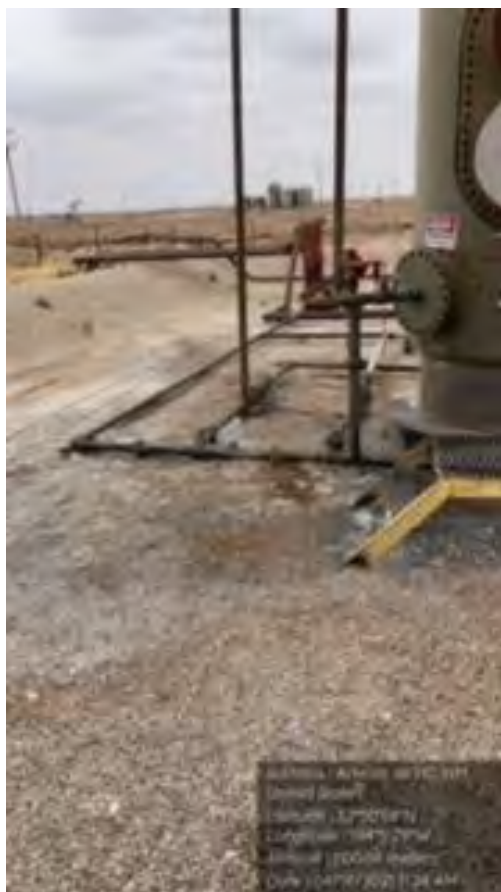
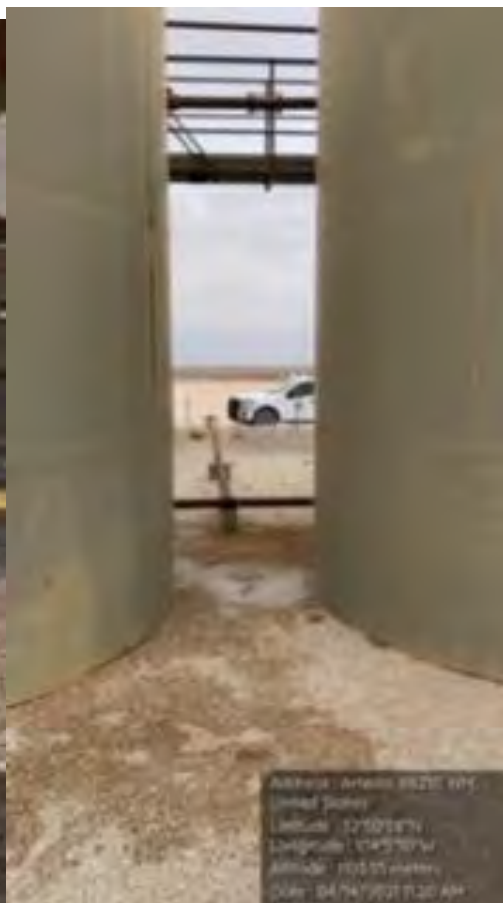
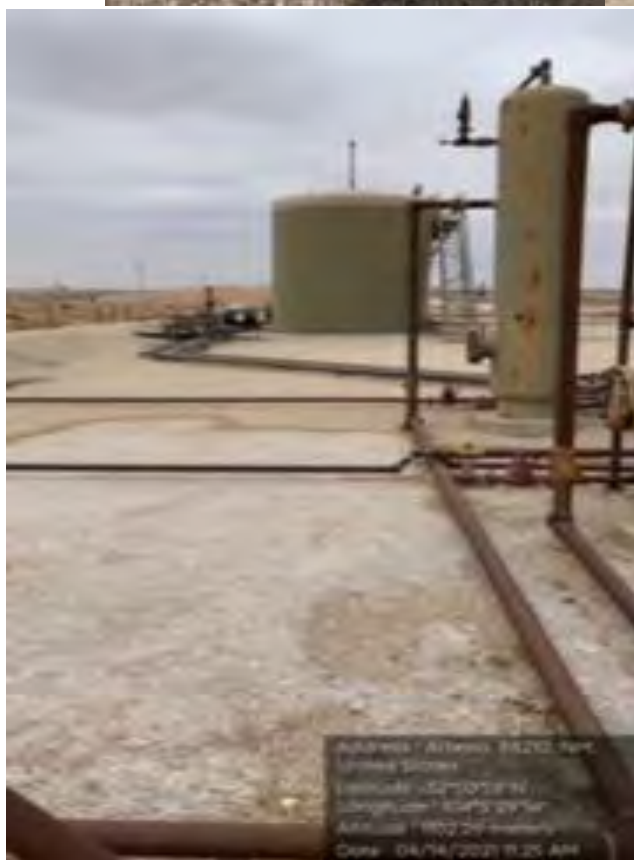
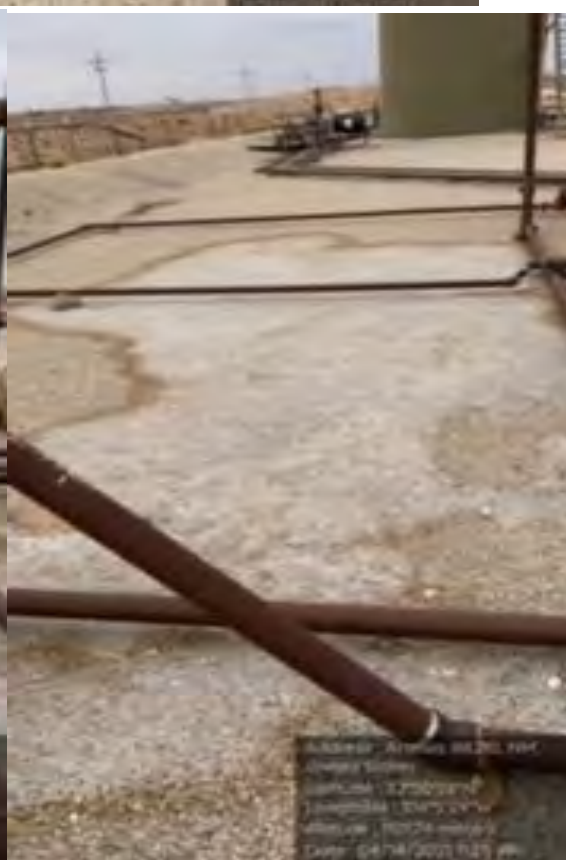
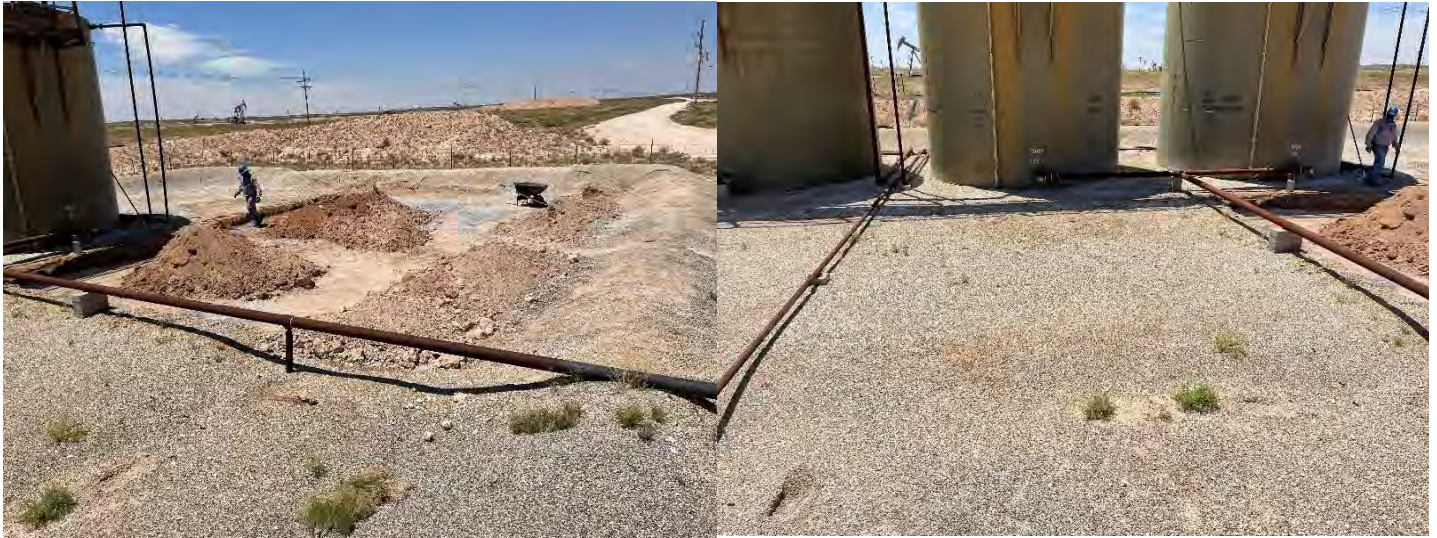
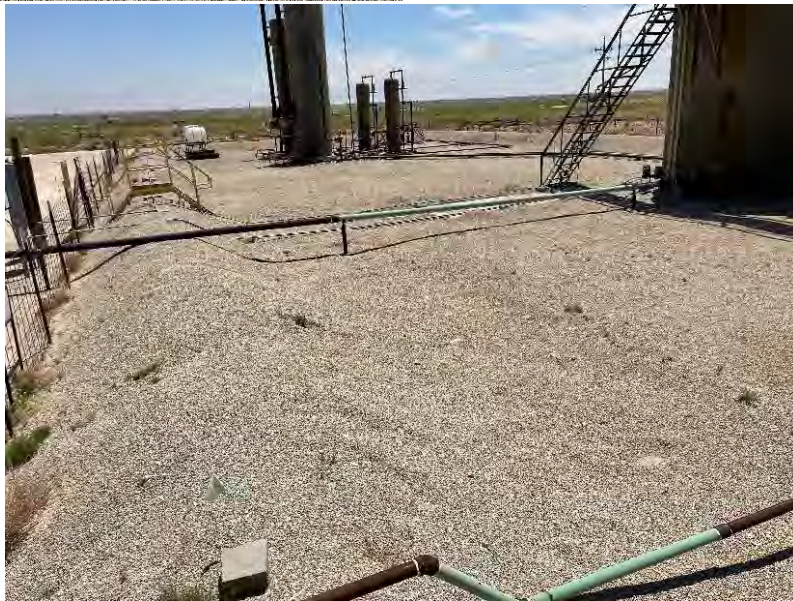
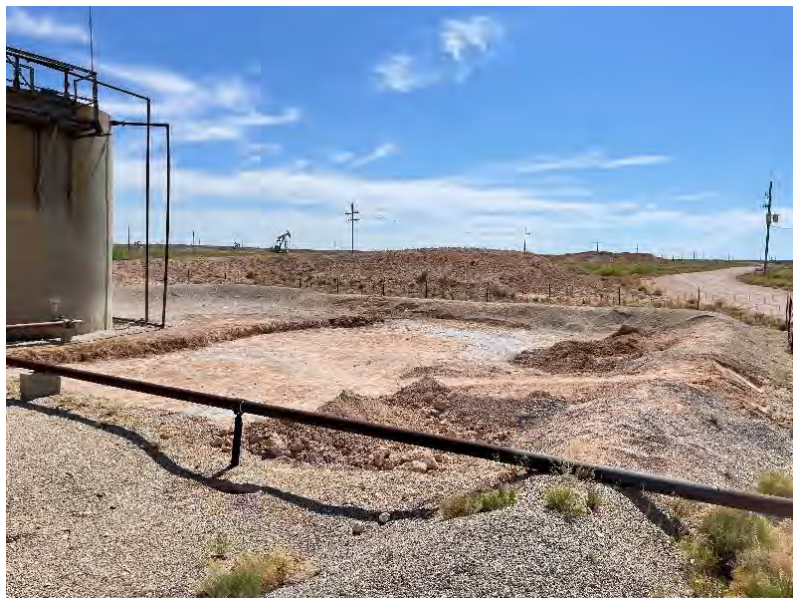
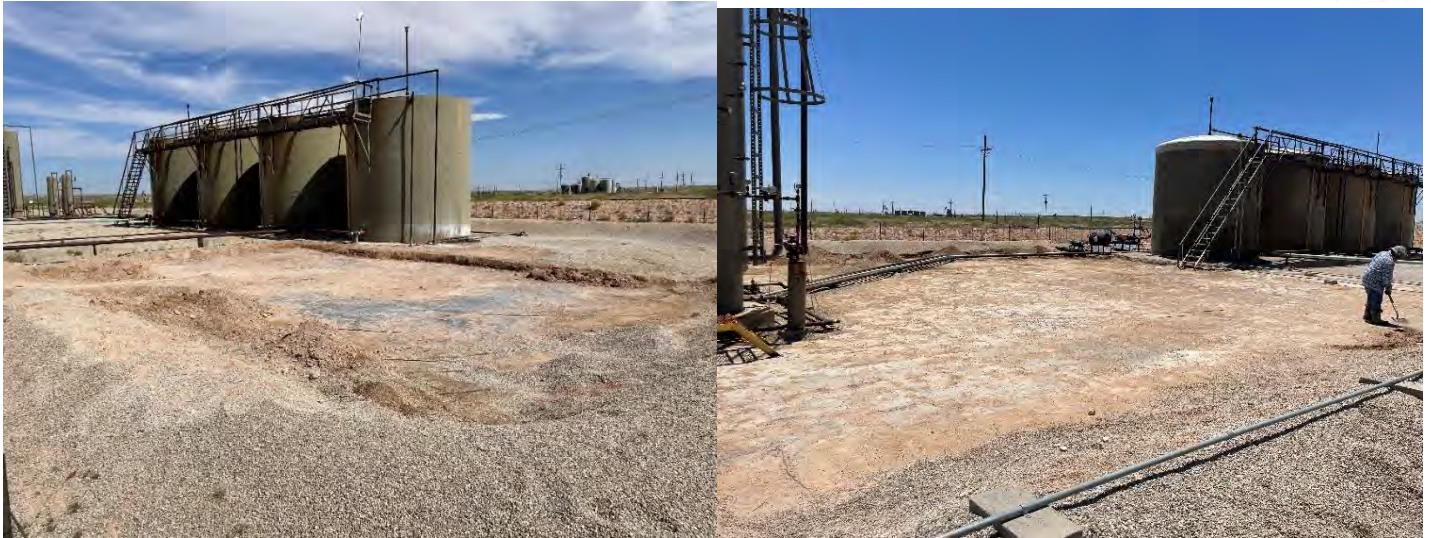
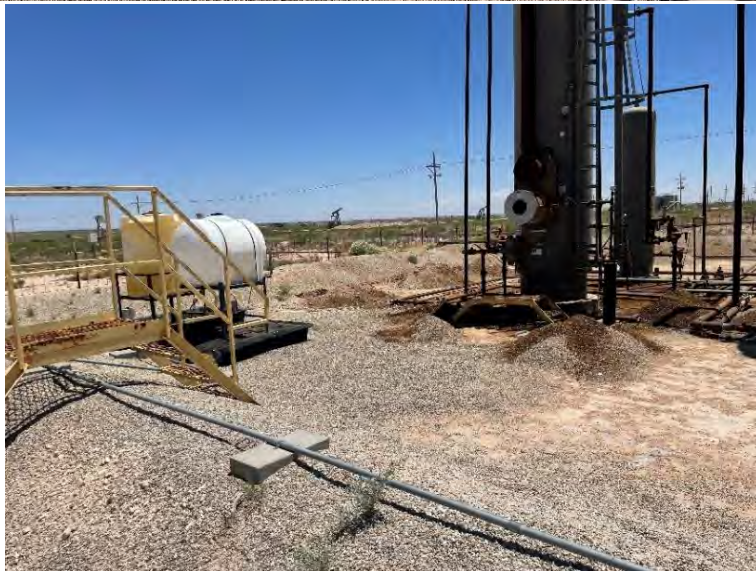
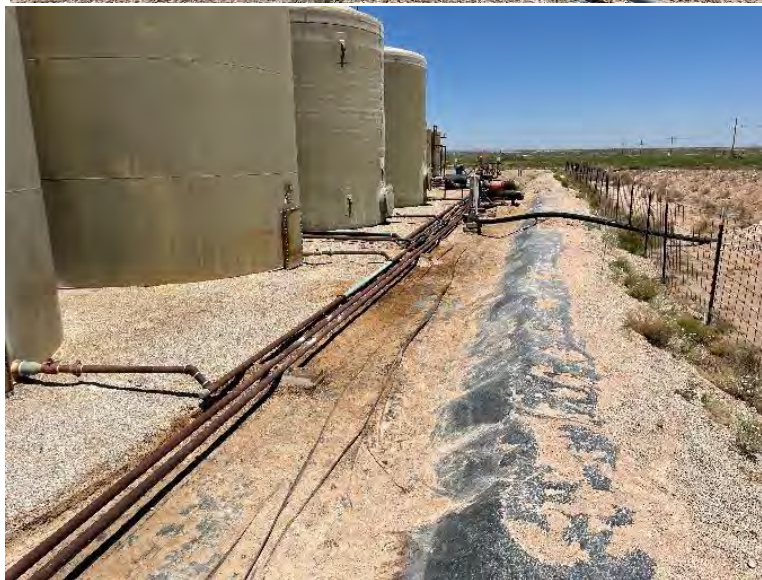
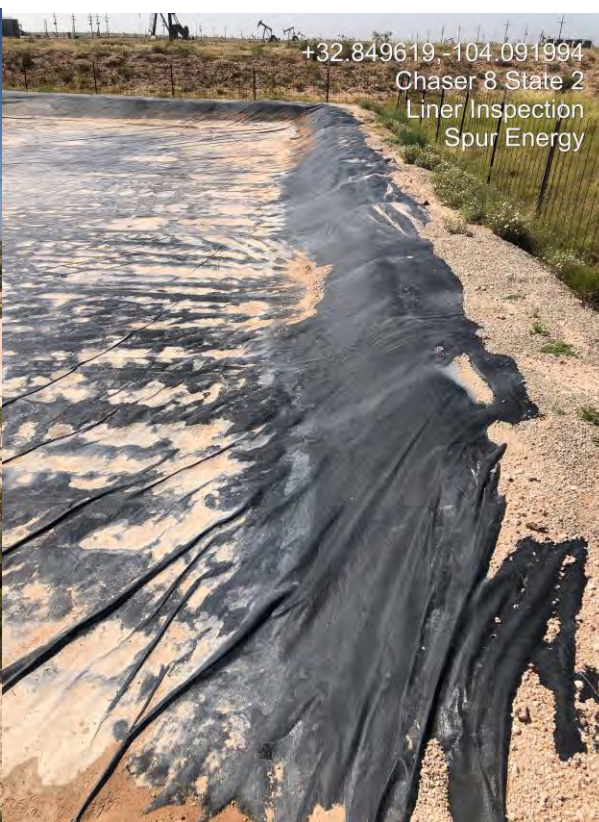
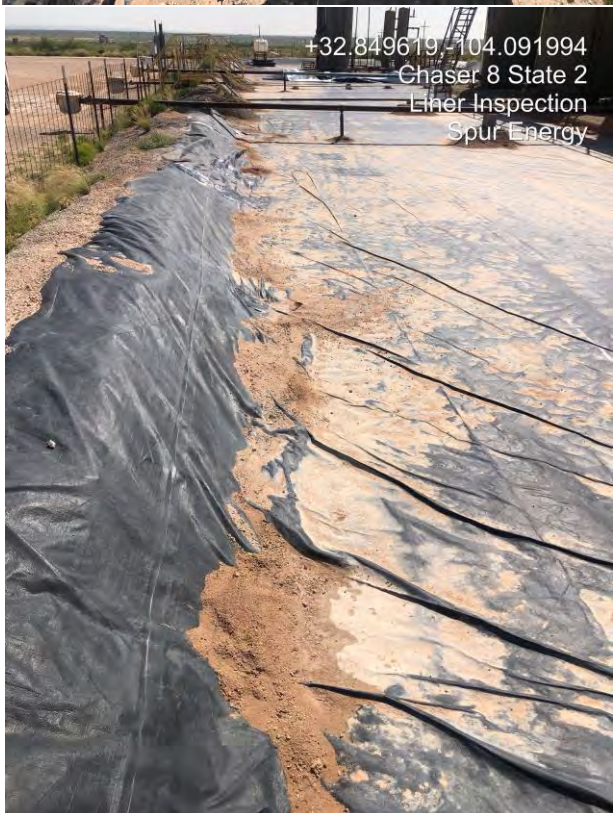
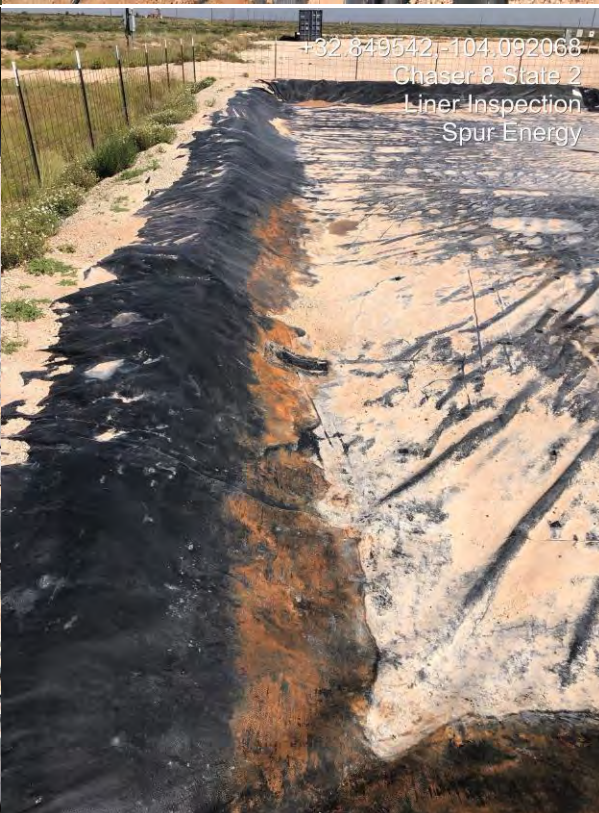
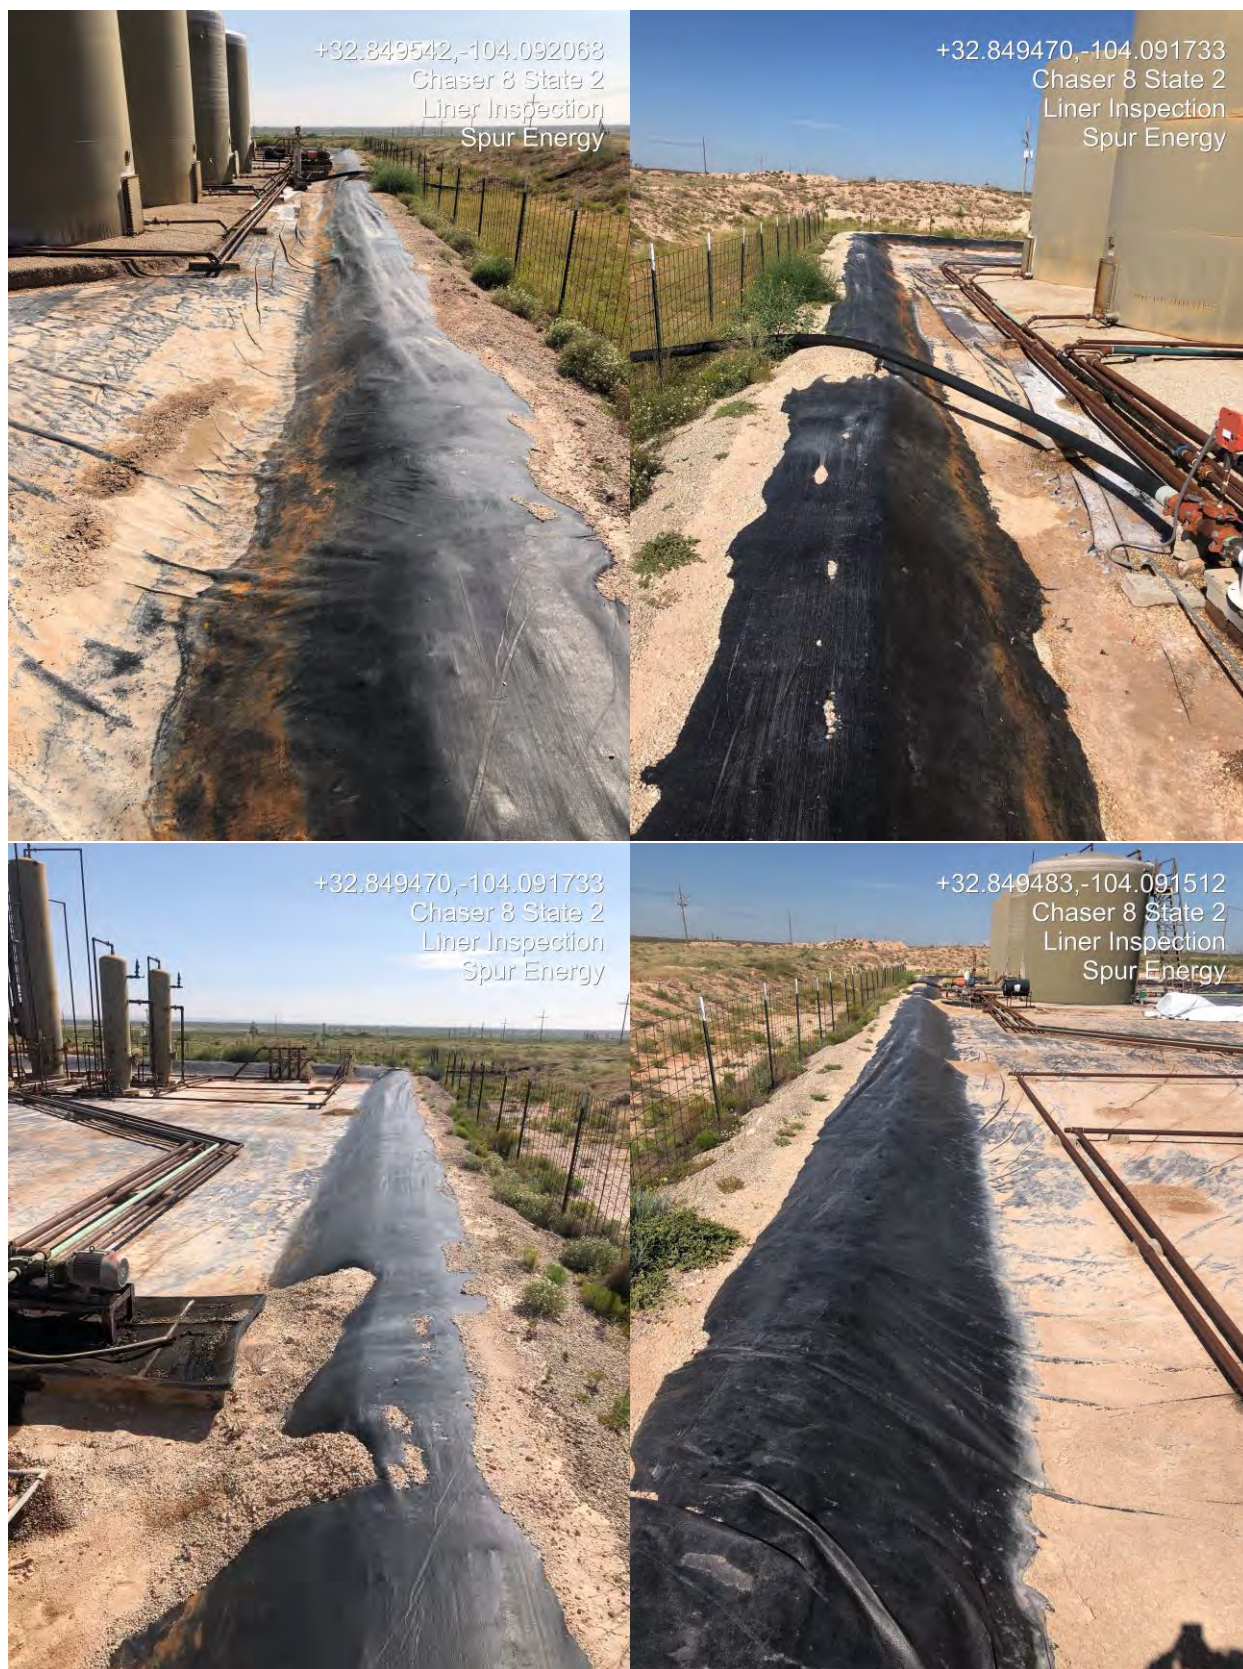
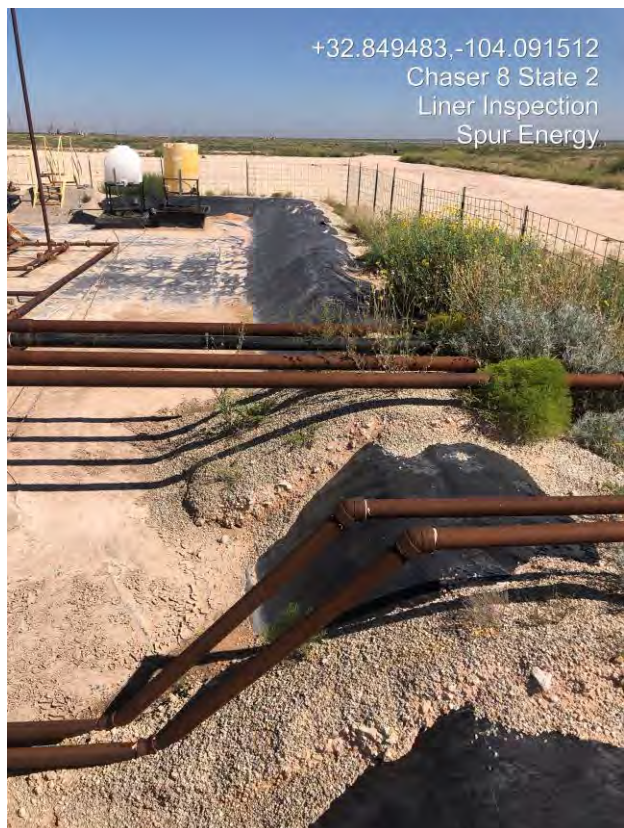
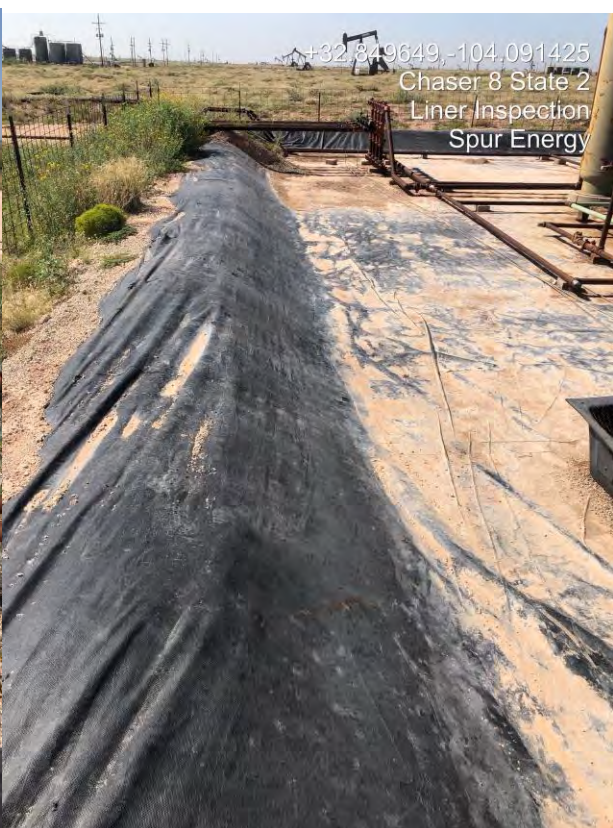
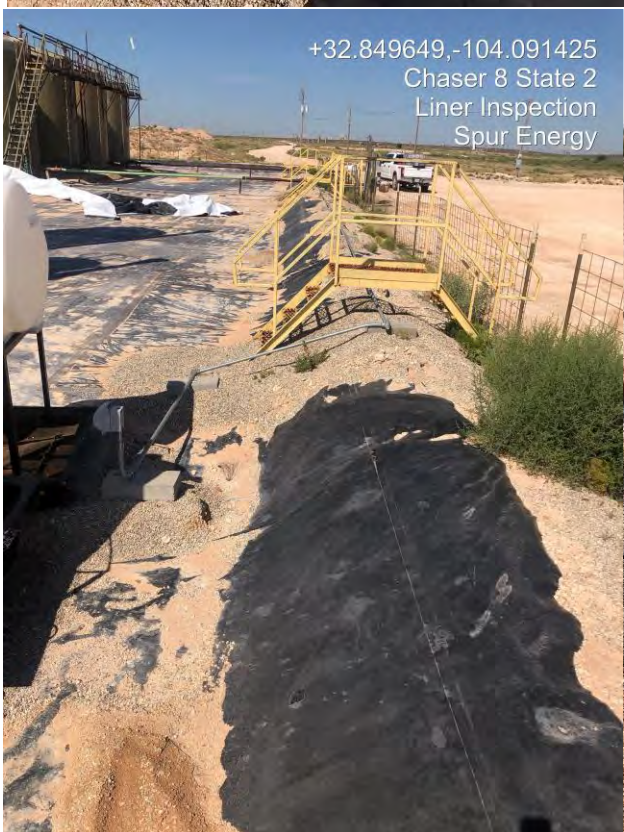
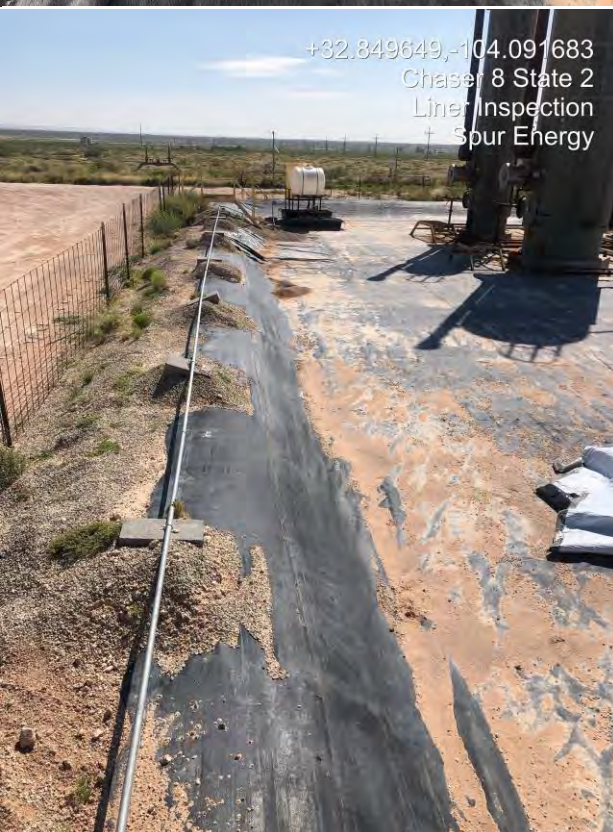
**SITE PHOTOGRAPHS  
SPUR ENERGY PARTNERS  
CHASER 8 STATE #002**

On September 1<sup>st</sup>, 2021, after sending a 48-hour notification, Pima returned to the site to perform a liner inspection and collect composite samples from around the outside of the secondary containment. The liner inspection report and photographic documentation can be found in Appendix C. The laboratory results of this sampling event can be found in the following table.

| Visualization | Yes | No | Comments |
|---|---|---|---|
| Does the liner have integrity to contain a leak? | X | | |

On May 5<sup>th</sup>, 2021, Pima returned to the site to begin remedial activities. We used a hand crew to remove all the loose pea gravel from within the secondary containment area. We did not remove any gravel that was pertinent to the foundation of any vessel base. All contaminated material was hauled off to an approved disposal site.
