Remediation Summary & Deferral Request

COG Operating, LLC Save DA Federal 1 Tank Battery

Eddy County, New Mexico
Unit Letter "D", Section 21, Township 25 South, Range 29 East
Latitude 32.12085 North, Longitude 103.99555 West
NMOCD Reference No. nAPP2102530060

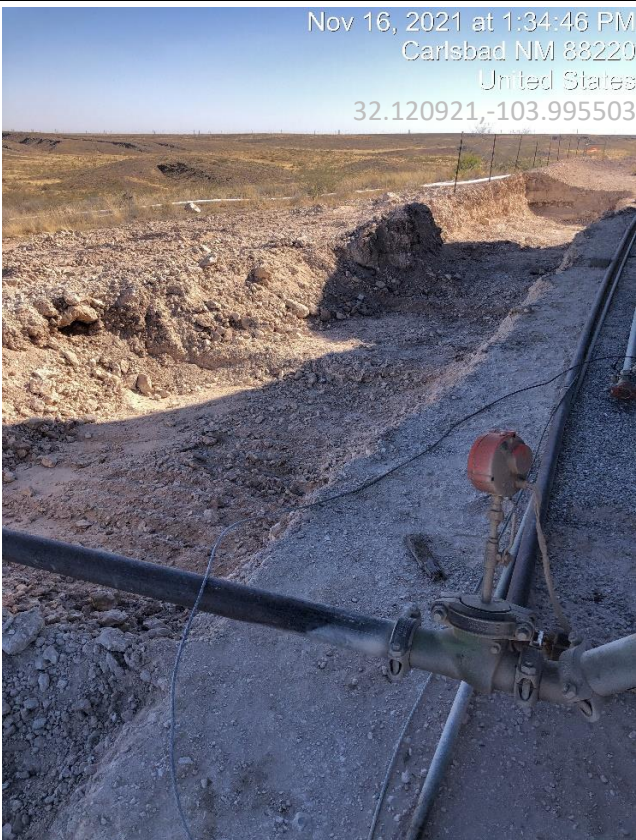
Photo Number: 9

<p>Nov 16, 2021 at 1:34:46 PM Carlsbad NM 88220 United States 32.120921,-103.995503</p>
Photo Direction: South-Southeast	
Photo Description: View of the excavated area.

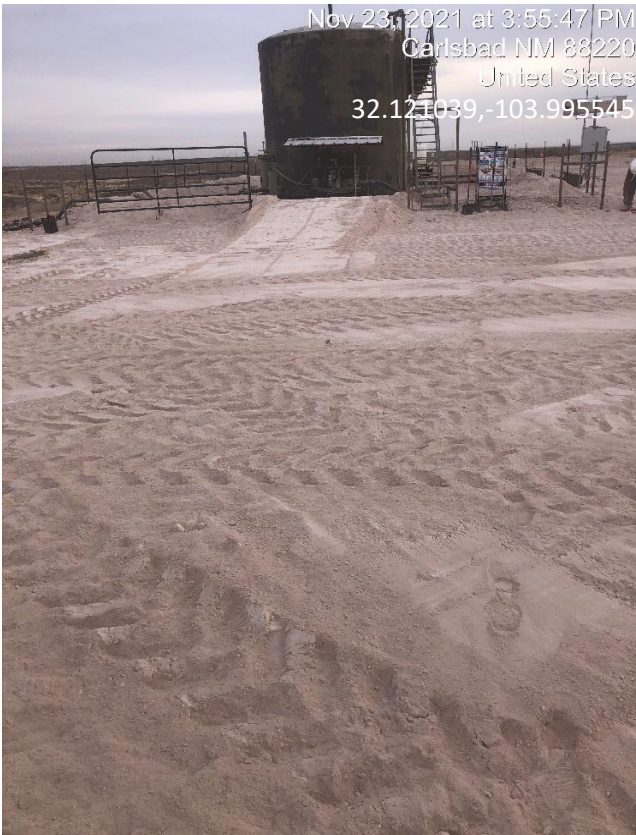
Photo Number: 10

<p>Nov 23, 2021 at 3:55:47 PM Carlsbad NM 88220 United States 32.121039,-103.995545</p>
Photo Direction: South	
Photo Description: View of the remediated area after backfill and regrading.

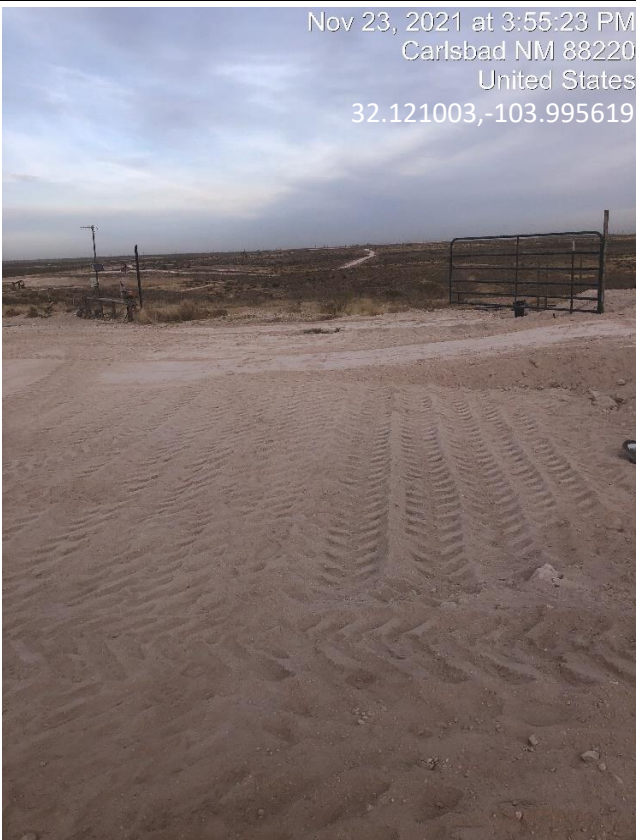
Photo Number: 11	<div>Nov 23, 2021 at 3:55:23 PM Carlsbad NM 88220 United States 32.121003,-103.995619</div>

Photo Direction: East	
Photo Description: View of the remediated area after backfill and regrading.

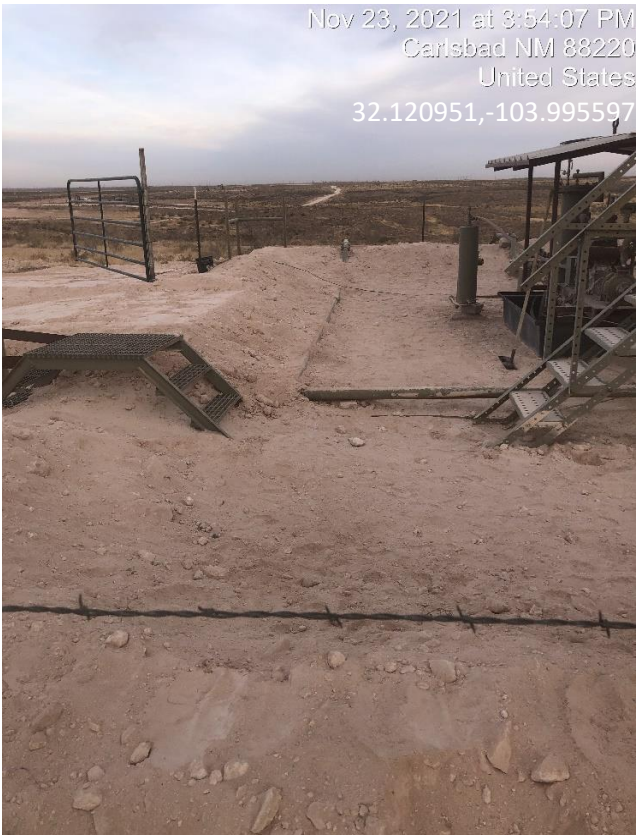
Photo Number: 12	<div>Nov 23, 2021 at 3:54:07 PM Carlsbad NM 88220 United States 32.120951,-103.995597</div>

Photo Direction: East	
Photo Description: View of the remediated area after backfill and regrading.

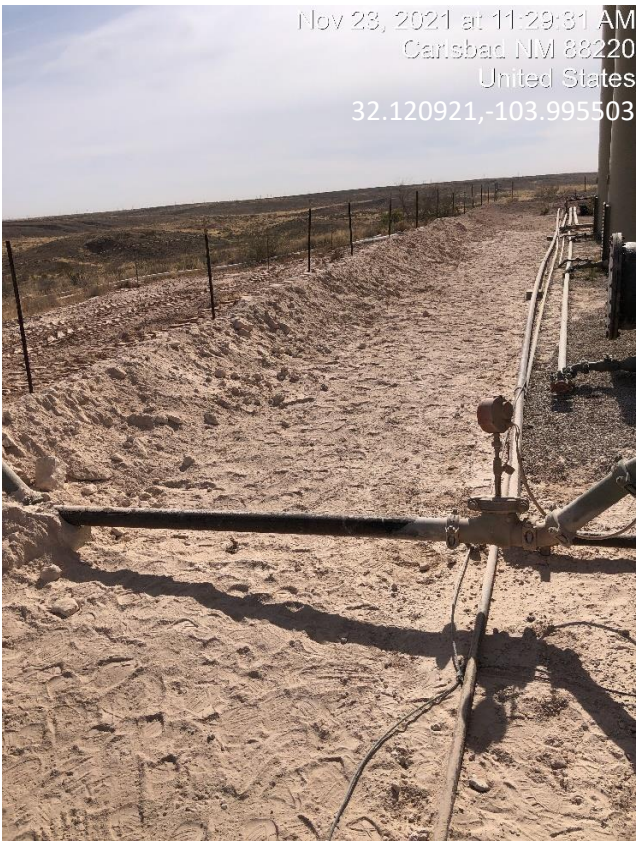
Photo Number: 13

<p>Nov 23, 2021 at 11:29:31 AM Carlsbad NM 88220 United States 32.120921,-103.995503</p>
Photo Direction: South-Southeast	
Photo Description: View of the remediated area after backfill and regrading.

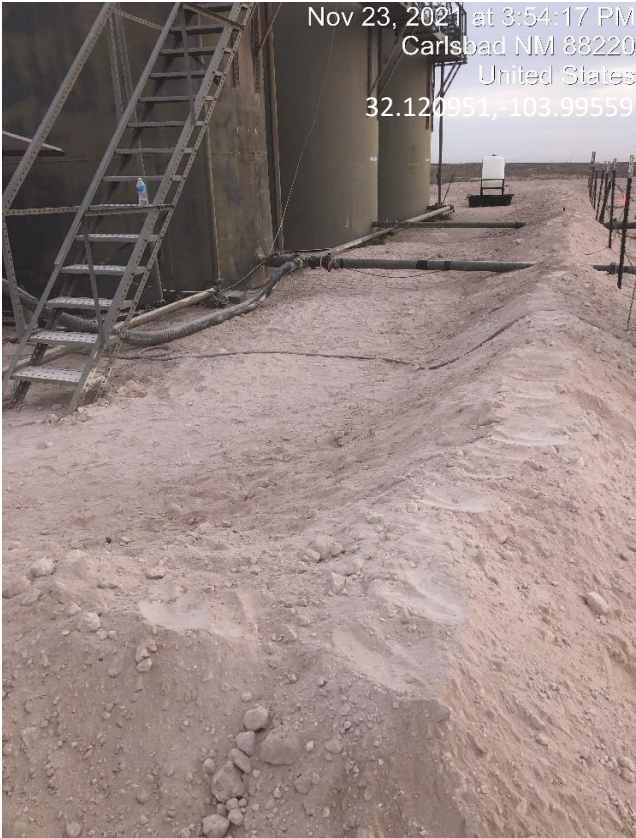
Photo Number: 14

<p>Nov 23, 2021 at 3:54:17 PM Carlsbad NM 88220 United States 32.120951,-103.995559</p>
Photo Direction: South-Southeast	
Photo Description: View of the remediated area after backfill and regrading.
