**December 29, 2021**

**RE: Request for Closure  
Mewbourne Oil Company – Parkchester 24 State #3H  
UL/C sec. 24 T19S R32E  
API No. 30-015-37998  
Reference - nAPP2124236054**

Mewbourne requests site closure to the Parkchester 24 State #3H release site.

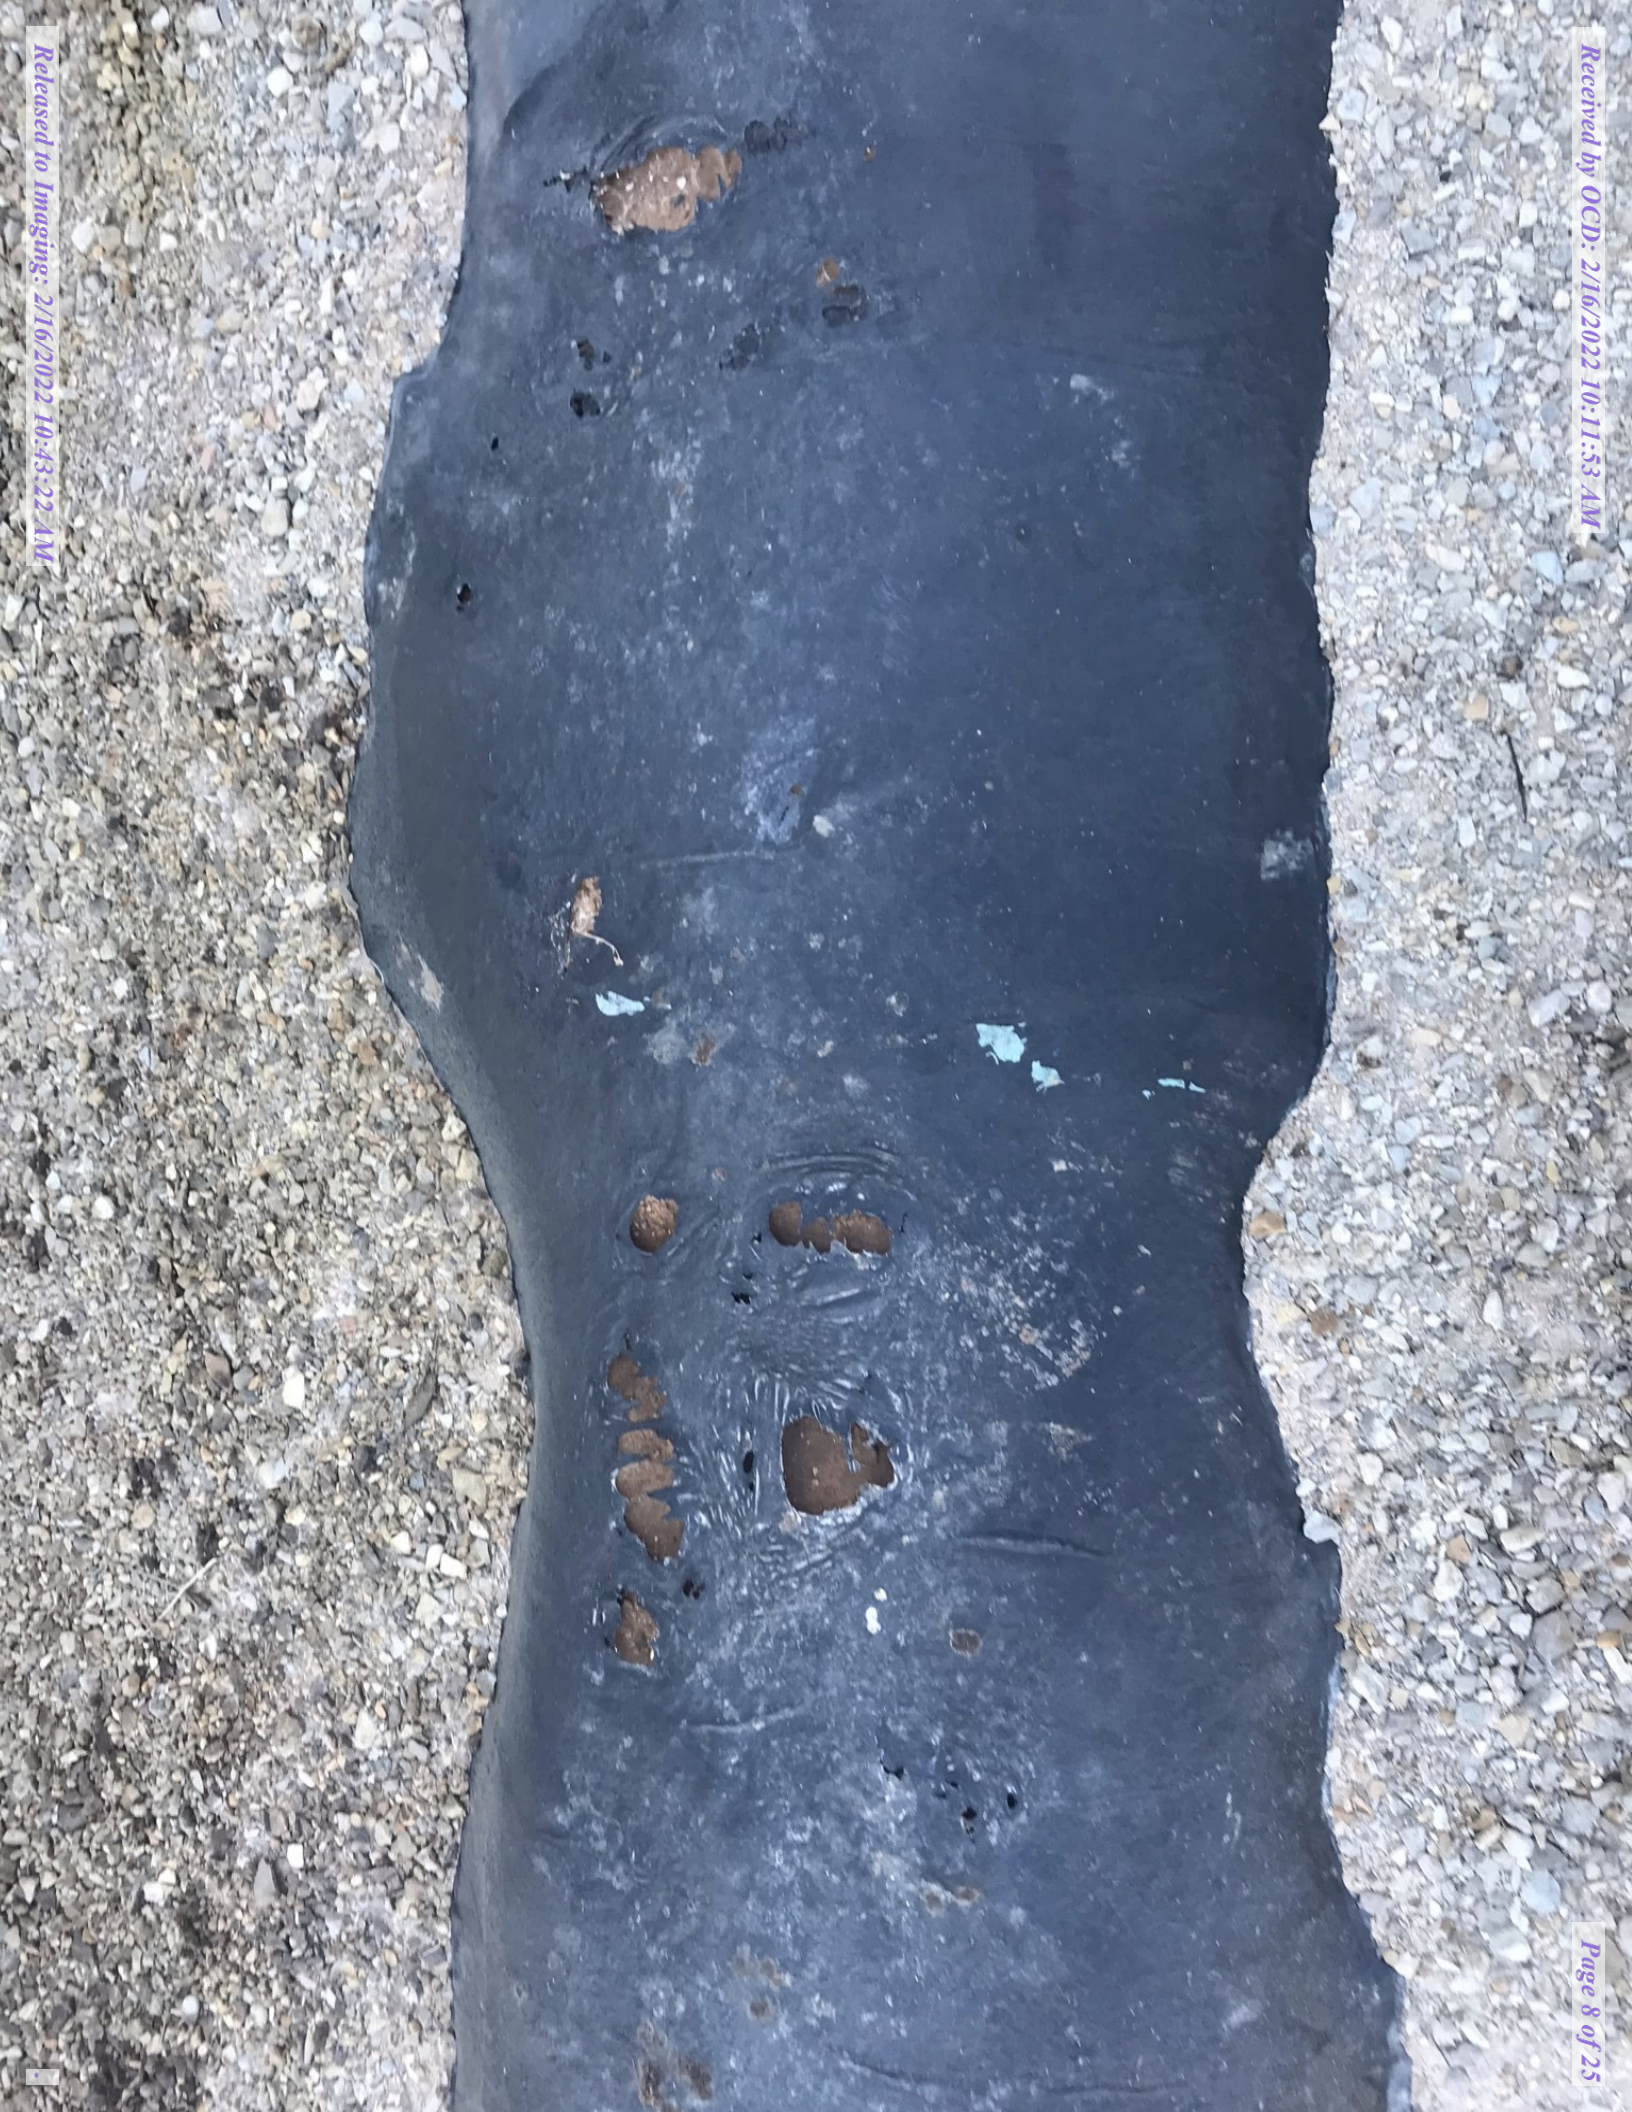
## Photo Documentation

Once the water was removed from the lined, secondary containment, the liner was inspected for damage. On top of the berm on the north side of the containment, a few small holes had been found in the liner, at the top of the berm, above the water mark for the spill (Appendix A). A composite soil sample was retrieved below the liner holes in order to determine if the release had breached the liner integrity. The soil sample was submitted to an approved NMOCD commercial laboratory (Cardinal Laboratories in Hobbs, NM [Cardinal]) for concentration analyses of chloride, Gas

Hole in liner at top of berm above water mark

Dec 28, 2021 at 12:23:53 PM  
+32.652713,-104.133254  
342° N  
NM, Carlsbad

A contractor was hired to repair the liner. A photo shown in Appendix C indicates the repair is complete.
