Re: Remediation Summary and Closure Report
MG-6-2 Line (9/28/21)
GPS: Latitude 32.568505 Longitude -104.121708
UL "M", Sec. 18, T20S, R29E
Eddy County, New Mexico
NMOCD Ref. No. nAPP2127753495

Tasman Geosciences, Inc. (Tasman), on behalf of DCP Midstream, LP (DCP), has prepared this Remediation Summary and Closure Report for the natural gas Release Site known as the MG-6-2 Line (9.28.21). Details of the release are summarized below:

DCP Midstream MG-6-2 Line Leak (9.28.2021) nAPP2127753495 GPS: 32.568505, -104.121708 UL "M", Section 18, Township 20 South, Range 29 East Eddy County, New Mexico
--

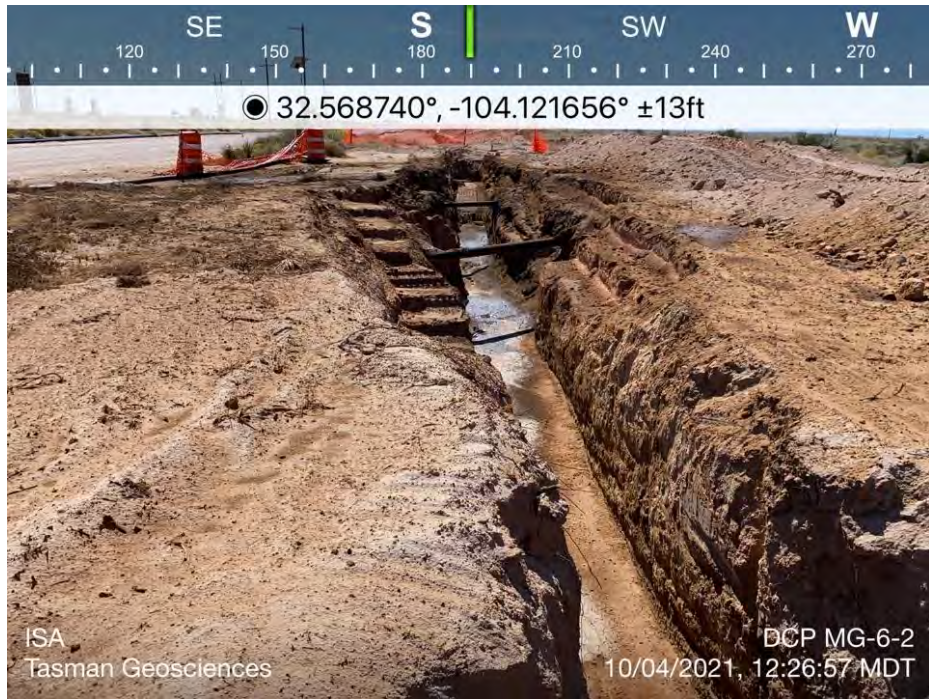
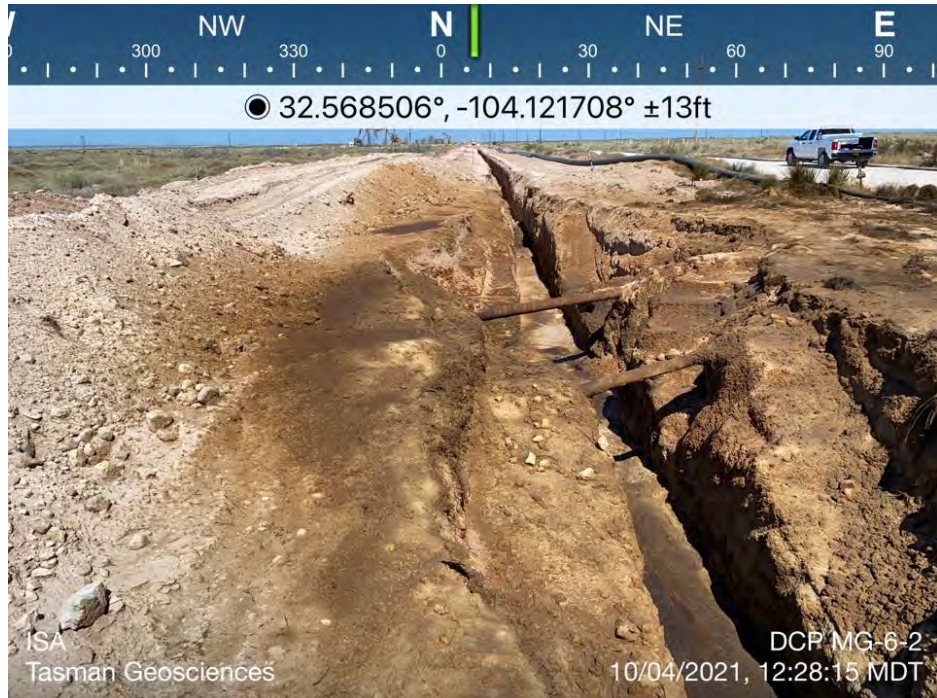
A company installing a pipeline struck the existing DCP poly pipeline resulting in a release of 75 bbls of natural gas condensate. A vacuum truck was called to location and recovered 65 bbls of condensate. A Notification of Release was submitted on October 4, 2021. The MG-6-2 pipeline was the suspected source and therefore isolated and shutdown. DCP and Tasman personnel were dispatched to the release location to assess the extent and condition of the condensate release.

Leak area

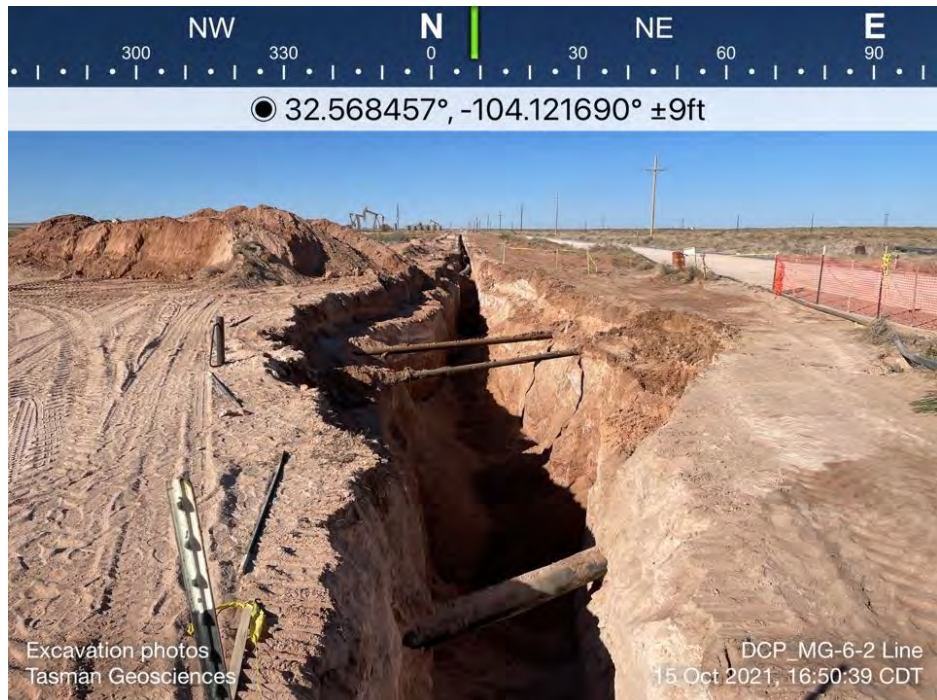
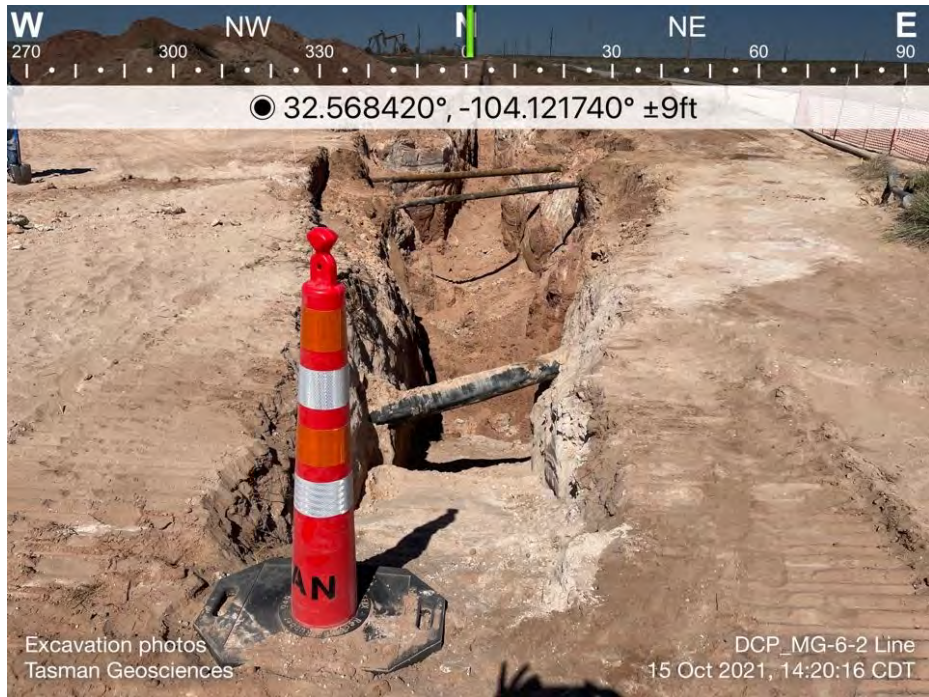
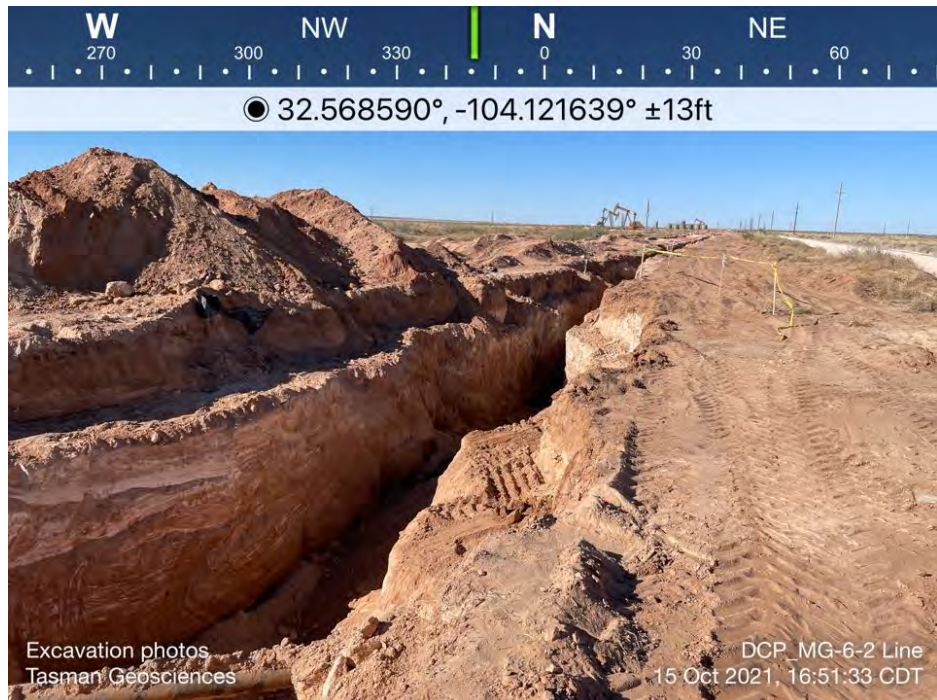
Final Excavation

Approximately 624 cubic yards of impacted soil was excavated and properly disposed of off-site. Between October 19 and October 21, 2021, Tasman backfilled the excavation with appropriate fill material to grade, and restored Right-of-Way.

As described in the site delineation section of this report, on October 5, 2021, DCP and Tasman personnel were dispatched to the release location to assess the extent and condition of the condensate release. The remediation and delineation activities were initiated. Between October 7 and 21, 2021, Tasman performed excavation and soil confirmation sampling to depths of 14 feet bgs. Soil analytical results for the bottom and sidewall confirmation samples collected from the final extent of the excavation were below NMOCD soil closure criteria.

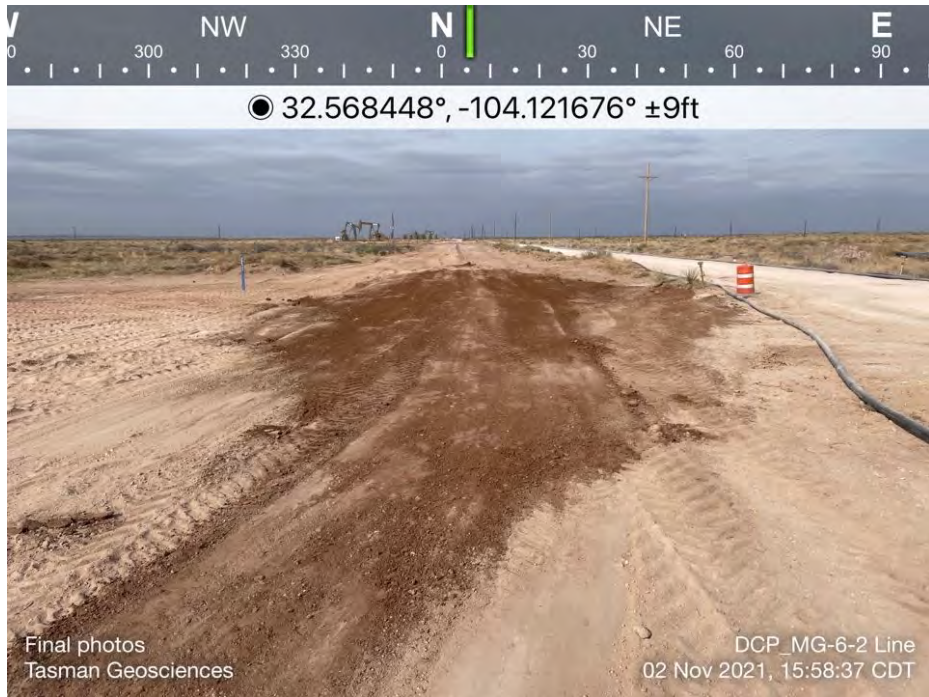
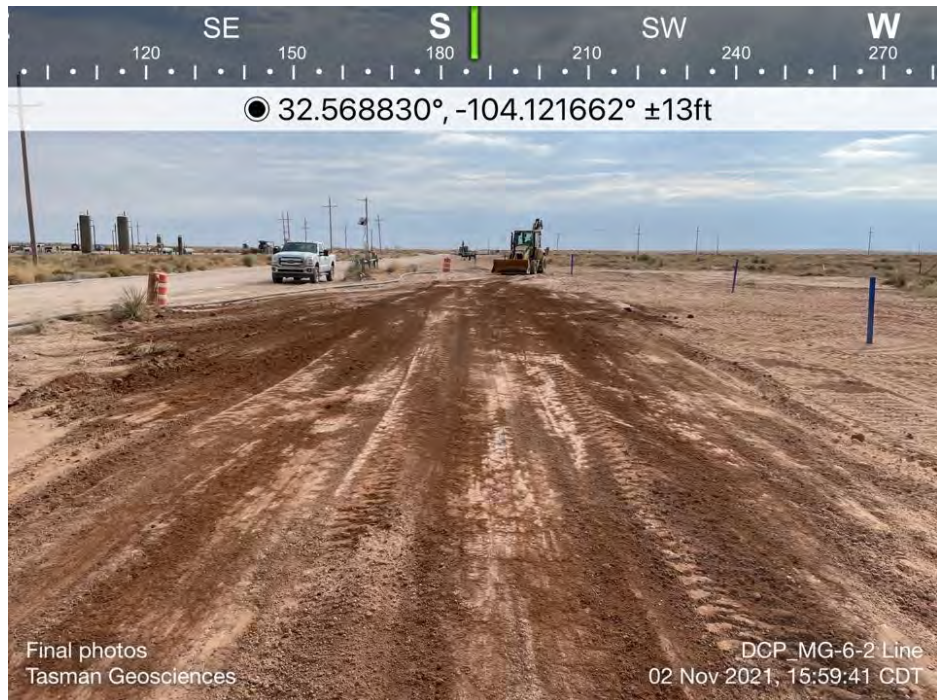
Backfilled

On November 2, 2021, the excavation was backfilled and compacted using the locally sourced, non-impacted "like" material. The affected area was contoured and/or compacted to achieve erosion control, stability and preservation of surface water flow to the extent practicable and to match the surrounding grades.
