**EOG Resources, Inc.
Morris Estate CC Tank Battery**

Closure Report

**UL M, Section 14, T17S, R25E
Eddy County, New Mexico**

NAPP2127935396

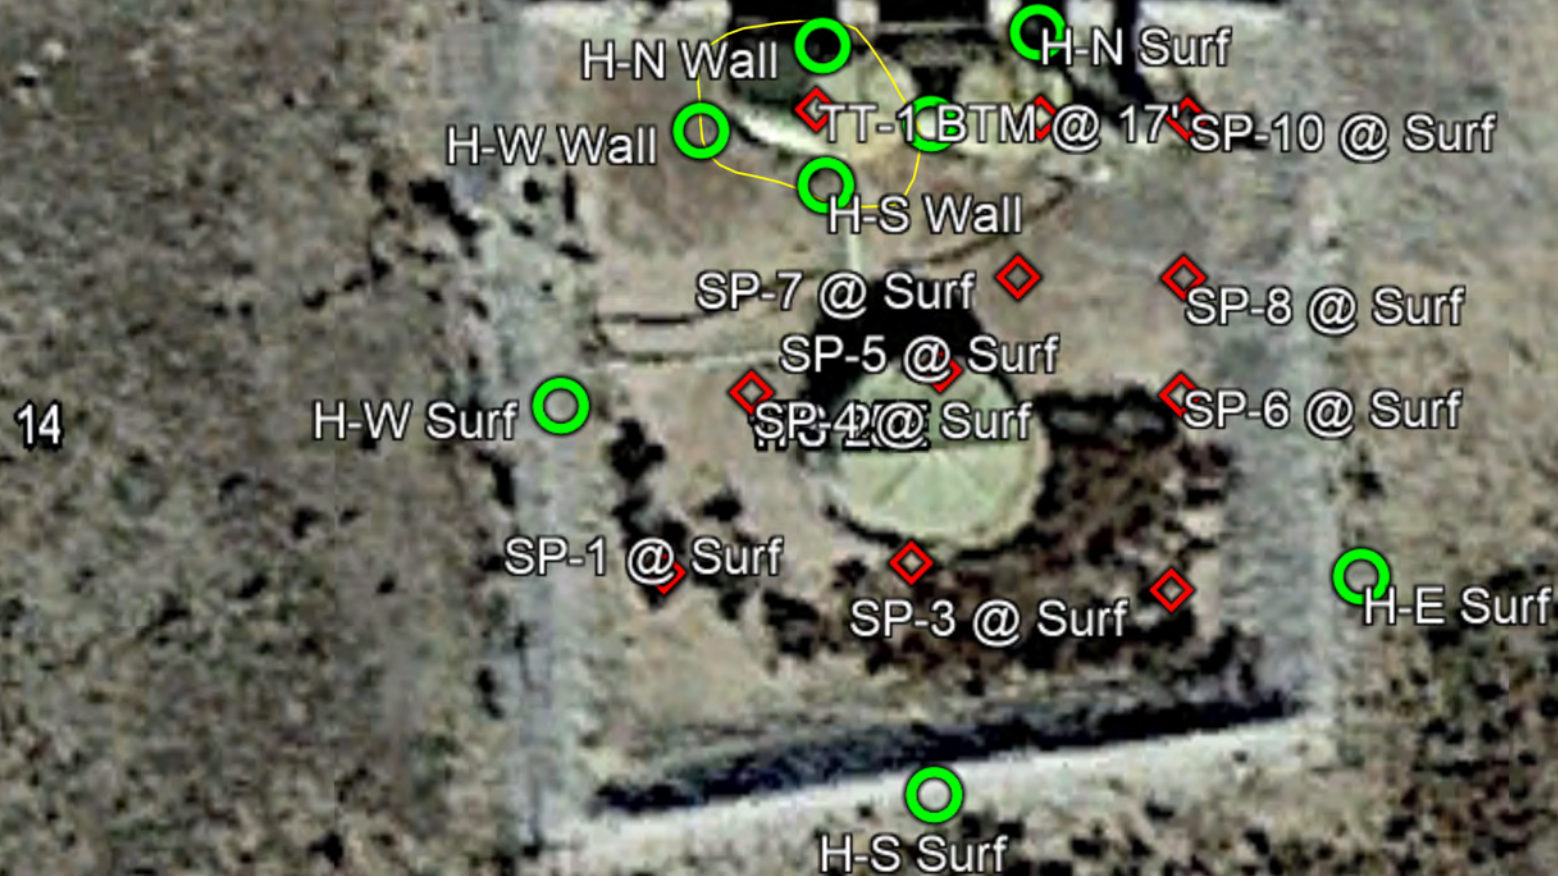
Morris Estate Battery
14-17S-25E
Site Map w/ Confirmation Samples

- Excavation 20
- Horizontal Extent
- Vertical Extent

Based on the results of the delineation, SESI, determined the best course of action is to excavate the contaminated soil to depth in establishing the vertical extent in the singular area identified in the delineation. In October of 2021, contaminated material was removed by excavating the affected area. Confirmation samples were taken to ensure remediation was successful and that the vertical and horizontal extent of the release area had been established. The samples were properly preserved and packaged then sent to Hall Laboratories for analysis. The results of the sampling is captured in the table below.

Once sample results verified both successful remediation and horizontal extent, the site was backfilled with clean soil. Pictures of the remediation are included in this report. The Vertical extent of the release was caught at a depth of 17'. Confirmation samples of the depth, and side walls showed no further migration.
