CLOSURE REPORT

**Wood #2 (9/1/21)
Unit Letter G, S35 T30N R11W
San Juan County, New Mexico**

NM EMNRD OCD Incident ID No. NAPP2125739917

November 30, 2021
Ensolum Project No. 05A1226156

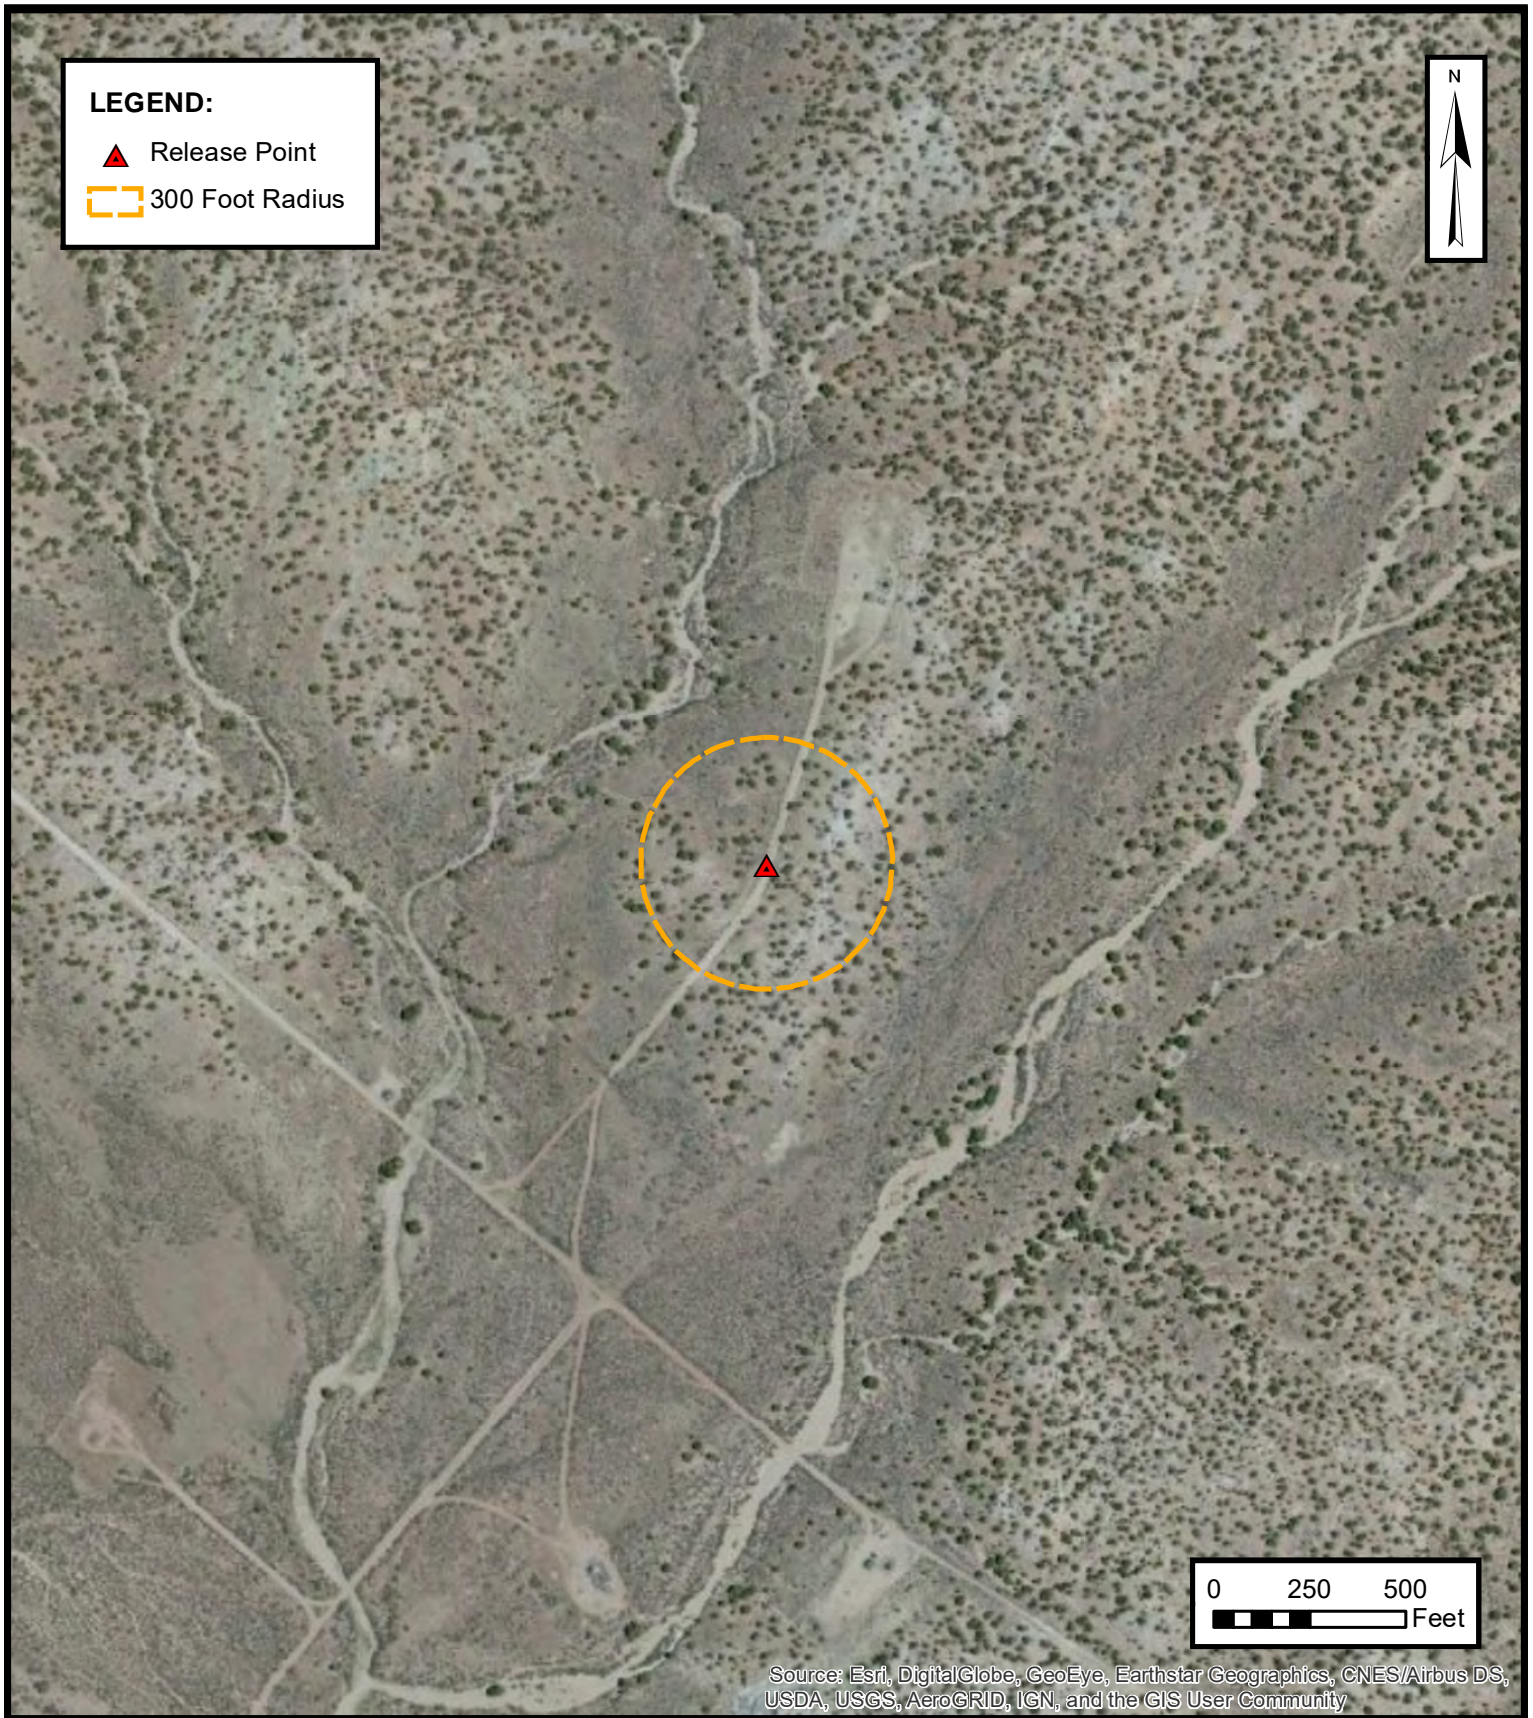
**FIGURE
D**

- The Site is not located within 200 feet of a lakebed, sinkhole, or playa lake.
- The Site is not located within 300 feet of a permanent residence, school, hospital, institution, or church (**Figure D, Appendix B**).

**300 FOOT RADIUS
OCCUPIED STRUCTURE IDENTIFICATION**
ENTERPRISE FIELD SERVICES, LLC
WOOD #2 (9/1/21)
Unit Letter G, S35 T30N R11W, San Juan County, New Mexico
36.769485° N, 107.958157° W
PROJECT NUMBER: 05A1226156

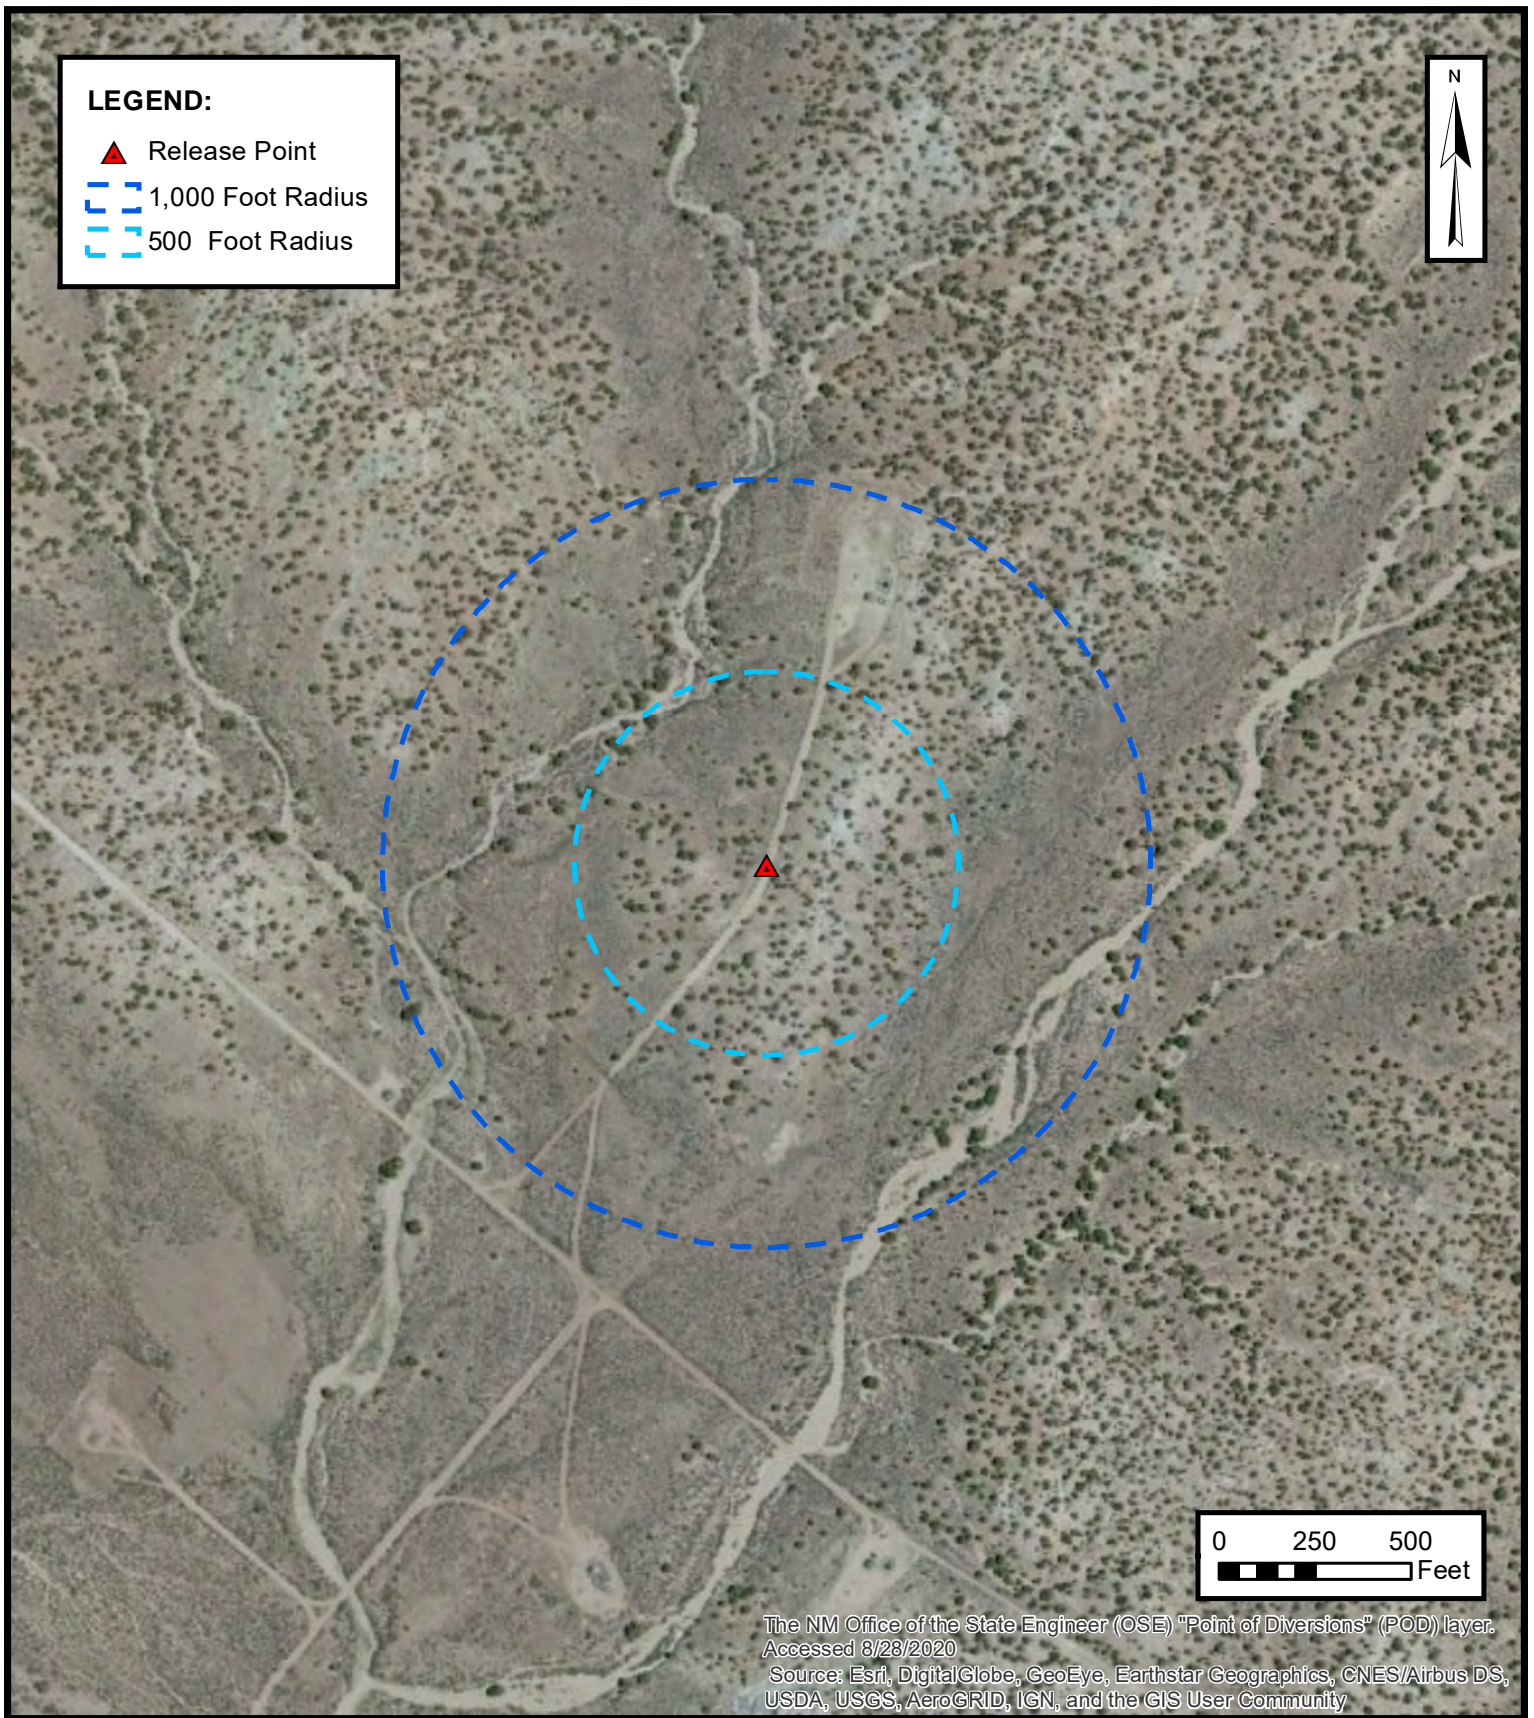
**FIGURE
E**

- No springs, or private domestic fresh water wells used by less than five households for domestic or stock watering purposes were identified within 500 feet of the Site (**Figure E, Appendix B**).

- No fresh water wells or springs were identified within 1,000 feet of the Site (**Figure E, Appendix B**).
- The Site is not located within incorporated municipal boundaries or within a defined municipal fresh water well field covered under a municipal ordinance adopted pursuant to New Mexico Statutes Annotated (NMSA) 1978, Section 3-27-3.

WATER WELL AND NATURAL SPRING LOCATION

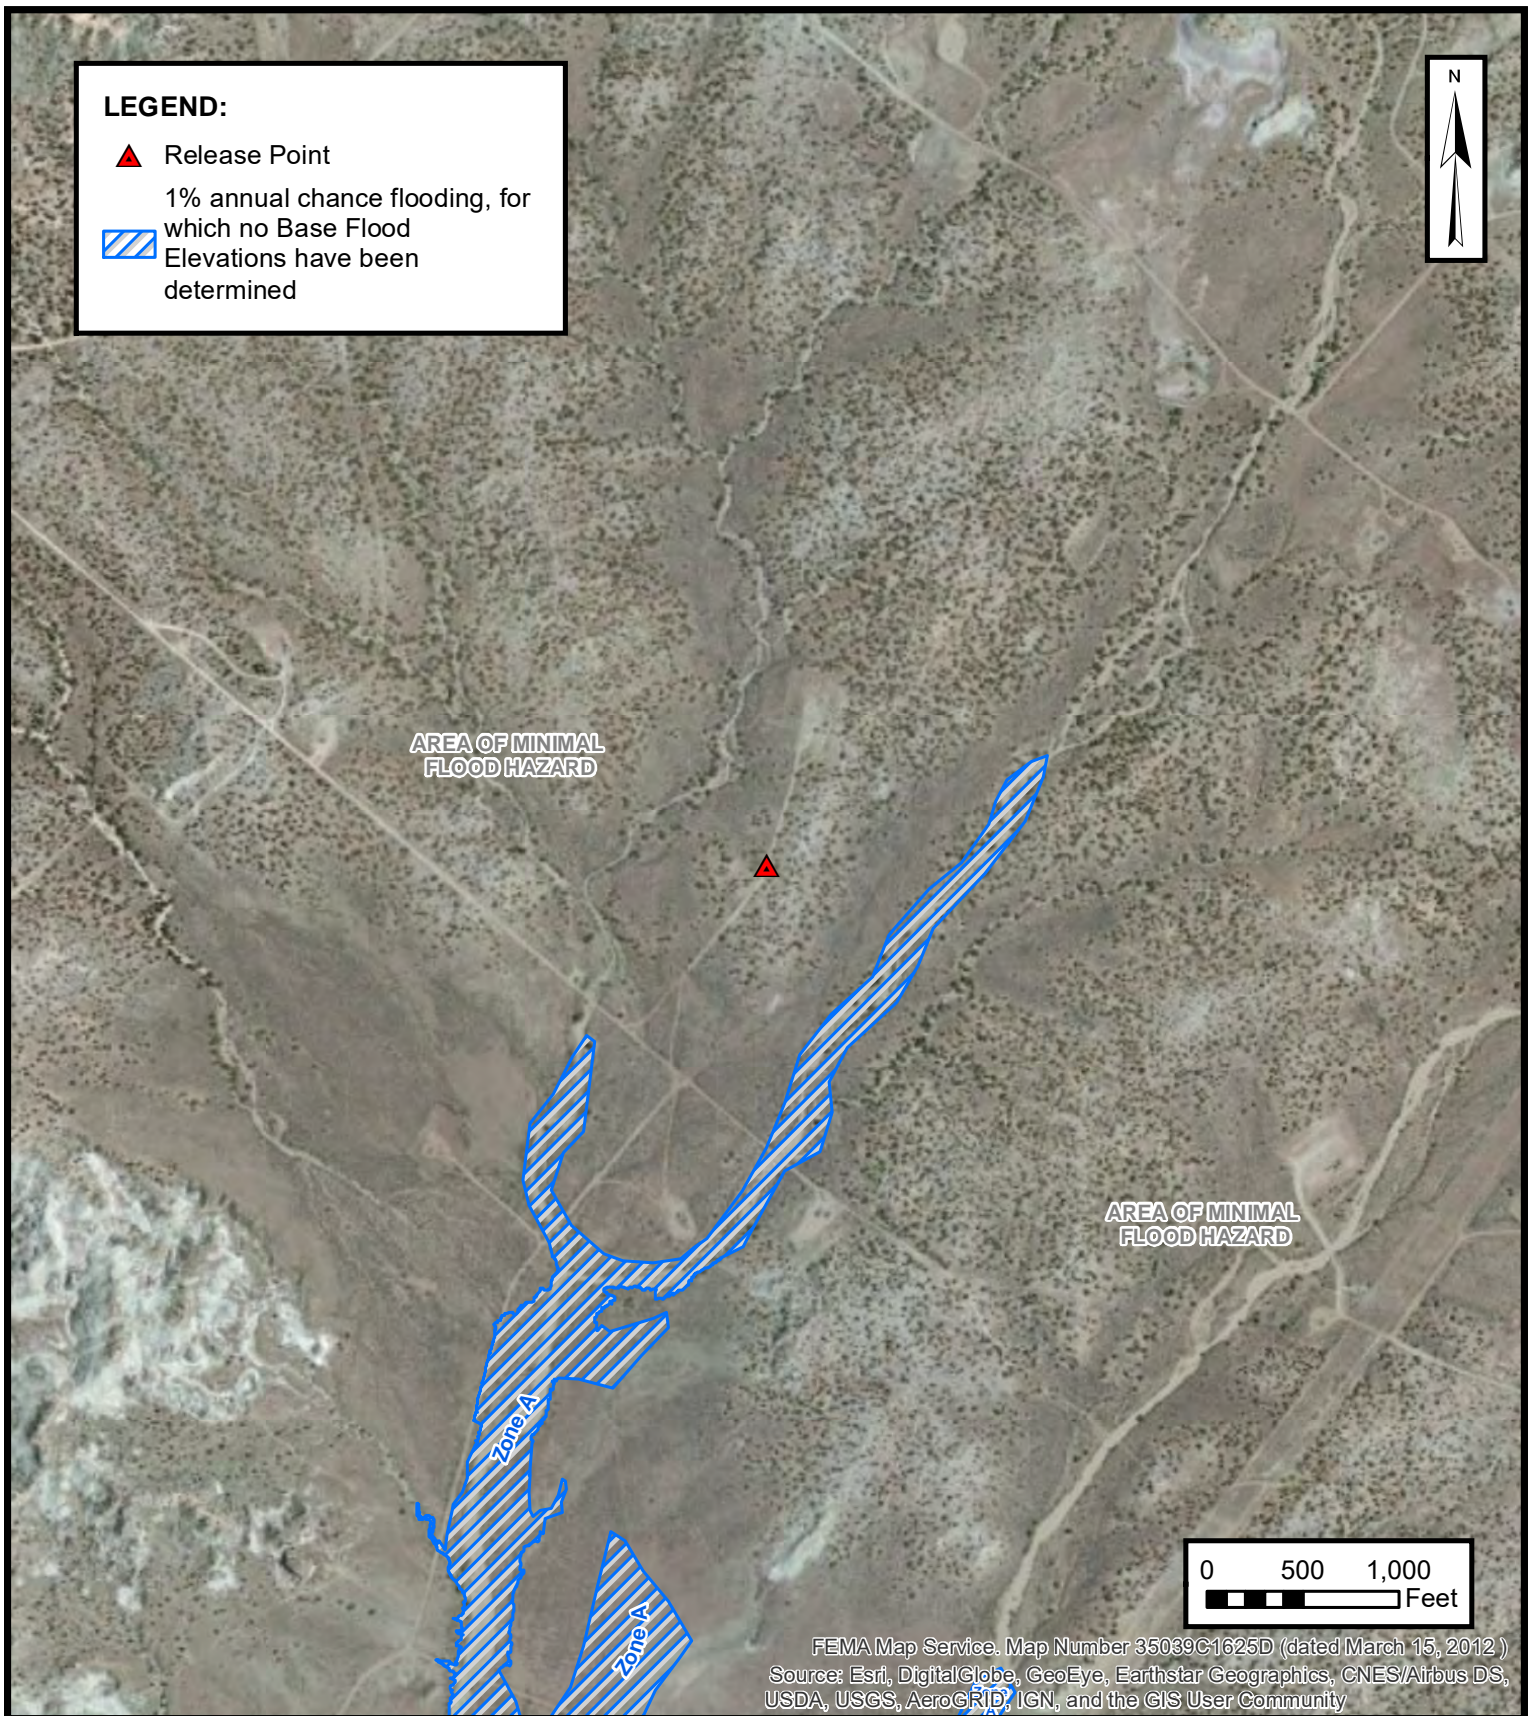
FIGURE

- The Site is not located within an unstable area.
- Based on information provided by the Federal Emergency Management Agency (FEMA) National Flood Hazard Layer (NFHL) geospatial database the location of the Site is not located within a 100-year floodplain (**Figure H, Appendix B**).

100-YEAR FLOOD PLAIN MAP

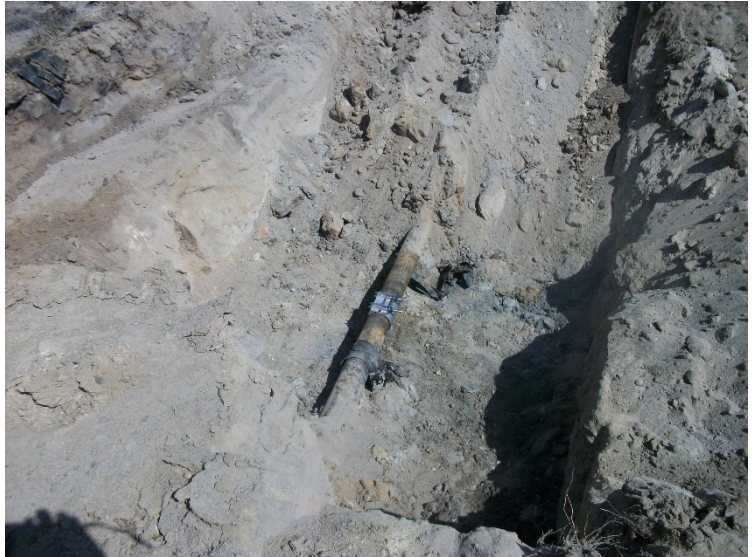
**Photograph 1**

Photograph Description: View of the initial excavation activities.

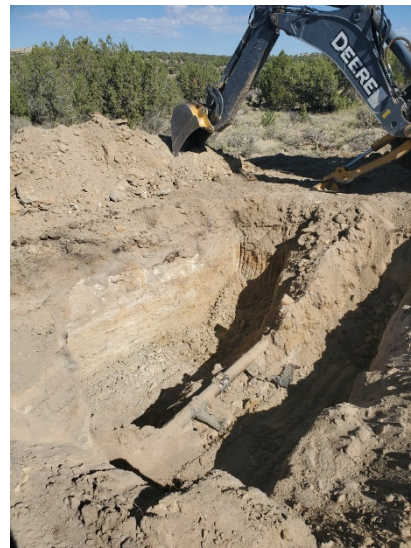
**Photograph 2**

The final excavation measured approximately nine feet long and nine feet wide at the maximum extents. The maximum depth of the excavation measured approximately four feet bgs. The lithology encountered during the completion of remediation activities consisted primarily of unconsolidated silty sand underlain by weathered sandstone.

Photograph Description: View of the final excavation.

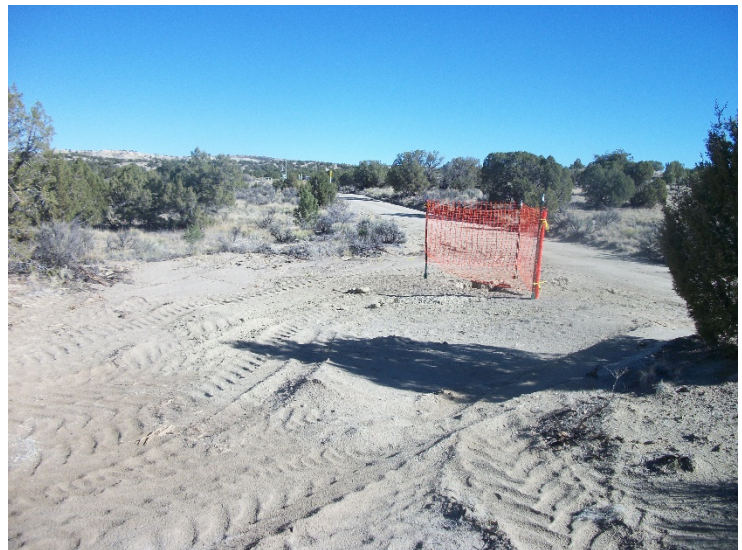
**Photograph 3**

Photograph Description: View of the site after initial restoration.

The excavation was backfilled with imported fill, and the area was then contoured to surrounding grade. The pipeline was hydro-excavated again after backfilling was complete to facilitate upcoming pipeline replacement. After permanent repairs are complete, Enterprise will re-seed the Site with a BLM-approved seed mixture.
