Release Notification

Site Name Gissler B 3-2 Battery Produced Water Transfer Line	Site Type Produced Water Transfer Line
Date Release Discovered 11/20/2021	API# (if applicable)

A C-141 initial report for this release was submitted to the NMOCD on December 3, 2021. The C-141 stated the release on November 20, 2021, was caused by, "The 3-inch poly transfer line sustained damage from the vehicular traffic which caused it to crack and split open". Approximately ninety-two (92) barrels (bbls) of produced water was released with zero (0) bbls being recovered. On November 21, 2021, EOG's contractor BDS Enterprise, LLC (BDS), on behalf of EOG scraped the surface of the impacted area and hauled the material to a NMOCD approved facility.

EOG RESOURCES
EDDY COUNTY, NEW MEXICO
GISSLER B 3-2 BATTERY
PRODUCED TRANSFER LINE

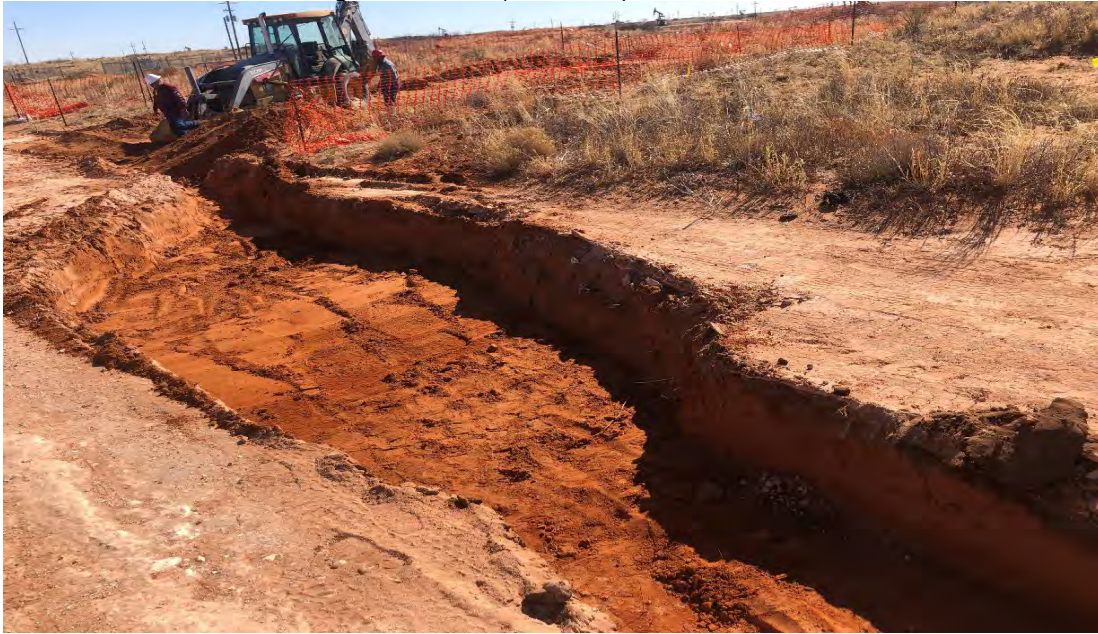
View of Excavation Facing Southeast (01/24/22)

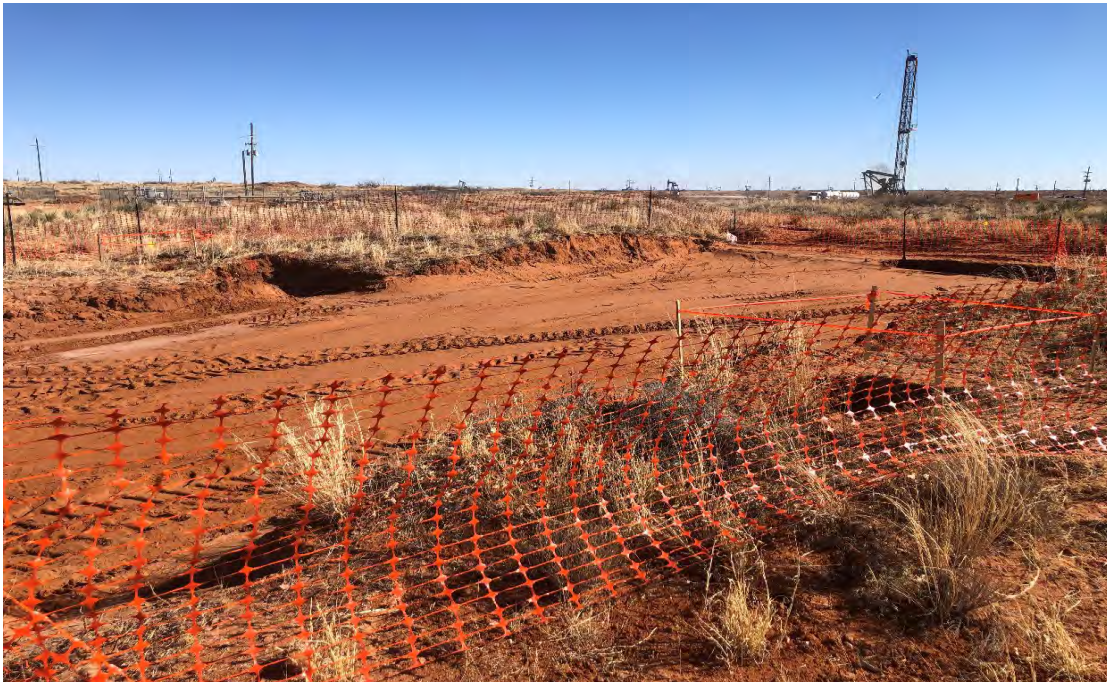
View of Excavation Facing Southeast (01/24/22)

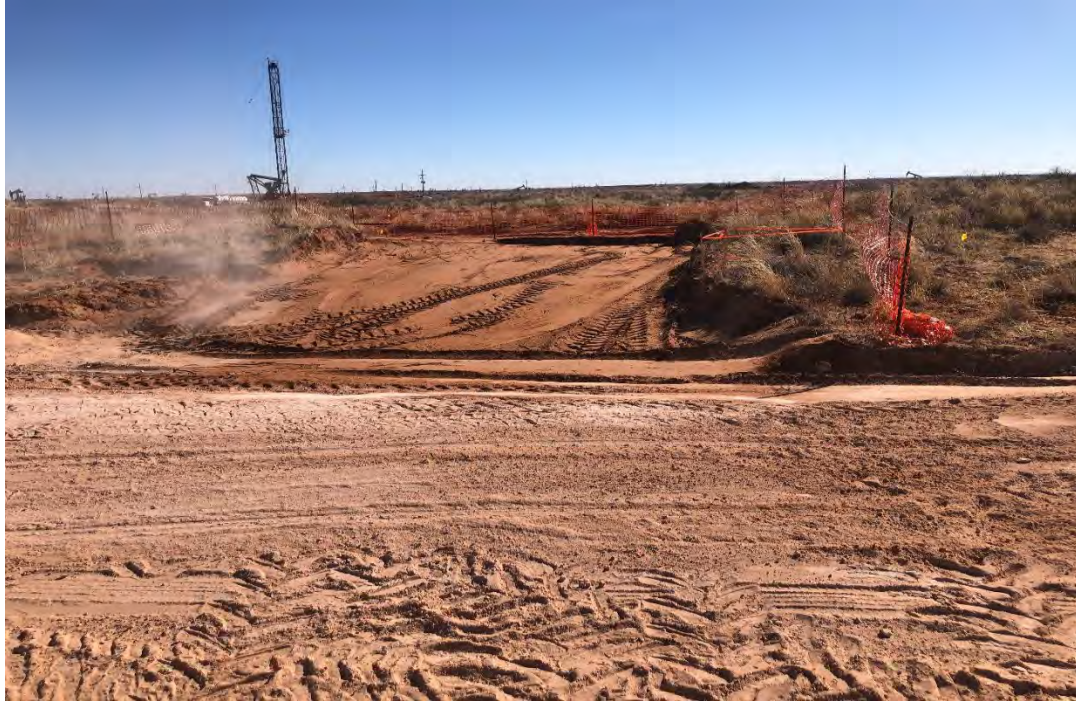
View of Excavation Facing South (01/24/22)

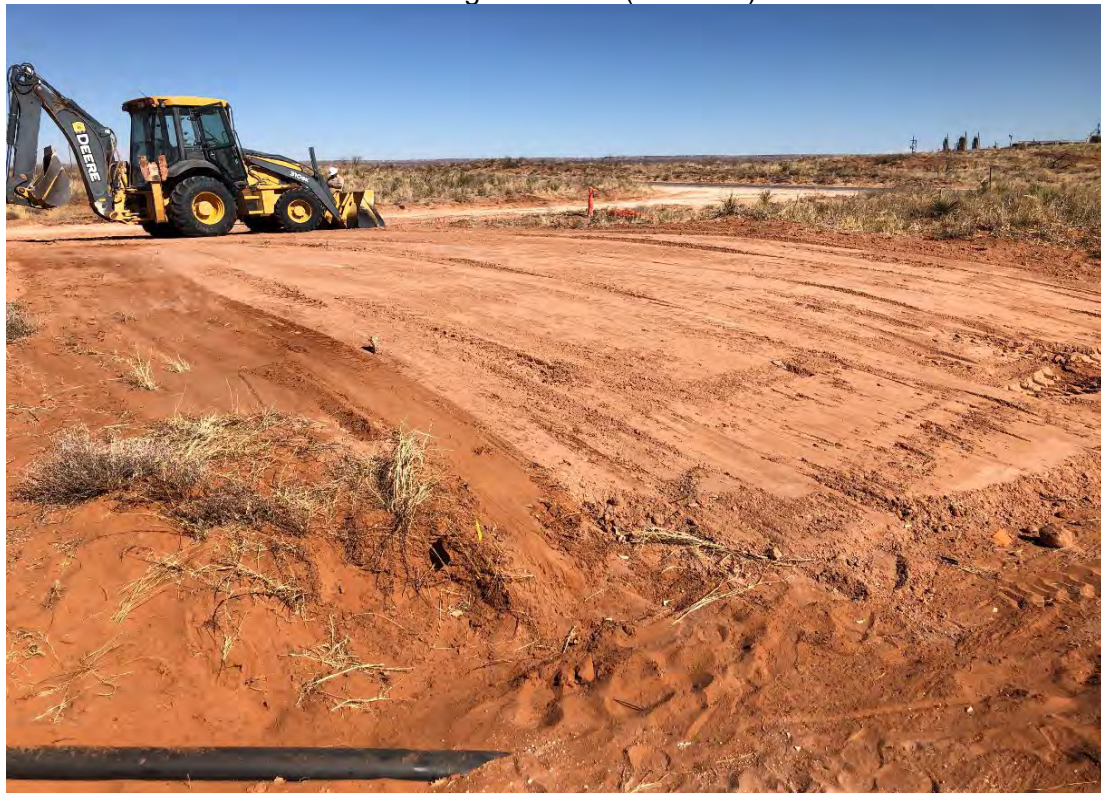
View of Backfilled Excavation Facing Northeast (01/27/22)

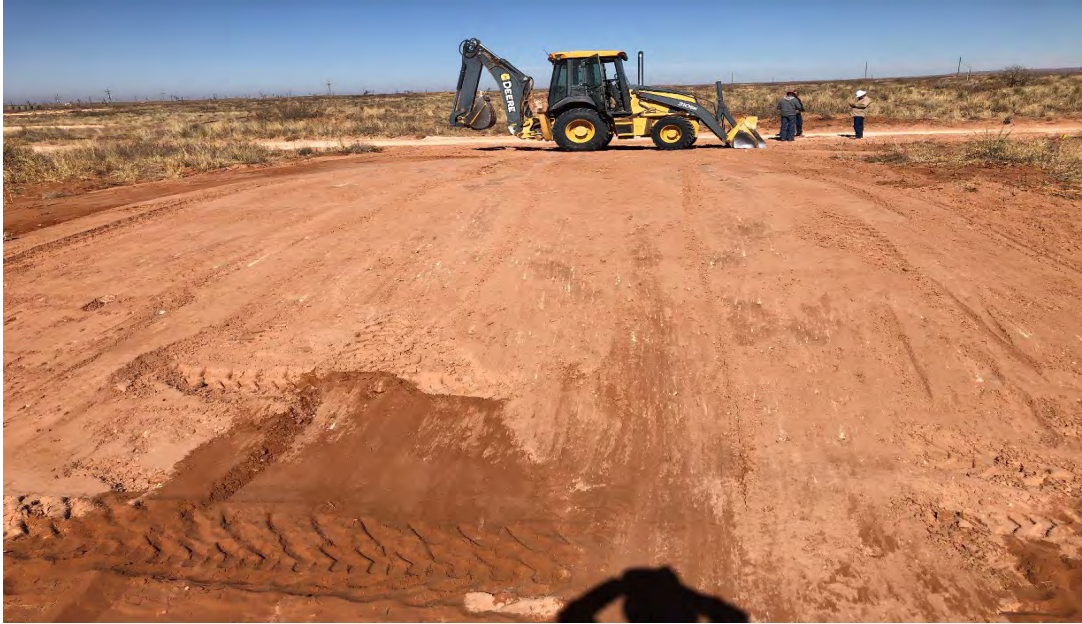
View of Backfilled Excavation Facing Northeast (01/27/22)

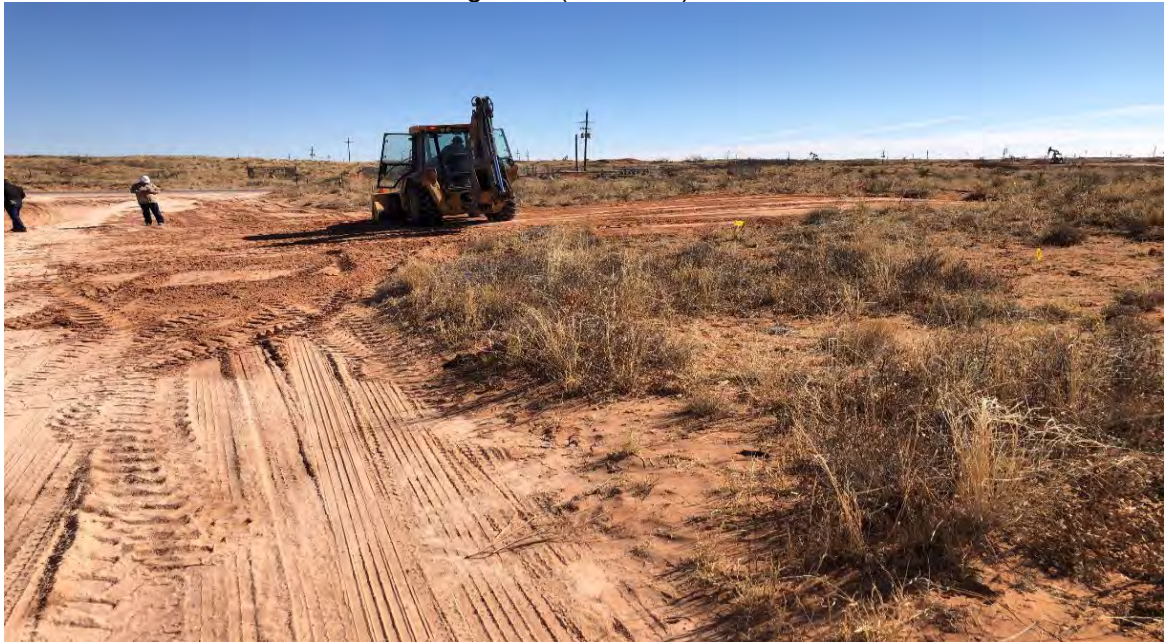
View of Backfilled Excavation Facing East (01/27/22)

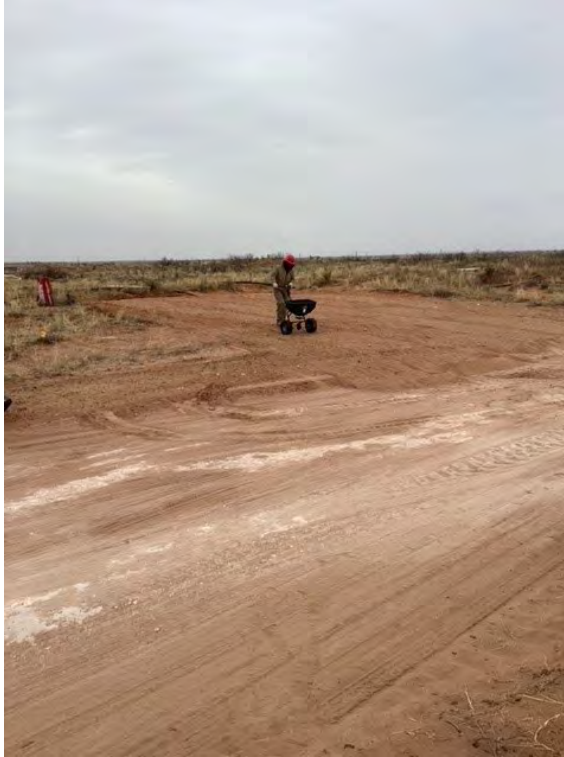
View of Excavation During Re-Seeding Facing Southwest (02/03/22)

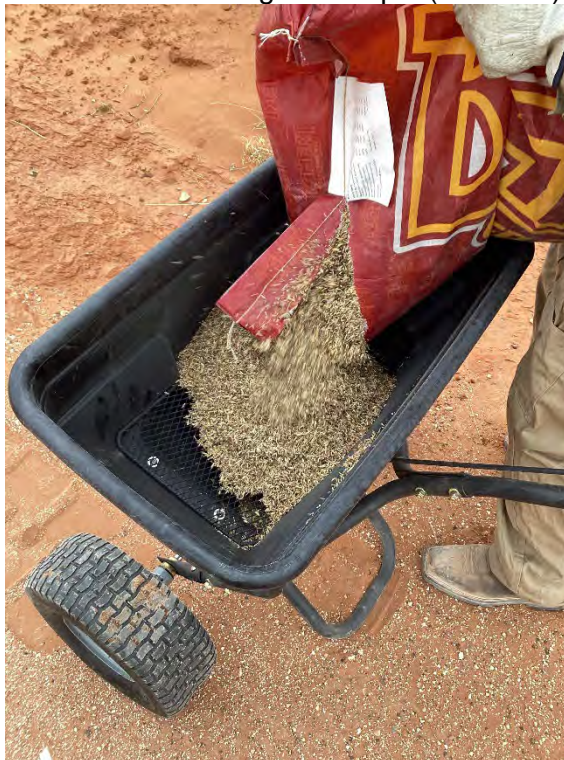
View of Re-Seeding Technique (02/03/22)

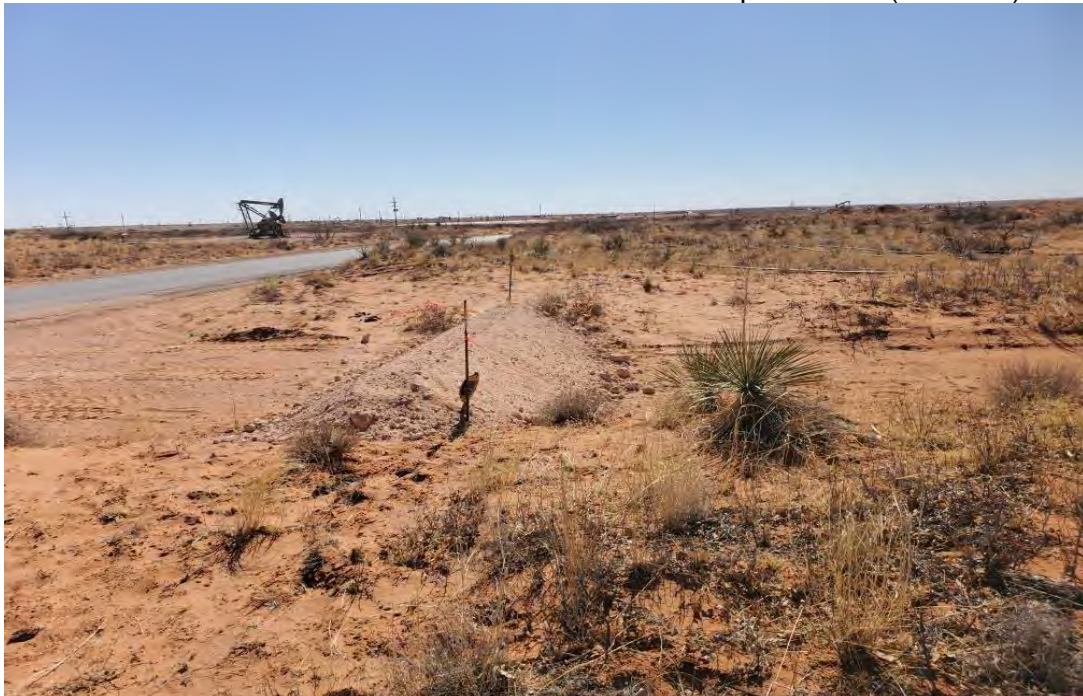
View of Berm Installed to Block Off Two-Track Trespass Road (02/03/22)
