Re: Goat Roper LP #1
30-015-23059
P-30-17S-26E
Eddy County, NM
Incident #NRM2035039644

Goat Roper LP #1

Closure Report

NRM2035039644

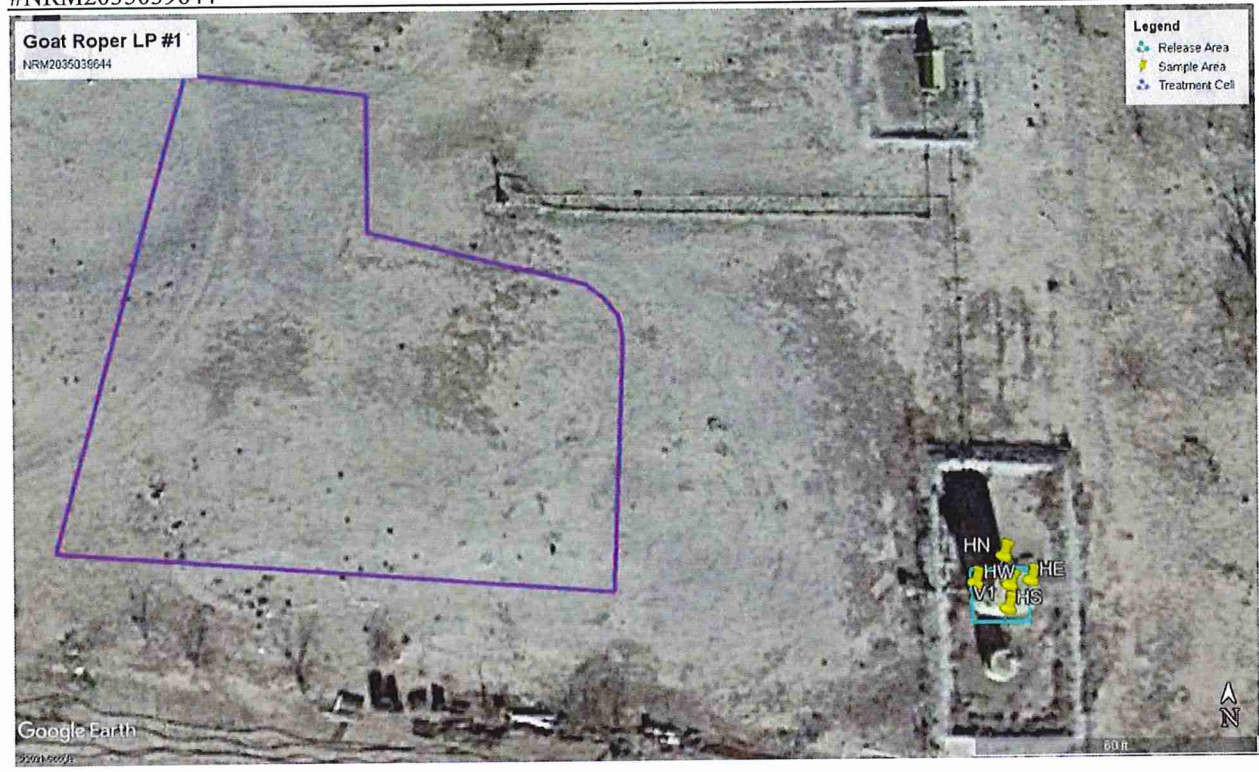
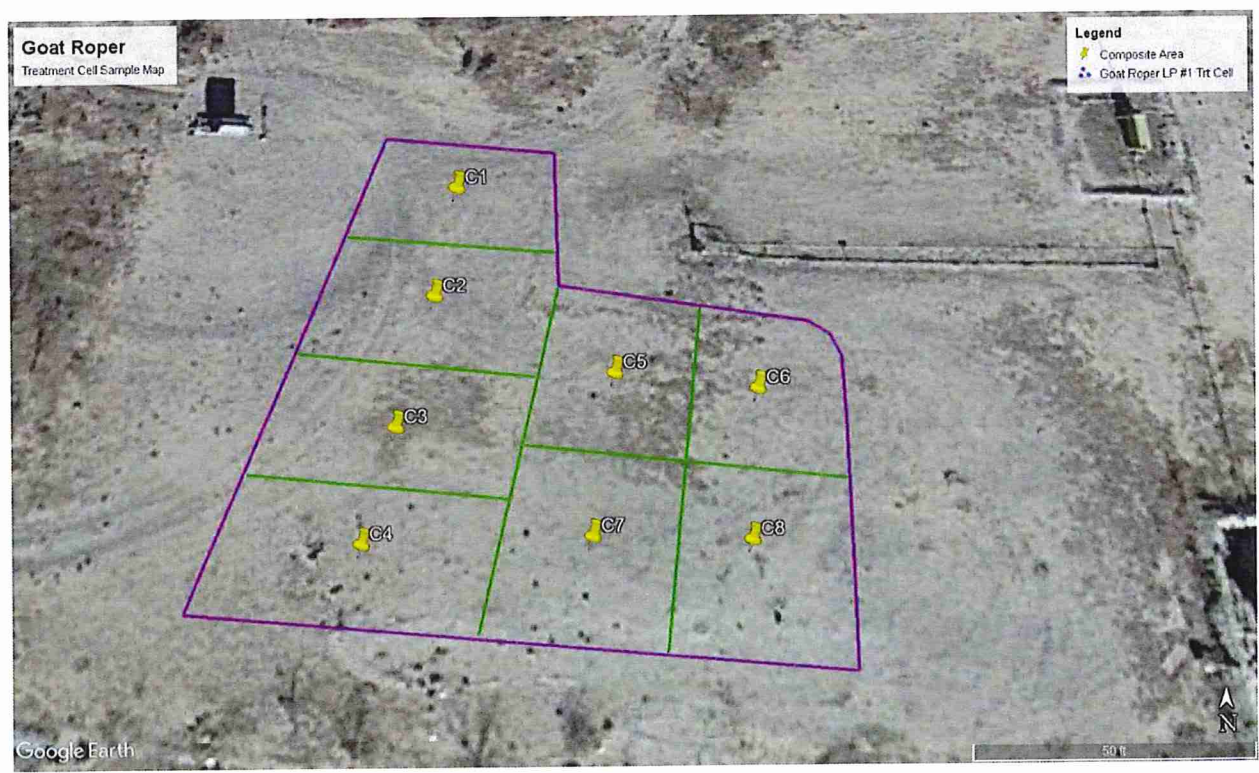
Figure 1

On September 14, 2021, GHD Services Inc. mobilized to the site to perform confirmation sampling of the bioremediated soils within the treatment cell, notification of this sampling event was provided to NMOCD through email on September 9, 2021. Confirmation sampling followed the protocol approved by NMOCD in the Remediation Plan, one 5-point composite sample collected per 25 cubic yards of bioremediated soil. GHD created a sampling summary document that is included as Appendix C.

Site Map with Sample Points

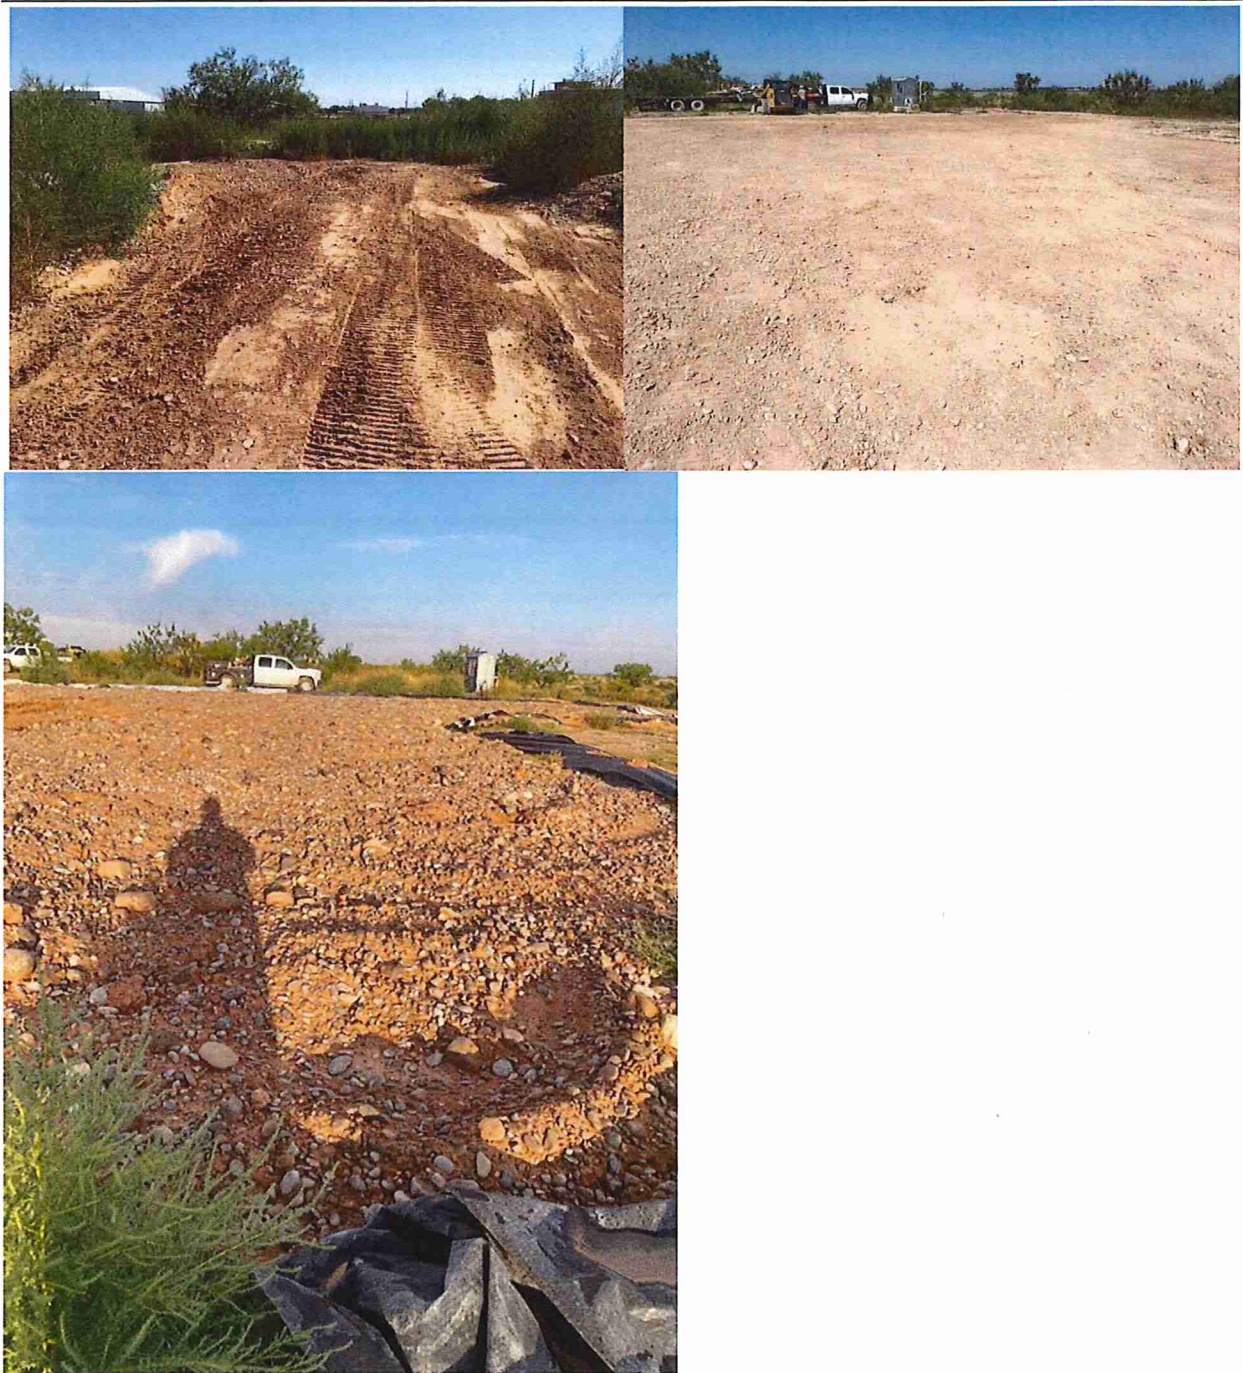
Photos

After reviewing the results, EOG hired a dirt contractor to backfill the excavation, providing guidance to remove all liner material prior to installing the bioremediated soil into the excavation. The process began on October 1, 2021, but due to precipitation could not be completed until October 4, 2021.
