CLOSURE REPORT

**Lateral MD 7 Loop (01/16/21)
NW ¼, S15 T32N R10W
San Juan County, New Mexico**

NM EMNRD OCD Incident ID No. NAPP2105454212

June 7, 2021
Ensolum Project No. 05A1226134

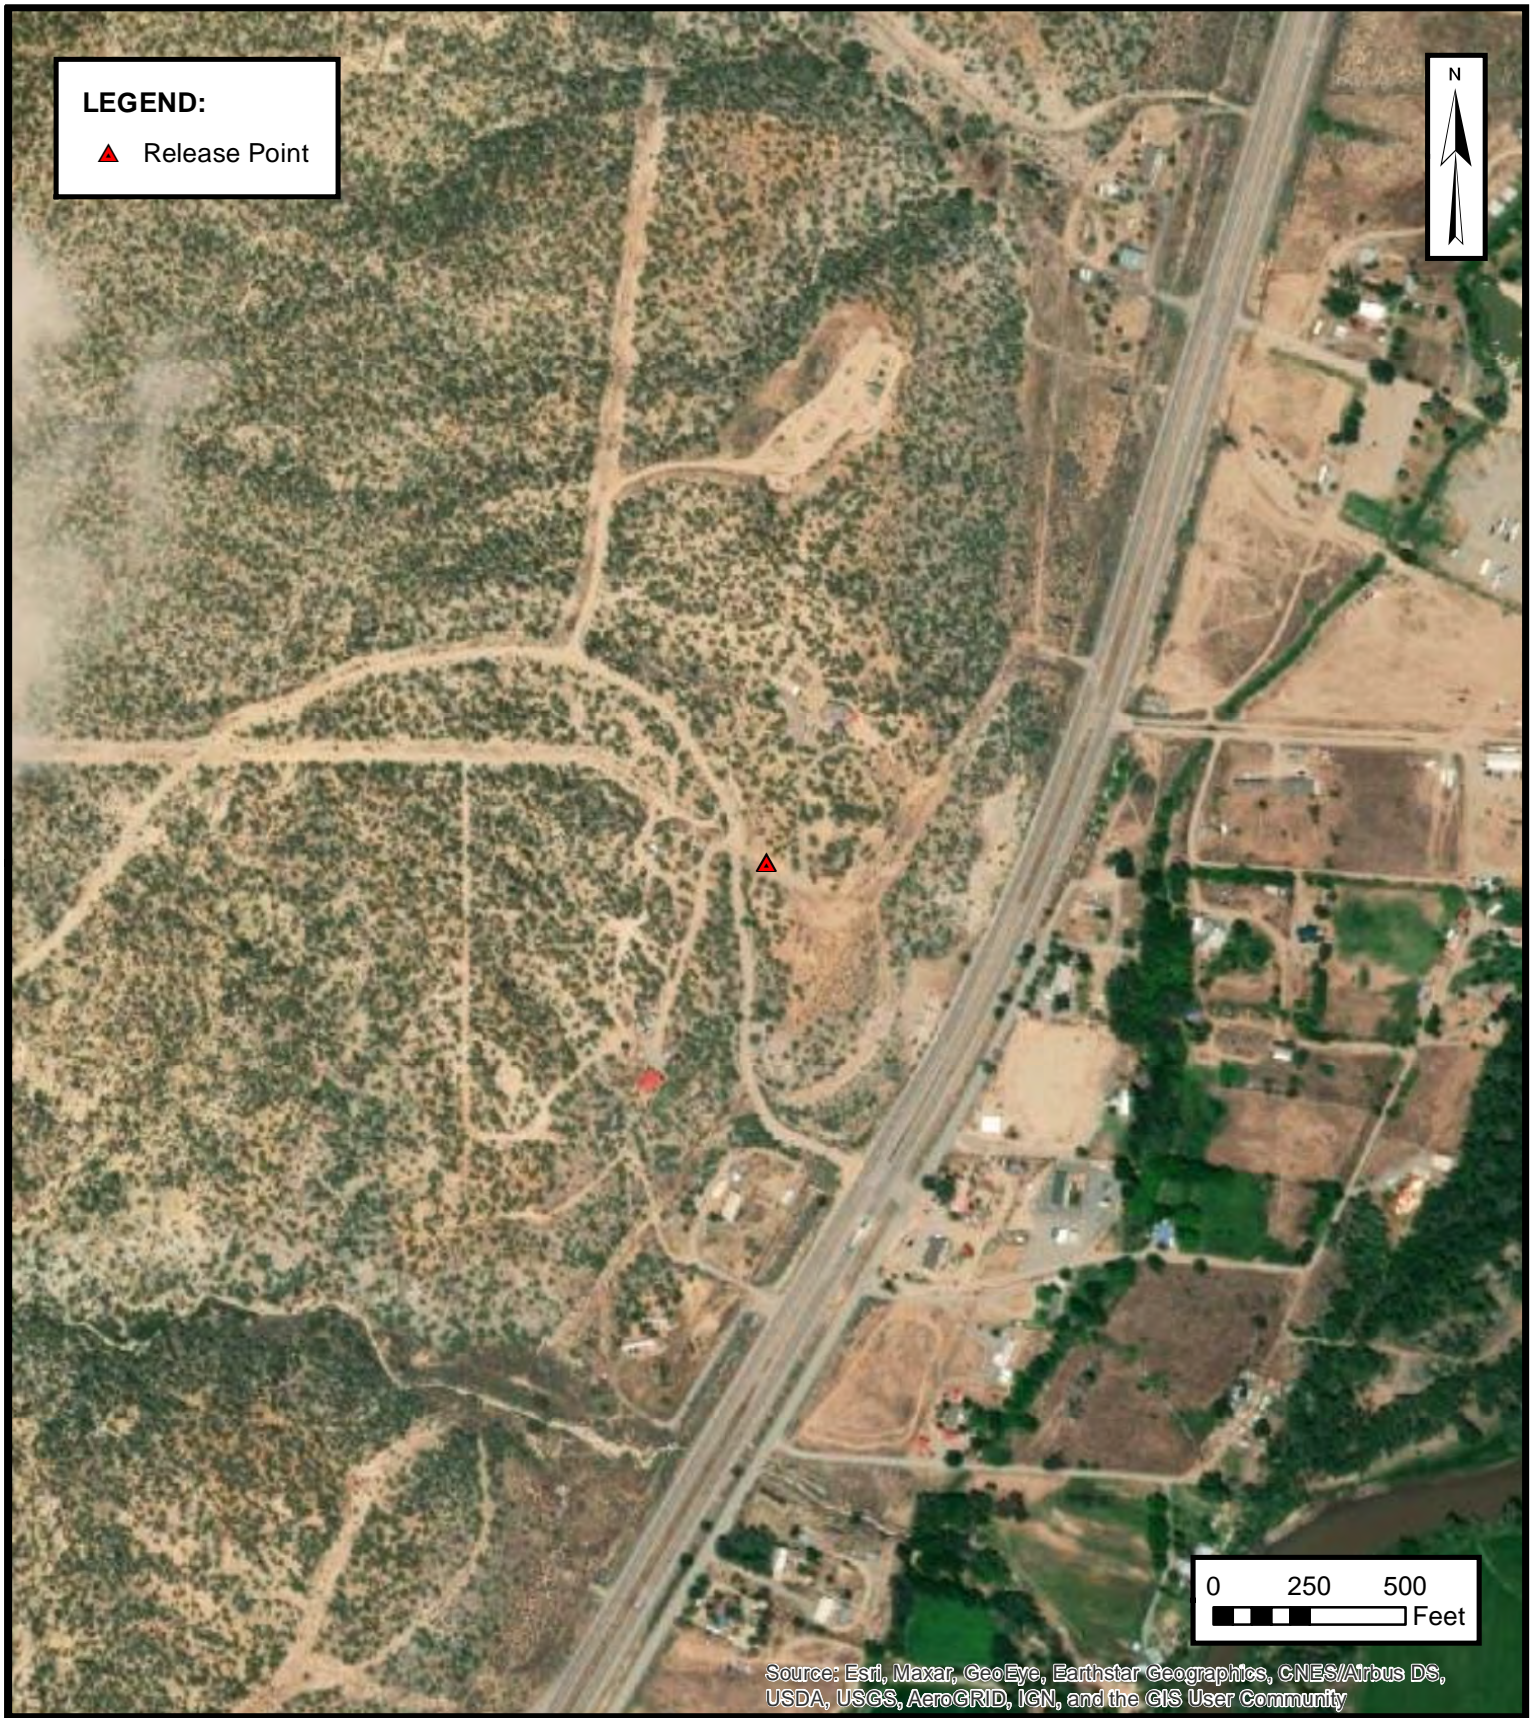
1

SITE VICINITY MAP

ENTERPRISE FIELD SERVICES, LLC
LATERAL MD 7 LOOP (01/16/21)
NW ¼, S15 T32N R10W, San Juan County, New Mexico
36.987093° North, 107.875699° West

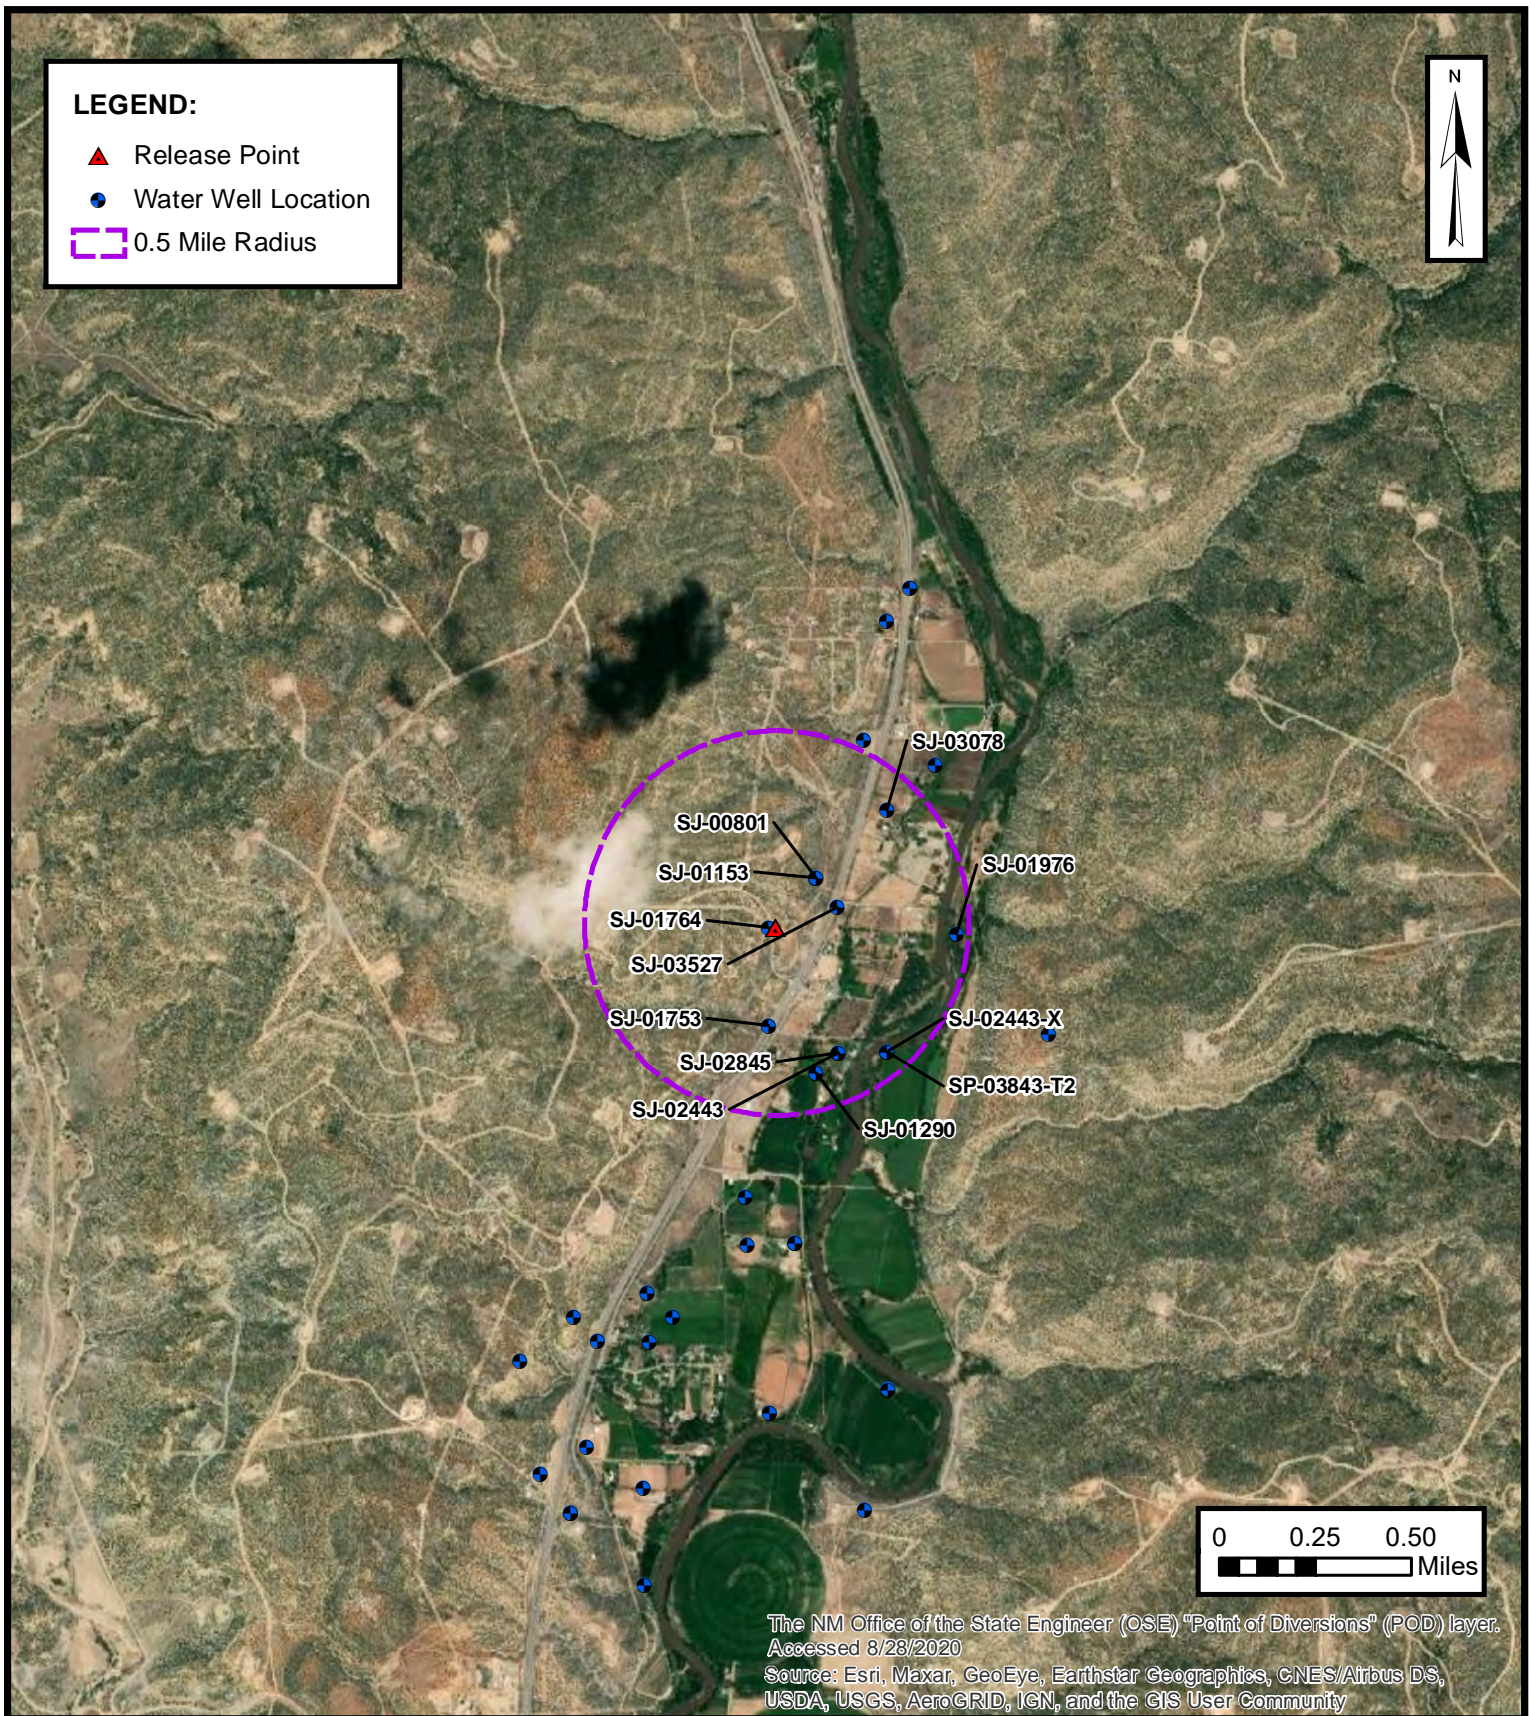
FIGURE
A

and includes an interactive map). Numerous PODS were identified in the same Public Land Survey System (PLSS) section as the Site as well as in adjacent sections. The average depth to water for the PODs located in this PLSS section and in adjacent PLSS sections is approximately 49 feet below grade surface (bgs). The permit for the closest POD (SJ-01764) was approved by the OSE in 1983 but apparently the well was never installed, and no additional information was available (nor was a well identified at the property). The next nearby PODs (SJ-01153 and SJ-03527) appear to be located approximately 0.17 miles from the Site and approximately 100 feet lower in elevation than the Site (6,100 feet). The records for these PODs indicate depth to water at 47 feet bgs and 80 bgs, respectively (**Figure A, Appendix B**).

0.5 MILE RADIUS WATER WELL MAP

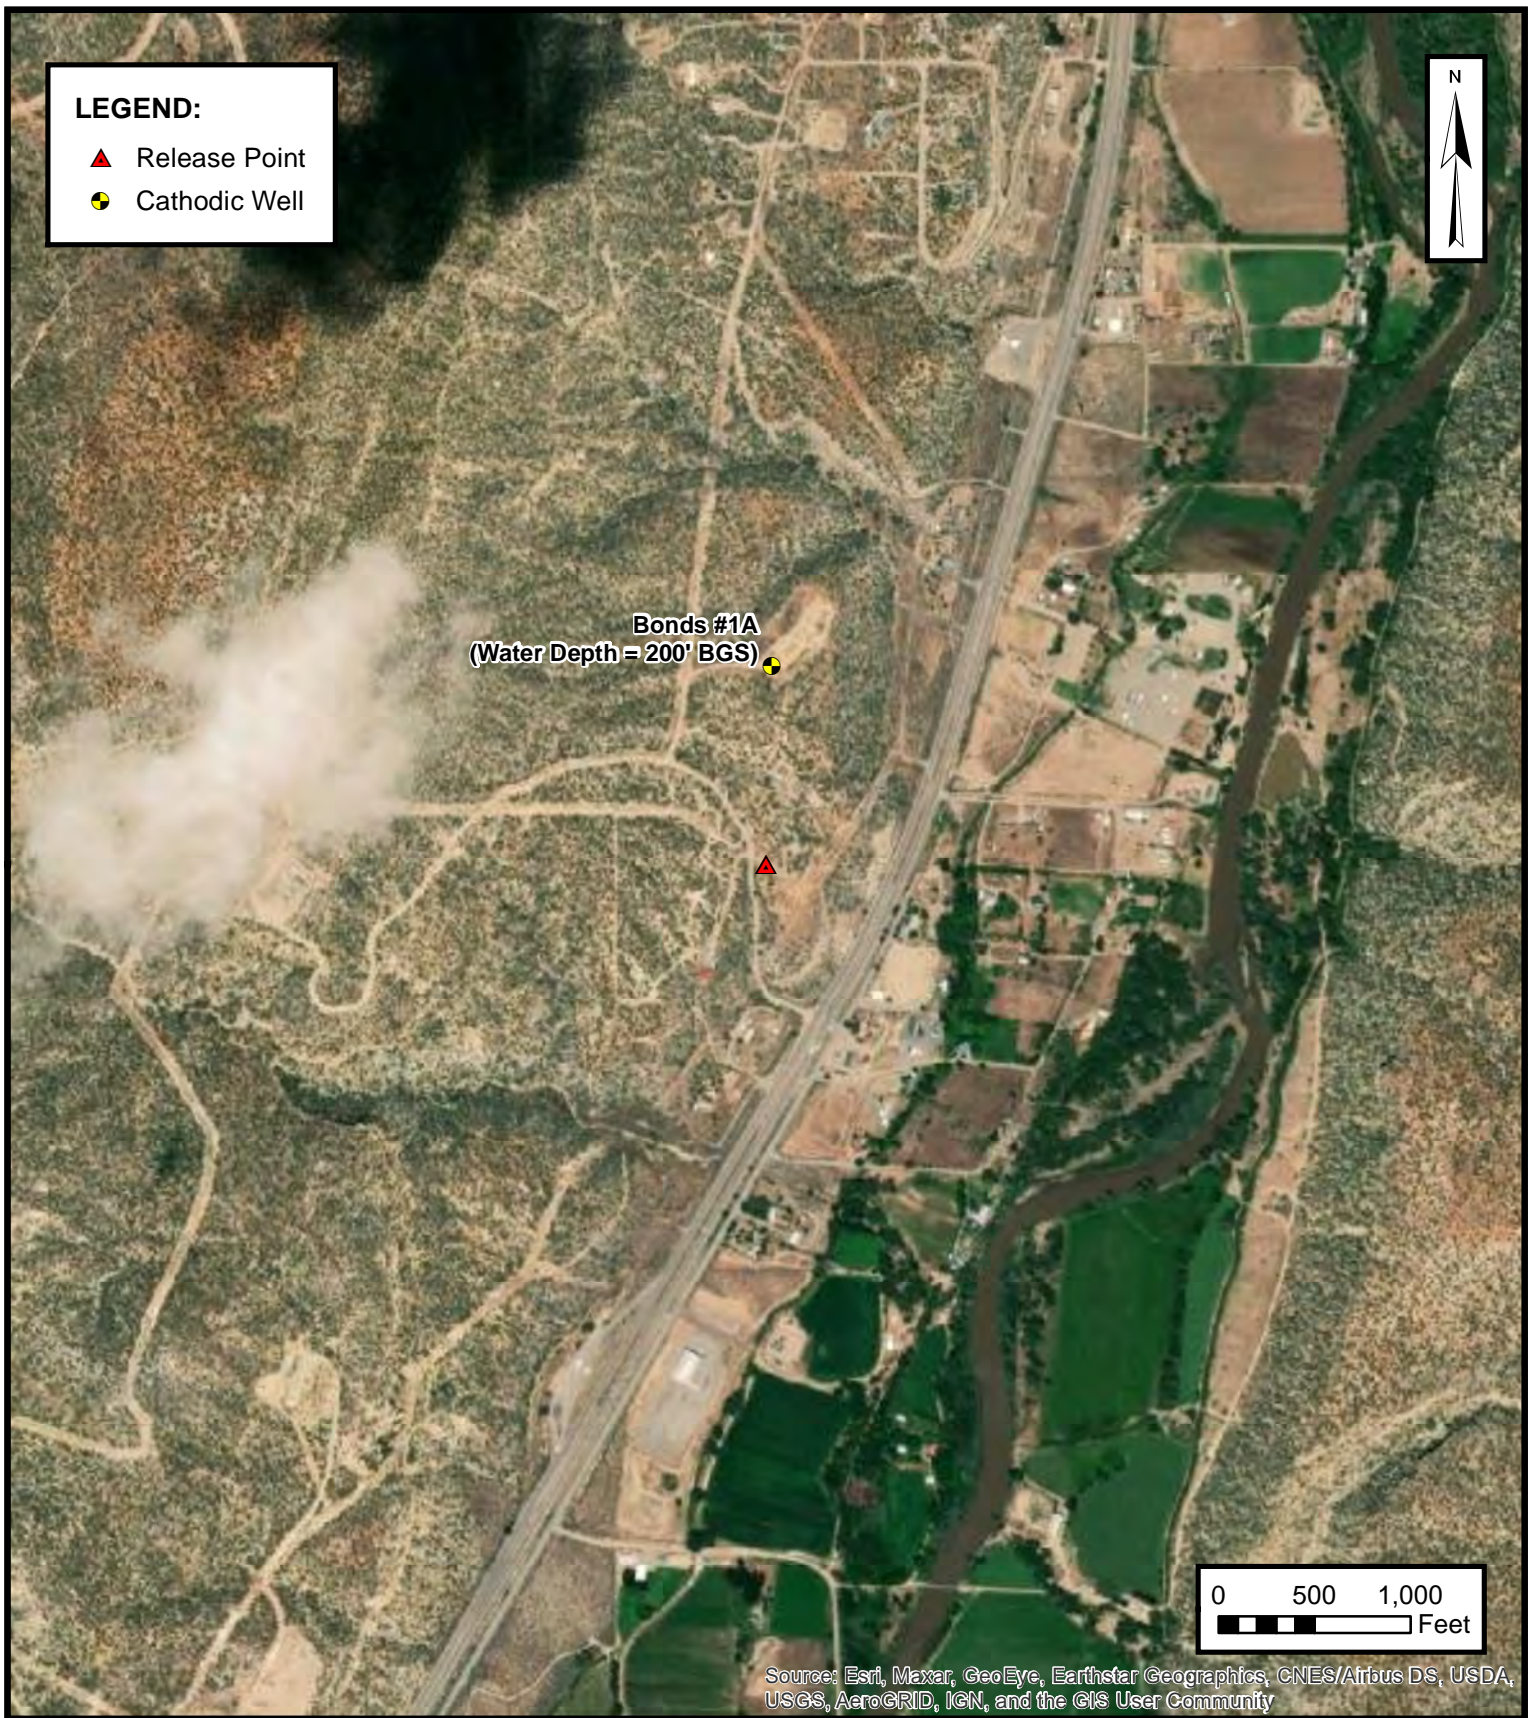
**FIGURE
B**

- One (1) cathodic protection well (Bonds #1A (Unit D, Sec15 T32N R10W)) was identified in the New Mexico EMNRD OCD imaging database. This cathodic well is located approximately 982 feet north of the Site at an elevation approximately 33 feet higher than the site. The records indicate a depth to water of 200 feet bgs.

**CATHODIC PROTECTION WELL RECORDED
DEPTH TO WATER**

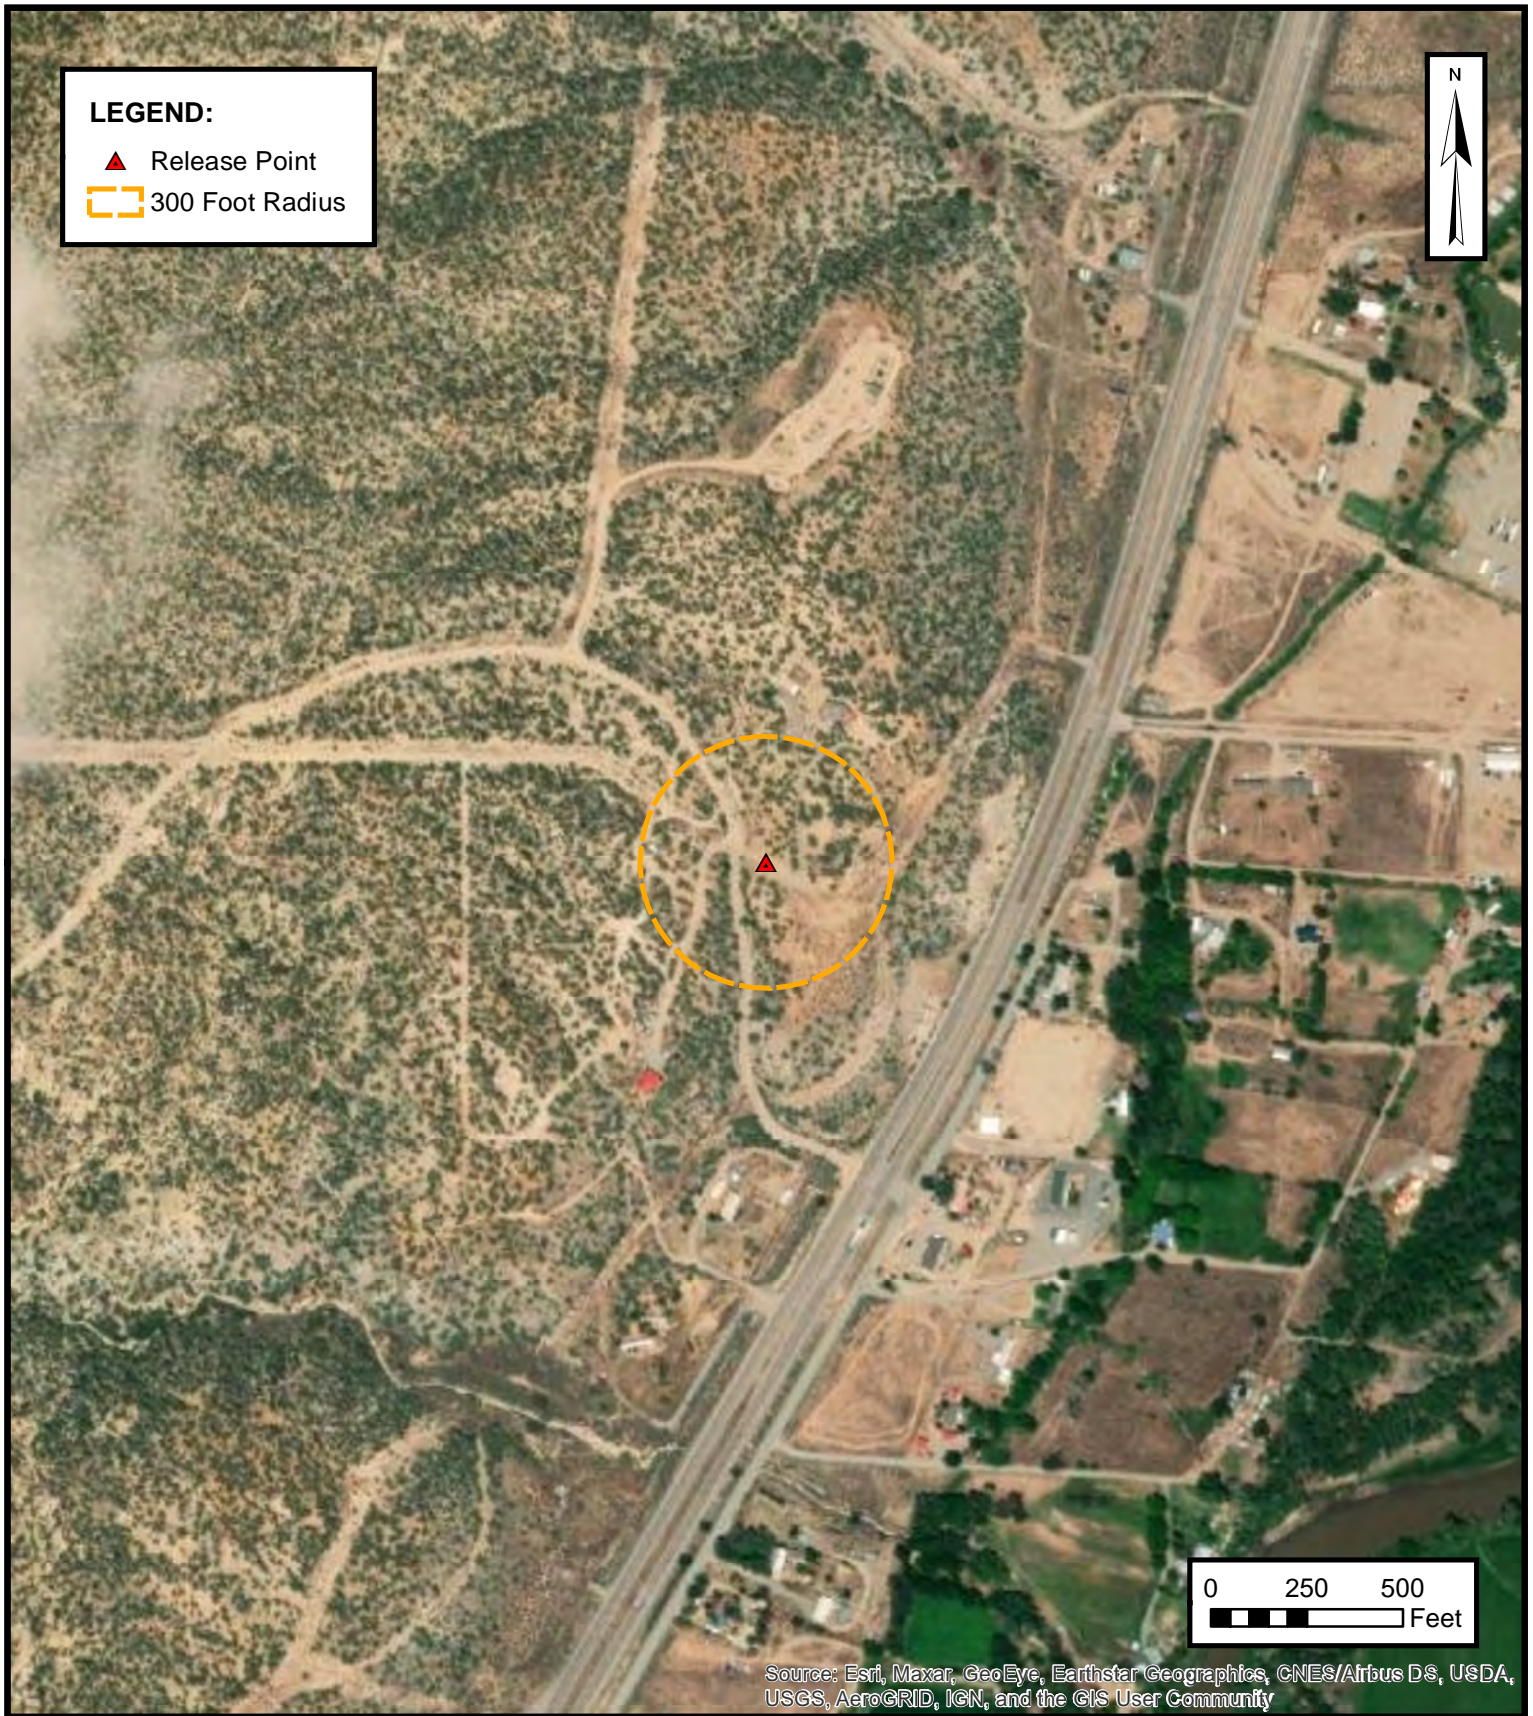
**FIGURE
C**

- The Site is not located within 300 feet of a New Mexico EMNRD OCD-defined significant watercourse. (**Figure C, Appendix B**).
- The Site is not located within 200 feet of a lakebed, sinkhole, or playa lake.

**300 FOOT RADIUS
WATERCOURSE AND DRAINAGE IDENTIFICATION**
ENTERPRISE FIELD SERVICES, LLC
LATERAL MD 7 LOOP (01/16/21)
NW ¼, S15 T32N R10W, San Juan County, New Mexico
36.987093° North, 107.875699° West
PROJECT NUMBER: 05A1226134

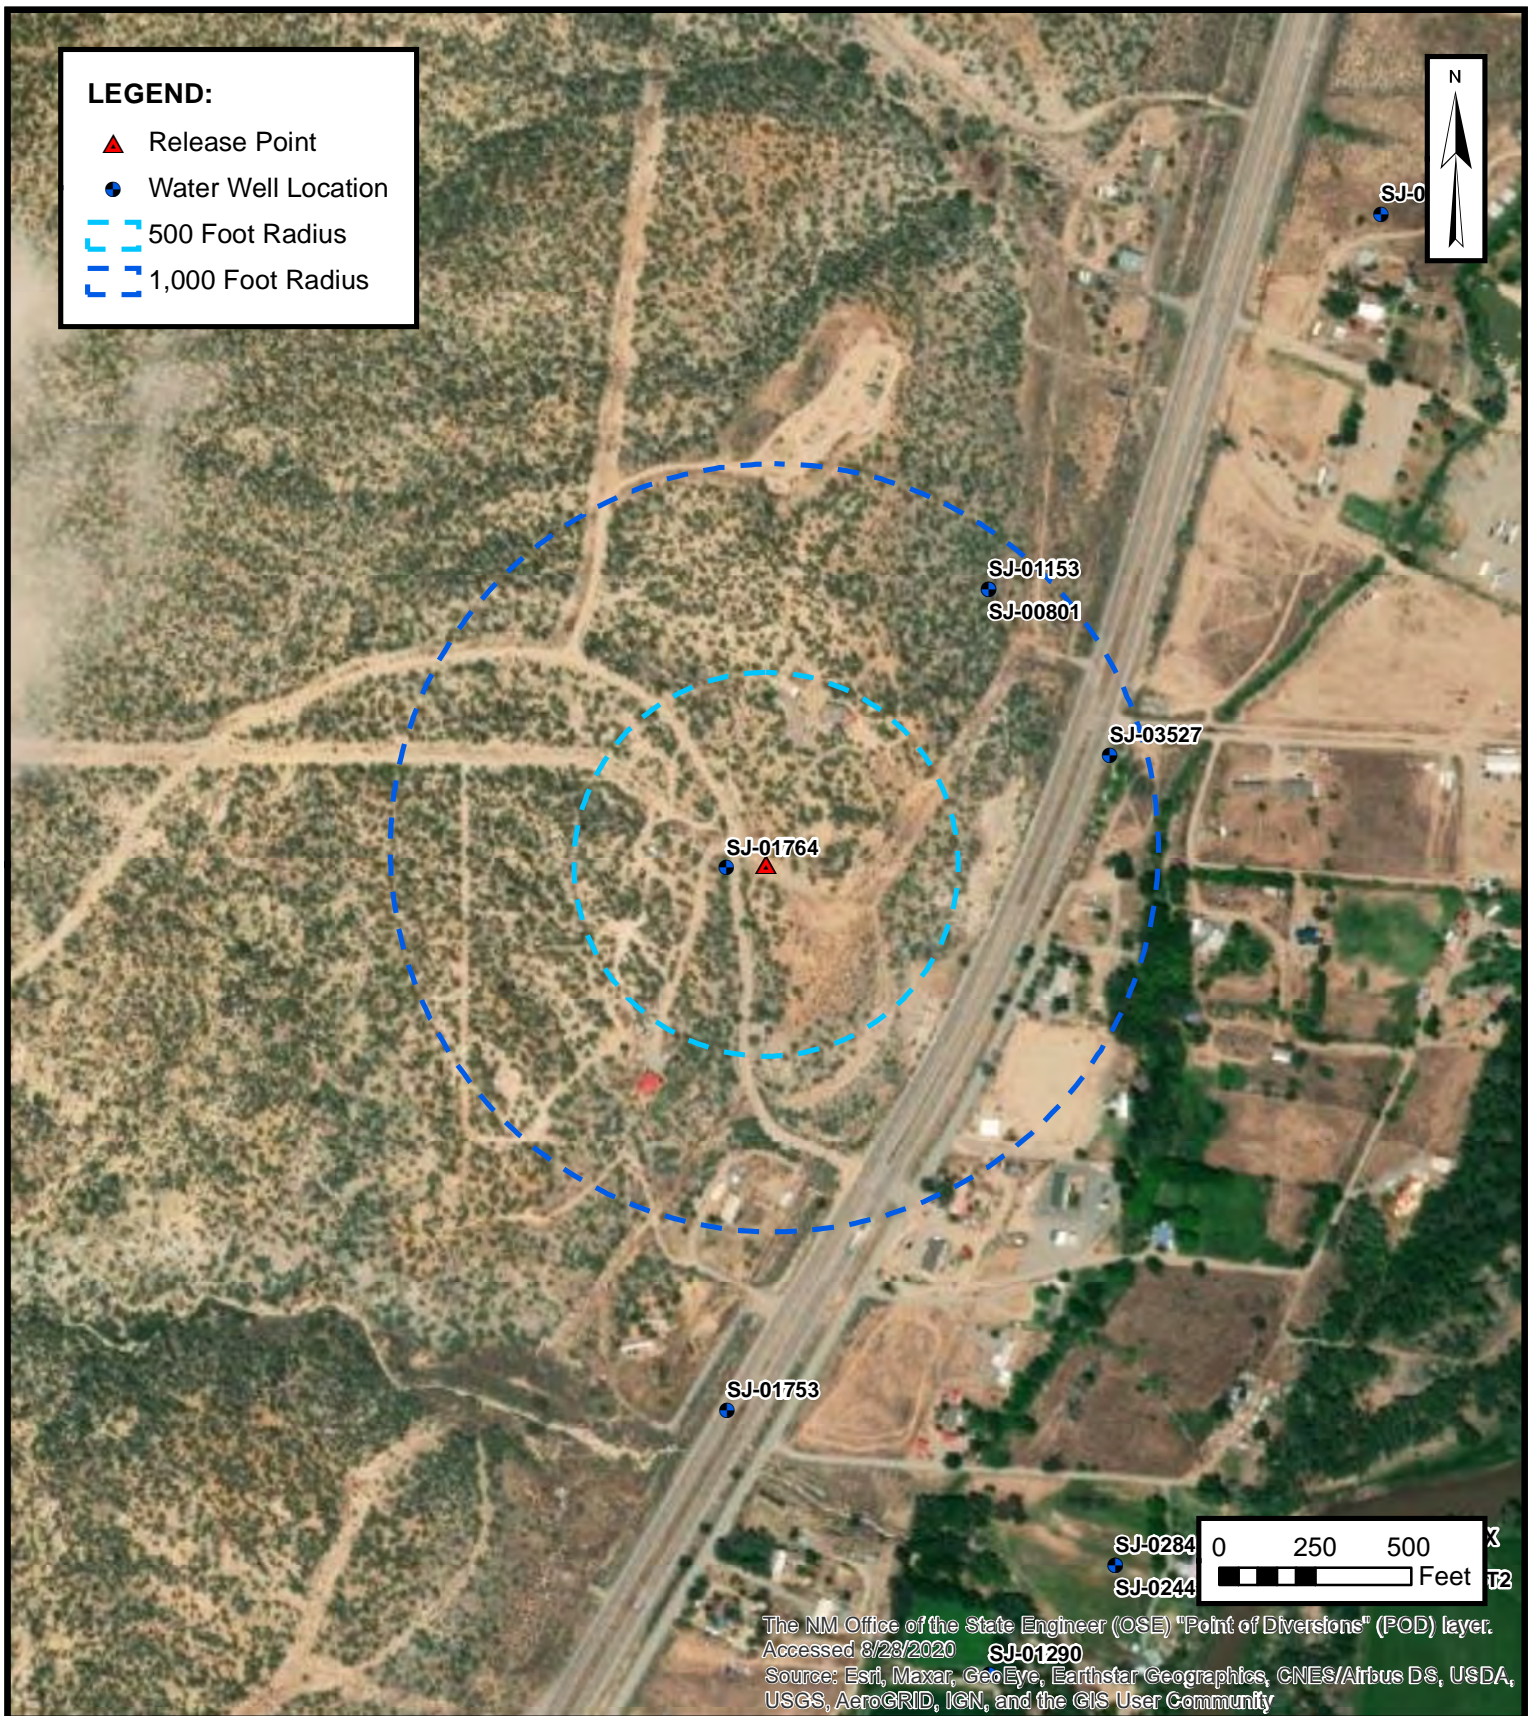
FIGURE
E

- Based on information provided in the OSE WRRS, a permit was approved in 1983 to install a well to be potentially used by less than five (5) households for domestic purposes located near the Site. However, the well associated with this permit (for POD (SJ-01764)) was apparently never installed, and no well records were available (**Figure E, Appendix B**).

- Based on information provided in the OSE WRRS there are no fresh water wells identified within 1,000 feet of the Site (**Figure E, Appendix B**).
- The Site is not located within incorporated municipal boundaries or within a defined municipal fresh water well field covered under a municipal ordinance adopted pursuant to New Mexico Statutes Annotated (NMSA) 1978, Section 3-27-3.

WATER WELL AND NATURAL SPRING LOCATION

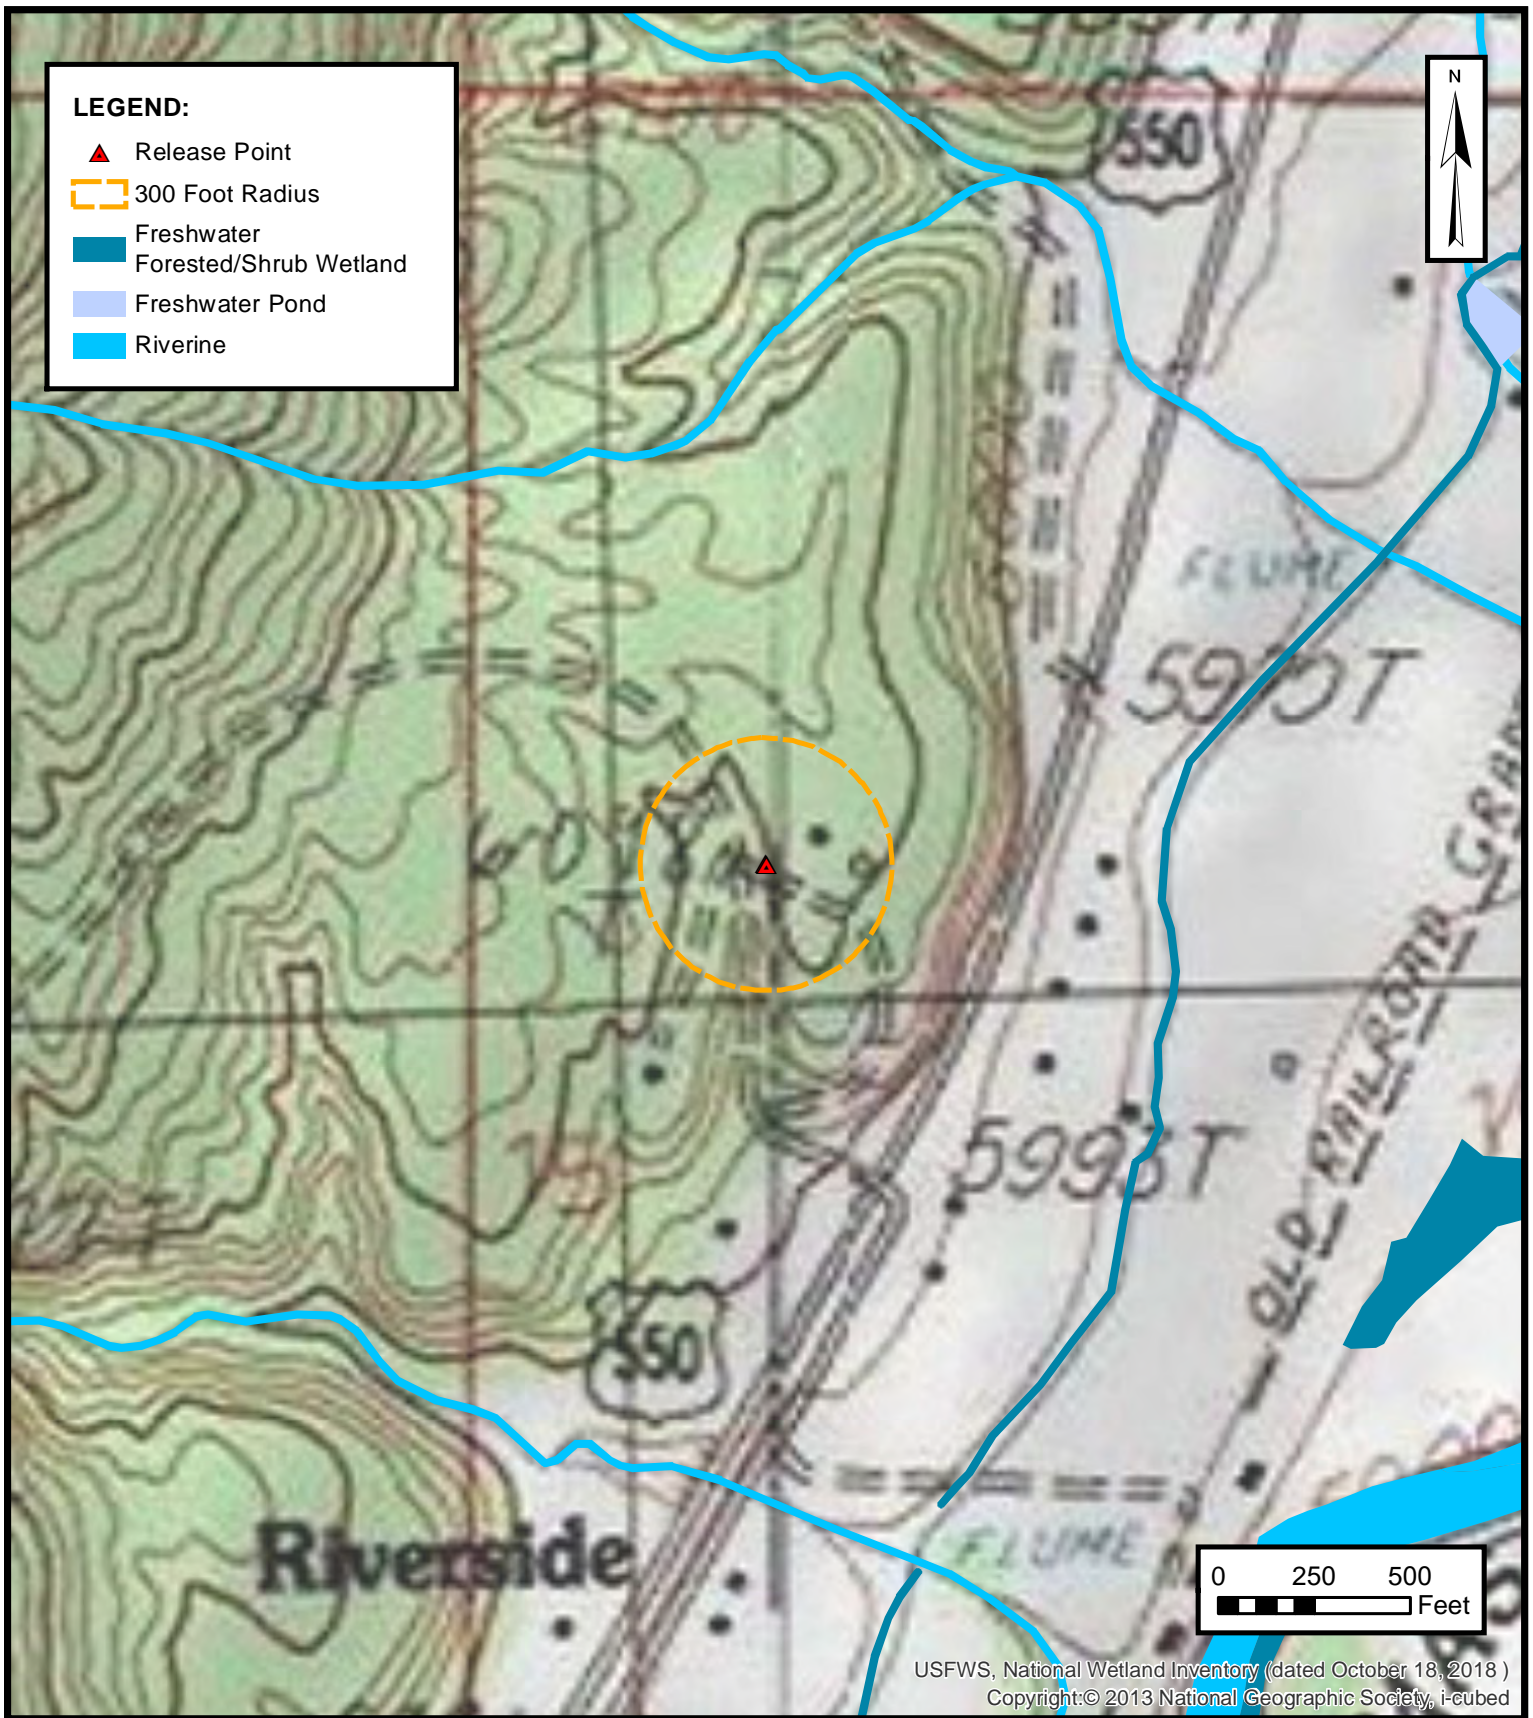
FIGURE
F

- Based on information identified in the United States (US) Fish & Wildlife Service National Wetlands Inventory Wetlands Mapper, the Site is not located within 300 feet of a wetland. (**Figure F, Appendix B**).

WETLANDS

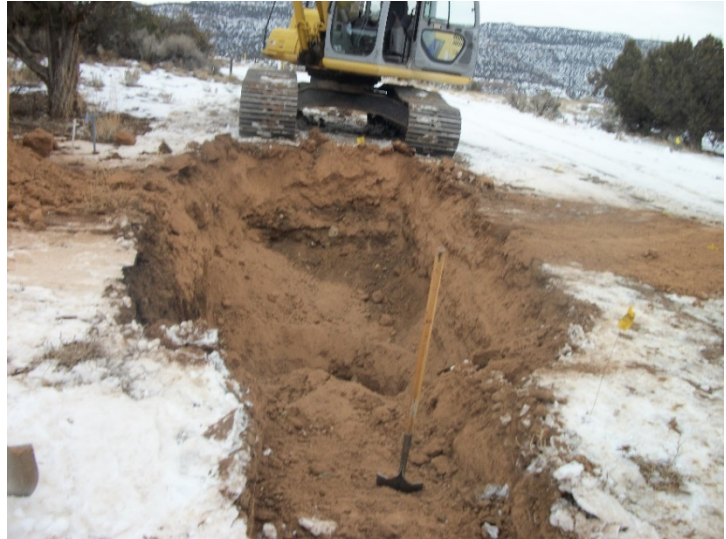
**Photograph 1**

Photograph Description: View of the pipeline repair excavation activities (January 2021).

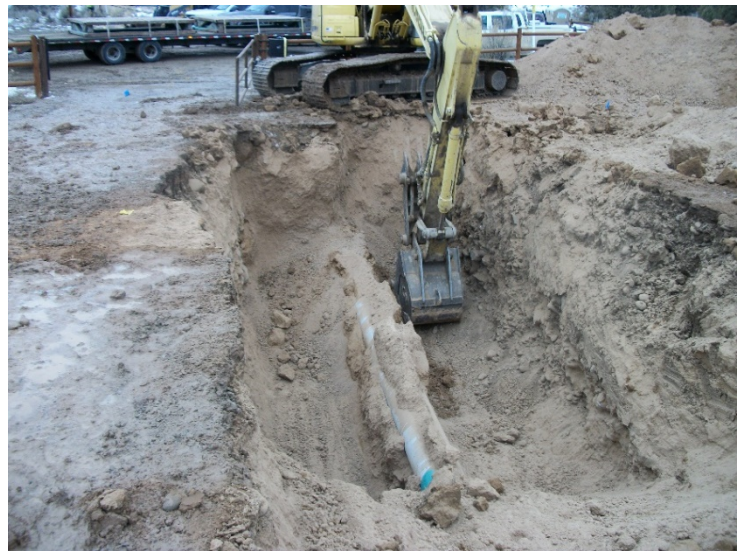
**Photograph 2**

Photograph Description: View of the pipeline repair excavation (January 2021; first sampling event).

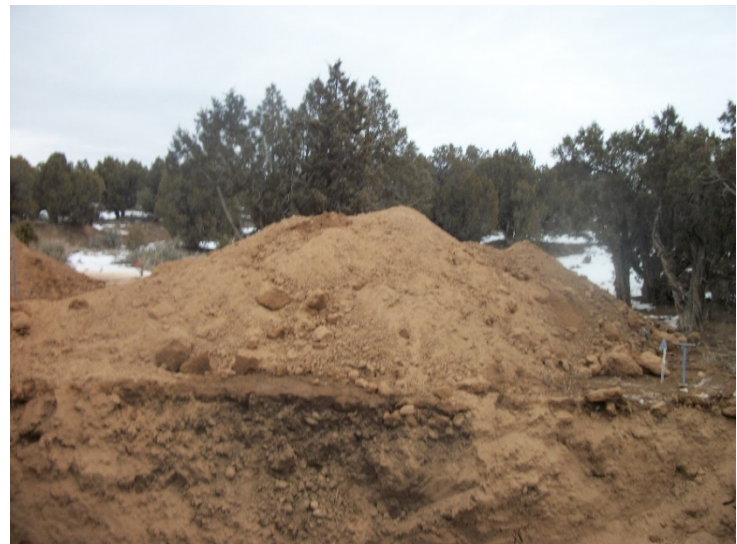
**Photograph 3**

Photograph Description: View of the stockpiled soil (January 2021; first sampling event).

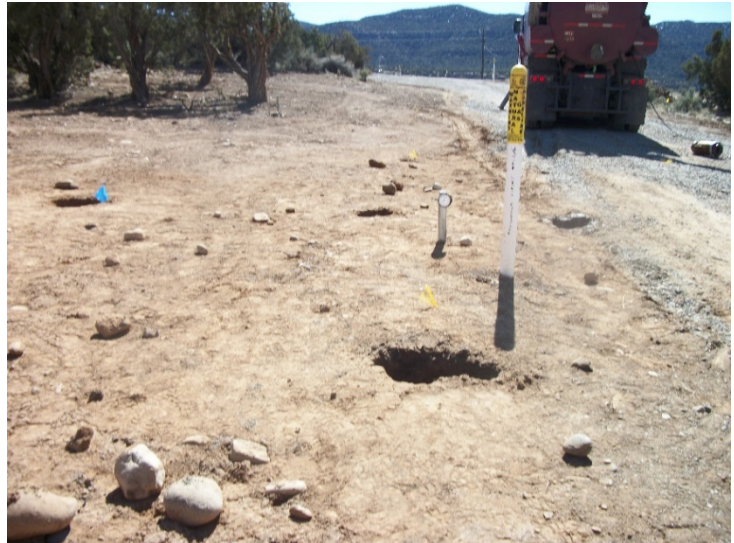
**Photograph 4**

Photograph Description: View of the soil boring locations (March 2021; second sampling event).

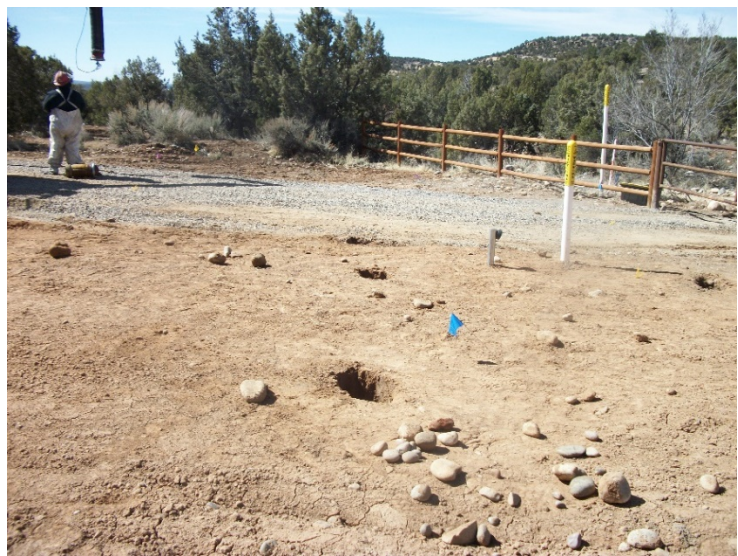
**Photograph 5**

Photograph Description: View of the soil boring locations (March 2021; second sampling event).
