CLOSURE REPORT

**Blanco C-11 @ 1600 – East Release Site
NE ¼, S11 T27N R9W
San Juan County, New Mexico**

New Mexico EMNRD OCD Incident ID No. nAPP2112326263

July 6, 2021

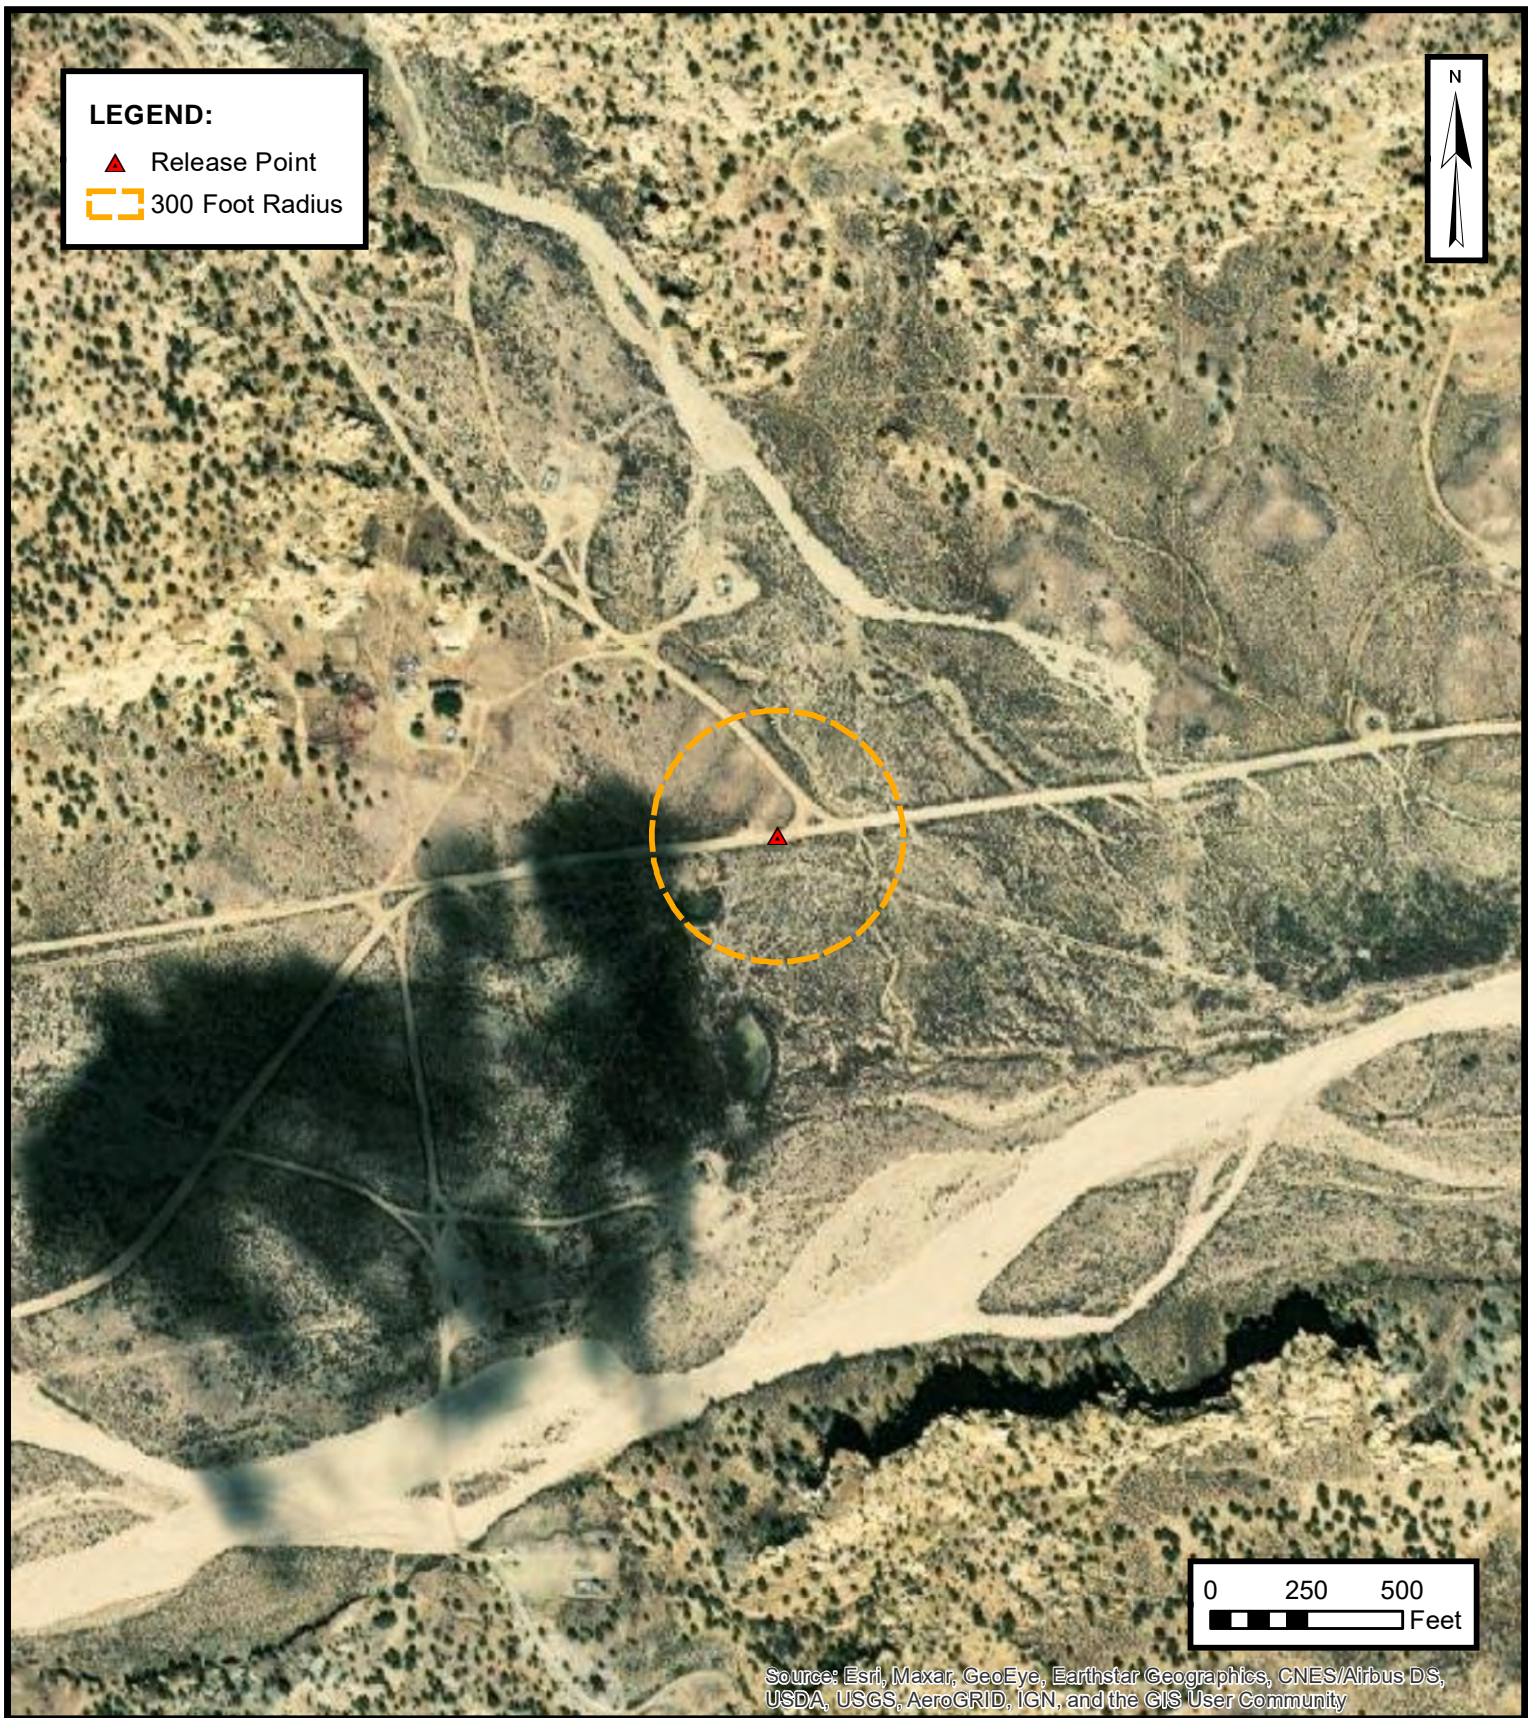
**FIGURE
C**

- The Site is located within 300 feet of a New Mexico EMNRD OCD-defined continuously flowing watercourse or significant watercourse. The Site is located approximately 176 feet west of an unnamed ephemeral wash and approximately 850 north of Jaques Canyon Wash (**Figure C, Appendix B**).

**300 FOOT RADIUS
WATERCOURSE AND DRAINAGE IDENTIFICATION**

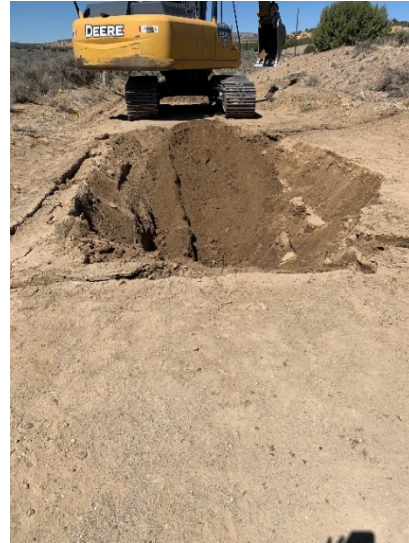
**Photograph 1**

Photograph Description: View of in-process excavation activities.

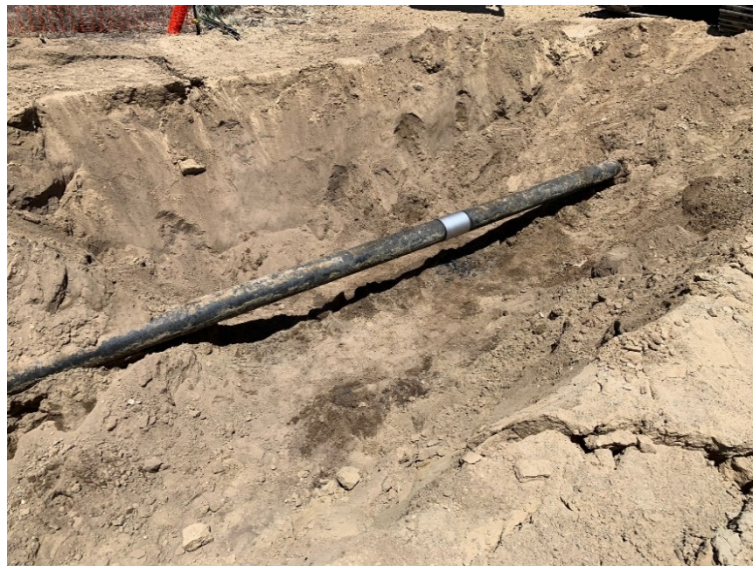
**Photograph 2**

Photograph Description: View of in-process excavation activities.

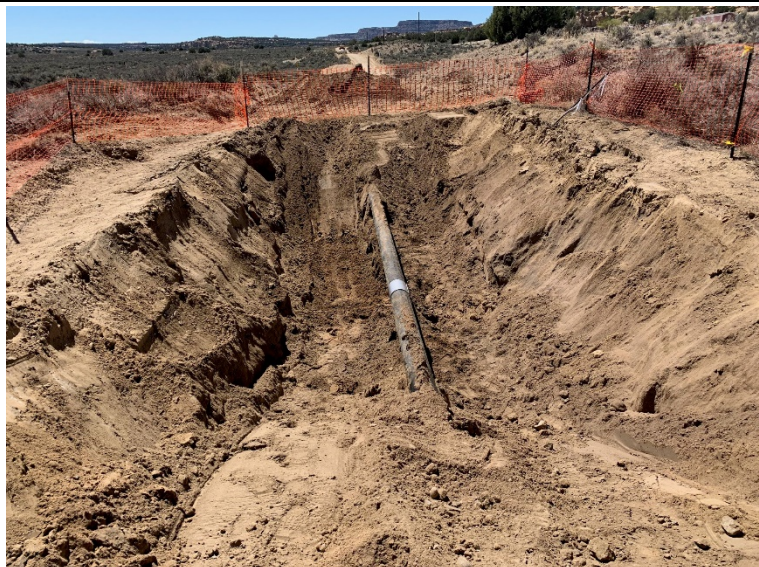
**Photograph 3**

Photograph Description: View of in-process excavation activities.

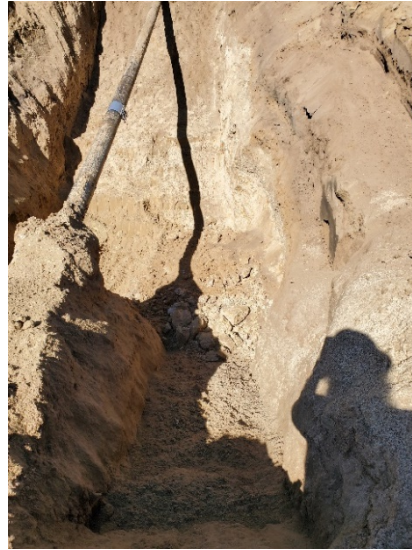
**Photograph 4**

The final excavation measured approximately 48 feet long and 10 feet wide at the maximum extents. The maximum depth of the excavation measured approximately 17 feet bgs. The lithology encountered during the completion of remediation activities consisted primarily of unconsolidated silty sand.

Photograph Description: View of the final excavation.

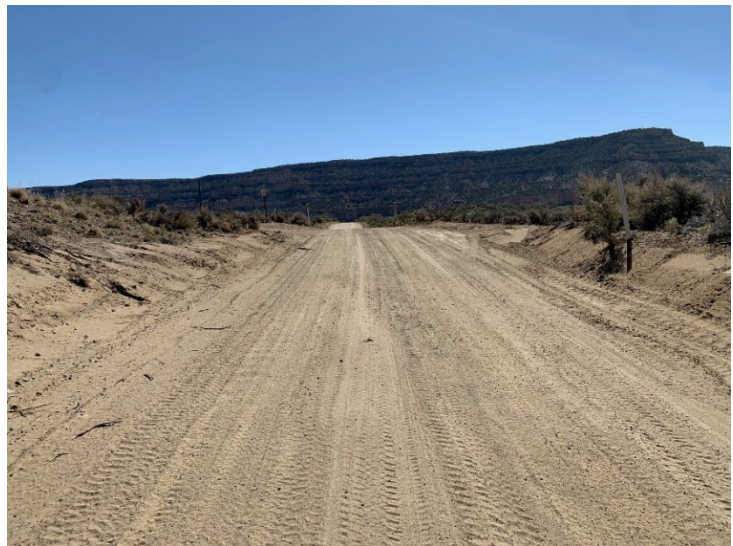
**Photograph 5**

Photograph Description: View of the excavation after initial restoration.

The excavation was backfilled with clean imported fill and contoured to provide a suitable driving surface.
