Release Notification

Site Name Allison Unit 13N_13P	Site Type Well Location
Date Release Discovered 6/23/2021 @ 10:30am MT	API# 30-045-34376 (Allison Unit 13N)

Executive Summary

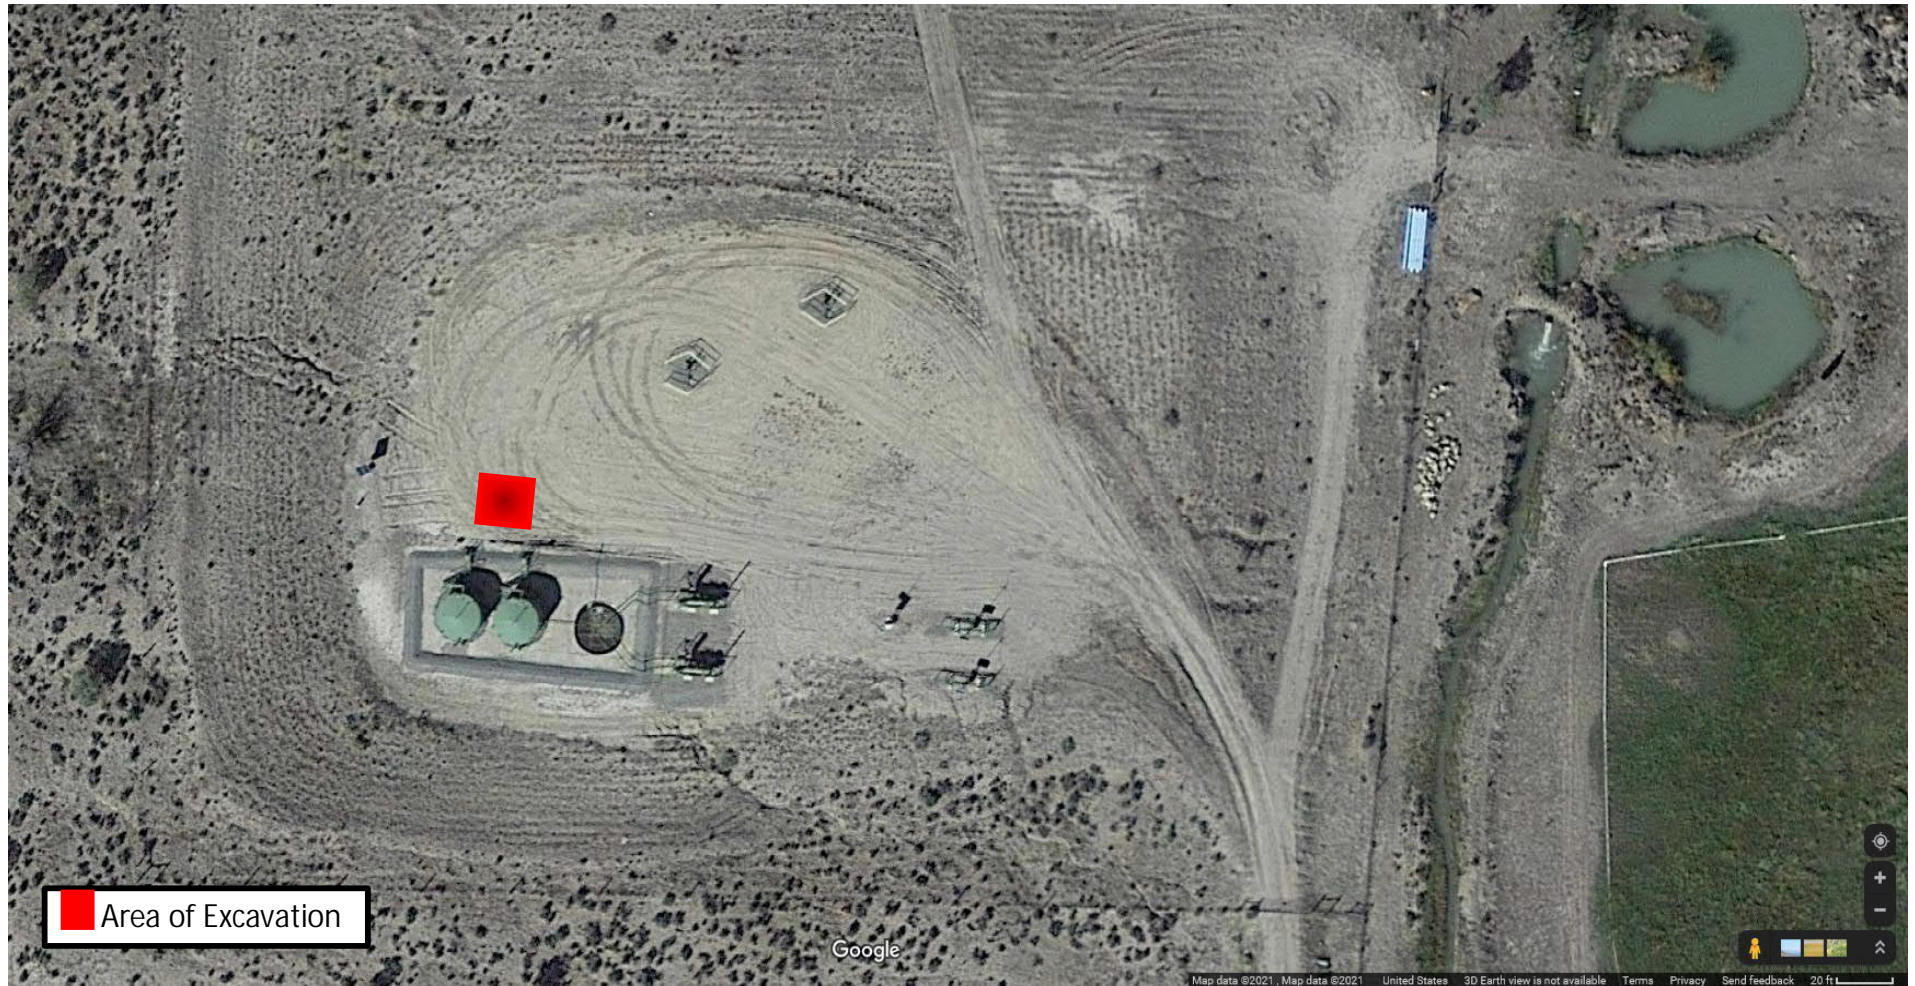
Scaled Map – Close-up

Note 1: The final dimensions of the excavation measured 14' x 14' x 6'.

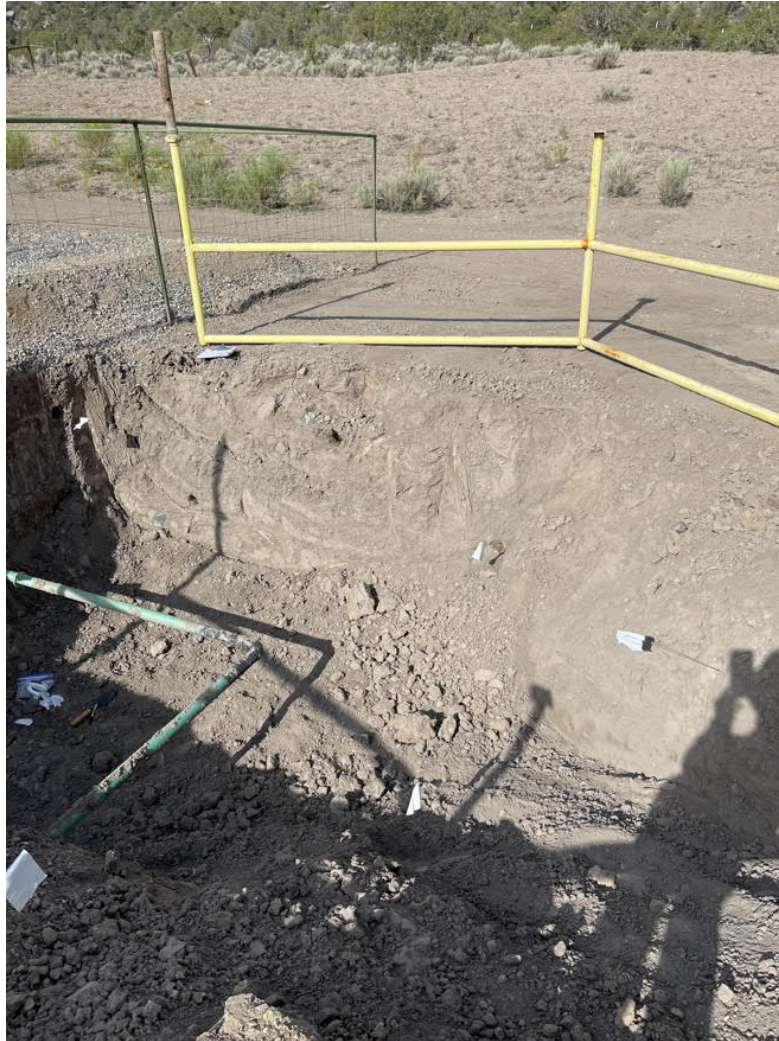
W&N Walls
8/10/2021

Note 1: A single 5-point composite was collected from the West and North sidewalls on 8/10/2021. Sample results indicated that these sidewalls were below clean up action levels after the initial excavation attempt.

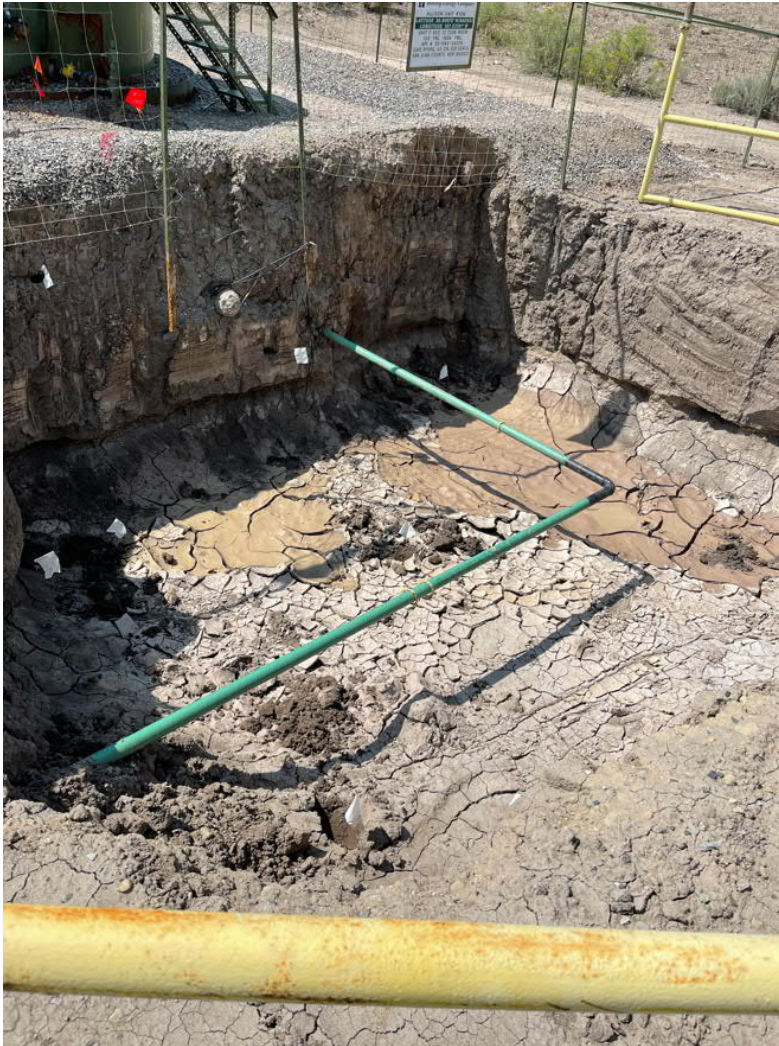
Base
8/30/2021

Note 1: A single 5-point composite was collected from the base of the excavation on 8/30/2021. Laboratory results indicated that this sample was below clean up action levels following additional excavation activities during the week of August 16. It should be noted that several storm events occurred in the area between the initial and follow-up sampling events.

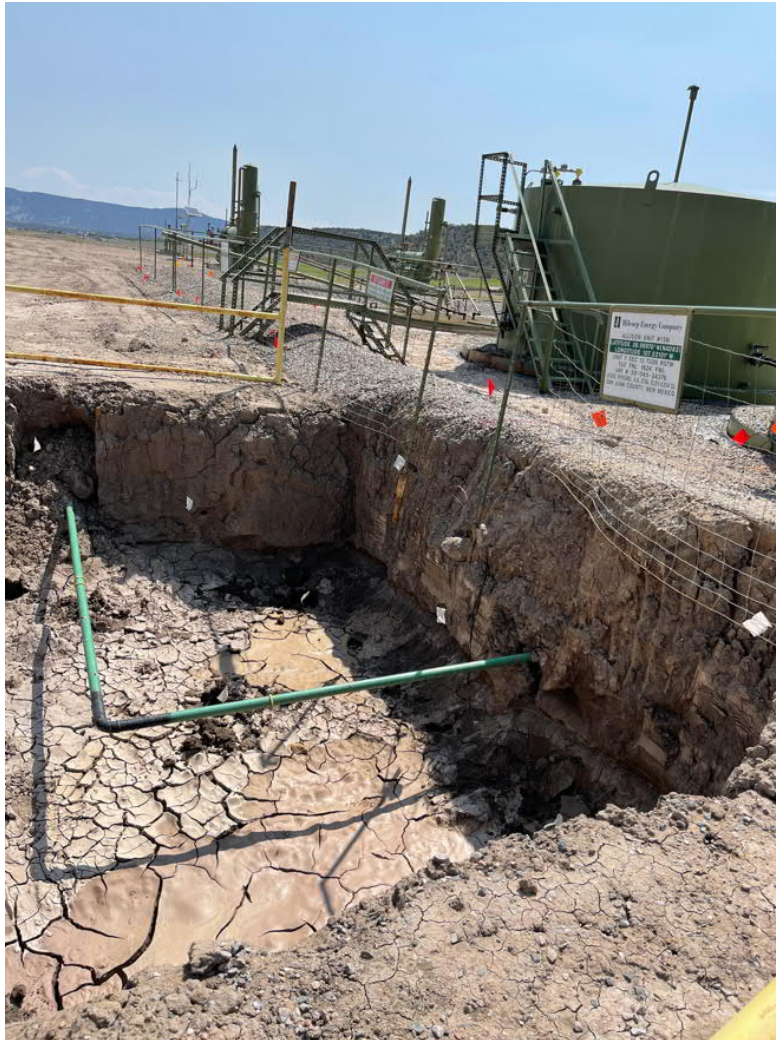
South &
East Walls
8/30/2021

Note 1: A single 5-point composite was re-collected from the south and east sidewalls of the excavation on 8/30/2021. Laboratory results indicated that this sample was below clean up action levels following additional excavation activities during the week of August 16. It should be noted that several storm events occurred in the area between the initial and follow-up sampling events.
