CLOSURE REPORT

**Blackrock D#1E
SW ¼, S20 T26N R11W
San Juan County, New Mexico**

NM EMNRD OCD Incident ID No. NAPP2109046512

May 18, 2021
Ensolum Project No. 05A1226143

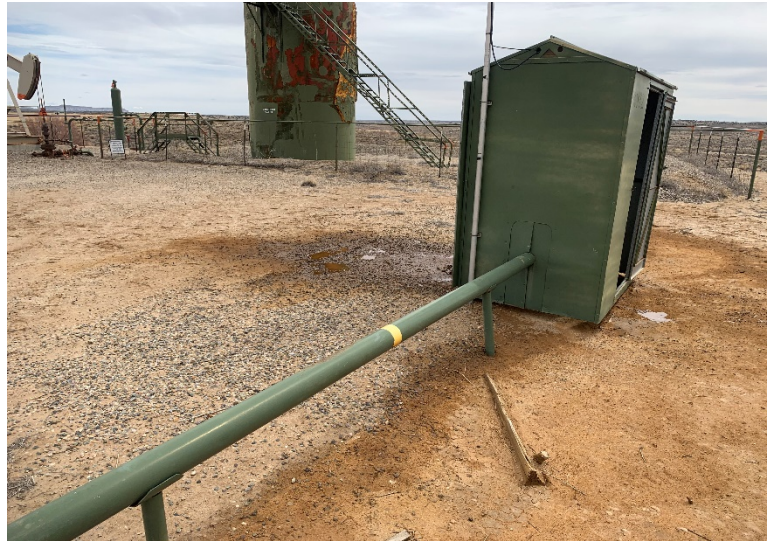
**Photograph 1**

Photograph Description: View of the release area.

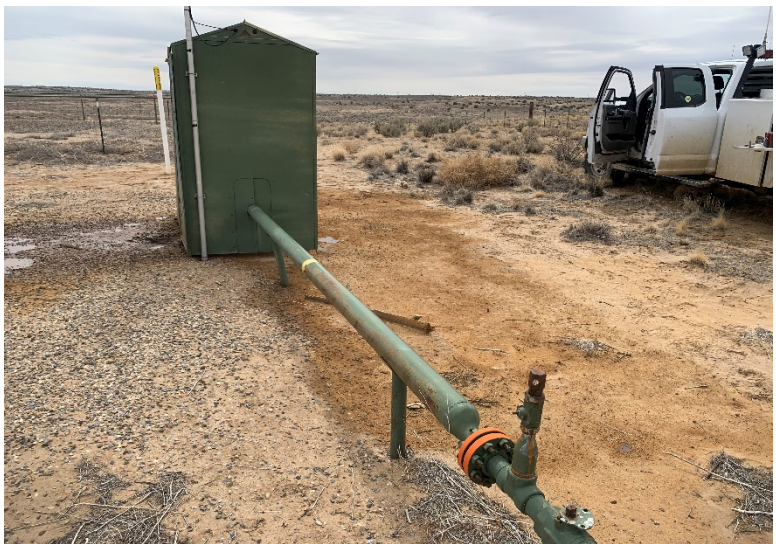
**Photograph 2**

Photograph Description: View of the release area.

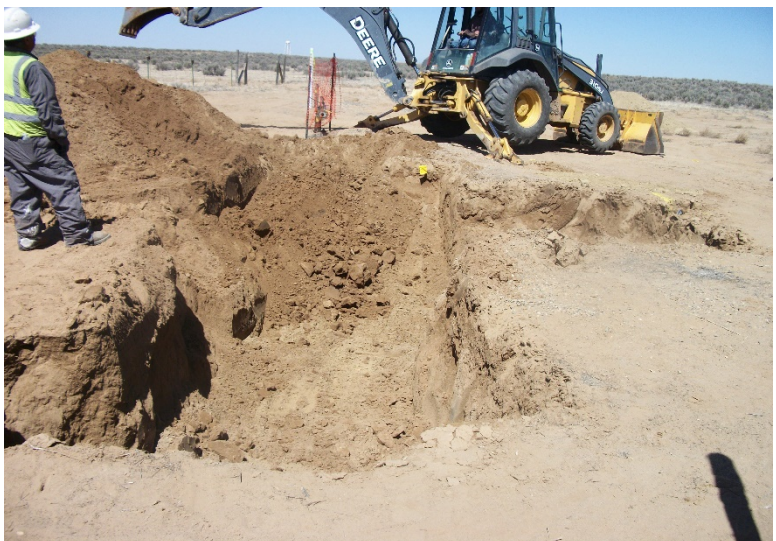
**Photograph 3**

Photograph Description: View of in-process excavation activities.

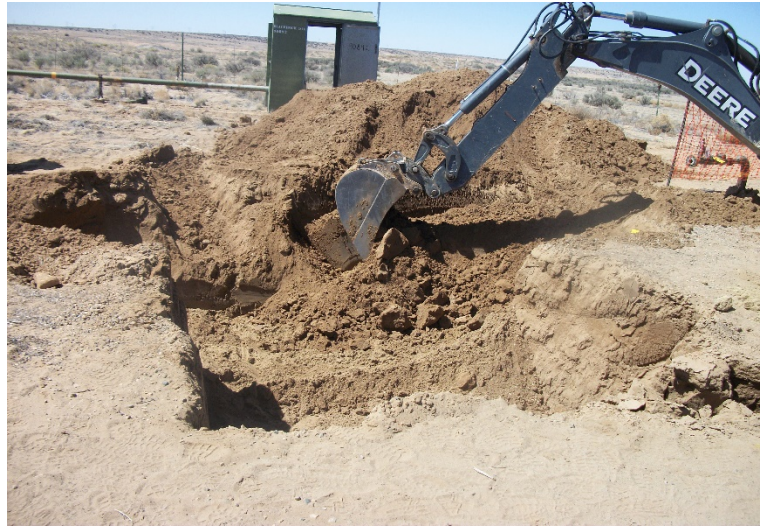
**Photograph 4**

Photograph Description: View of in-process excavation activities. Note removed meter house and above-grade piping in the background.

The meter house, meter, and above-grade piping were temporarily dismantled and removed to allow access to the impacted soils. The final excavation measured approximately 17 feet long and 15 feet wide at the maximum extents. The maximum depth of the excavation measured approximately 3.5 feet bgs. The lithology encountered during the completion of remediation activities consisted primarily of unconsolidated silty sand.

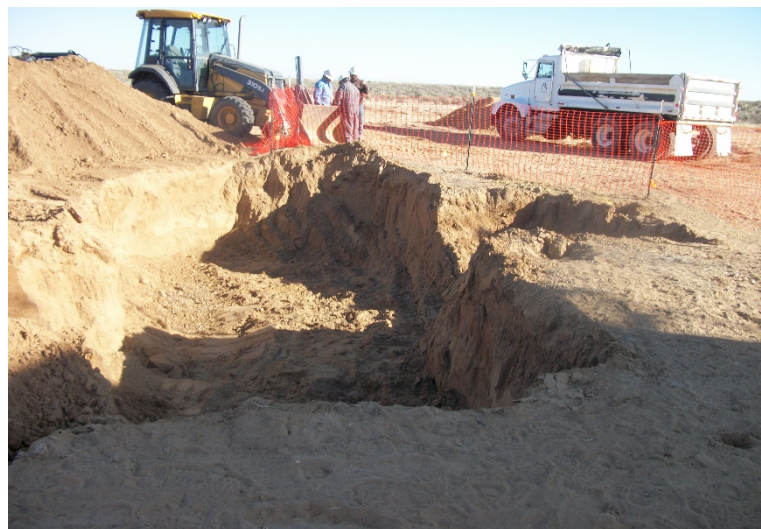
**Photograph 5**

Photograph Description: View of the final excavation.

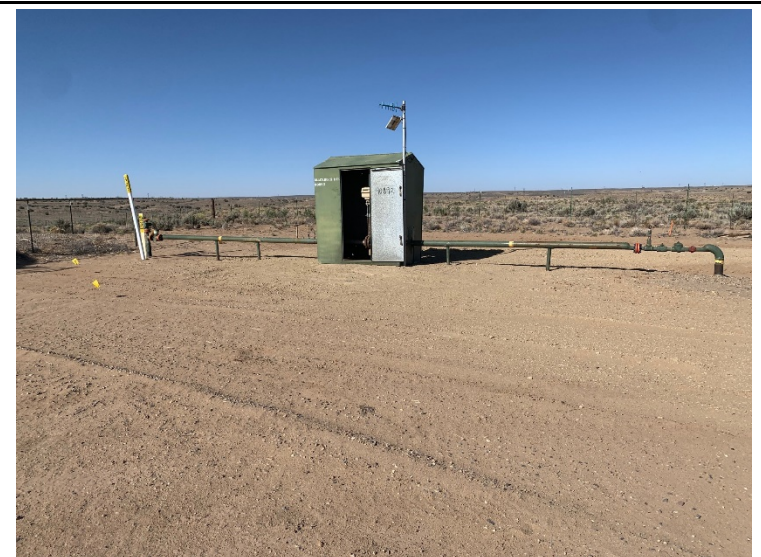
**Photograph 6**

Photograph Description: View of the excavation after initial restoration.

The meter house was re-installed.

The excavation was backfilled with imported soil and then contoured to surrounding grade. The area near the meter run is a driving area.
