## CLOSURE REPORT

**Blanco C-11 @ 1730 – West Release Site  
SE ¼, S10 T27N R9W  
San Juan County, New Mexico**

**New Mexico EMNRD OCD Incident ID No. nAPP2112327080**

Ensolum Project No. 05A1226146

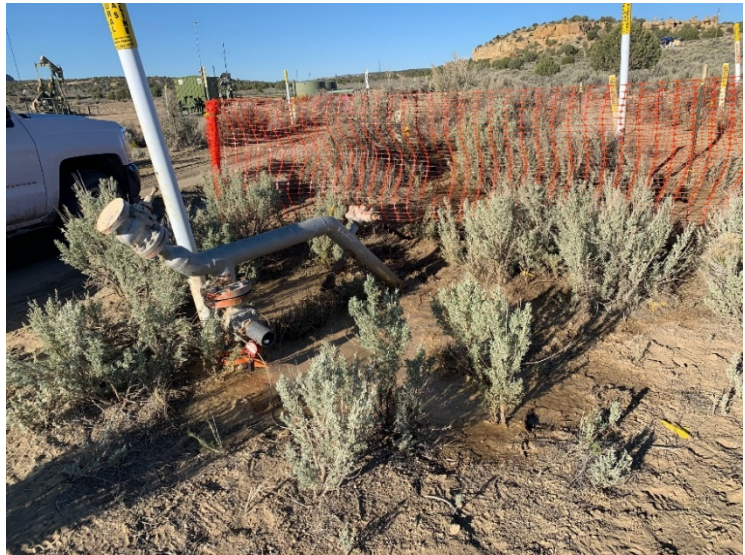
**Photograph 1**

Photograph Description: View of release area.

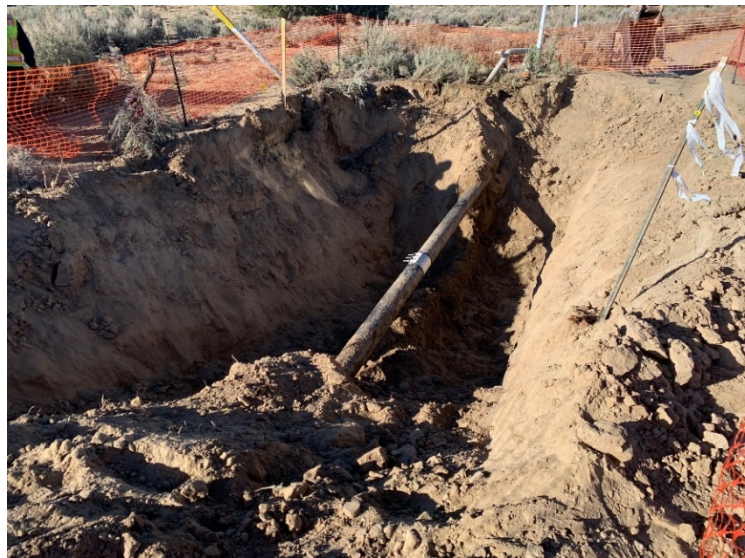
**Photograph 2**

Photograph Description: View of in-process excavation activities.

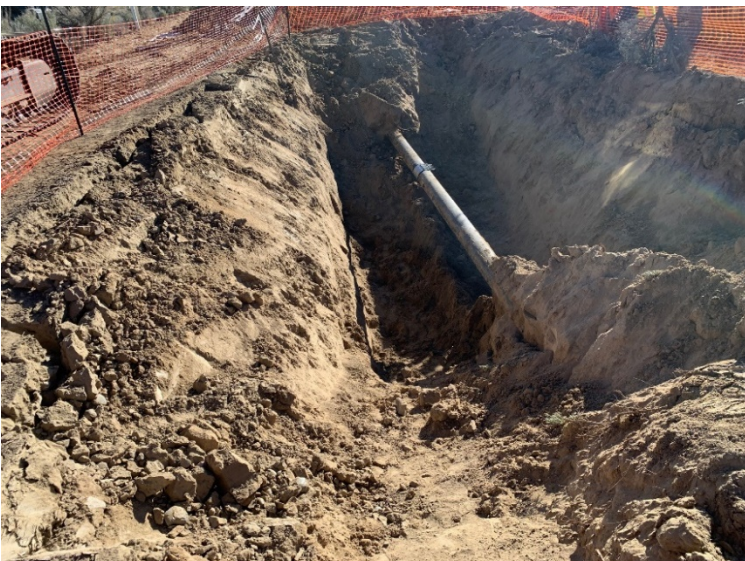
**Photograph 3**

Photograph Description: View of in-process excavation activities.

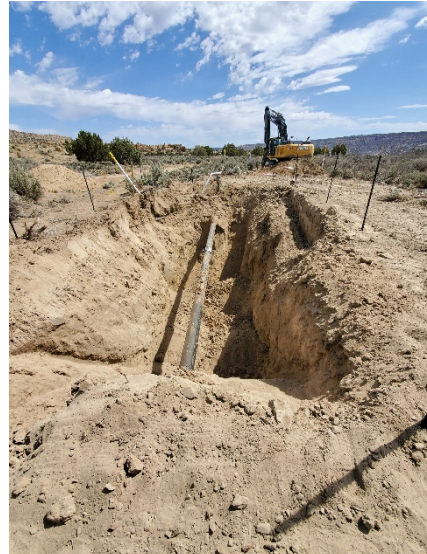
**Photograph 4**

Photograph Description: View of the final excavation.

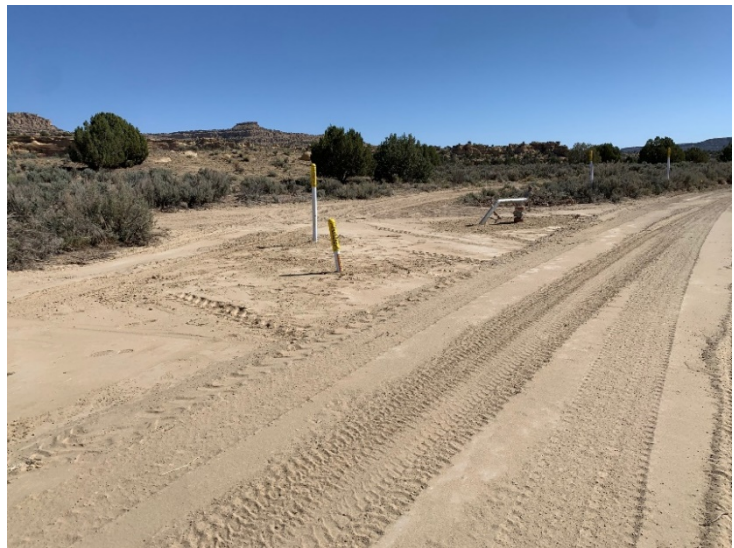
**Photograph 5**

Photograph Description: View of the excavation after initial restoration.

The excavation was backfilled with clean imported fill and contoured to provide a suitable driving surface.
